South Australian Heritage Act 1978-80	HERITAGE SURVEY ITEM IDENTIFICATION SHEET	PROJECT HERITAGE SURVEY REGION 4 Item Ref. No. 13A
ITEM NAME: Farm Complex and Irrigation System Former or other (Irrigation)		Office Use ITEM No. DOCKET No.
<p>DESCRIPTION: An unusual watering system consisting of an earthen weir across the creek at the junction of two creeks, with a spillway around the contour of the hill and a brick wall across the creek to deflect water into a brick channel down to the back aquaduct with outlets at regular intervals.</p> <p>HISTORICAL SUMMARY: Croser's property was originally part of Wm. Gerard's Yoho station, and was known as 'Duck's Hut'. Gerard split up Yoho, certainly prior to 1878 (although Gerard's stud was not dispersed until 1880). The irrigation system was, supposedly, based on Gerard's ideas at Yoho, and could have been built c.1860s-1870s, however it may be of a later date and designed by the local inventor, Garnet Kelly.</p> <p>HERITAGE SIGNIFICANCE: The item currently registered, should be extended to include the upper reaches of the irrigation system and the weir at the junction of No-where-else and Yoho Creeks. It is without doubt an amazing pointer t

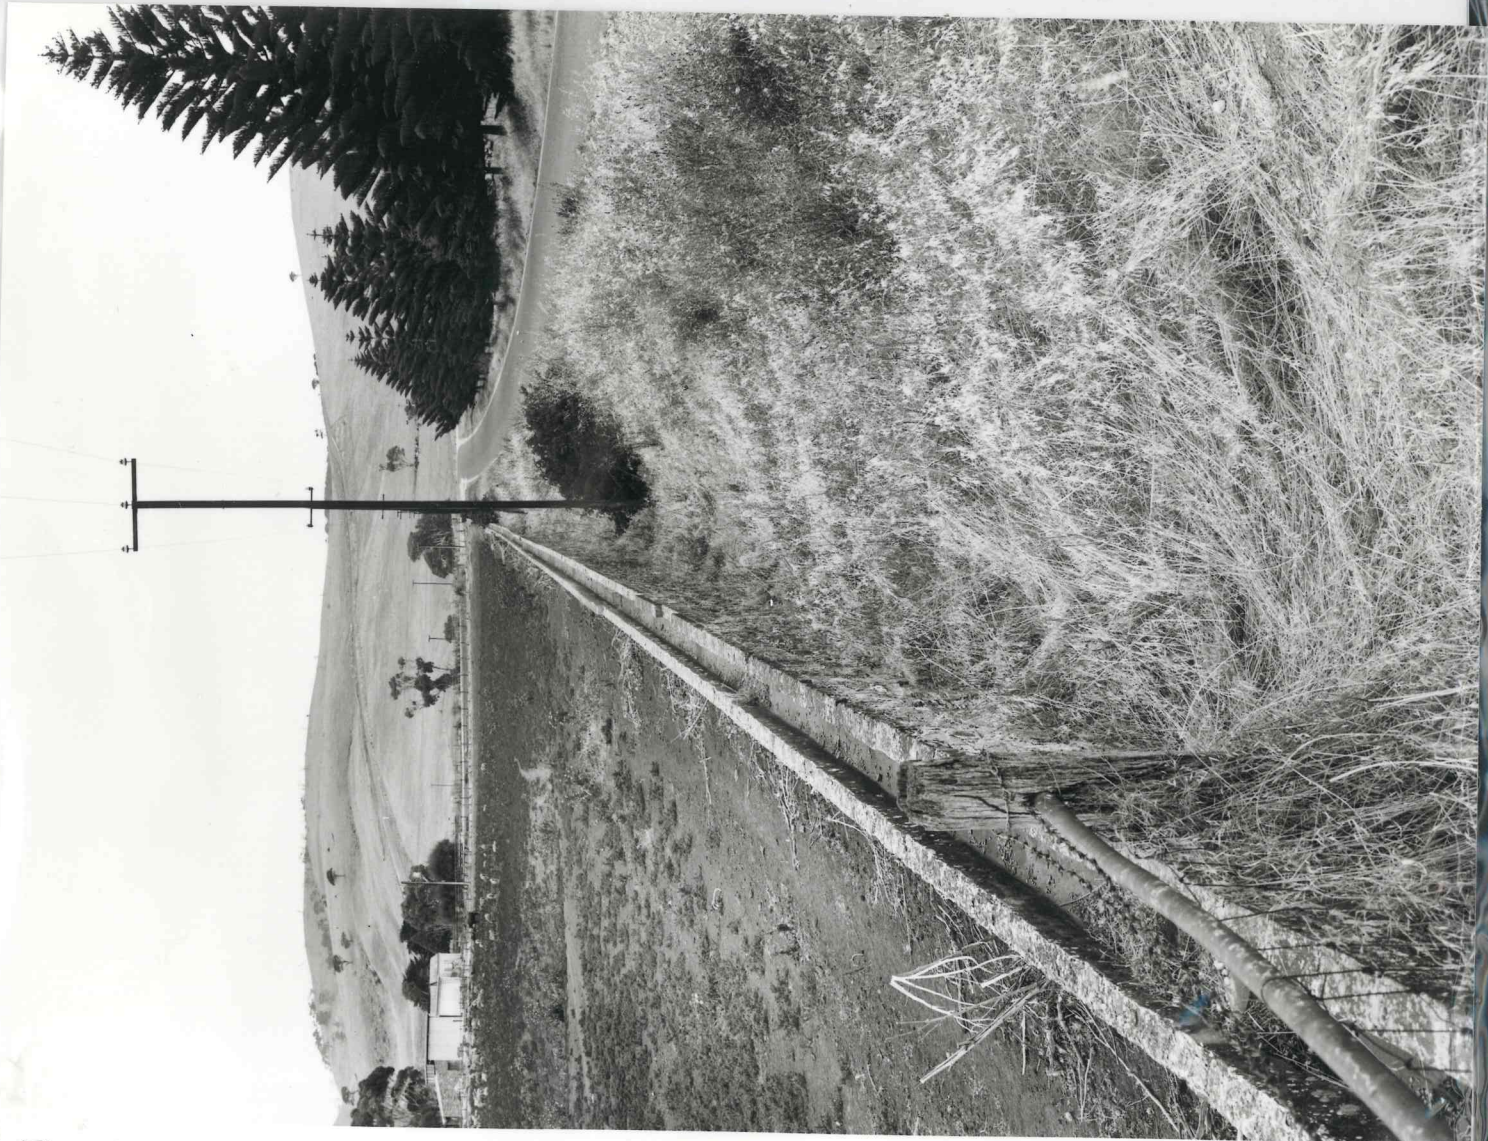
FILM 40
NO 7

VIEW EAST ALONG WALL WITH
IRRIGATION CHANNEL

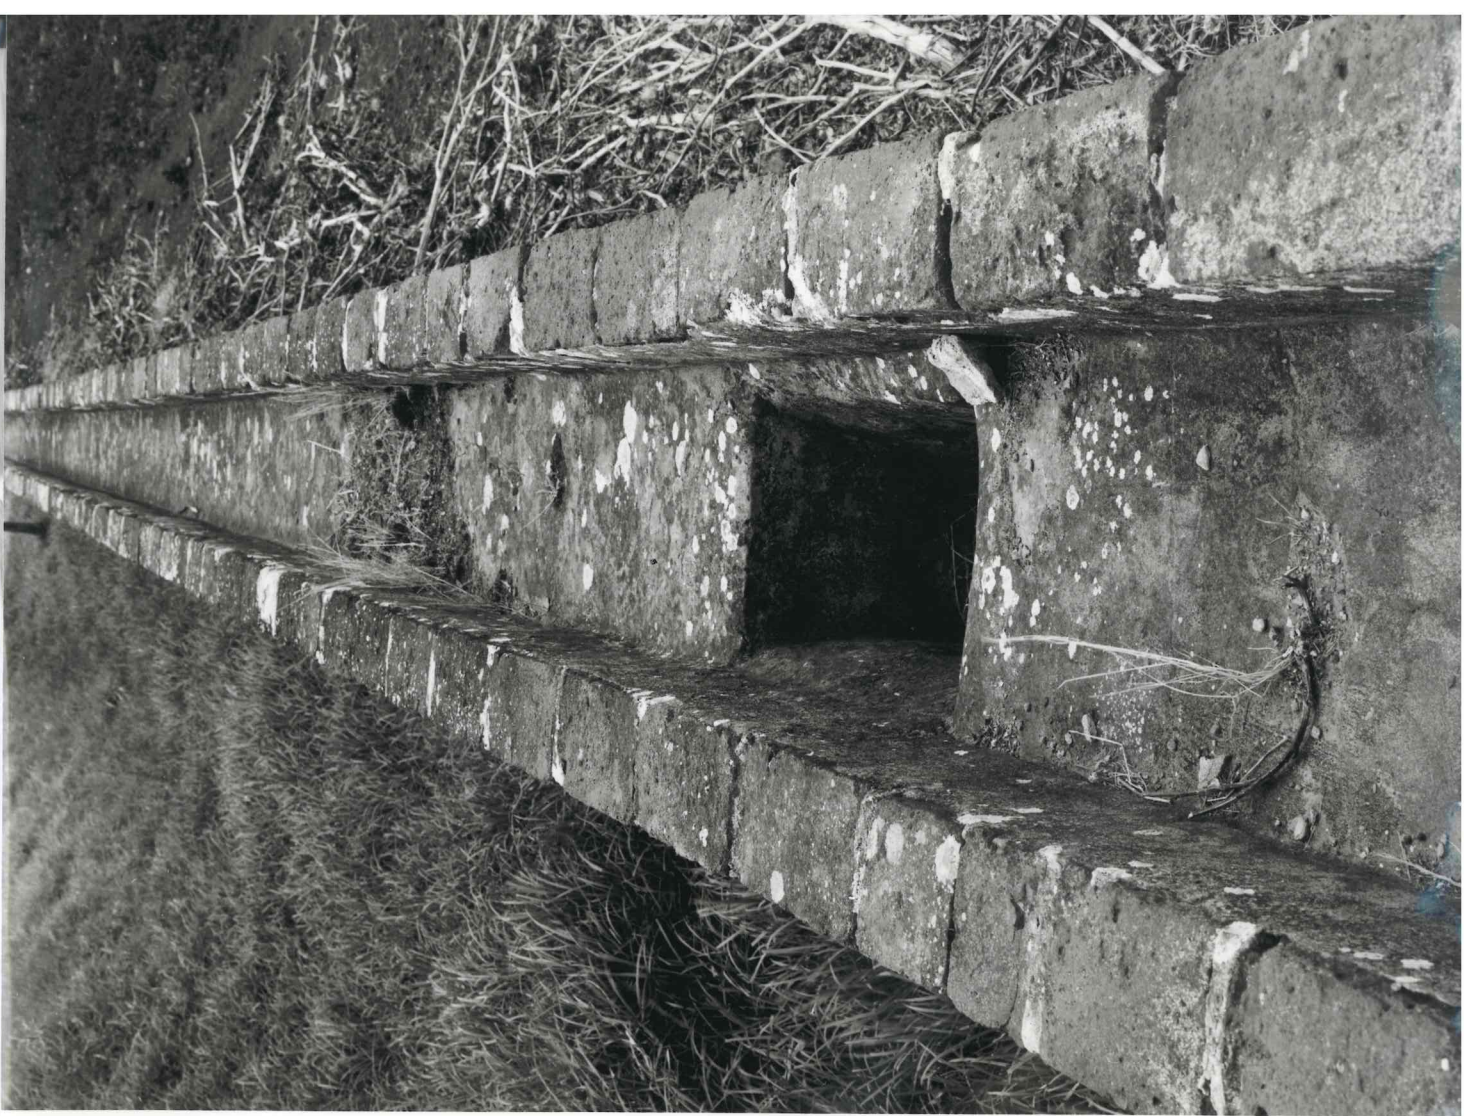
FILM 40
NO 10

IRRIGATION OUTLET IN CHANNEL
ON WALL

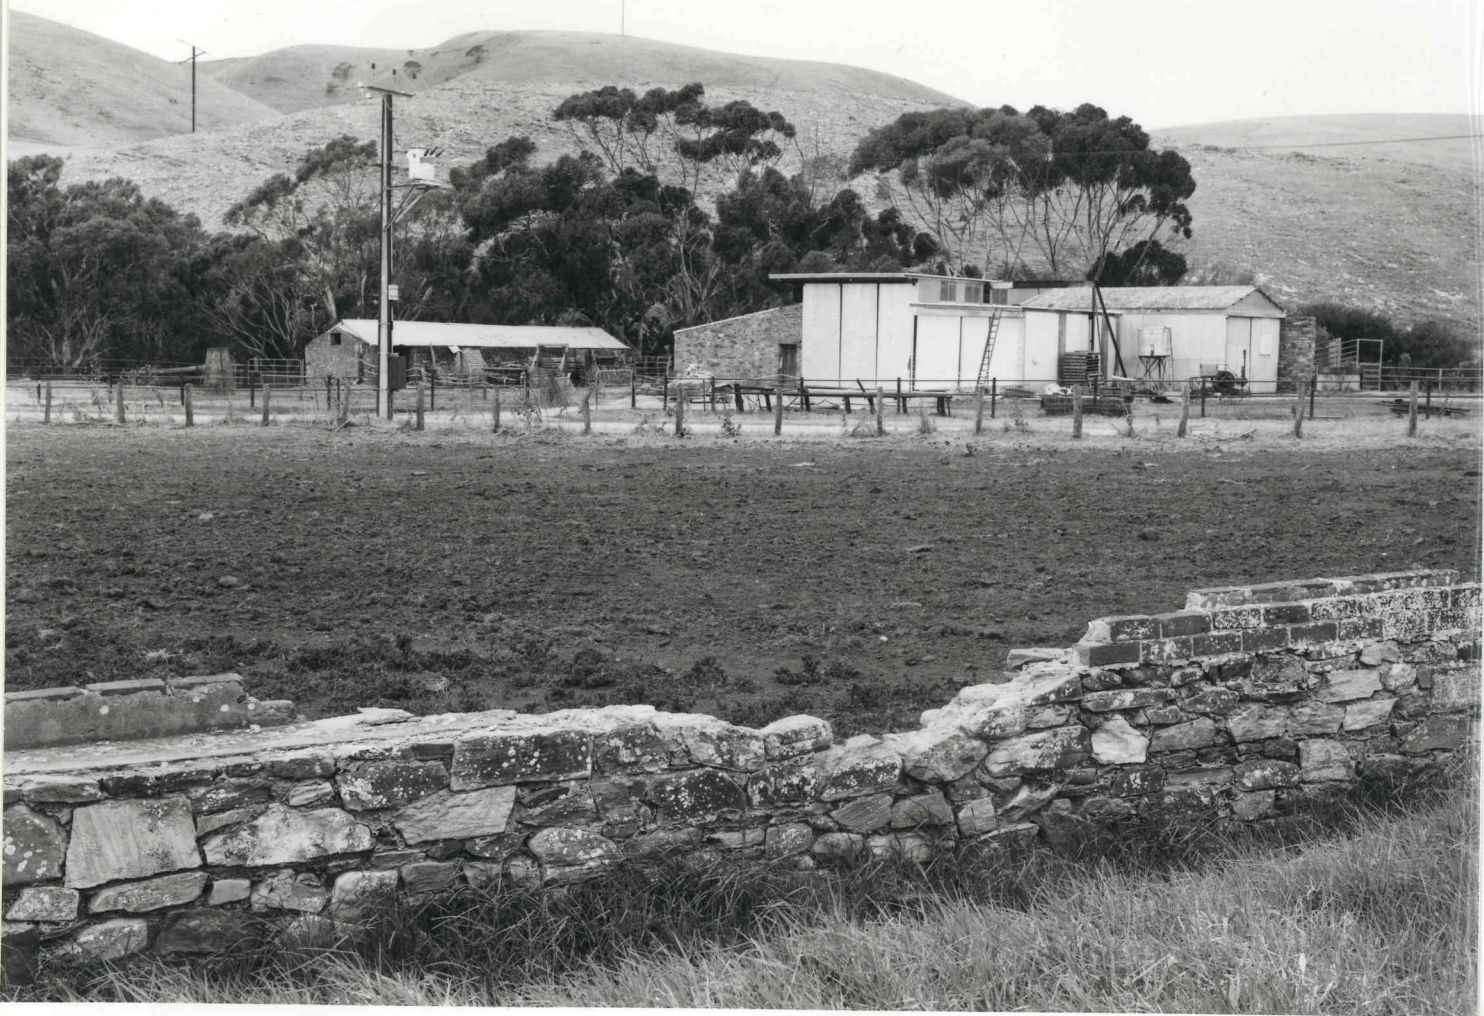
FILM 40
No 9

WALL WITH IRRIGATION CHANNEL
6527 - 10346

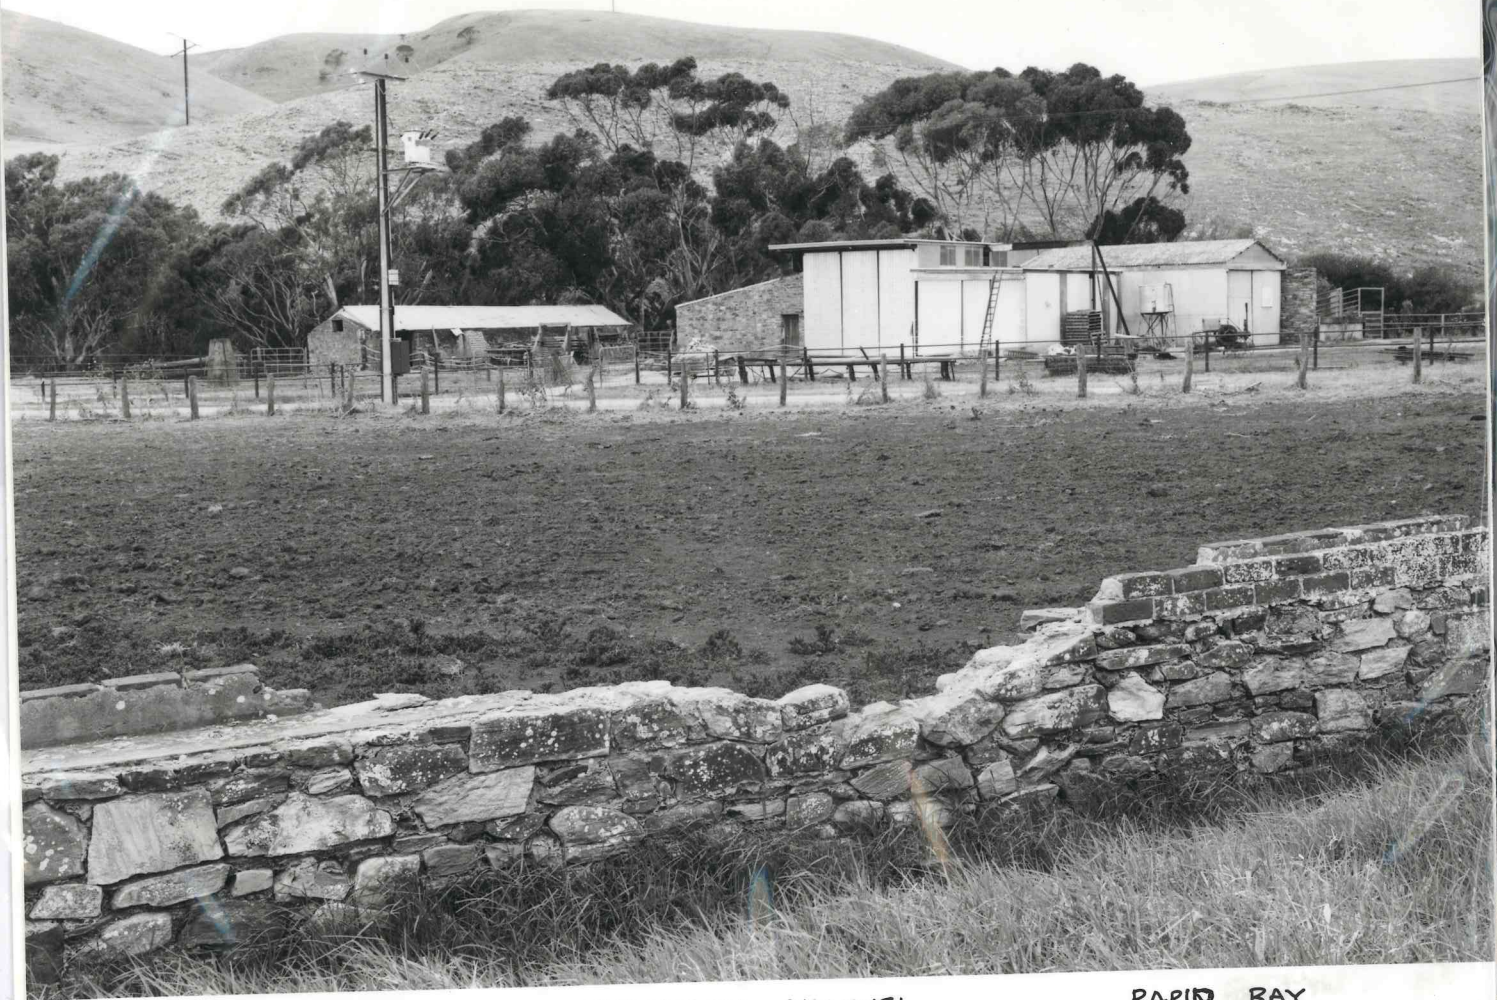
FILM 40
No 9

WALL WITH IRRIGATION CHANNEL

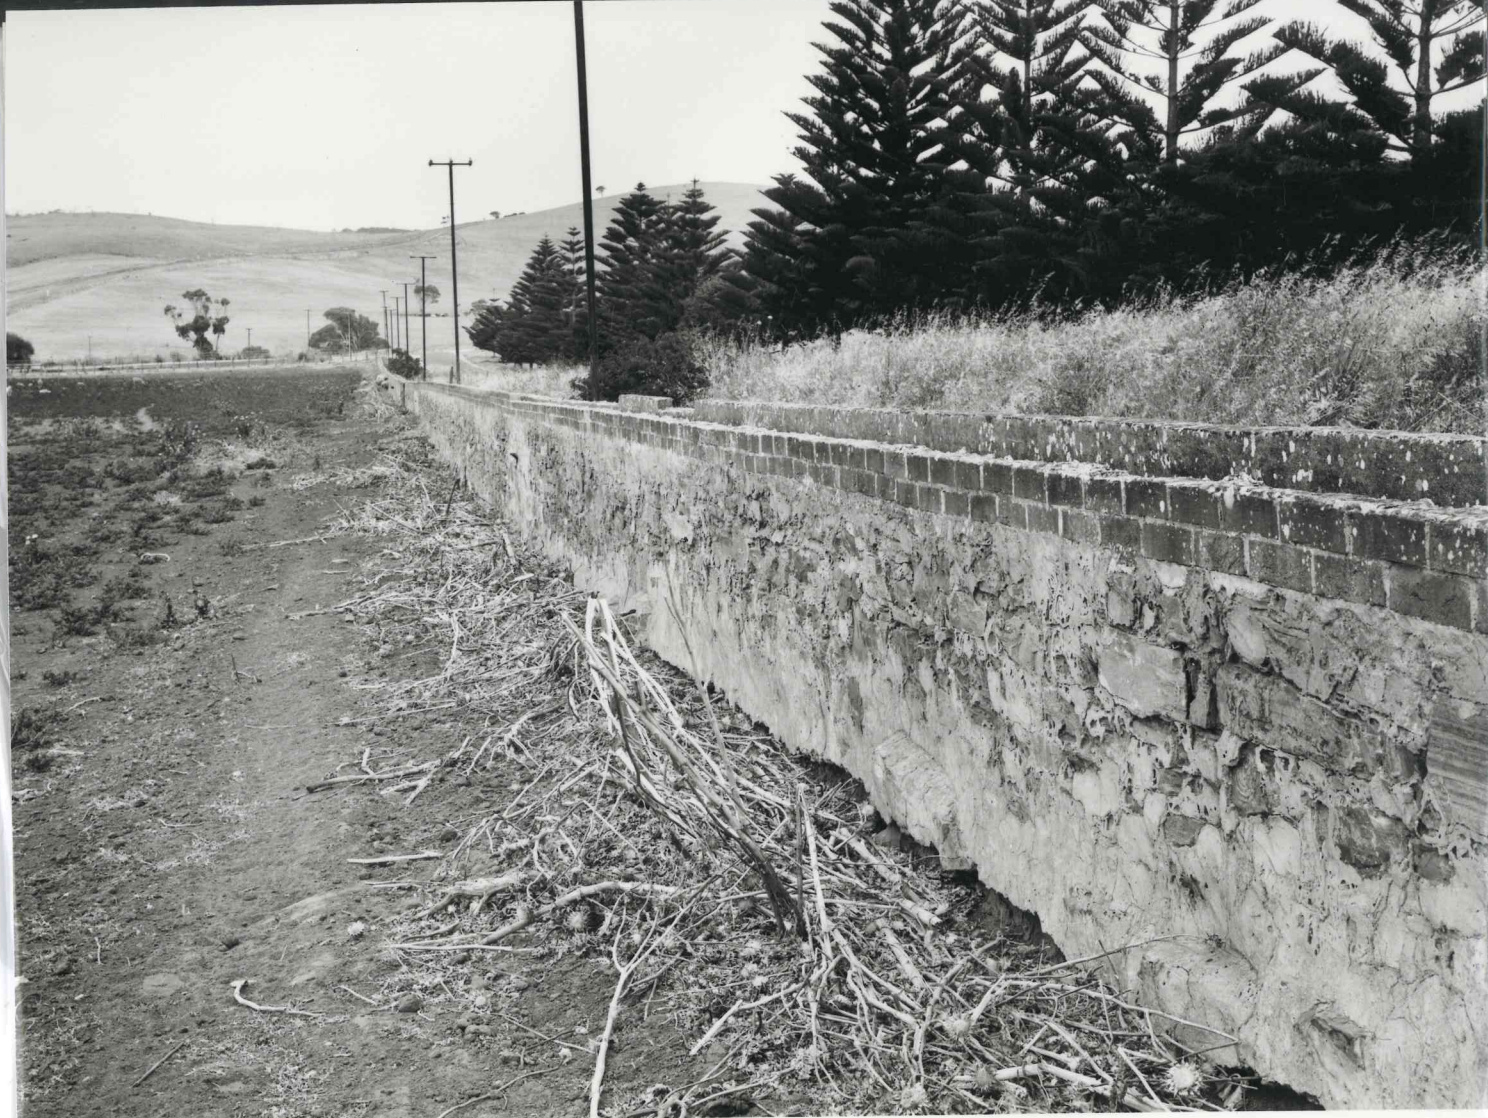
FILM 40
NO 8

VIEW EAST ALONG WALL WITH
IRRIGATION CHANNEL
