Well Construction Report for Mallee Dune Seeps Project

Chris Henschke

Primary Industries and Regions

August 2015

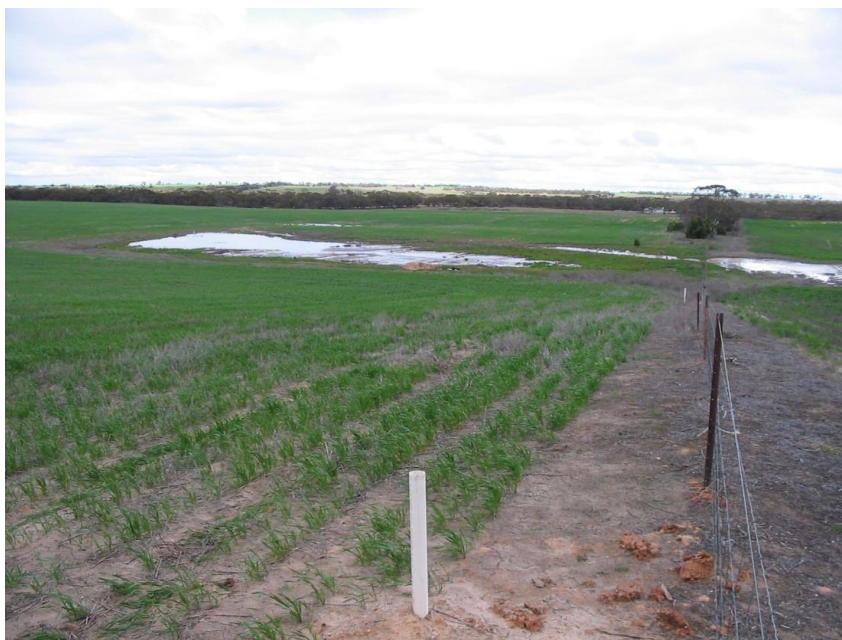
Figure 2. View of piezometer tube at site RO1 with seepage zone in background

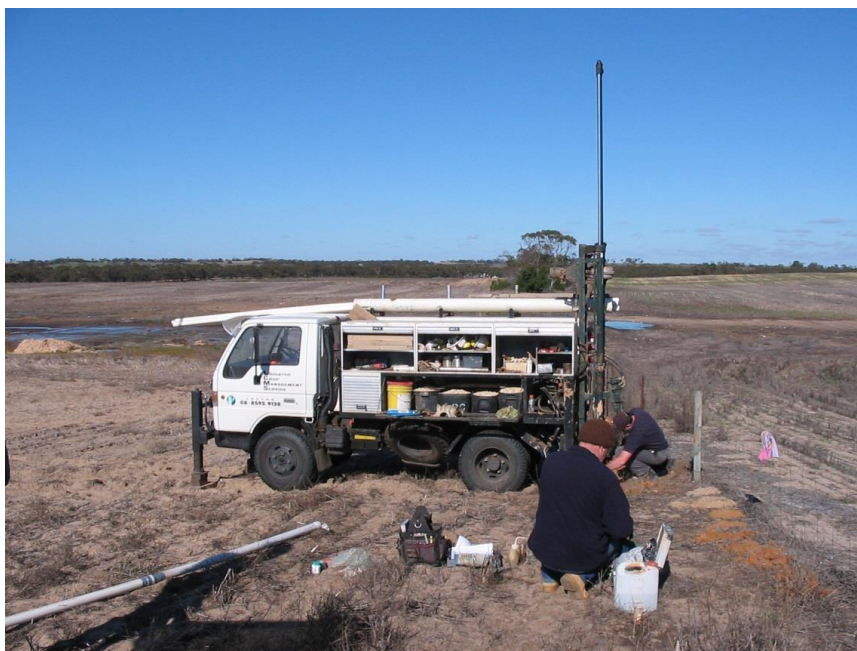
Figure 3. Describing samples at drill-site RO2 - base of sandhill

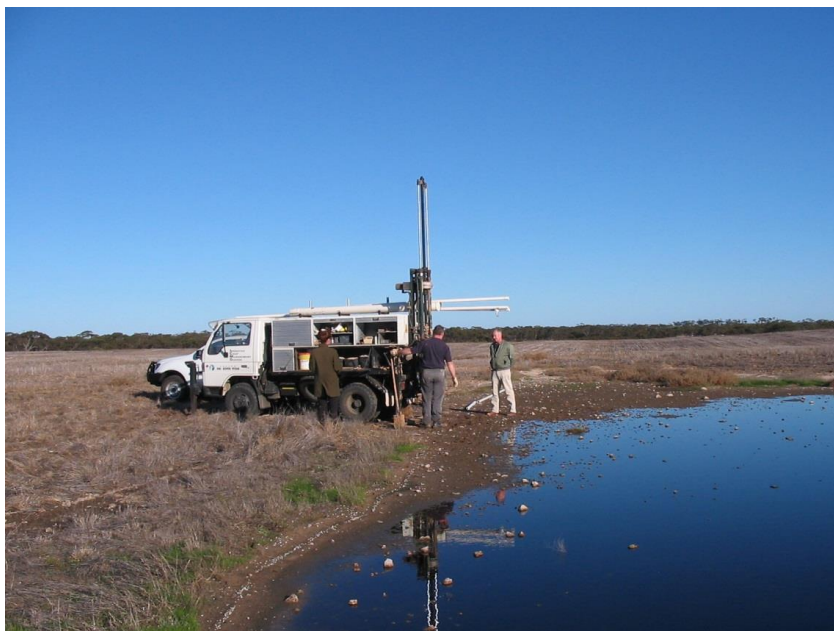
Figure 4. Drilling on edge of soak at site RO3

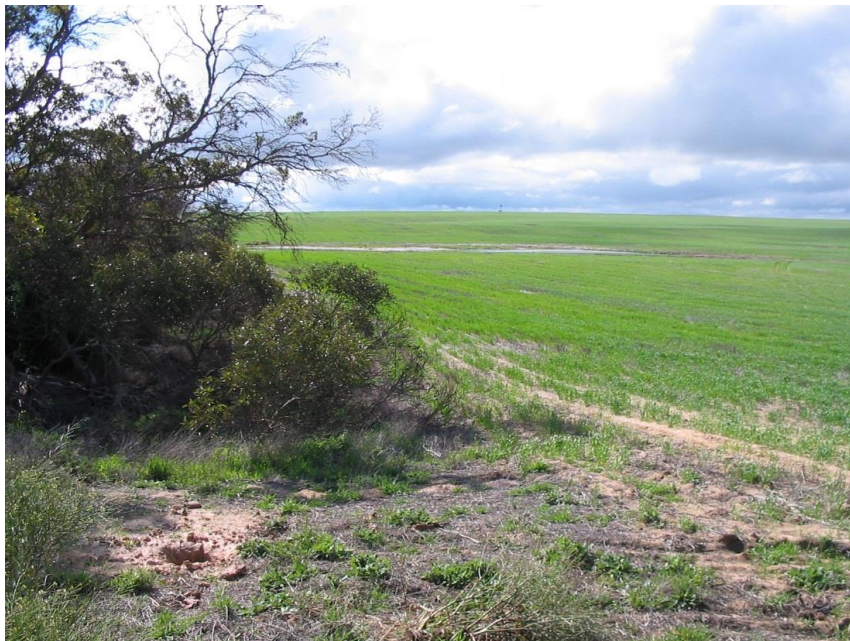
The borehole did not make any water at the time of drilling, so no casing was installed. Figure 5 shows the open borehole which is covered with a large stone.

Figure 5. Site RO4 on southern sandhill

No watertable was encountered below the southern dune (site RO4), although moist sandy sediments were encountered at depths of 3 – 5m. In August 2015, some water was found to be occurring in the open borehole (covered with a rock) and the EC tested at 2040 $\mu\text{S}/\text{cm}$ suggesting a temporary perched watertable may develop at this site at the end of winter. Further drilling is recommended in this sub-catchment to gain a better understanding of the geometry (spatial extent) of the perched system.

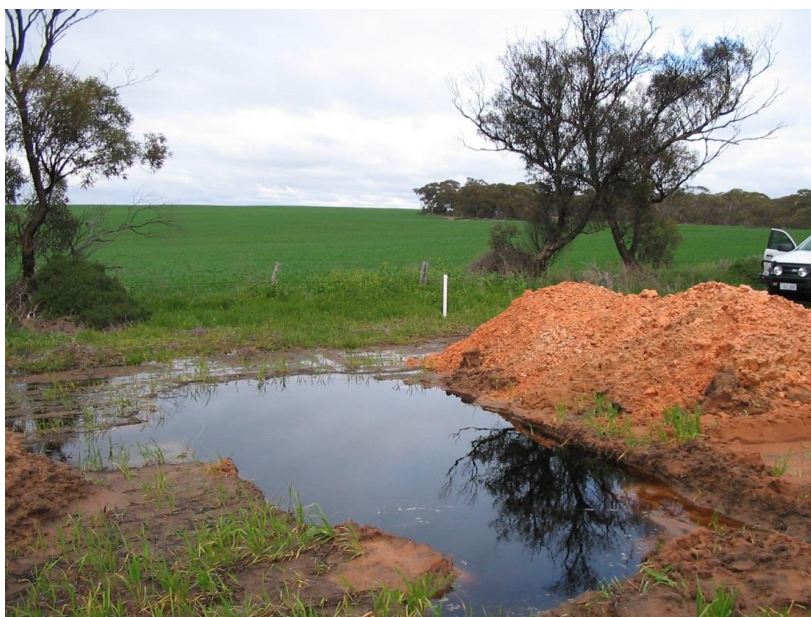
Figure 7. Site BO1 at Bonds with seepage inundating soil pit (August 2015)

Water ponding in the excavated soak at the Bond site had an EC of 8180 $\mu\text{S}/\text{cm}$ in June 2015 and an EC of 6980 $\mu\text{S}/\text{cm}$ in August 2015. In August the seepage area was much more active following late winter rainfall. The excavated soil pit at site BO1 had filled with water (see Figure 7) with an EC of 6760 $\mu\text{S}/\text{cm}$.

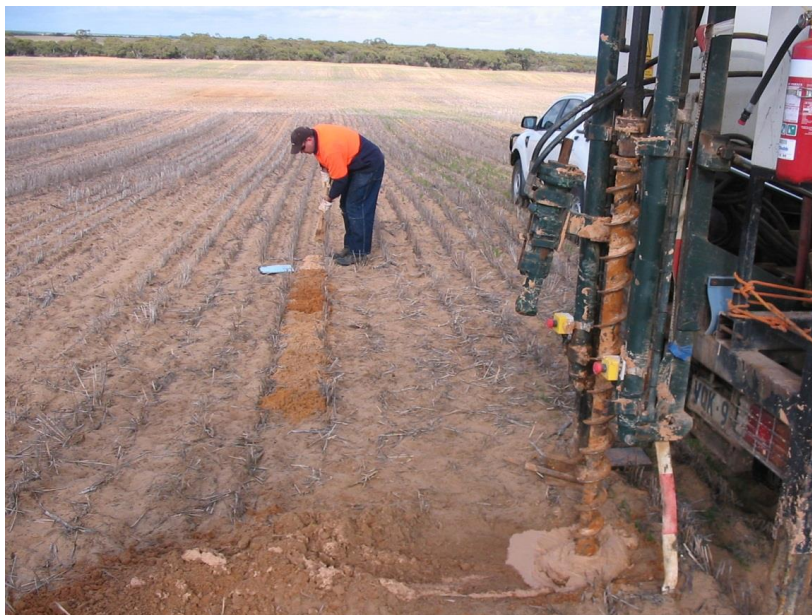
Figure 8. Drilling and taking samples on first sandhill above the seepage at Bonds

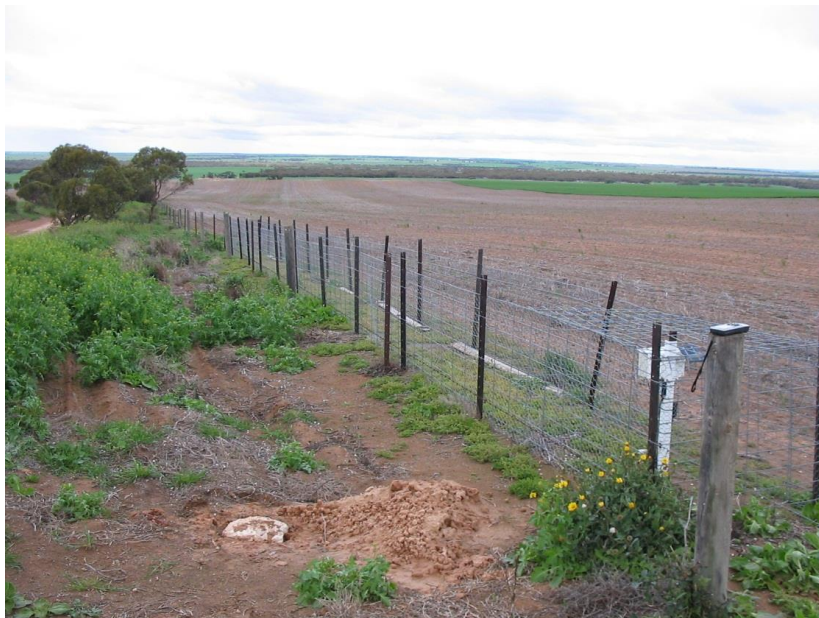
Figure 9. Site BO3 on highest sandhill above the seepage at Bonds

No watertable was encountered below the highest dune in the landscape (site BO3), although moist sediments were encountered at various depths down to 10m. Further drilling is recommended to gain a better understanding of the geometry (spatial extent) of the perched system.

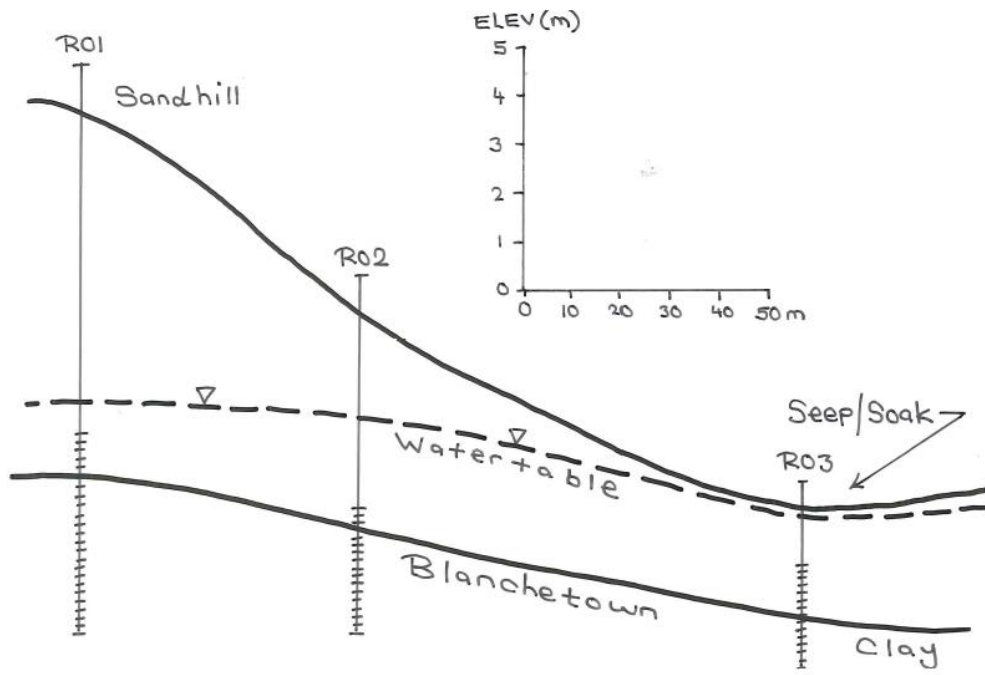
The results of drilling at four sites indicated that a perched watertable had developed above the Blanchetown Clay layer at three of the sites drilled. At the crest of the northern sand dune, the watertable is 6m below the surface with the impermeable clay layer at 7m depth. This gives a saturated thickness of around 1m.

At the base of the sandhill, the watertable is a little over 2m from the surface with the tight clay layer at 4.5m depth giving a saturated thickness of 2.5m. The watertable is at the surface in the seep with the tight clay occurring at 2.5m depth.

Figure 10 provides a hydrogeological cross-section of dune-swale system in the Rose-Thomas sub-catchment.

Figure 10. Hydrogeological cross-section of dune-swale system in the Rose-Thomas sub-catchment

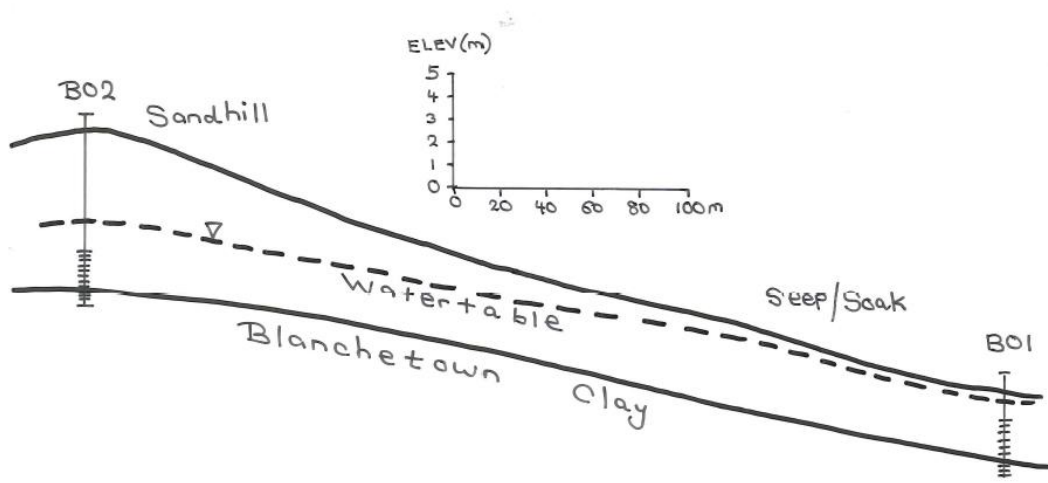
The results of drilling at three sites showed a perched watertable had developed above the Blanchetown Clay layer at two sites lower in the landscape. At the crest of the first sand dune from the seep, the watertable is 3.6m below the surface with the impermeable clay layer at 6 to 7m depth. This gives a saturated thickness of almost 3m.

Within the seep area, the watertable is close to the surface with a thin band of tight Blanchetown Clay occurring from 3.0 – 3.5m depth.

Figure 11 shows a hydrogeological cross-section of dune-swale system at the Bond site.

Figure 11. Hydrogeological cross-section of dune-swale system at Bonds seepage site
