Mallee Dune Seepage near Karoonda

Report to SAMDB NRM Board
Chris Henschke and Rebecca Tonkin
Rural Solutions SA
October 2011

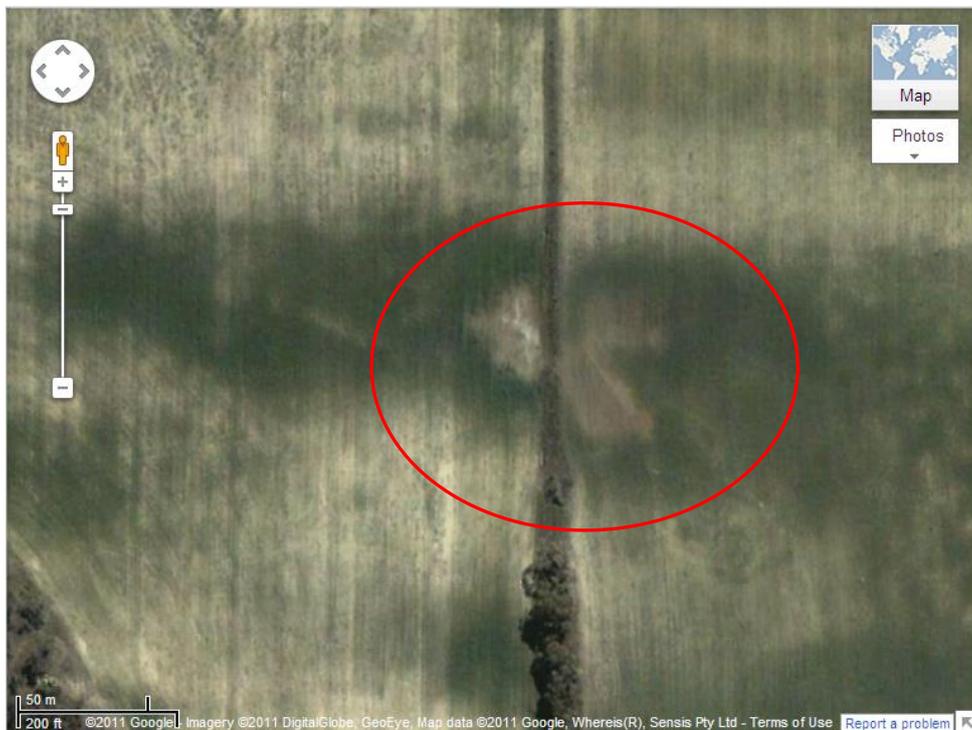
Figure 3: Close up satellite view of scalded area. Note light sandy areas on the dunes and greener area in the swale.

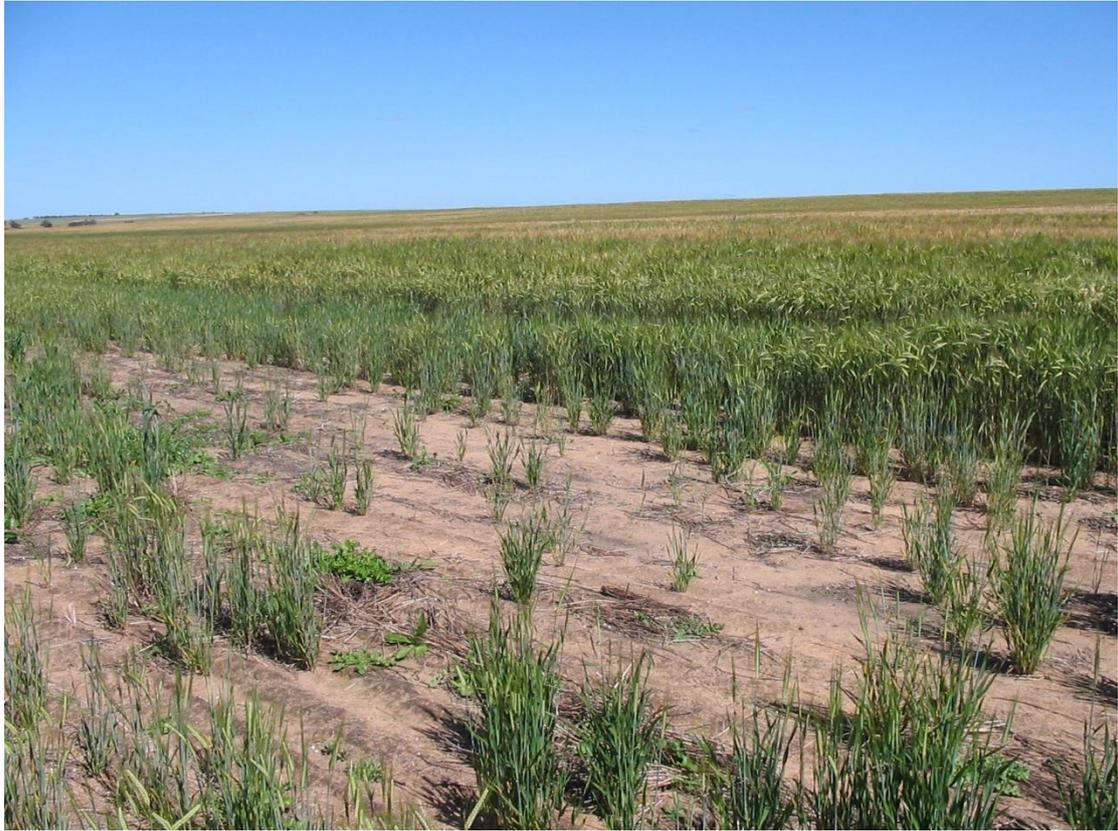
Figure 4: Dune seepage on property of S Pope, Karoonda

The photo in Figure 4 shows poor germination of a barley crop in a land-locked depression at the base of a sand dune. Lush crop growth is observed surrounding the wet depression at the base of the slope where the crop has likely tapped into a fresh perched watertable. There is currently no visible expression of salt in the seepage area (soil samples were taken to confirm this).

At Stuart Pope's, it is unlikely that these seepage areas will expand, but may be sustained by future out-of-season large rainfall events. However, it would pay to keep an eye on the 'pans' to see if they become saline over time. Revegetation along the road side or fence line would increase water use in the area, reducing the risk of developing salinity, and drawing down the water table to make it easier to get heavy machinery over the site.

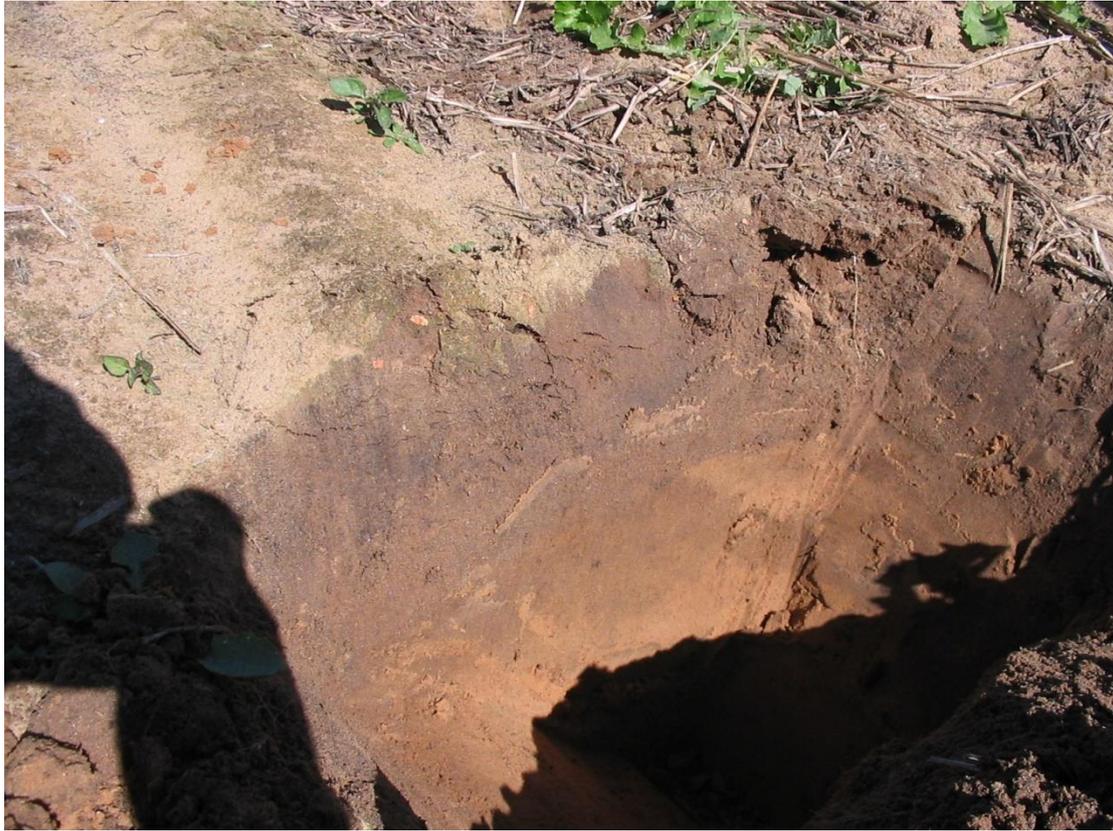
Figure 5: Soil profile within a dune seepage showing anaerobic staining on the surface and saturated sand at 20 to 30cm.

The seepage areas at Stuart Pope's occur in land-locked depressions at the base of large sand dunes. Soil profiles in affected areas (Figure 5) comprise of sandy loams with a dark anaerobic staining indicating waterlogged conditions. The topsoil is underlain by pale brown saturated sand, containing water which appears to be quite fresh. The perched watertable overlays red slightly mottled calcareous light to medium silty clay at 30 to 40cm.

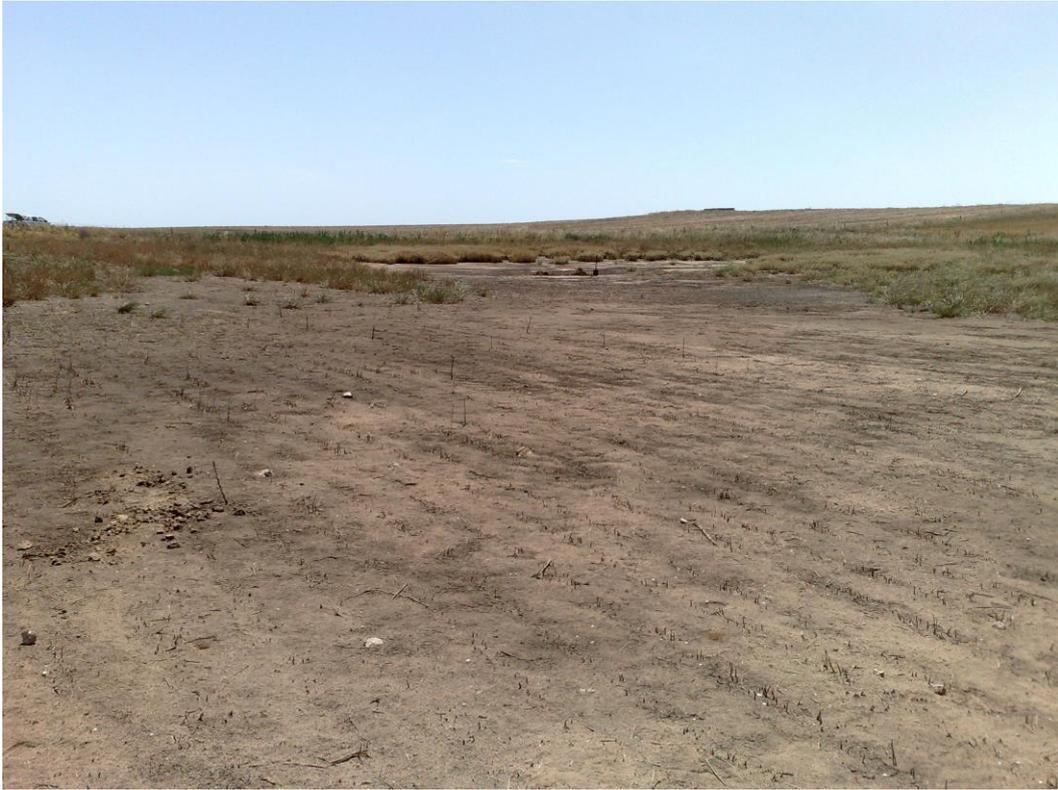
The situation is different on the land located near Wynarka, currently being leased by Peter Rose. Here salinity is evident as the ground is bare and scalded (Figure 6), with salt crystals visible on the surface (Figure 7). The area is too soft for machinery to be driven over for most of the year, and so cannot be sown to crops or pasture. No plants are growing on the most severely affected parts, and around it are mostly growing rye-grass, brome, and thistles.

Until a few years ago this area was apparently not saline although tending to be boggy, and grew good crops, but it has gradually turned saline, and the area has become larger. There is concern that it may continue to expand.

Figure 6: Scalded land area leased near Wynarka.

Revegetating the site with salt-tolerant species is likely to be successful as long as plants are placed in soil which is not too saline. This may require a gradual approach, planting at the edges of the saline waterlogged area and moving in as the area becomes drier and less salty. Once plants have established and roots have accessed the deeper moisture, they should do well. Salt on the surface should leach away over time with normal rainfall.

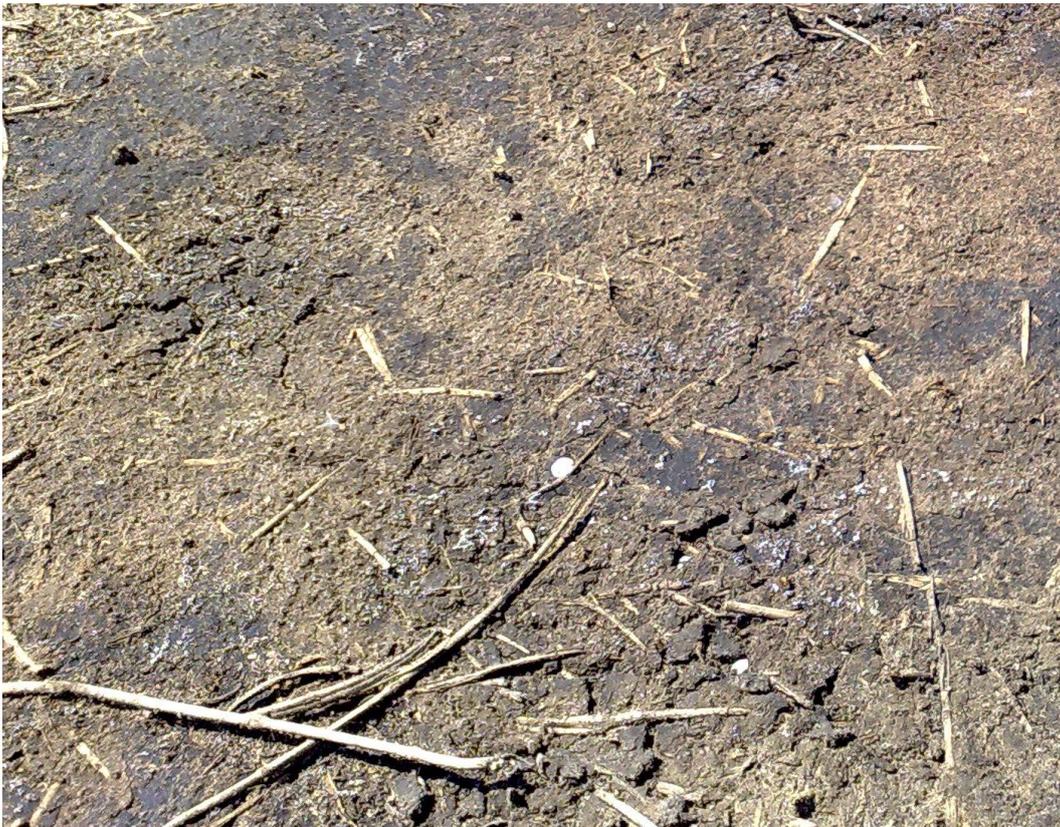
Figure 7: Bare soil with salt crystals visible on surface.

This indicates that mildly saline water has been wicked up from the lower layers in the soil and the water evaporated, leaving increasingly concentrated salt on the surface.

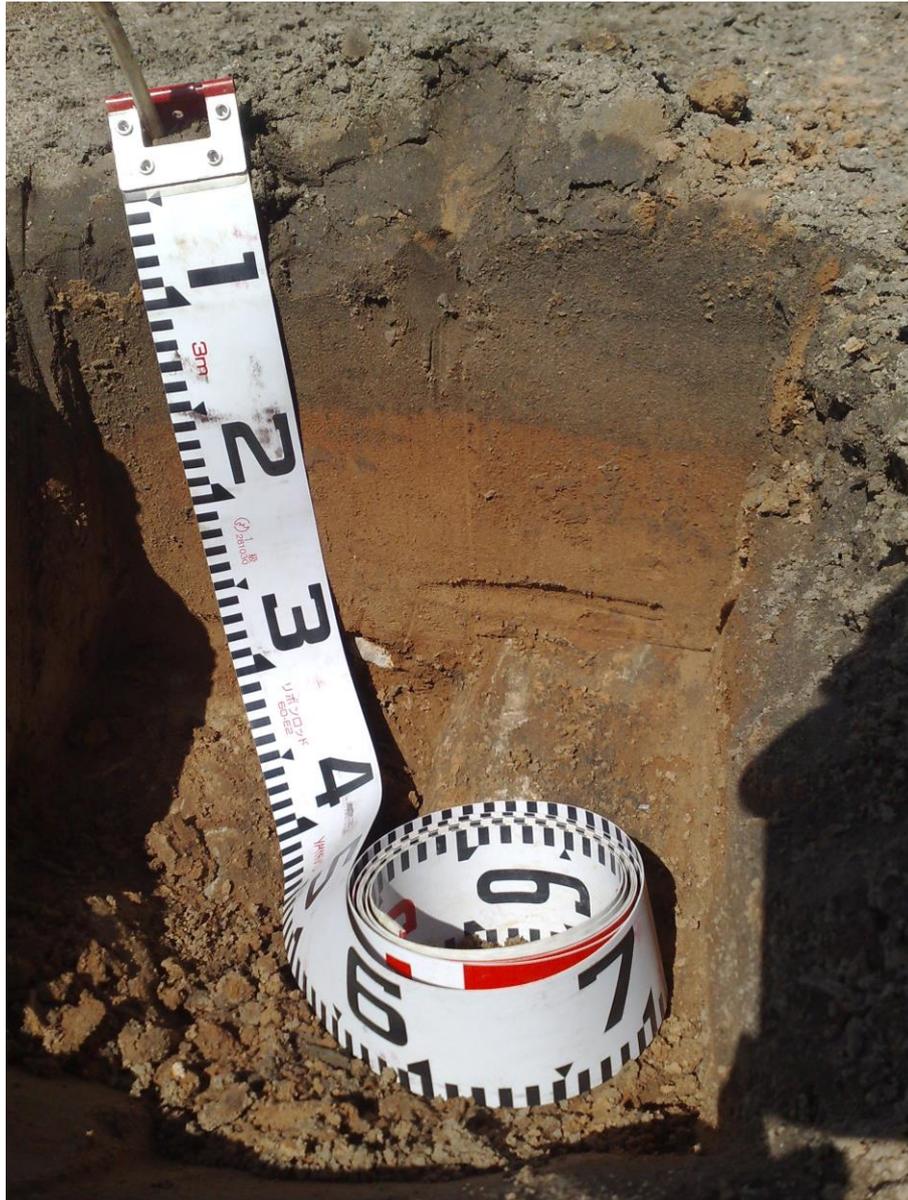
Soil pits dug with a spade showed that the general profile consists of a dark grey-brown sandy loam in the topsoil (0-15 cm), showing anaerobic staining from waterlogging. This sandy layer has a crust on it which may contain salt crystals, and is dry to about 10cm, after which it is damp. This lies over a reddish brown sandy light clay (15-30 cm), which is wet to touch. After 30cm, there is a mixture of light clay (becoming heavier with depth) and calcrete. The clay varies from reddish-brown at about 30cm, to cream/yellow/grey further down the profile as more lime is mixed with the clay. The calcrete may be in large rocks (Figure 8, higher ground) or a soft gravel (Figure 9, low in the scalded area). The water table is at ~63 cm below the lowest part of the scald as at 16/11/11.

Figure 8: Soil profile in upper scalded area near Wynarka.

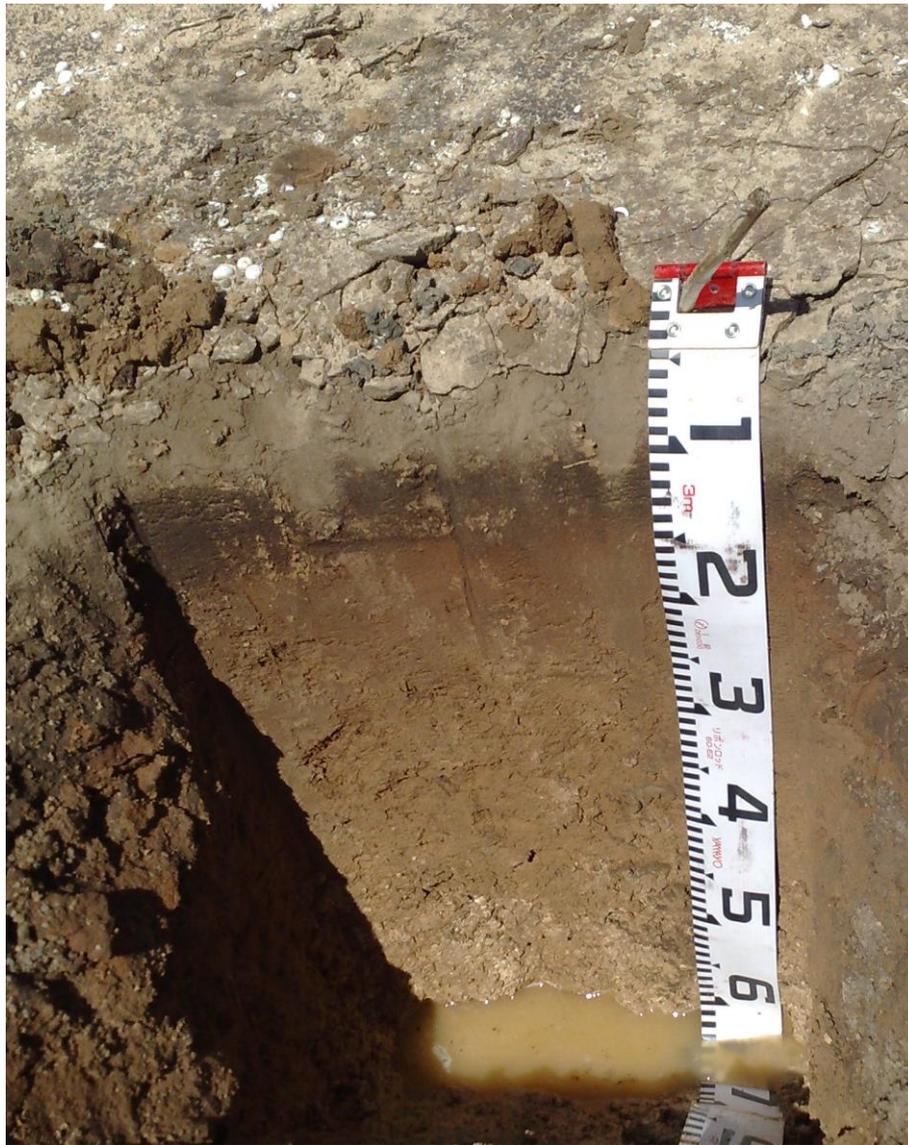
Figure 9: Soil profile in lowest part of scald near Wynarka. Water has seeped into the pit at about 63 cm.
