# EARTH CONSTRUCTION

BRIAN WOODWARD

DIRECTOR,  
EARTH CONSTRUCTION UNIT,  
UNIVERSITY OF NEW SOUTH WALES. 1979.

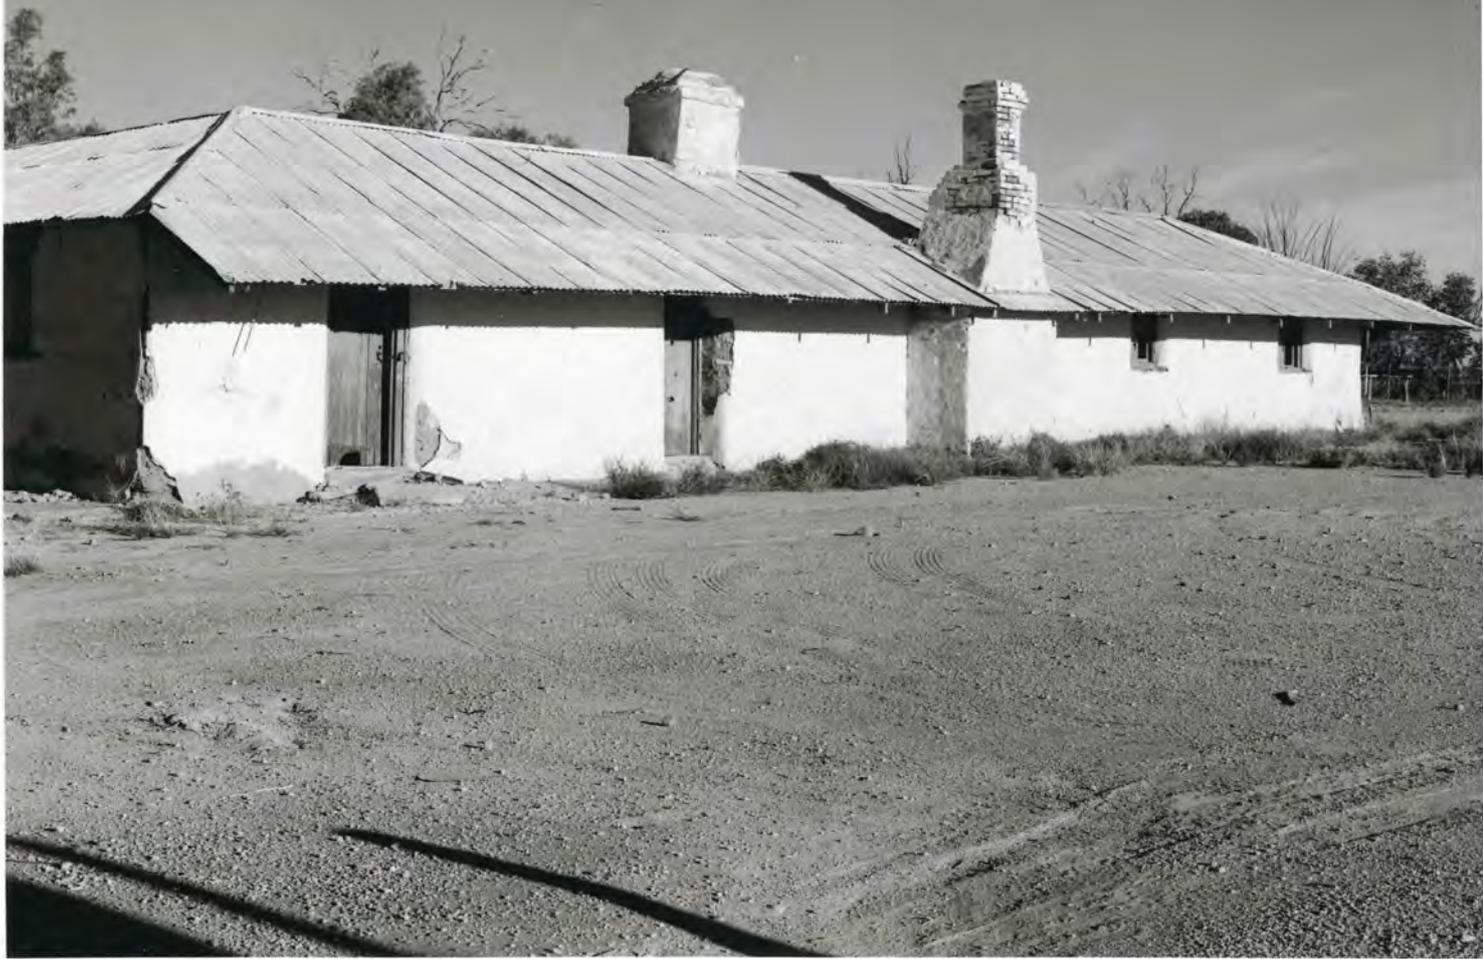
FILM 75  
NO 1

WEST WALL OLD HOMESTEAD

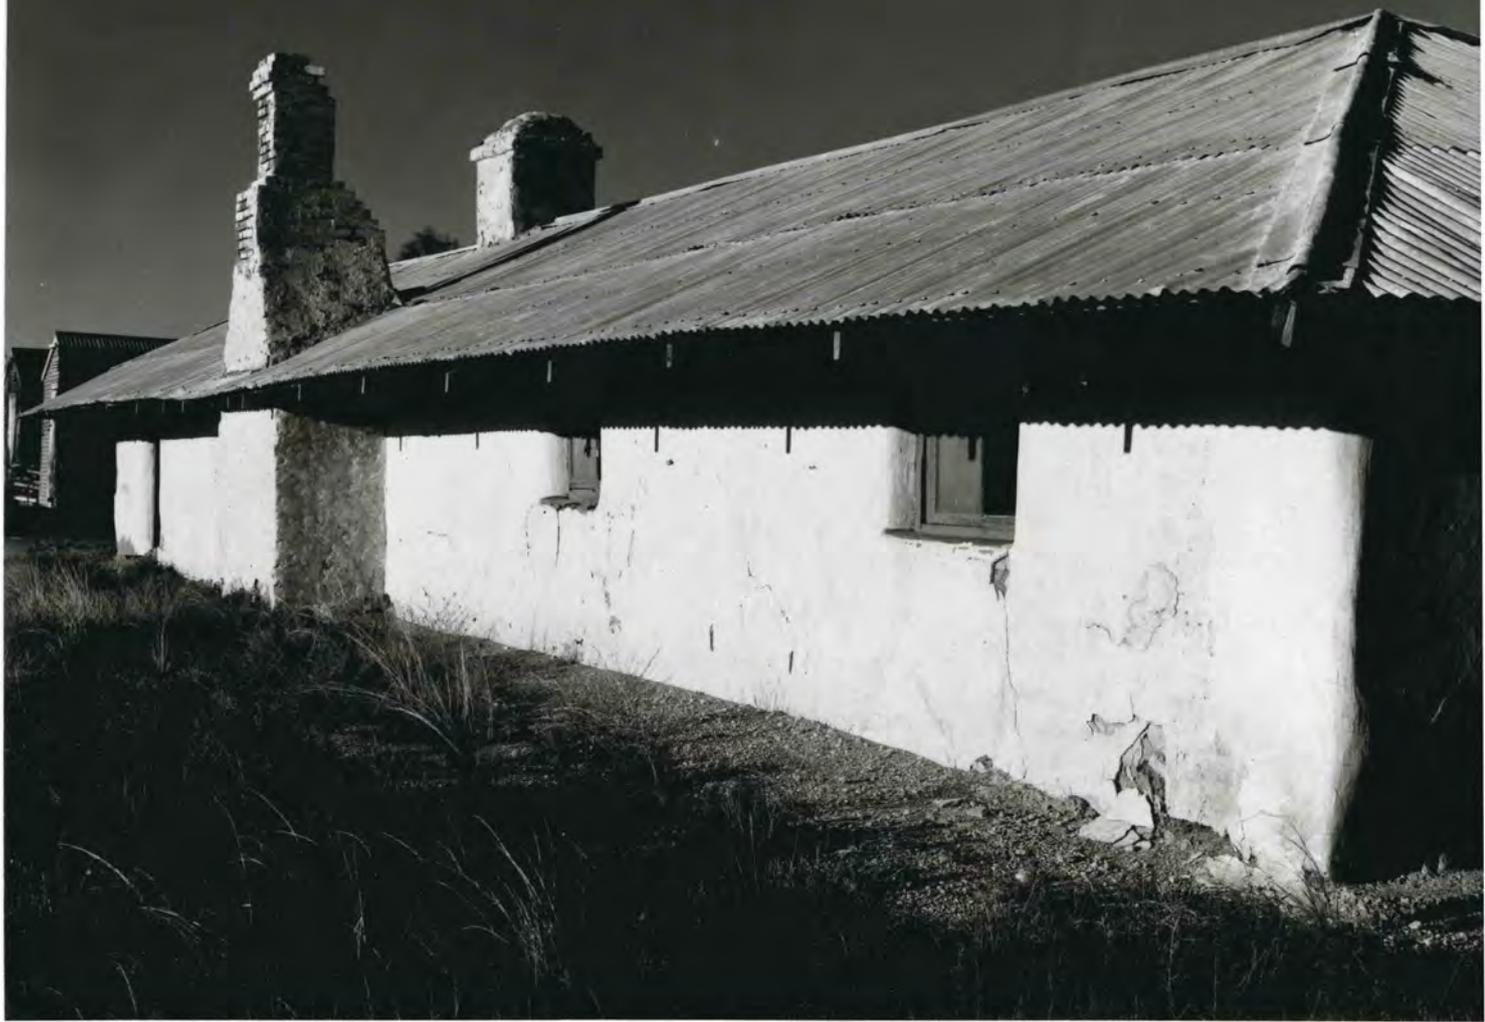
FILM 75  
NO 4

WEST WALL OLD HOMESTEAD  
VIEW FROM SOUTH

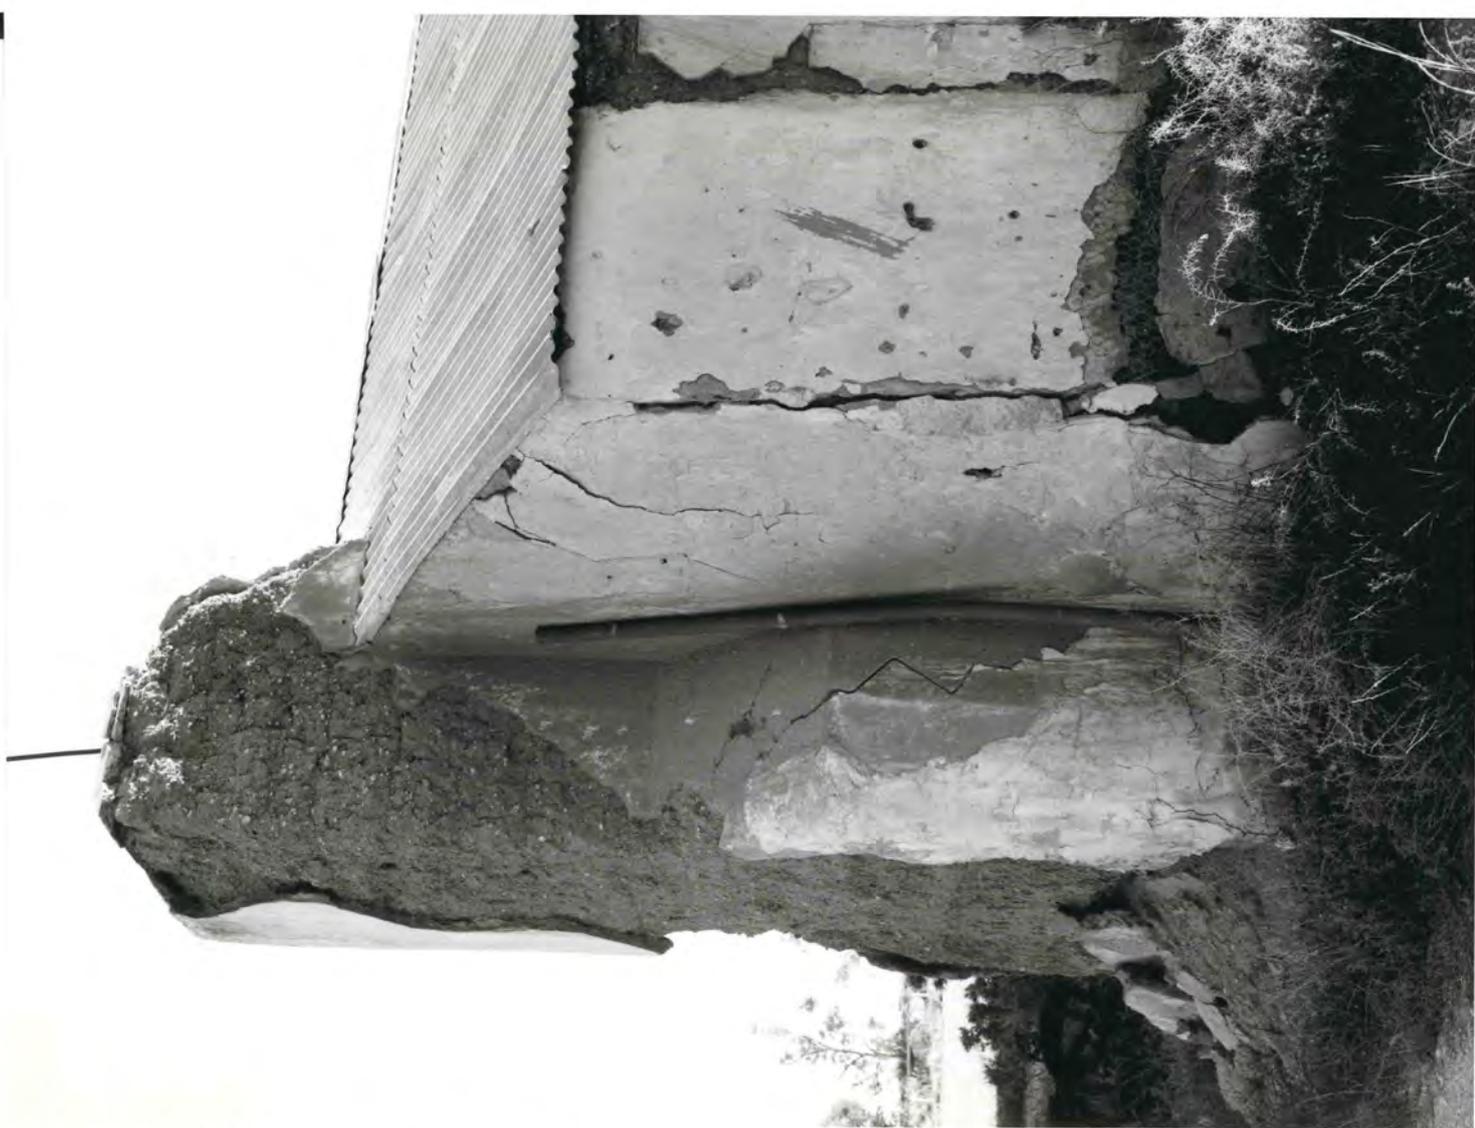
FILM 75  
NO 8

CHIMNEY NORTH EAST CORNER  
ORIGINAL HOMESTEAD

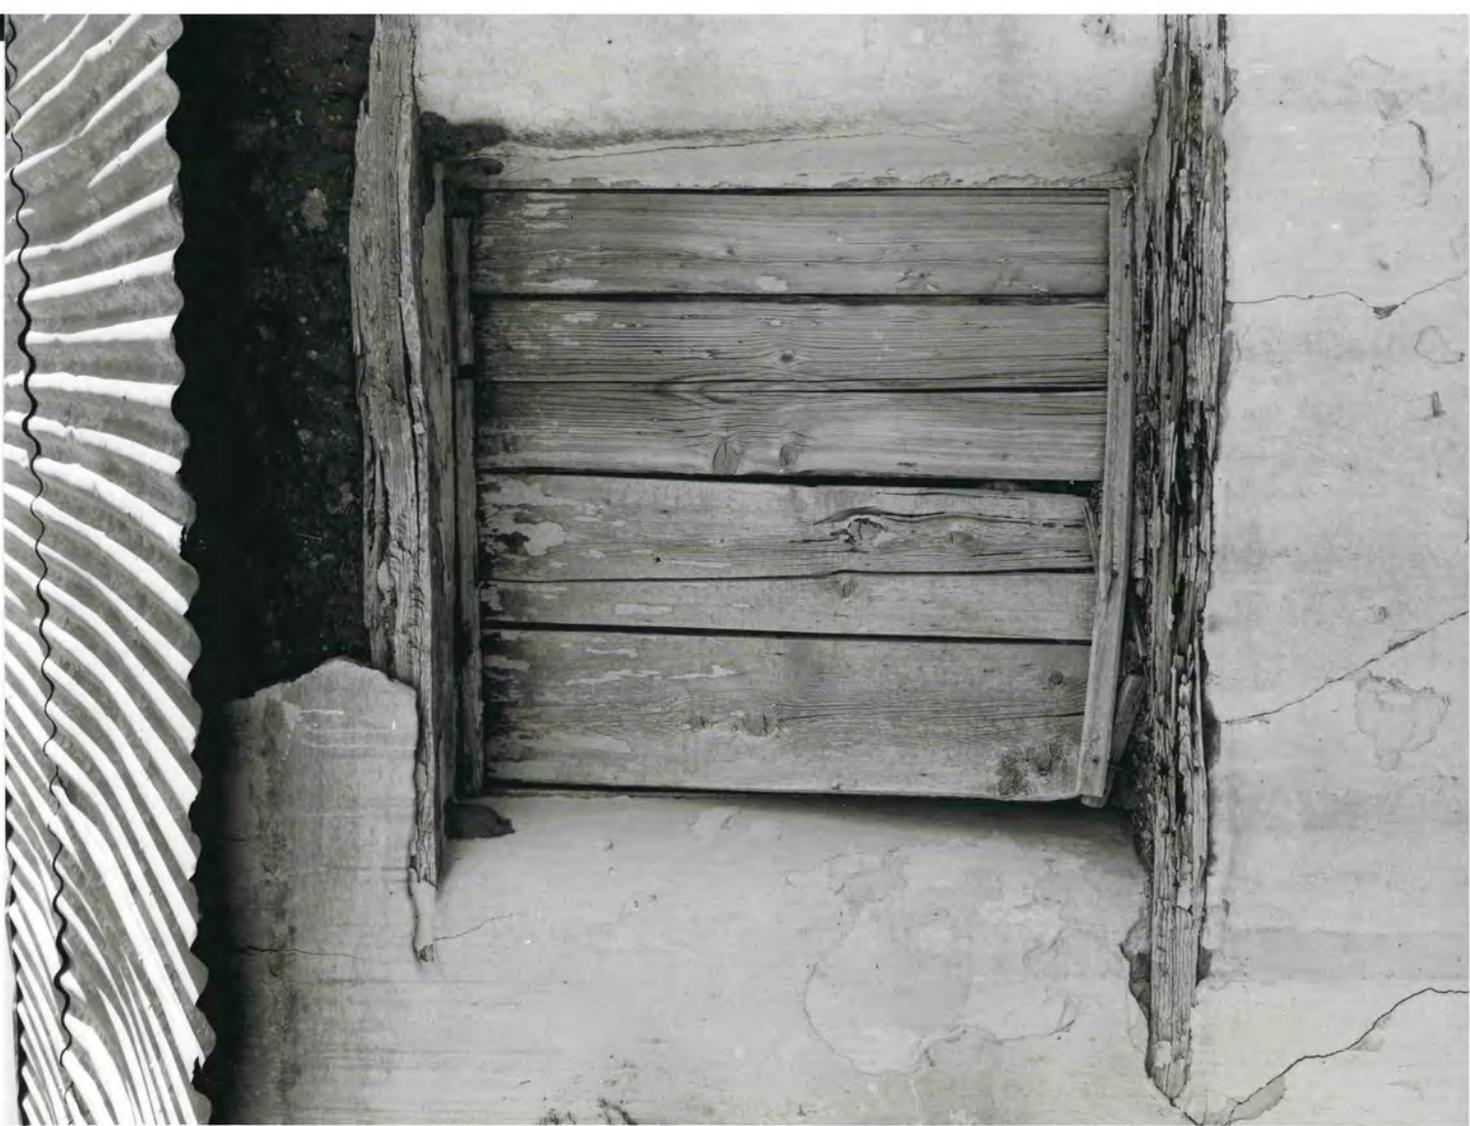
FILM 75  
NO 9

WINDOW, NORTH WALL  
ORIGINAL HOMESTEAD

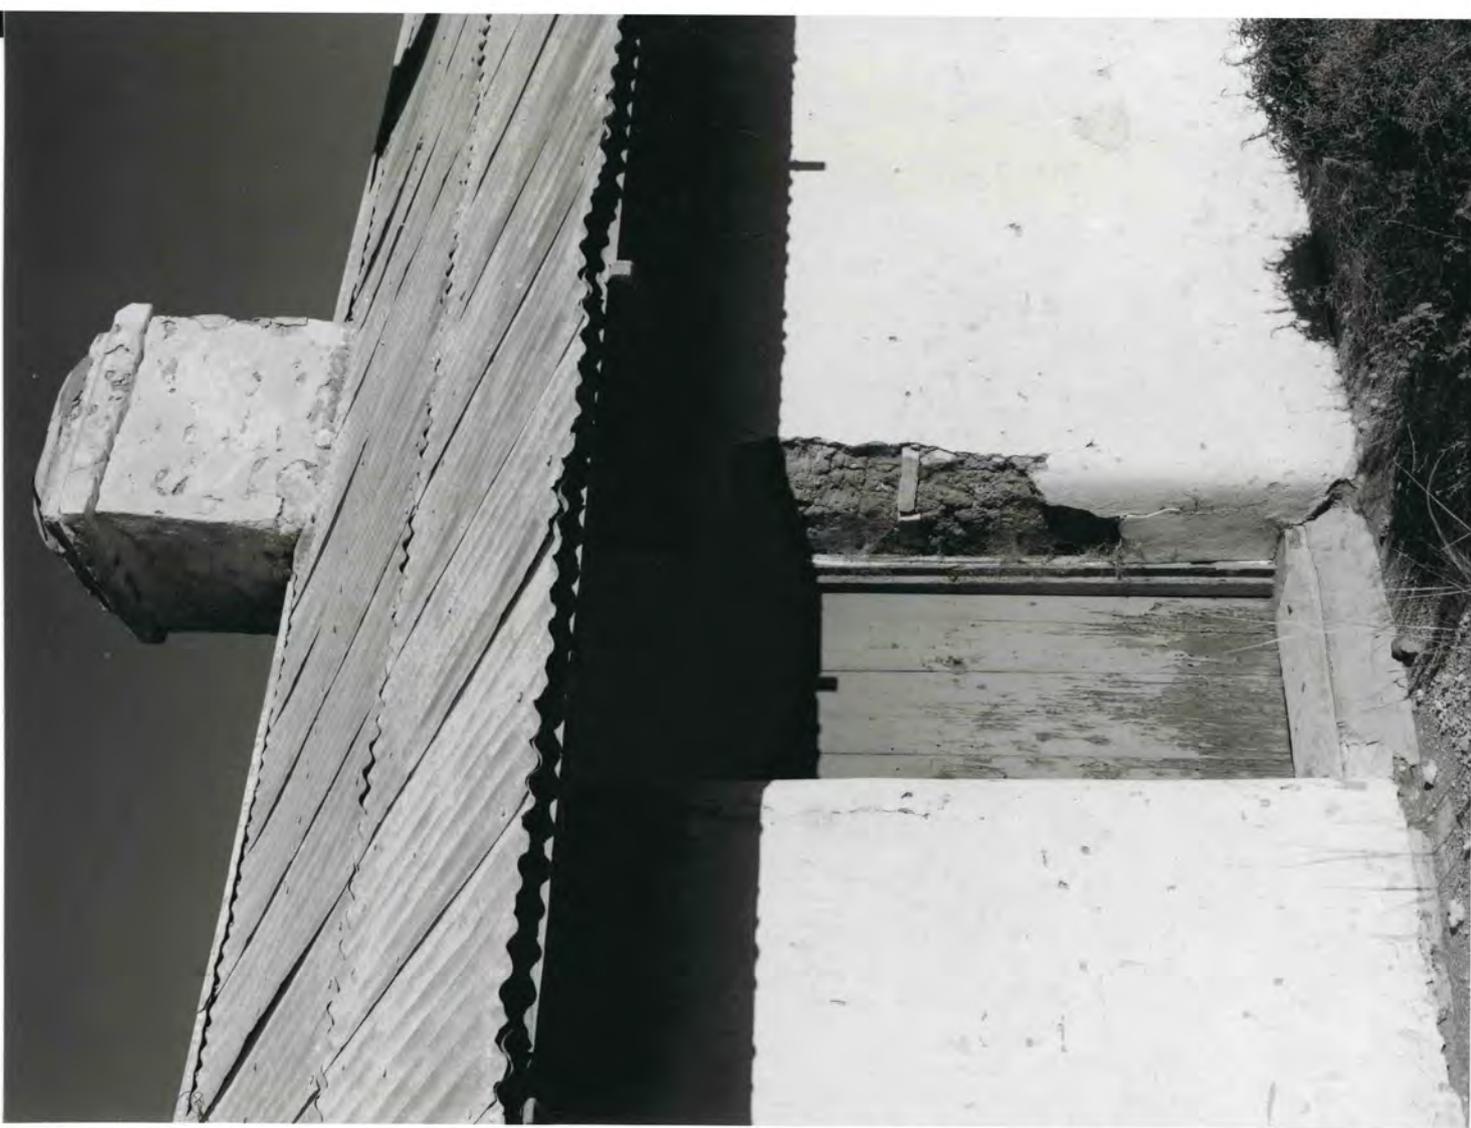
FILM 75  
NO 2

WEST WALL, ORIGINAL HOMESTEAD

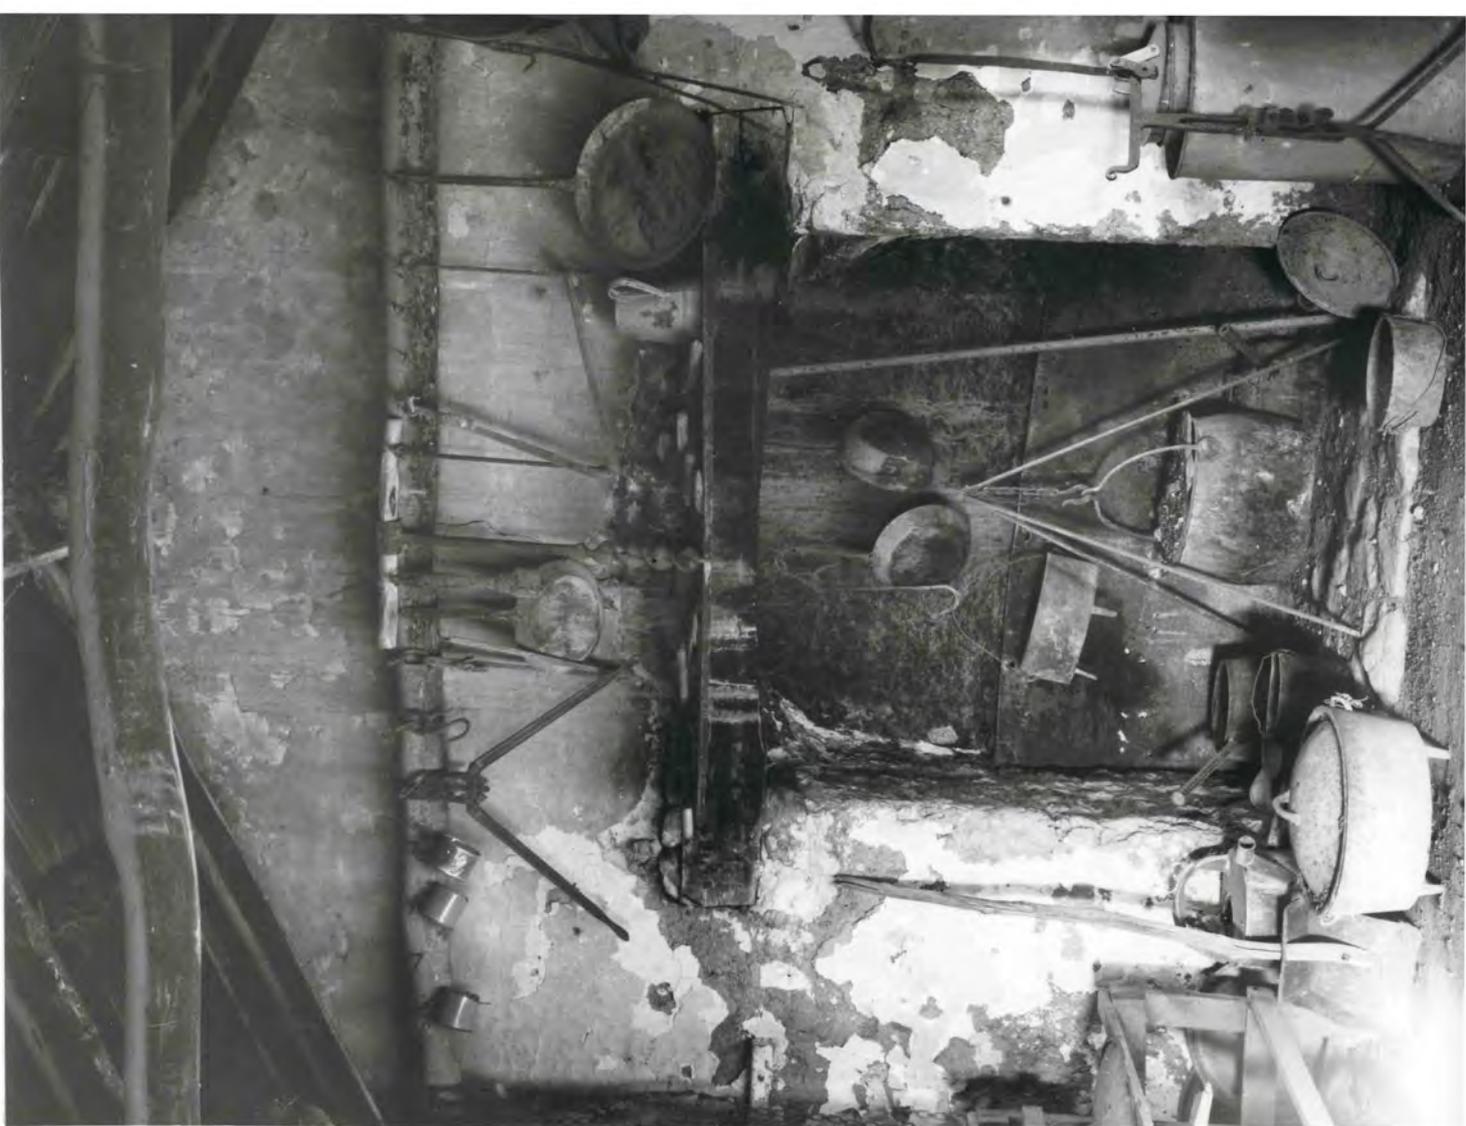
FILM 75  
NO 10

FIREPLACE NORTH EAST CORNER  
ORIGINAL HOMESTEAD
