**Miner's Cottage and Fence****CC:198****LOCATION**

**Address** Vercoe Street, Moonta Mines SA 5558  
**Land Description** Section 2091, Hundred of Wallaroo  
**Certificate of Title** 21 1100/2091

## Miner's Cottage and Fence

Vercoe Street, Moonta Mines

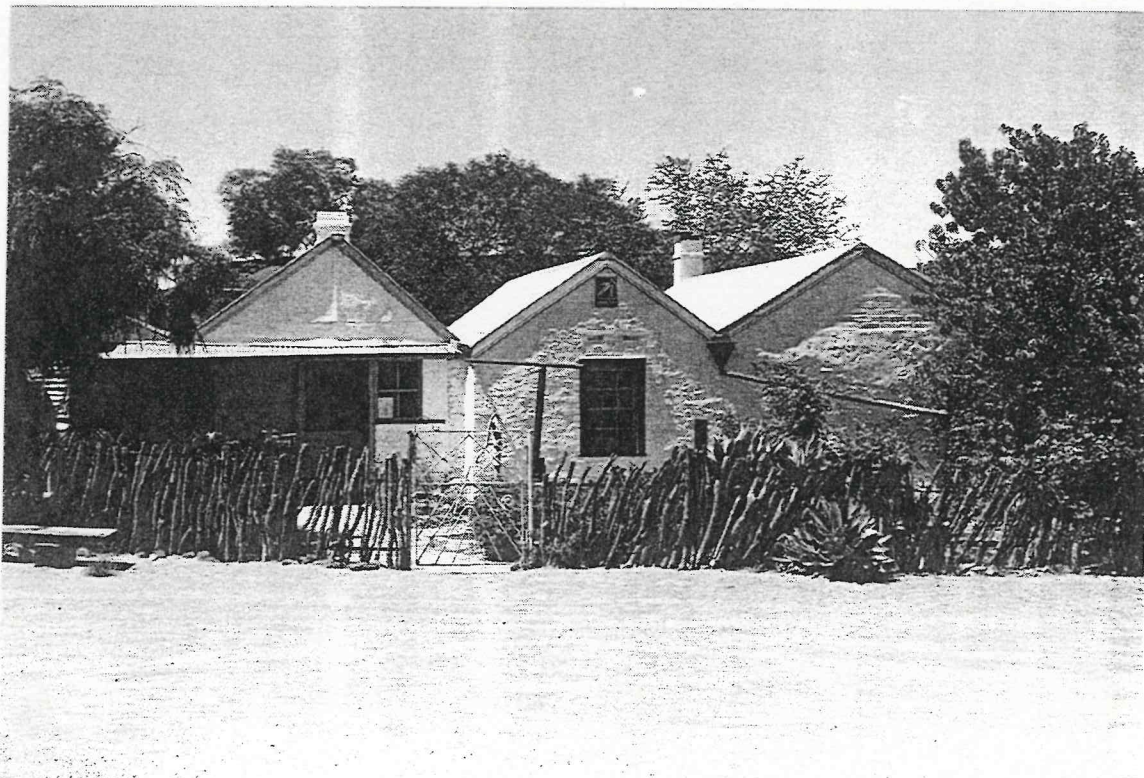
**Photograph No** 25/17-20

*Miner's cottage*

Small cottage of limestone rubble and pug, now extensively restored, with an adjacent garden planted in recent decades.

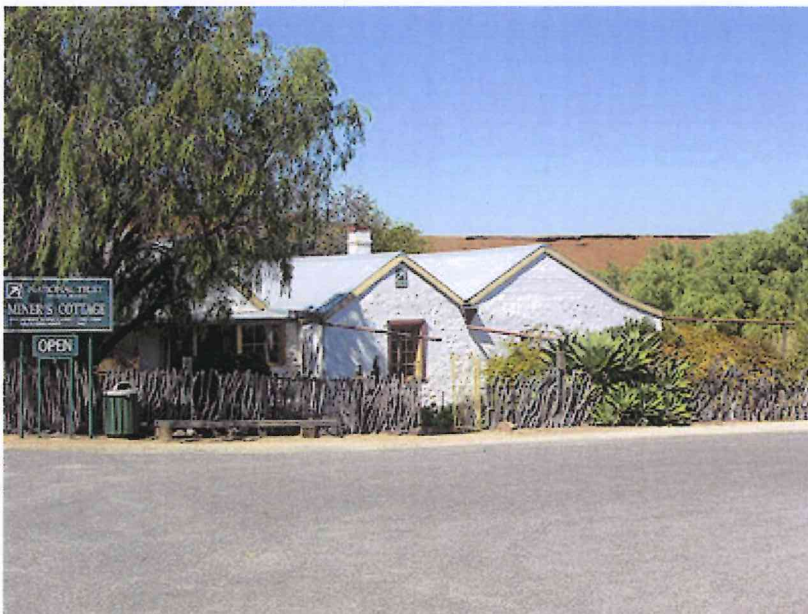
*Miner's Cottage & Fence, 2005*

The cottage has a typical narrow-pitched roof, with central gutters that were necessary because of a shortage of long timber. It is of mixed construction, combining stone, bricks and dried clay. The garden fence has a timber frame and is clad with old iron sheets.

The house is an excellent example of the early Cornish miner's cottages that were so numerous on the mine site during the 1860s and 1870s. It seems possible that there were originally two attached cottages, or that this dwelling was built in stages.

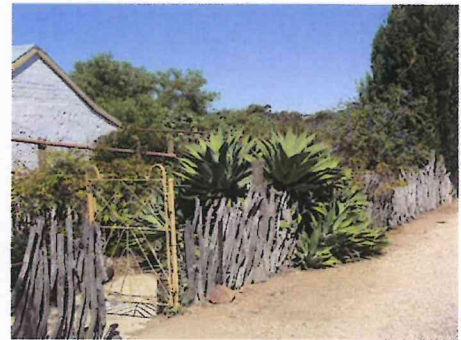
*Side fence, 2005*
