A.2.5.1 Mackereth's Cottage, Matthew Road, Dorset Vale

A.2.5.1 Former House—Mackereth's Cottage, Matthews Road, Dorset Vale. Grid Reference: Noarlunga 884 148, Section 285, (now Section 1427), Hd Noarlunga.

MACKERETH COTTAGE

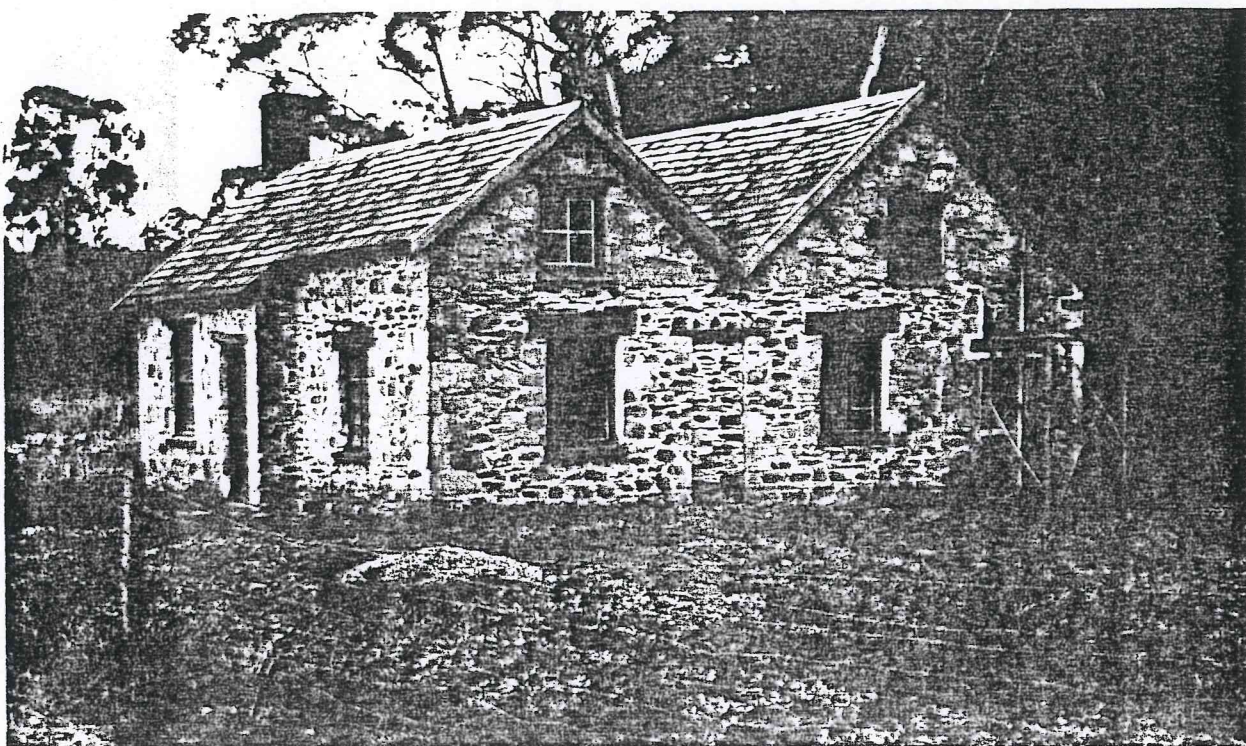
This rectangular single-storeyed cottage is built of sandstone rubble with large roughly squared quoins, and appears to have been built in three main sections. The roof is typical of the early cottages with its M-shaped structure clad in shingles. The windows, eight-paned casements and twelve-paned double-hung, are surrounded by roughly shaped stones and have large timber lintels and sills. Two attic-type windows exist on the northern elevation. The building's setting is good, with a creek at the rear and relocated slab shed opposite.

Integrity: In 1978 the roof was clad with sawn shingles, this being the third covering to the basic roof structure, the original shakes and corrugated galvanised iron remaining underneath. Split shakes could have been used rather than the sawn variety which tend to give a tailored appearance. A rear wall has been rebuilt in secondhand stone, some of which has been poorly selected and pointed in cement. The building is in basically good condition, although some cracking is evident. It is threatened by vandals and disuse.
