**Coorong, Lower Lakes and
Murray Mouth (CLLMM)
Wetland Condition Assessments,
2014**

**Report to the Department of Environment, Water
and Natural Resources, South Australia.**

**Craig Billows, Mark Bachmann, Nick Whiterod &
Lauren Ascah**

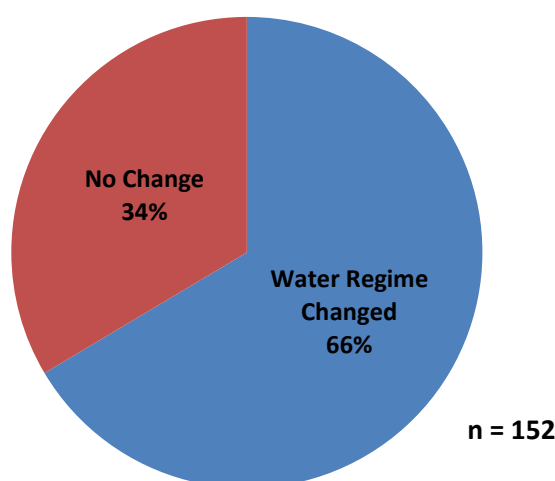
Figure 2. Percentage changes in water regime from 2010 to 2014

Approximately two thirds of the 2014 sample set exhibited signs of hydrological change following the three years since the 2010 assessments (Figure 2). With the return of flows, 62% of wetlands sampled in 2014 returned to their 2003 water regimes, whilst 15% did not. Twenty three percent of wetlands did not experience any observable change in water regime (i.e. remained unchanged) between assessment periods 2003, 2010 and 2014 (Figure 3).

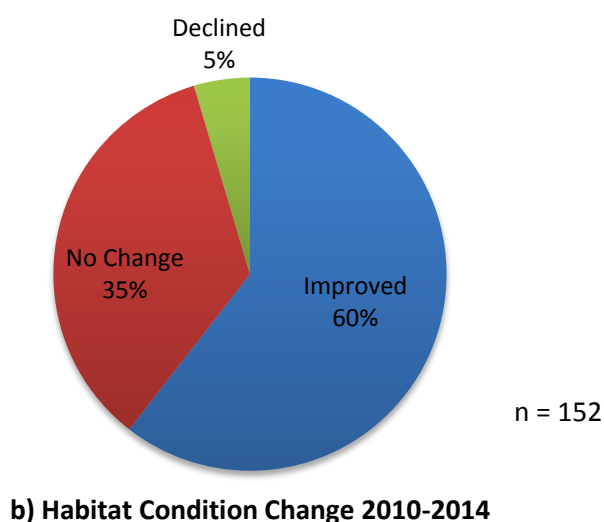
Figure 4. Habitat condition change of the same sample of 152 wetlands assessed from 2003 to 2010 and 2010 to 2014

Recent changes (2010 to 2014) of the 152 sites assessed in this survey, showed that 92 (60%) were found to have improved in habitat condition, 7 (5%) had declined in condition, and 53 (35%) showed no observable signs of change in their condition from 2010. Table 3 details the direction of change for each habitat condition ranking from 2010 to 2014, detailing the number of sites that improved, remained stable or declined.

These results contrast with the changes of the same sites grouped by habitat condition from 2003 to 2010, which found that 9 (6%) of the sites improved, 79 (52%) of the sites declined, and 64 (42%) of the sites showed no observable signs of change in their condition. Figure 4 clearly contrasts the direction in the change in habitat condition between each survey event from 2003 to 2014.

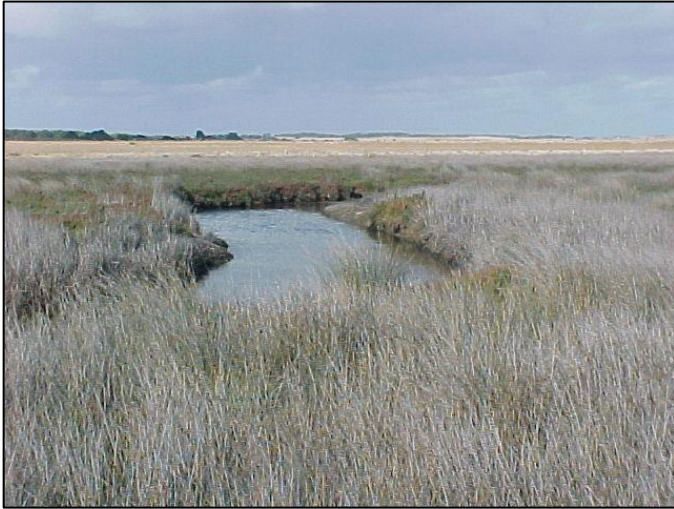
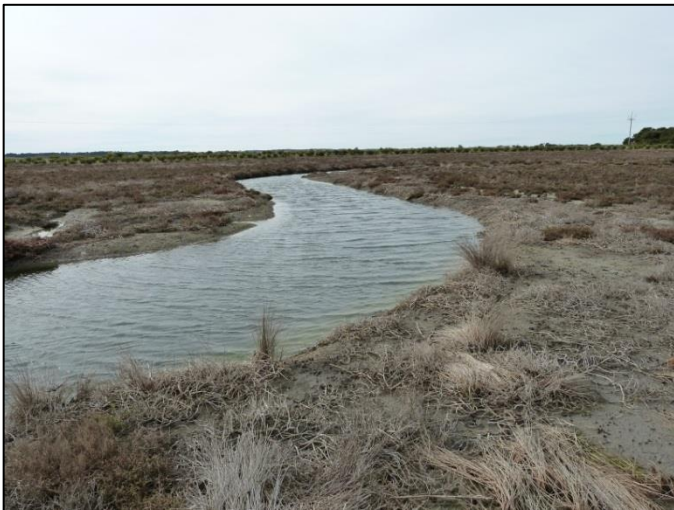
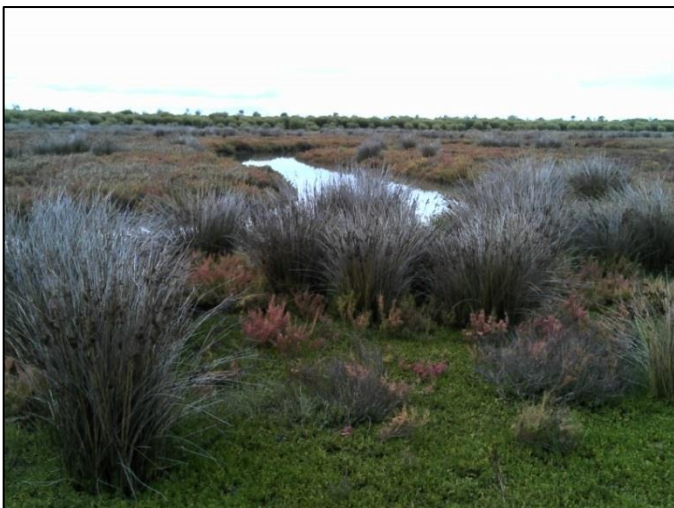
Plate 1. Example of a net improvement in Wetland Habitat Condition at Site HIND0031 from 2003 to 2014.

Plate 1 illustrates a wetland site on the Goolwa Channel estuary downstream of the Goolwa Barrage where a net improvement in habitat condition from 2003 to 2014 has occurred. This figure represents the change within a saltmarsh creek from very good (prior to drought), to degraded (at height of prolonged drought), to pristine (3 years post drought) condition.

2003 – Very Good

2010 – Degraded

2014 – Pristine

Areas downstream of the barrages continue to display more variable hydrological regime over the 3 assessment periods, with limited oceanic connectivity during the period of several years of mouth dredging (during the earlier assessments), now replaced by a return to a more apparent tidal influence since the mouth has remained naturally opened due to sufficient River Murray flows over the barrages (refer to illustrated example in Plate 1).

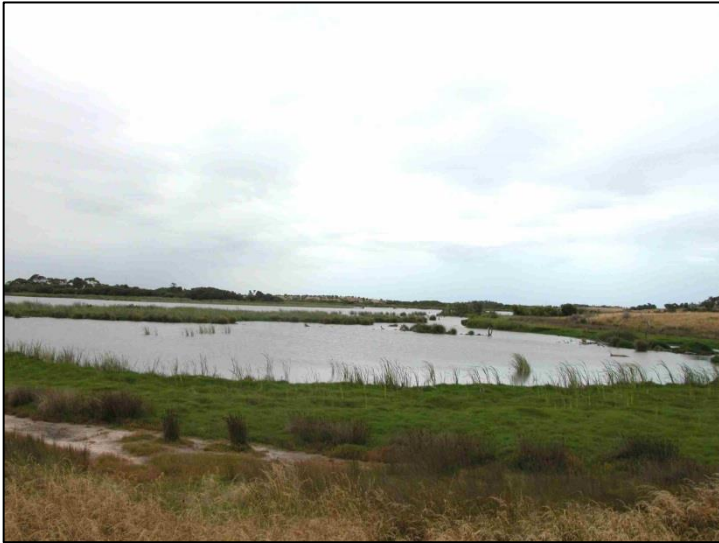
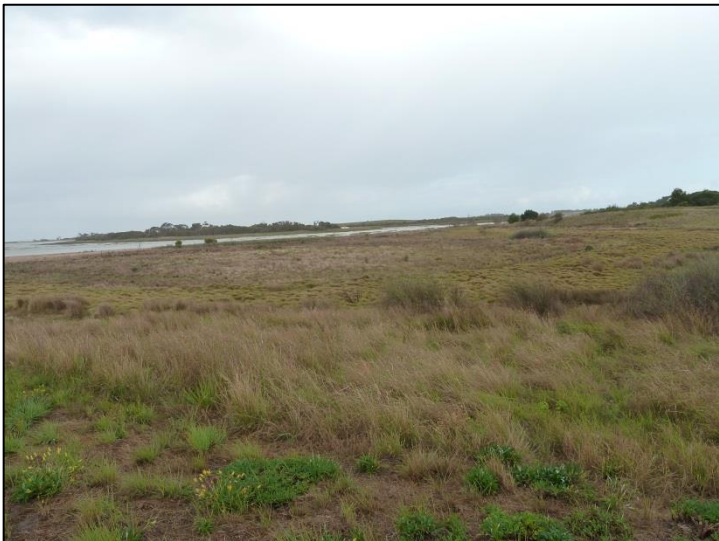
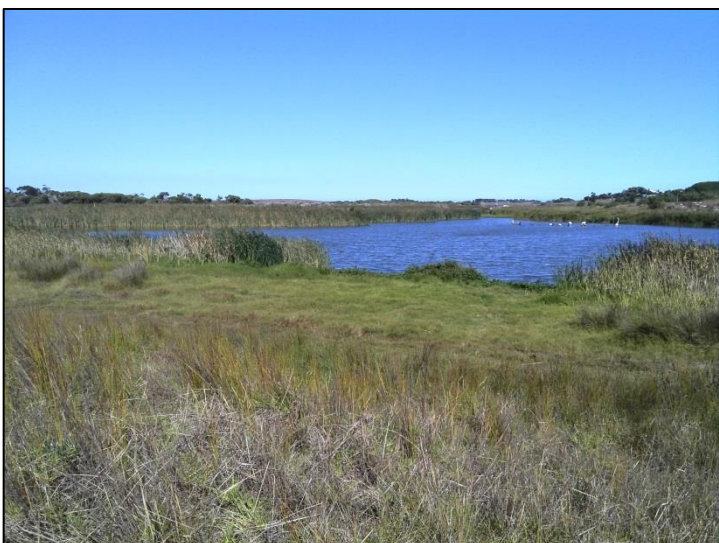
Plate 2. Example of change in habitat community – vegetation association at Site DUNN0010 from 2003 to 2014

Plate 2 illustrates the post drought return of water to a small cove on Dunns Lagoon at Clayton Bay with associated change in habitat type over the 10 year period.

2003 – Shallow open water cover with *Typha domingensis* reed beds (rear left)

2010 – Loss of open water habitat replaced with introduced grasses and scattered sedges

2014 – Return of open water habitat and re-established reed beds of *T. domingensis* and *Scheonoplectus validus*.

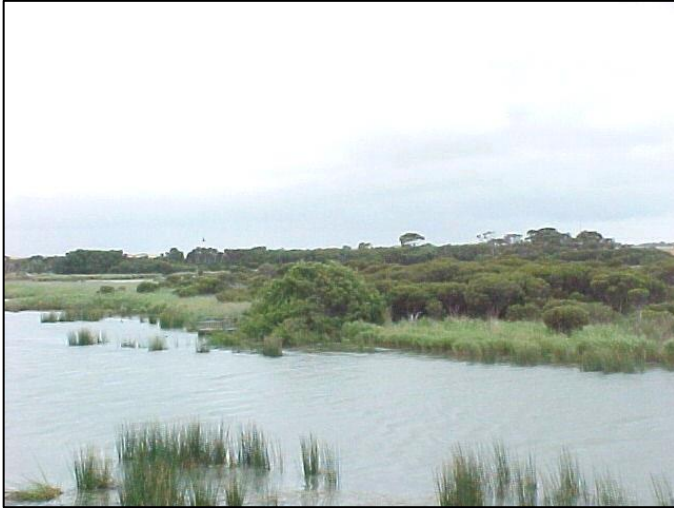
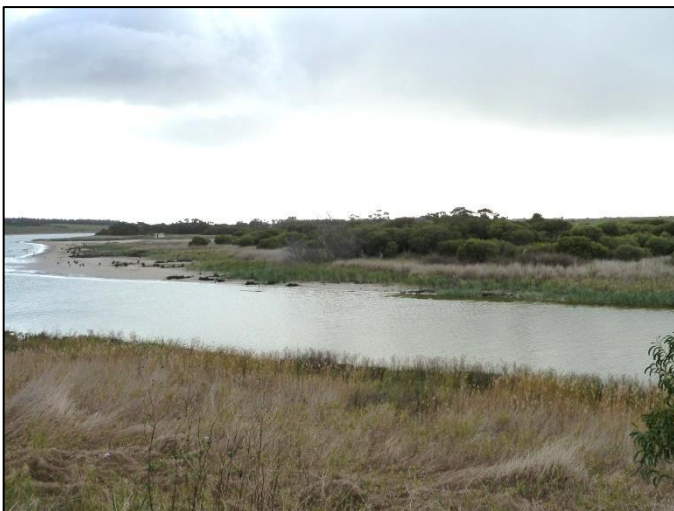
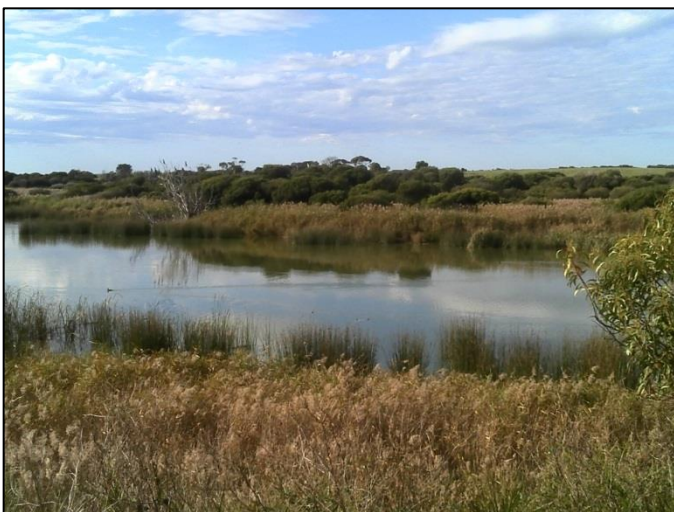
Plate 3. *Melaleuca halmaturorum* woodland, Site DUNN0017 as a representative site of the Ramsar Wetland Type, Freshwater, tree-dominated wetland (Xf); exhibiting minimal observable change from 2003 to 2014, as illustrating its persistence and tolerance to drought conditions in 2010 and return to soil saturation and likely seasonal inundation. This site maintained its Excellent Habitat Condition Ranking throughout the 11 year period. Note that the willow (*Salix* sp.) in the 2003 image has not shown signs of regeneration in 2014.

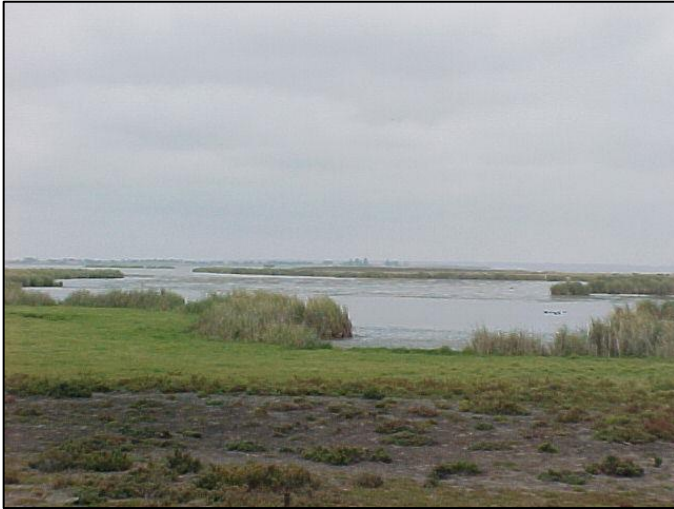
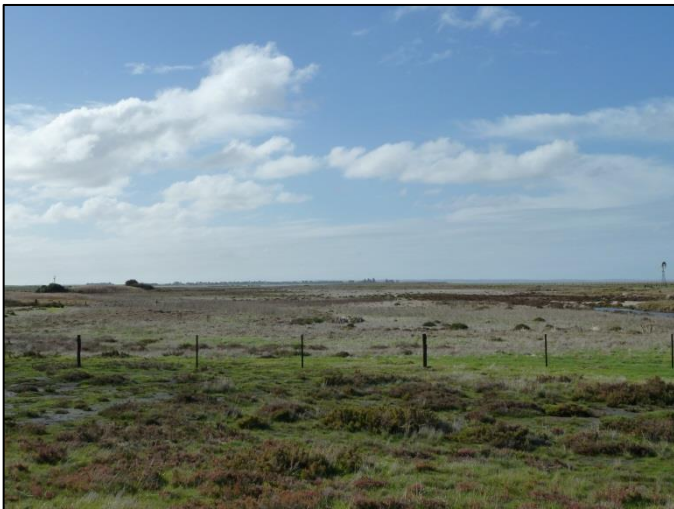
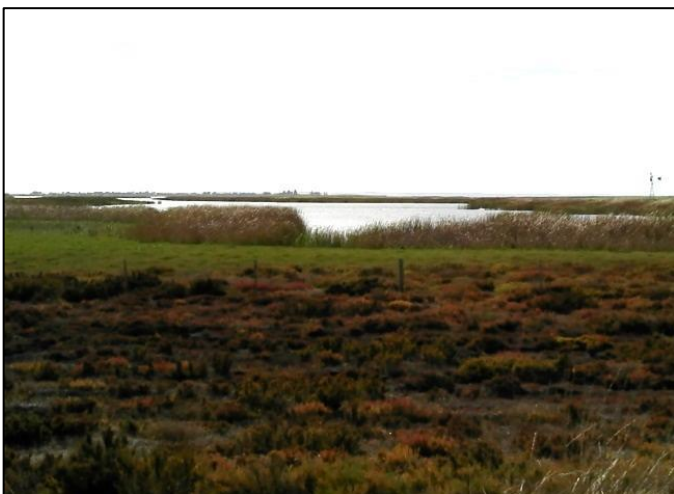
The Lagoon and Cove sites generally changed from dry, sediment beds in 2010 (mostly colonised by introduced grasses, often with scattered woody weeds and native samphire species) as a result of prolonged drought conditions to mostly open water areas, sometimes supporting aquatic herbaceous beds with fringing reed beds mostly dominated by *Typha domingensis*, *Phragmites australis*, *Schoenoplectus validus* or a combination of any of the three species in shallower areas by 2014. For a representative example, please see Plate 4.

Plate 4. Representative of a Cove Landform, Site LALB0028, with a historical 'permanent' water regime, exhibits typical reversible change in habitat/vegetation type from open water with fringing reed beds in 2003 to introduced grasses with low, open samphire shrubland, before returning to its pre-drought habitat state in 2014.

2003 – Habitat condition rated as Excellent

2010 – Habitat condition rated as degraded

2014 – Habitat Condition rated as Very Good

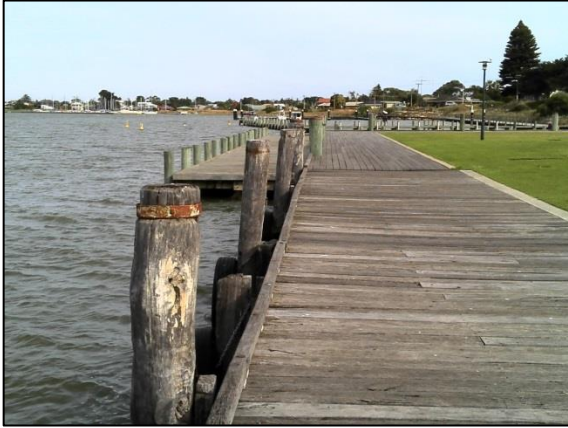
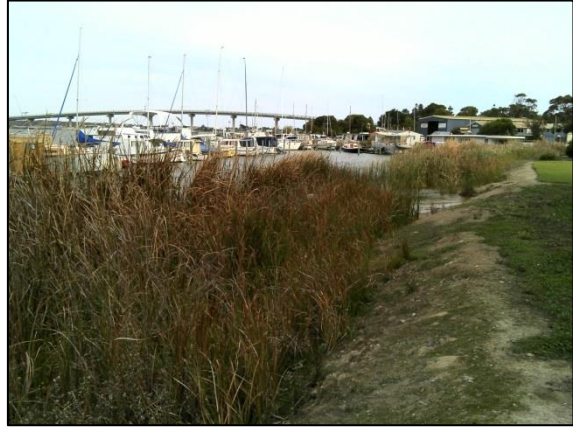
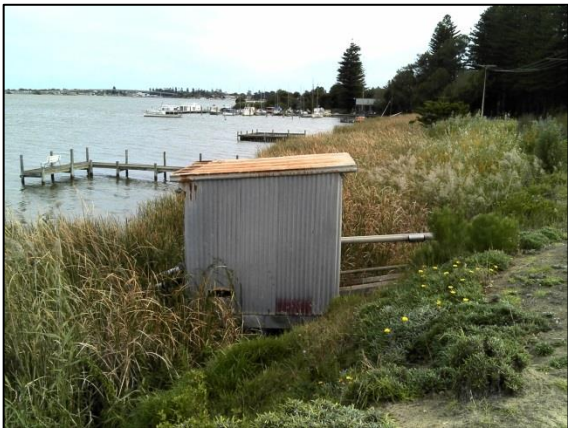
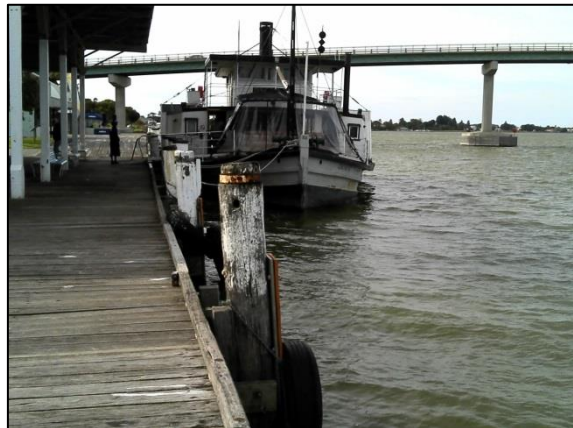
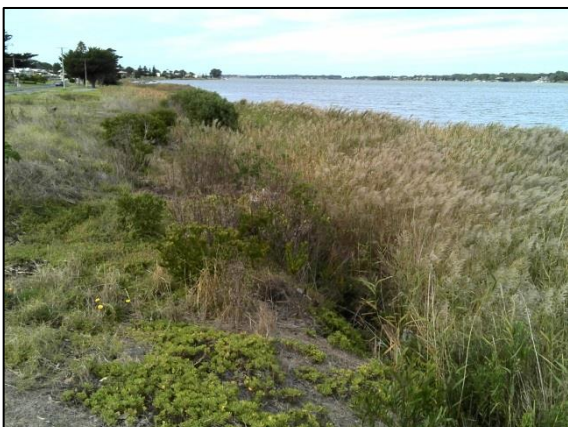
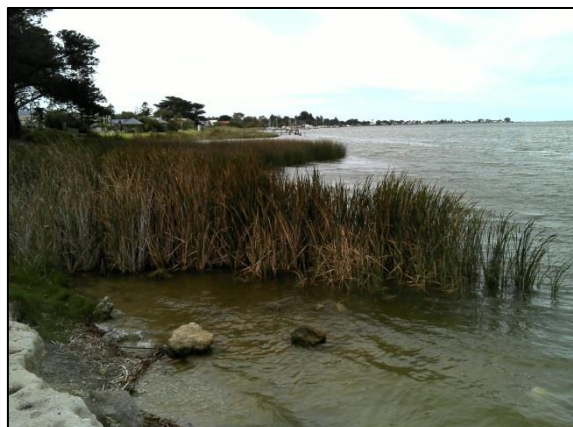
Plate 5. These images of six locations along the Goolwa Channel shoreline at Goolwa in 2014 illustrate the variation in habitat condition, habitat type/vegetation association, over a large area and the importance of recognising that a condition assessment at one location is not necessarily representative of the entire wetland polygon. Whilst this wetland polygon was assessed as Completely Degraded in 2003 it was given an average habitat rating of Degraded in 2014 based on the combined condition assessment from several locations along its length. The fact that generally healthy and extensive native reed beds occur along its length suggests that some areas are at least in Good condition as determined by the assessment criteria. The presence of a variety of waterbirds during the current study indicates that these areas provide suitable habitat resources to support these species.

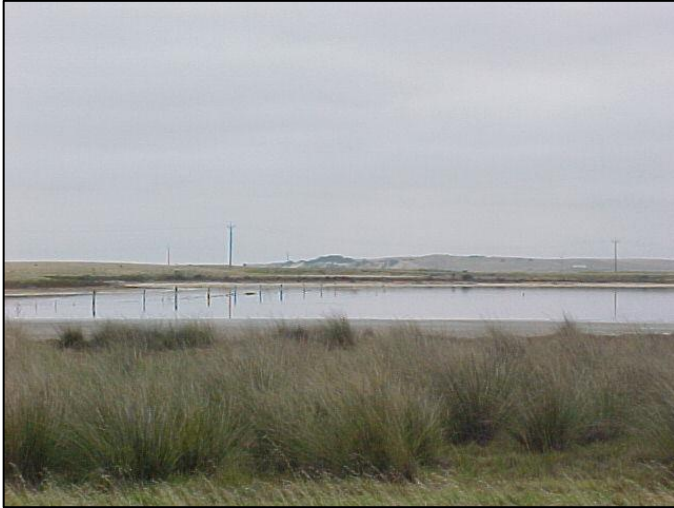
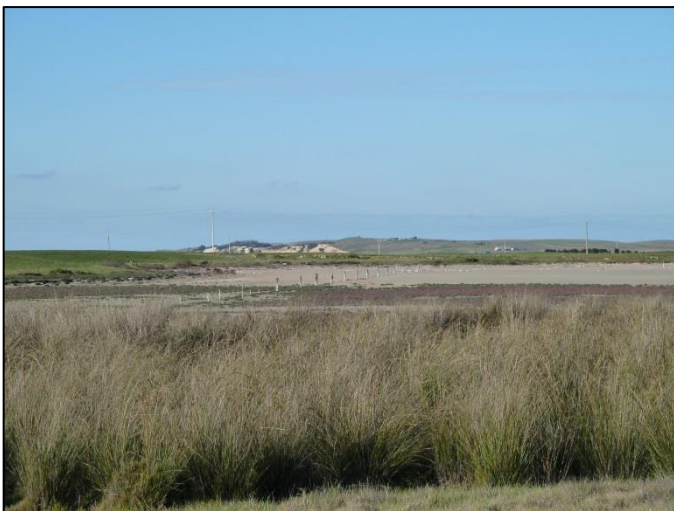
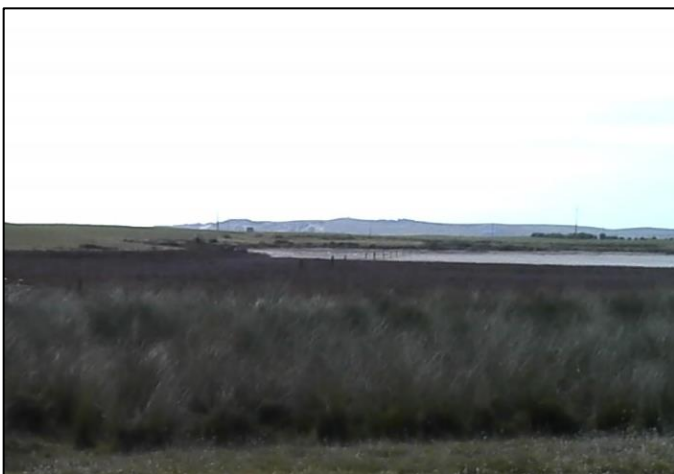
The return in 2014 of obligate wetland plants that were previously absent when many open water areas such as coves and lagoons became dry highlights that some wetland vegetation associations were able to return to their pre-drought state with sufficient return of water. Others transitioned to an entirely new state (with a different condition score), seemingly encouraged by shifts in composition that the drought encouraged, as indicated in Plate 6. For an earlier illustrated example, see Plate 1.

Plate 6. Representative of a Closed Depression Landform, Site LALB0075, with an historical 'seasonal' water regime, exhibits a transition from inundated shallow saline basin (fringed by samphire and *Gahnia filum*) in 2003 to a dry basin with colonising samphire in 2010. Further expansion of the samphire across the muddy sediments in 2014 illustrates that some sites may not return to their pre-drought habitat type under certain environmental variables that may favour a shift in habitat type.

2003 – Shallow water over mud sediment.
Habitat condition rated as Degraded

2010 – Early colonisation of samphire species over mudflat.
Habitat condition rated as Degraded

2014 – Increasing cover of samphire across the bed of the wetland.
Habitat Condition rated as Good
