**Coorong, Lower Lakes and  
Murray Mouth (CLLMM)  
Wetland Condition  
Assessments:  
Coorong sites, 2015**

**Report to the Department of Environment, Water  
and Natural Resources, South Australia.**

**June 2015**

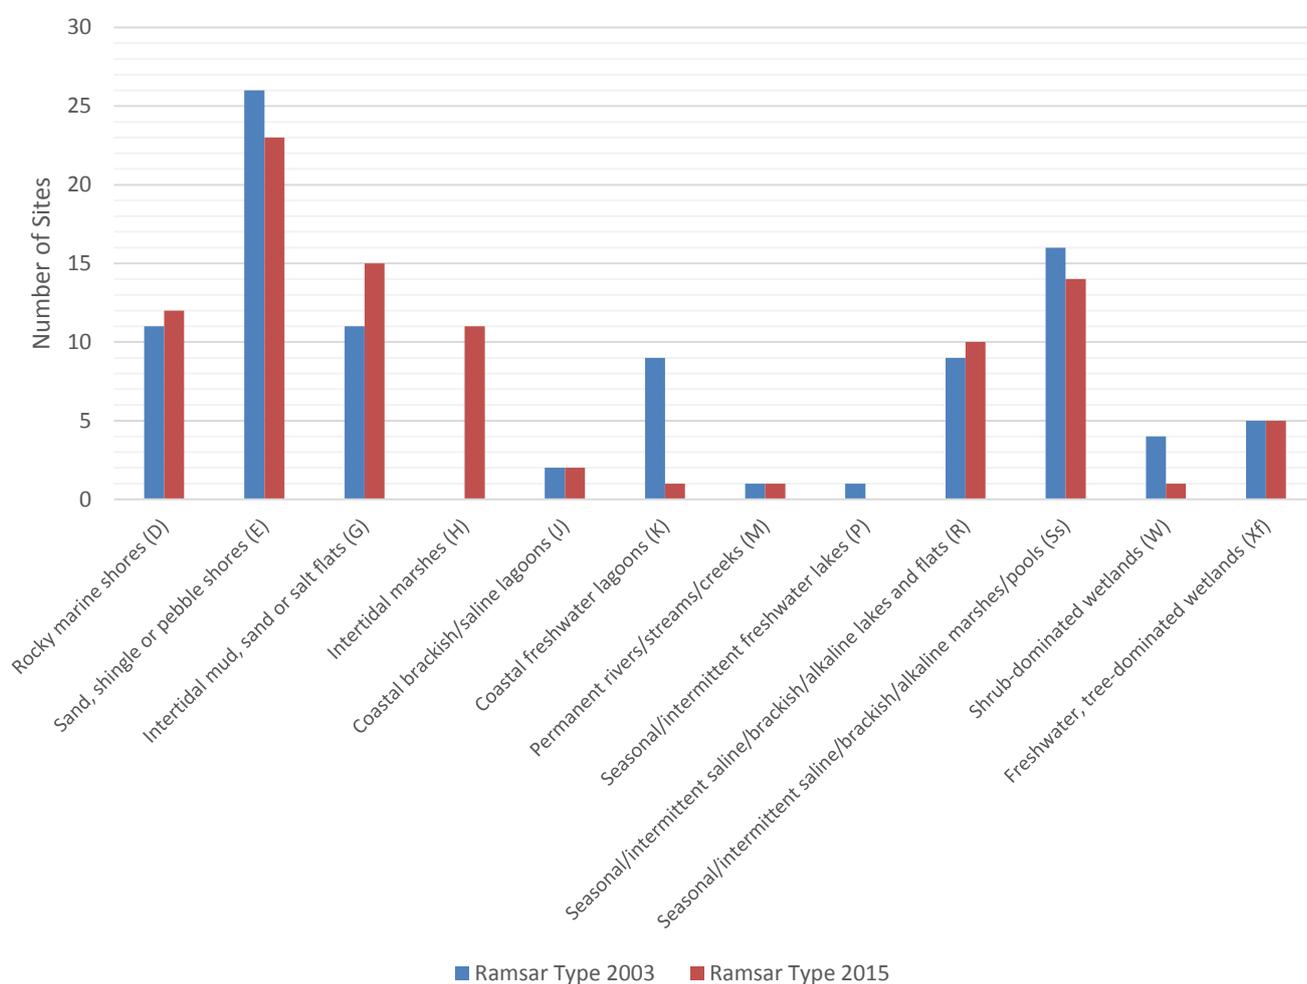
**Figure 2. Changes to Ramsar wetland type at the Coorong National Park between 2003 and 2015**

The 2015 assessment recommends 26 changes to the Ramsar wetland type across the 95 sites, or changes to 27% of sites (Table 2). The largest change occurred with the addition of Intertidal marshes (H) category, which was identified at 11 sites in 2015. Sites in this category had previously been assessed as Coastal freshwater lagoons (K) (7 sites) or Seasonal/intermittent saline/brackish/alkaline marshes/pools (Ss) (4) in 2003 (Table 2). Conversely four sites were newly described as Seasonal/intermittent

saline/brackish/alkaline marshes/pools (Ss), which had previously been described as Shrub-dominated wetlands (W) or Freshwater, tree-dominated wetlands (Xf). The changes are unlikely to be reflecting a hydrological change, but rather the ambiguity of the description, discrepancies in mapping, site assessment location and/or how the Ramsar types were applied.

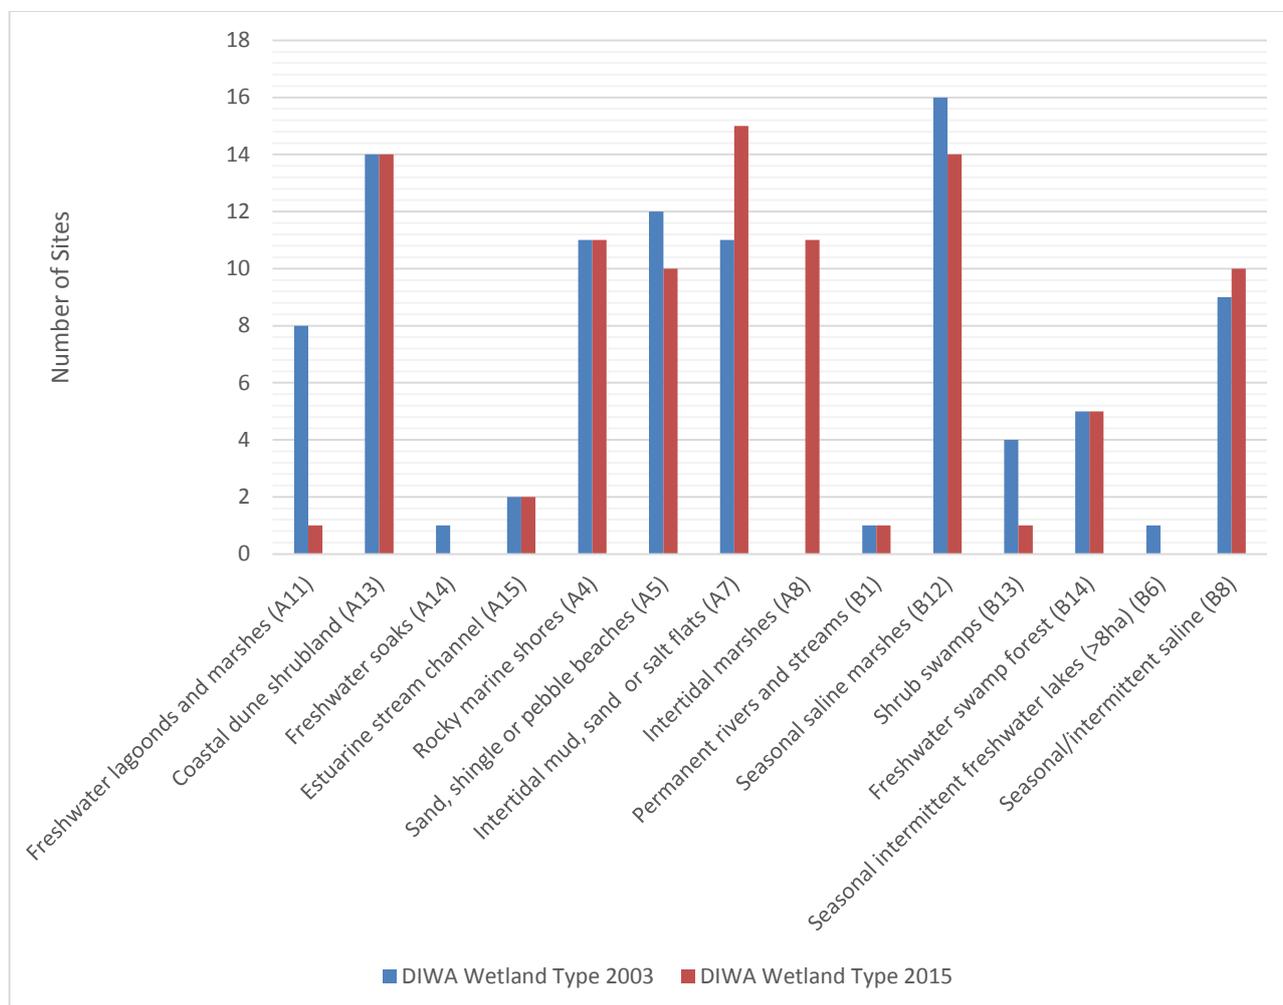
**Figure 3. Change in the Directory of Important Wetland in Australia (DIWA) type in the Coorong NP between 2003 and 2015.**

In 2003 no wetlands were described as Intertidal marshes (A8), however, in 2015 11 sites were considered an Intertidal marsh (Figure 3). Consequently there was a decrease in the number of identified Freshwater lagoons and marshes (A11) and Seasonal saline marshes (B12) (Figure 3). The sites that had very clear descriptions, such as Estuarine stream channel (A8), Permanent rivers and streams (B1) and Seasonal intermittent freshwater lakes (B6), which also had low number of occurrences, did not change type. However, the clearly described Coastal dune shrubland (A13) had one recommended change to Freshwater swamp forest (B14), which may have been due to the point of assessment and the fact that it is a large polygon with two clear DIWA (or equally Ramsar) types.

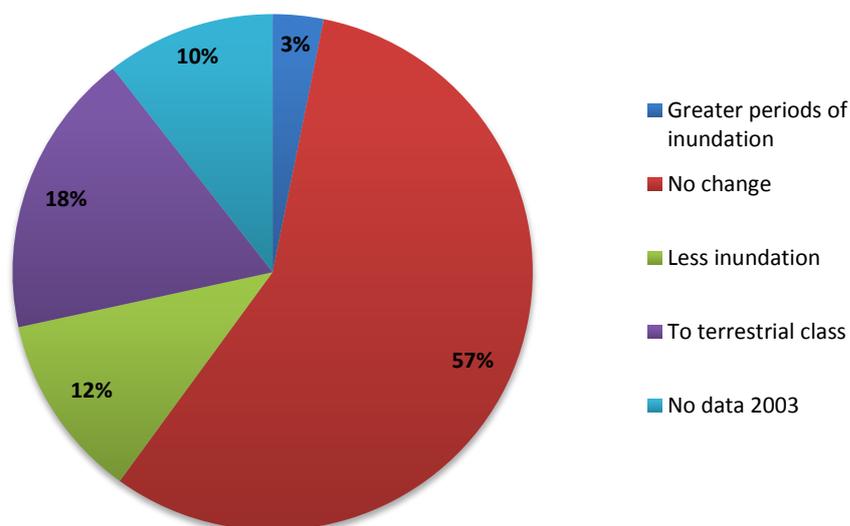
**Figure 4. Percentage changes in water regime from 2003 to 2015**

Of the 95 sites assessed across the Coorong National Park in 2015, 57% did not record a change in the water regime since 2003 and a further 10% had no data in 2003 (Figure 4). Three percent were recorded as having a slightly greater period of inundation in 2015 than 2003, which represented sites changing from seasonally or intermittently flooded to semi-permanent or permanently flooded. Twelve percent of sites considered to be receiving less inundation generally only experienced changes of one water regime class.

The proportion of sites that were reclassified as terrestrial in 2015, or without a water regime, represented the second most commonly recorded class, of 18%. As previously described, these sites generally did have water regimes described in 2003, however, they were either rocky cliffs or consolidated dunes without wet depressions present.

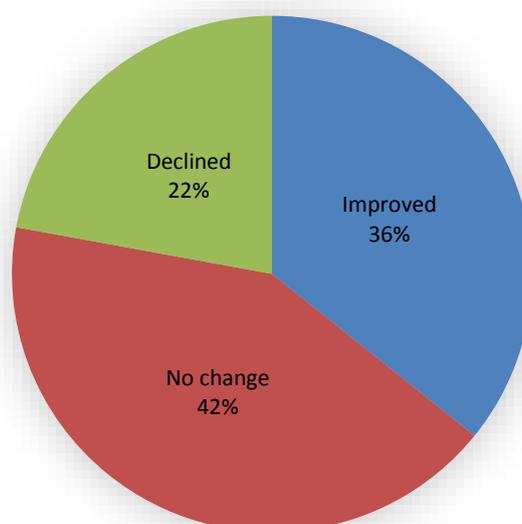
**Figure 5. Habitat condition change of the same sample of 95 wetlands assessed from 2003 to 2015**

Assessments of the habitat condition at the 95 sites in 2015 found that 34 (36%) have improved in condition, 40 (42%) have not changed condition, and 21 (22%) have declined in condition since 2003 (Table 5, Figure 5). Table 5 details the proportion and direction of change for each condition class.

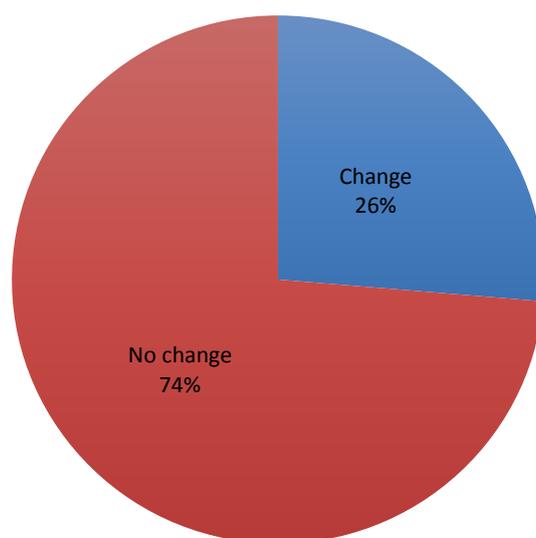
**Figure 6. Habitat Community – Vegetation Association Change between 2003 and 2014**

A manual assessment was undertaken to compare the two vegetation communities at each site between 2003 and 2015, finding that 70 sites (74%) retained the same vegetation community (47 sites) or maintained no vegetation community (23 sites) (Figure 6). Of the 26% that had changed vegetation community, 17 sites had a vegetation community recorded where previously there was none, noting the 11 of these sites had an overall cover of <5%. Only two sites had a change of vegetation community, one from a *Eucalyptus diversifolia* Mallee (which was outside the polygon) to *Gahnia filum*, *Samolus repens* Sedgeland and one from an *Olearia axillaris*, *Leucopogon parviflorus* Coastal shrubland to *Melaleuca halmaturorum* Tall open shrubland. Of the 74% of sites that exhibited no change in the vegetation community or lack thereof, 8 sites (8.4%) had a change in overall cover class across the polygon, however, generally this was only one class of 25%.

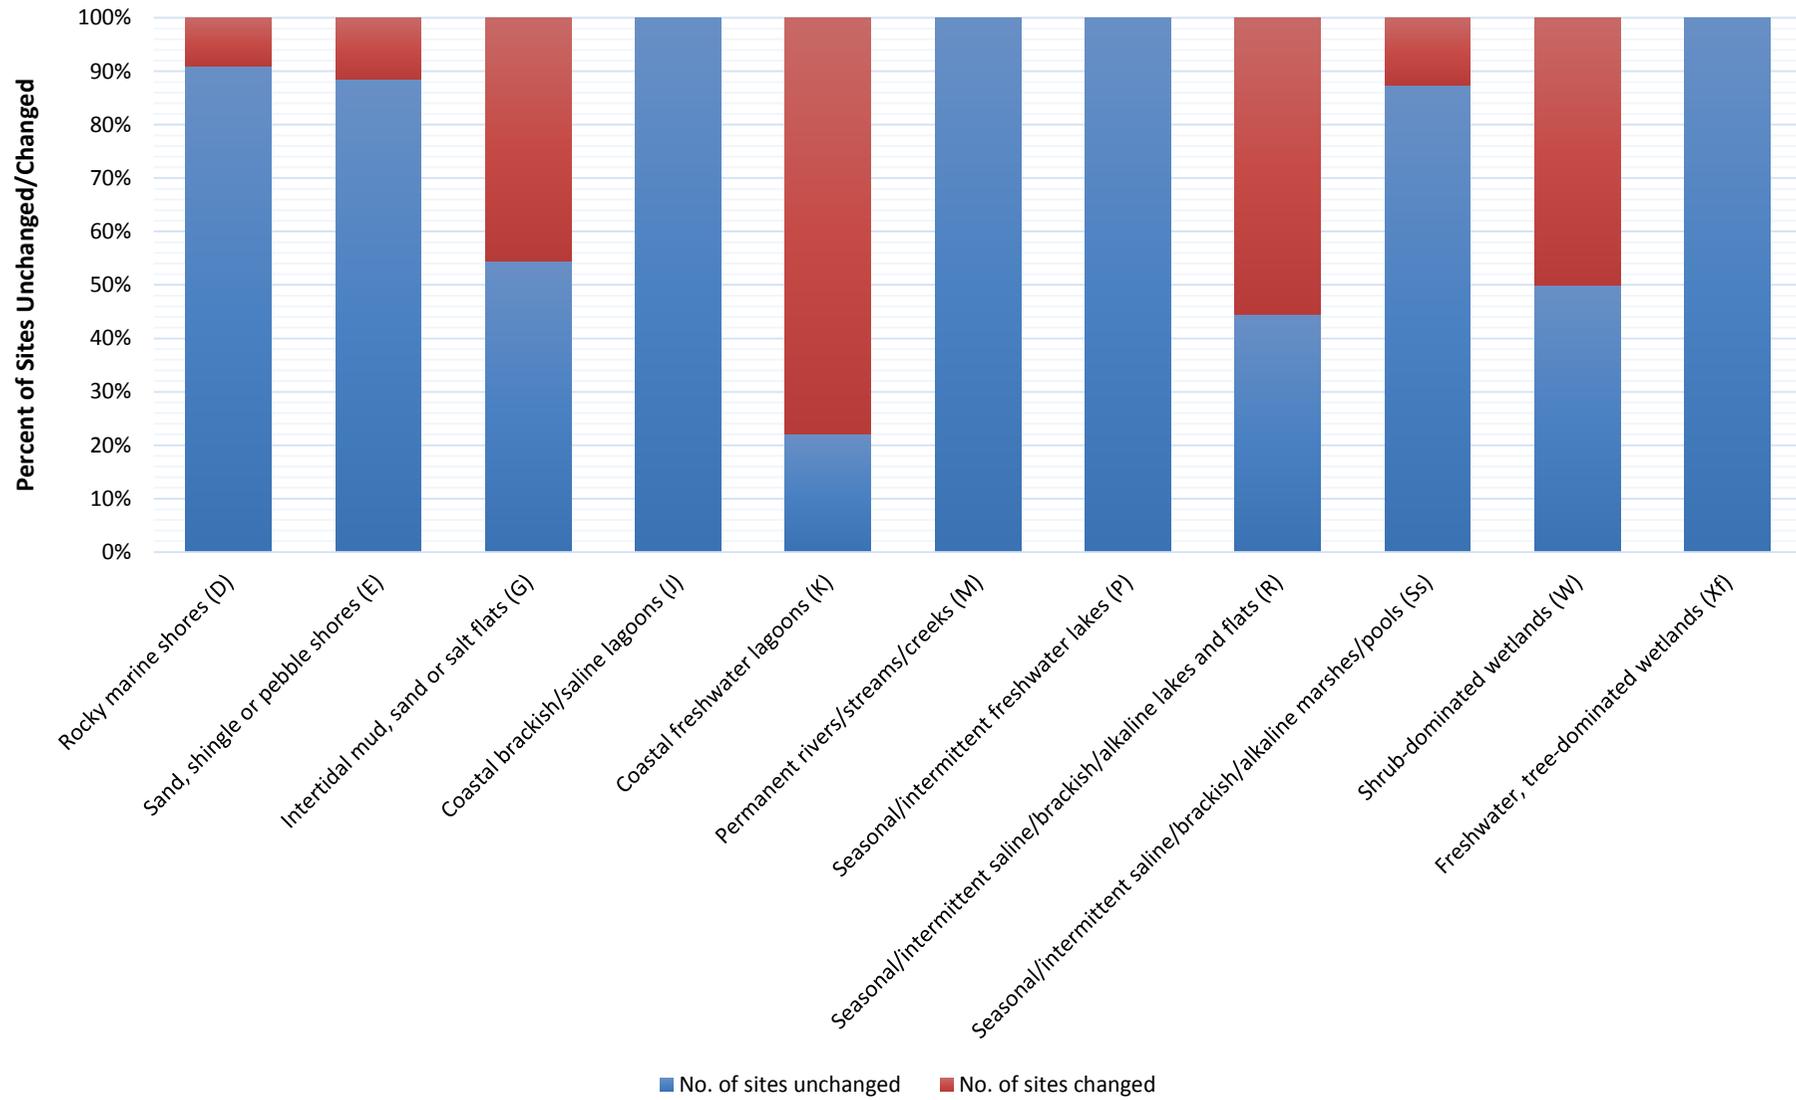
Figure 7. Change in vegetation community across Ramsar wetland types in the Coorong National Park between 2003 and 2015

The highest variation in the recorded vegetation community was in the Coastal Freshwater Lagoons (K), Intertidal mud, sand or salt flats (G) and Seasonal/intermittent saline/brackish/alkaline lakes and flats (R) (Figure 7). However, it should be noted that some of these changes could have been quite minor, such as the inclusion of a vegetation community with <5% cover (usually at the buffer) at 11 sites where previously there had been no vegetation recorded.

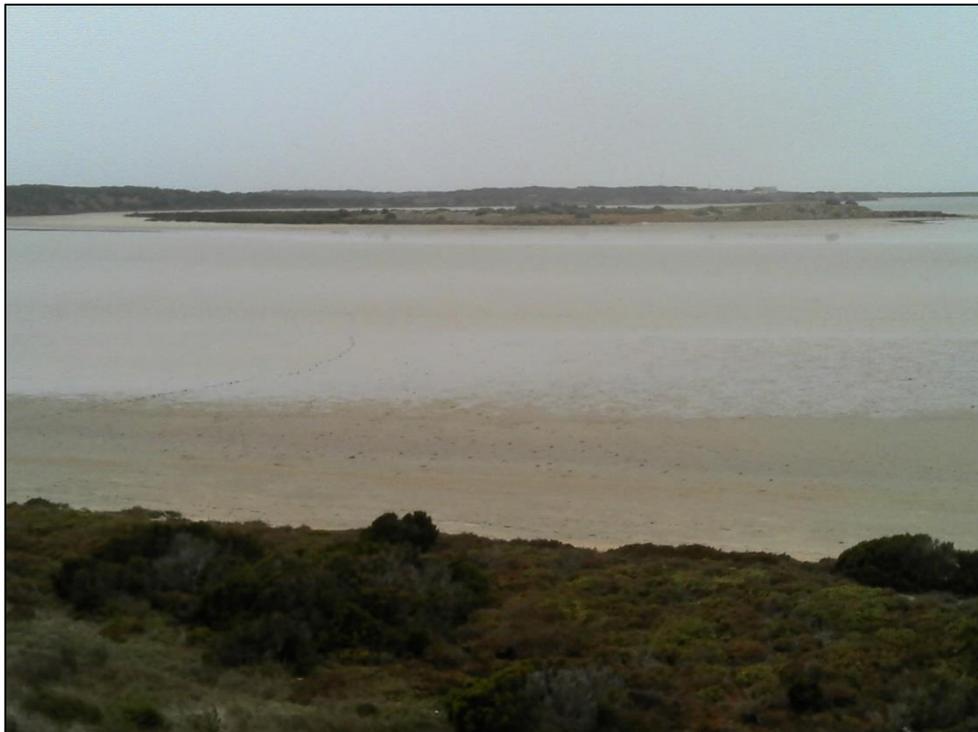
**Plate 1.** Photo-point image of vegetated island (polygon 458), a relatively stable geological feature east of Parnka Point, taken in 2015. It shows the occurrence of low samphire shrubland (left of view) and the dominance of introduced terrestrial vegetation (centre and right of view), verified using a spotting scope.

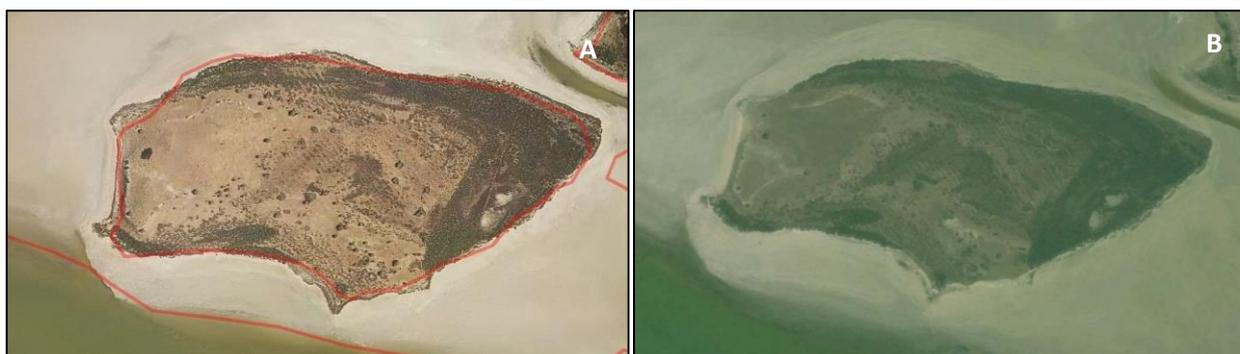
**Plate 2.** Illustrates the level of accuracy of the 2003 wetland mapping of the island over 2013 aerial imagery (left A) and the same area in 2005 (right B).

Plate 2A shows the deviation of the polygon perimeter from the island shoreline at several locations. The 2003 assessment identifies the *Tecticornia*, *Sarcocornia* shrubland as the primary vegetation association ahead of an *Acacia longifolia* - introduced grasses association, whereas 2015 observations recognise the terrestrial open shrubland of African Boxthorn \**Lycium ferocissimum* over *Euphorbia* spp. on higher elevations as the primary vegetation association due to its greater cover of the island compared with the extent of low samphire shrubland. For comparison 2005 imagery has also been provided of the island, showing very little change in vegetation cover or type between 2005 and 2015 (Plate 2B). Whilst geographically it is understandable to map the entire island as one polygon, particularly when assessing the whole Coorong, Lakes Alexandrina and Albert Ramsar site, there were inconsistencies in the level of mapping detail for different sites. In some cases sites were very small and split on much less detail than that given as an example for polygon 458 (Plate 1 and 2). Hence based on the 2015 observations in the field and of 2013 aerial imagery, recommended that the mapping units be reassessed and in this case the two visibly distinct areas of the island are separated into two polygons to identify two distinct Ramsar wetland types.

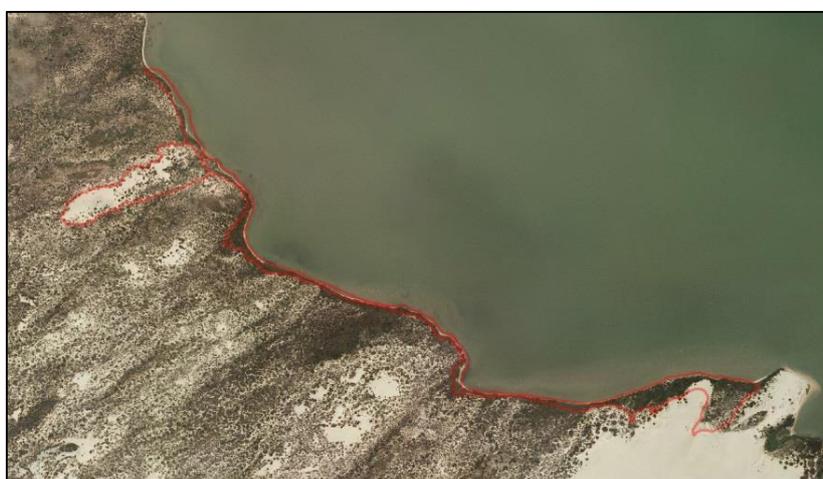
**Plate 3.** Coorong wetland polygon 1640, between the Youngusband Peninsula and North Lagoon.

This wetland polygon (1640) was assessed from the air in 2003 with the following characteristics:

- Ramsar wetland type: Coastal freshwater lagoon (K)
- DIWA wetland type: Freshwater lagoons and marshes in the coastal zone. Reed beds and vegetated bed sediments (A11)
- Vegetation Association: *Phragmites australis*, *Typha domingensis* reed bed
- Habitat Condition: Excellent

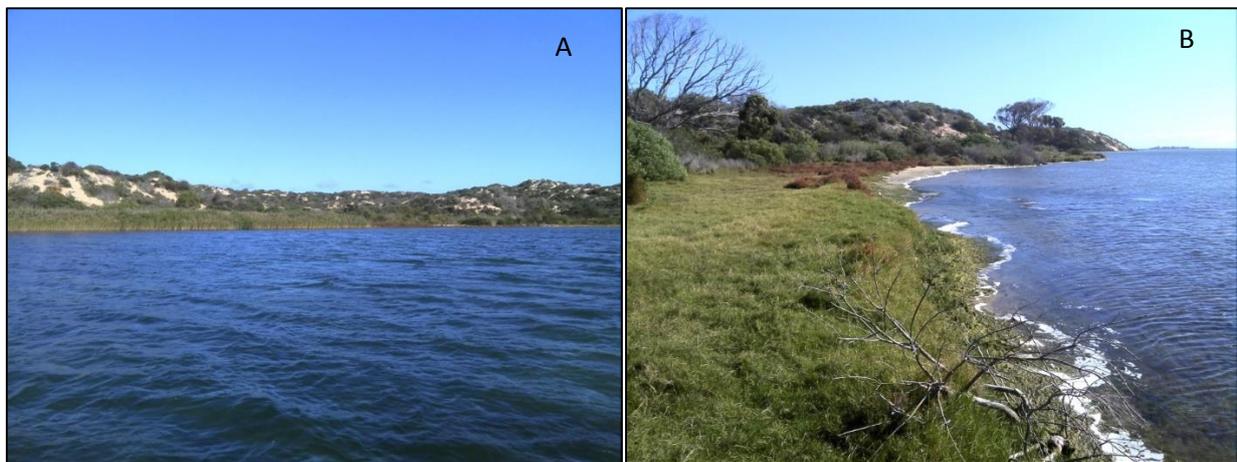
Plate 4. Coorong wetland polygon 1640 from the water and within the polygon.

A small portion of the same wetland photographed from open water in 2015 (Plate 4A). Note the *Phragmites australis* reed bed (centre left of Plate 4A) which may have influenced the characterisation of polygon 1640 (as above) in 2003. The occurrence of the reed bed is most likely due to a localised freshwater soak associated with the dune in the background. However it was observed during the current assessment period that the *P. australis* reed bed occurred within only a short section of the shoreline. As can be seen at centre right, vegetation changes to low samphire shrubland.

Plate 4B shows typical vegetation along the shoreline within polygon 1640 in 2015. The vegetation varies from *Sarcocornia quinqueflora*, *Suaeda australis* low shrubland (background) to areas invaded by the introduced amphibious grass *\*Paspalum distichum*. Recommended changes to the wetland polygon 1640's characteristics/condition assessment and mapping is based on the 2015 on-ground observations:

- Ramsar wetland type: Intertidal marshes, incl. saltmarshes, salt meadows, saltings, raised salt marshes, tidal brackish and freshwater marshes and vegetated shorelines (H)
- DIWA wetland type: Intertidal marshes, incl. as per Ramsar description (A8)
- Vegetation association: *Sarcocornia quinqueflora*, *Suaeda australis* low shrubland
- Habitat condition: Very Good (reduced from Excellent due to weed cover)

The observed reed bed (Plate 4B) suggests the occurrence of a freshwater spring and was recognised as a secondary Ramsar wetland type, Freshwater Spring (Y), within the polygon. On closer inspection of the wetland polygon layer over the 2013 aerial imagery revealed other significantly different vegetation and landscape features within the 1640 polygon, thus leading to the 2015 recommendation to remap this polygon to isolate and more accurately reflect the wetland types recorded.

It is recommended that mapping of wetland polygons in the CLLMM region be updated to:
