# Perched Watertable Induced Seepages in Dune-Swale Landscapes of SA's Agricultural Lands

Chris Henschke and Mary-Anne Young

Primary Industries and Regions

As part of the Department of Environment, Water and Natural Resources, "Improve Soil Protection 14-15" Project.

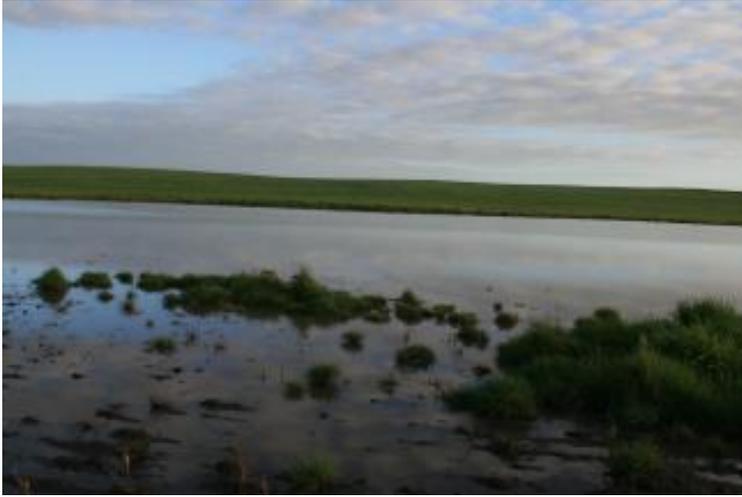
**Figure 4: Poned water in depression in cereal crop, Wokurna, September 2014**

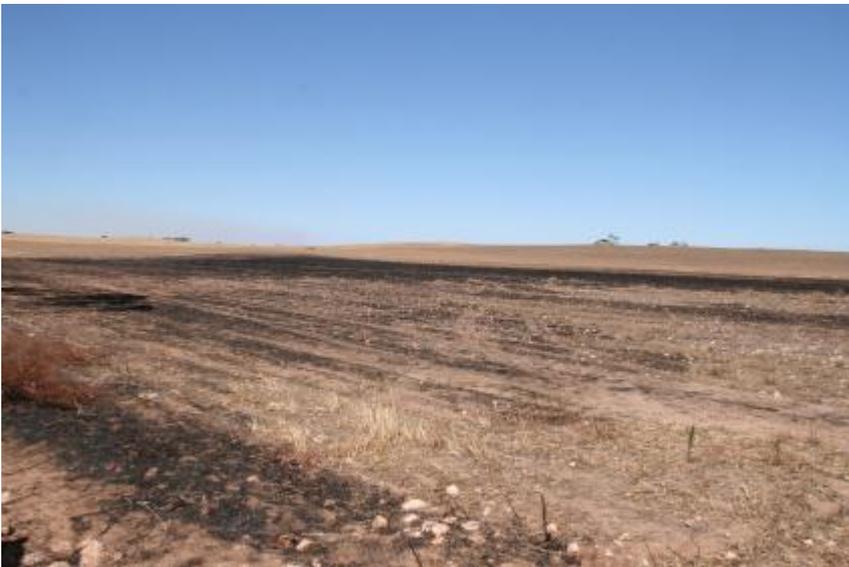
**Figure 5: Seepage area burnt presumably to control weeds and make it easier for tillage equipment to work through, March 2015.**

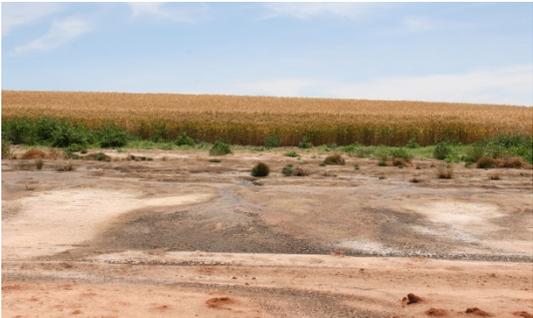
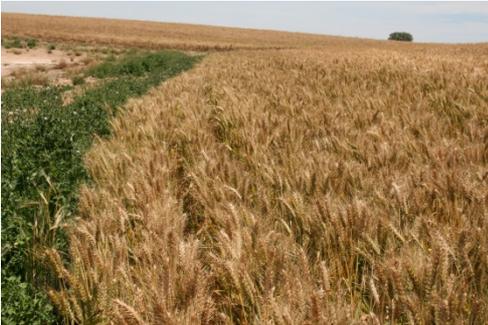
Figure 9: Western edge of seep 1, November 2014      Figure 10: Vigorous crop and weed growth on seepage

Observation of these areas in November 2014 found that all ponded surface water had either drained into the soil profile or had evaporated. Seepage was evident in some places. The areas were devoid of plant growth except near seepage where salt-sensitive plants such as ryegrass and milk thistle (*Sonchus oleracens*) grew. Wheat plants just above seepage on seep 1 were well grown and out in head with very full heads of grain.

A slight ridge at the western edge of this seep suggests a geomorphological structure running in an approximate south west to north east direction and it is possible that this structure has intercepted the watertable, forcing seepage to emerge at the surface higher in the landscape.

The surface appearance of the dried seep comprised a mix of colours. White non-crystalline deposits reacted to dilute hydrochloric acid indicating it is calcium carbonate. It is believed this has resulted from dissolution of calcium carbonate in the soil profile. Darker soil is associated with organic material accumulated under anaerobic conditions during periods of waterlogging.

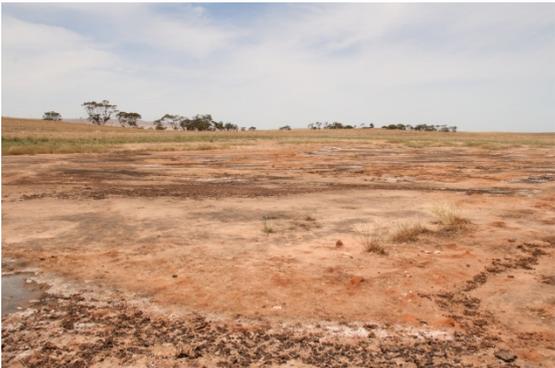
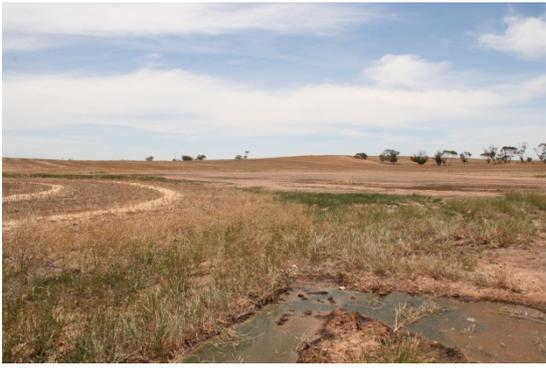
Figure 11: Seep 2, November 2014      Figure 12: Seepage western side of seep 2

Seep 2 was an area of bare land approximately 300 m<sup>2</sup> with seepage channels evident on the western side of the area.

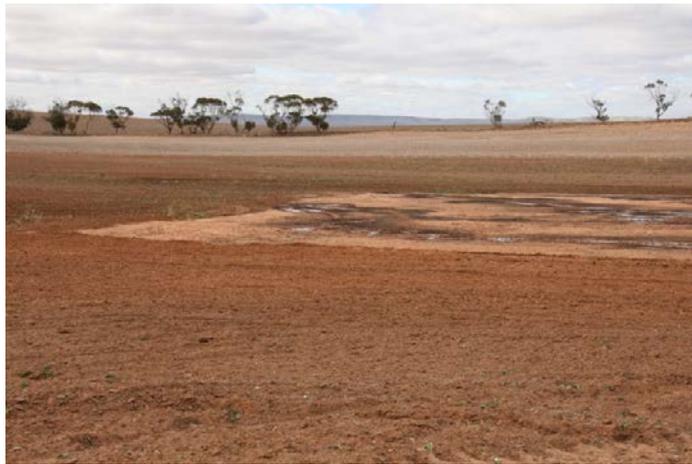
Figure 13: Seep 2 mostly cultivated except for active seepage area, May 2015

In autumn 2015, seeps 1 and 2 had dried out sufficiently to enable the Hewetts to cultivate most of the areas.

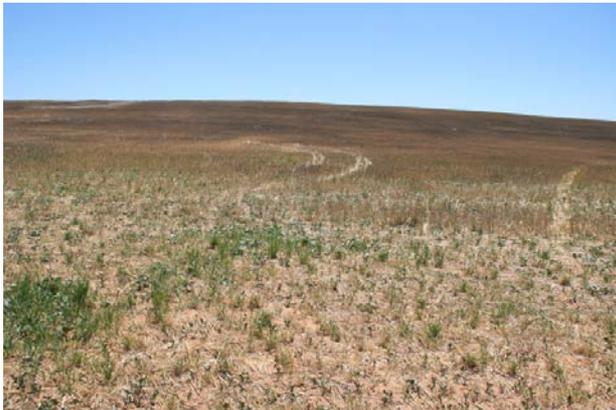
In January 2015, a backhoe was used to dig a pit on a “boggy” patch on Hewett’s property. A site was selected that was not an obvious soak or depression, but observed to be boggy when driving machinery over it. The site was mid-slope of a sandhill.

Figure 14: Looking up slope from soil pit site

On commencement of digging, water immediately began to seep into the pit. At the time of describing and collecting soil samples from the soil profile, the water was 80 cm below the soil surface. The salinity of the water was approximately 3,950 EC units or 2,500 mg/L Total Dissolved Salts.

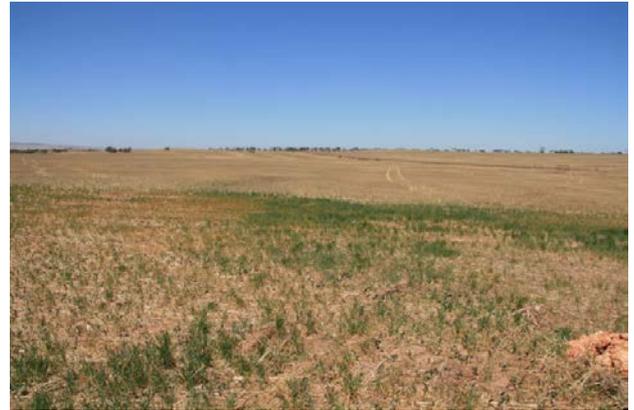
Figure 15: Looking down slope from soil pit site
