Monitoring Mallee Seeps

Project 1498C for the
South Australian Murray-Darling Basin
Natural Resources Management Board
Progress Report Jan-June 2017

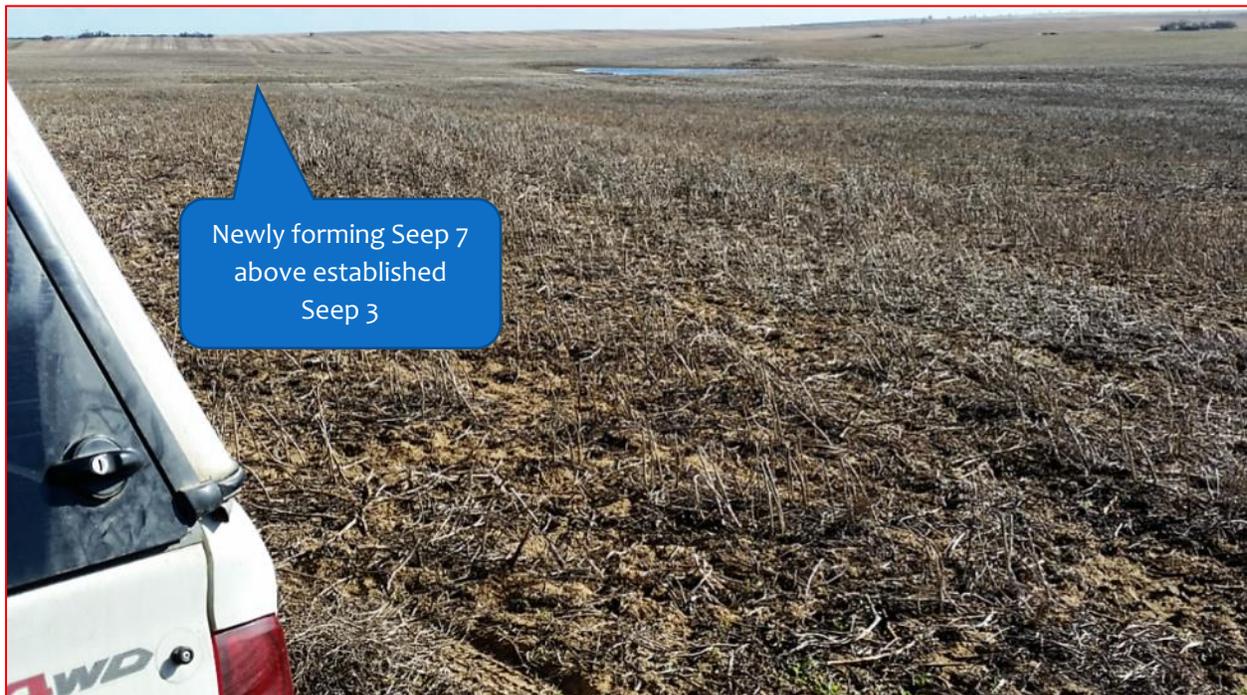
Photo 6. View from Piezometer 8 looking west toward upper Seep 3 and New Seep 7.

The increase in size of Seeps 3 & 4, along with the clear surface soil saturation of the new Seep area 7 (Photos 6 & 7) is evidence of the high level of soil moisture throughout the soil catchment area. Figure 7 shows a steadily increasing trend of soil moisture within the plant rootzone even on the very top of the rise since 2014.

This clearly indicates that factors contributing to recharge are active even from the very top areas of the landscape, leading to localized seep issues progressively down to the lower catchment areas. While the current increase in water levels and seep affected areas appears substantially due to the very wet year of 2016, there is no indication that these areas are likely to reduce unless higher water use paddock management is able to be applied. Crop growth alone appears to be insufficient to utilize all the soil moisture accumulated in the above average season, and this was greatly exacerbated by the high out of growing season December rainfall event.

This paddock may well benefit from spading chicken manure as has been successful in the lower paddock trial. However, it may also be a more feasible option to sow areas of the paddock to lucerne to utilize the deep soil moisture that is contributing to seep development within this catchment.

This paddock should be tested for evidence of compaction in the sand using either a penetrometer during winter, or using a probe for soil moisture after crop senescence in late October, to assess if this is contributing to the crops inability to utilize available moisture.

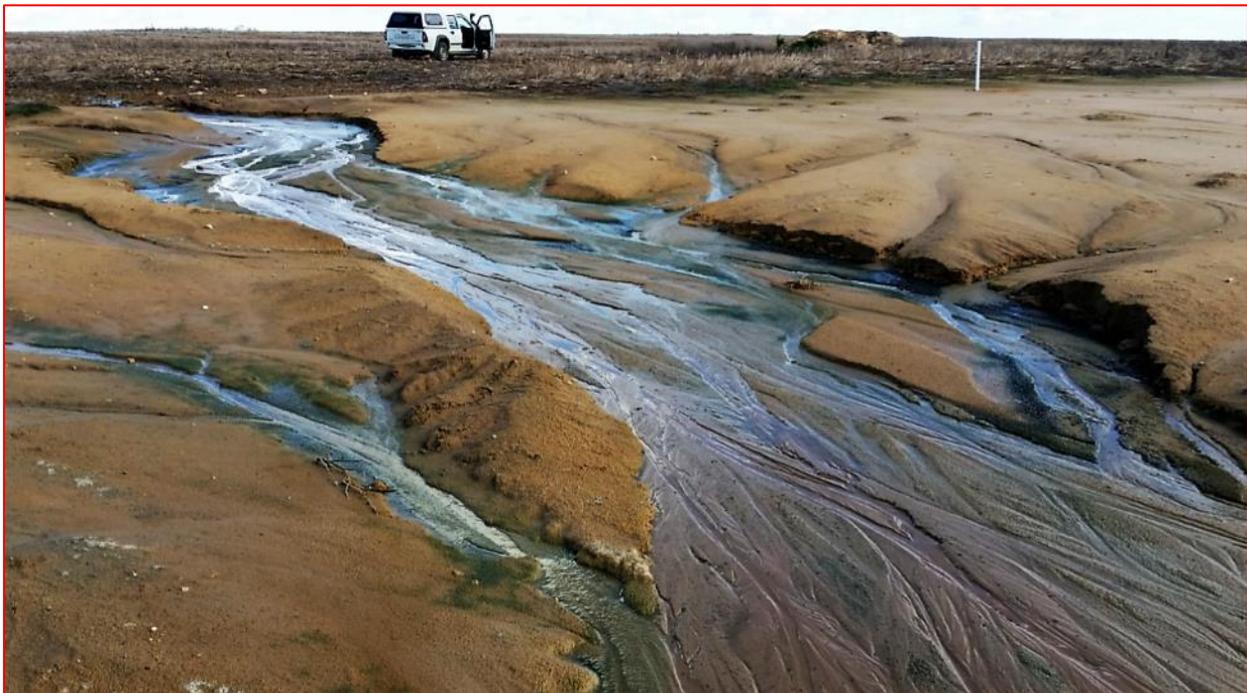
Photo 8. Moisture flowing from the paddock into the scalded Seep 1 area.

Photos 8 & 9 shows water streaming out of the paddock above into the scald area at Seep 1 on 24 May, after 30mm rainfall 20th-21st April and a further 14mm on the 13th-14th May. Piezometer 7 (visible in Photo 8) shows a sharp rise in the in water level at the 48mm December rainfall event to above the level of the moisture sensors, where it has been for most of 2017. This sensor has now been raised by 26cm, slightly above ground level, so that fluctuations in water level can still be measured. Photo 10 shows the soil pit just meters from this piezometer almost full to the brim.

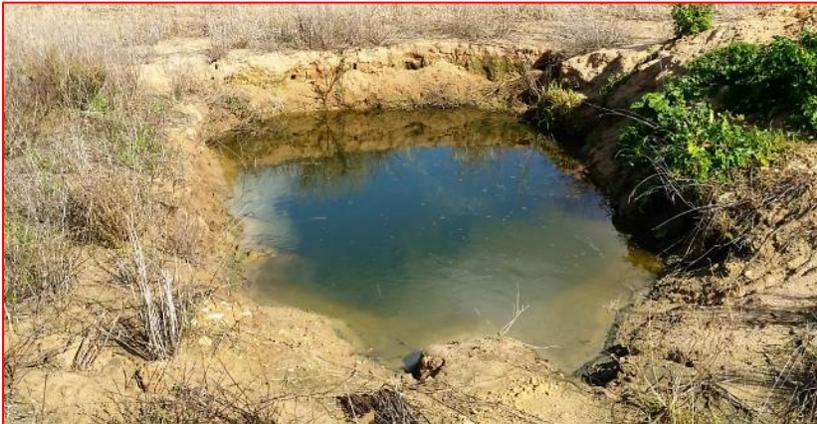
Photo 10. High water level in soil pit area near scald site piezometer 7

It is therefore clear that water table has risen and remained high at the lower region of the catchment, since the end of 2016. Moisture probe data from the spaded chicken manure treatment site (Figs 14-15) shows little change in moisture level at the 90cm sensor which is just in the top of the clay layer beneath the sand, and appears to be at a level nearing field capacity. All other sensors in the sandy layers to 70cm depth saw a sharp rise in moisture levels after the 48mm December rainfall, and then each rainfall of 8mm or more after this. Summer weeds have generally been controlled on this paddock, although there were some patches of skeleton weed observed. It is possible that the lowering of soil moisture levels after each rainfall event may have been due to some recharge to lower layers, however there are no obvious sharp spikes in the 90cm sensors.

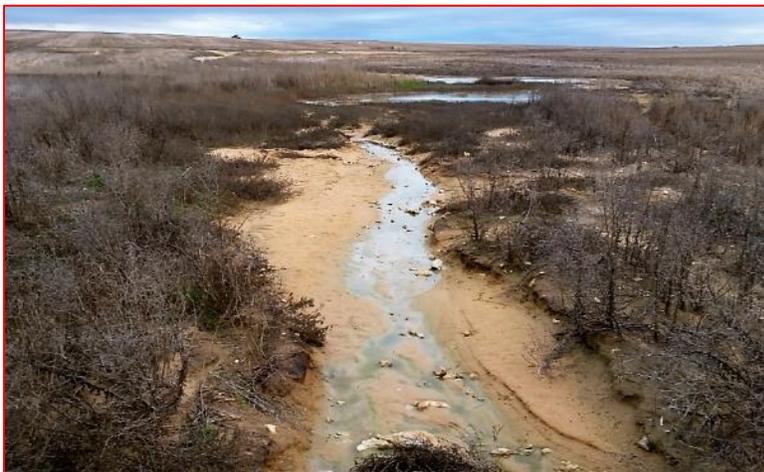
Photo 17. Overflow water channelling out of Seep 2 area.

It is clear from this data that there is a great deal of perched water table ground water flowing through this catchment and presenting a the surface around the main seep area. While the high rainfall year of 2016 has led to a swift expansion of waterlogged area, it is necessary to employ higher water use catchment strategies to combat further degradation of productive cropping land. While the spading of chicken manure has been shown to greatly increase yields on non-wetting sands by 1.8t/ha in year 2, using an estimated 90mm more water to produce this crop, this is still restricted to a small area of the catchment. While producing very high gross margins there is still high upfront costs and effort required to establish this over the whole catchment area. It essentially uses the rootzone moisture and has reduced ability to impact high summer rainfall events and much of the deeper lateral water movement below the top 1.5m depth.

Growing a 40m strip of lucerne along the east/west fenceline separating the 2 catchment paddocks has been discussed with the farmer. This could potentially intercept and utilize much of the water through the mid-slopes before they cause discharge lower down. It is less likely that the lucerne would completely dry out the profile to the extent that it would soon diminish its growth and production, as it will be fed from the large catchment area above. The lucerne could be cut for hay or be used as a fodder reserve for livestock over summer months, as well as create a race for stock movements through the farm.

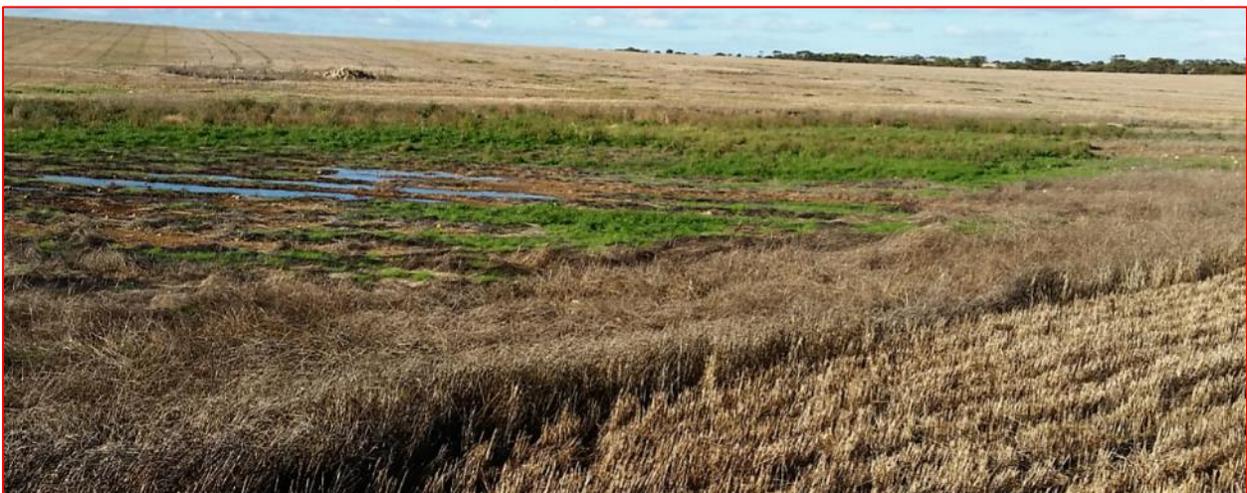
Photo 37. Water in basin of expanding seep area in the swale directly north of the main seep

The wet season of 2016 has led to the clear growth of developing seep areas within the catchment, many of which have been cropped in recent years. Photo 37 shows the seep directly north of the main seep which was holding surface water in May 2017. There is still a lot of grassy growth around this seep, suggesting that it is mainly suffering from waterlogging at present, rather than surface salinity. This area appears to have doubled in size over the last 3 years.

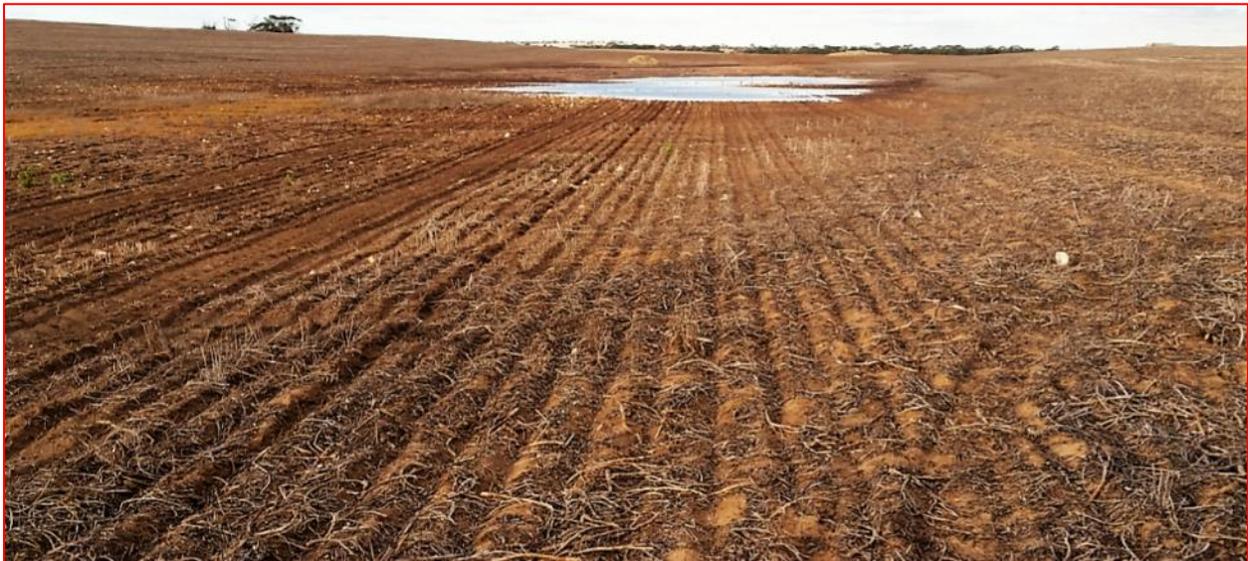
Photo 38. Rapidly developing seep in swale on Thomas side of catchment

Further east in the same loamy swale but within the Thomas paddock there has been a large collection of surface water in areas that were clearly cropped last season, as can be seen in Photos 38-39. The water may well be collecting from the large sandy rises on both the northern and southern sides of this seep area. There is a very strong concern that this seep will continue to grow and degrade many hectares of good cropping land unless high water use strategic management is taken. *Messina* is likely to be planted in this area this season once the water subsides to at least maintain soil cover and limit evaporation.

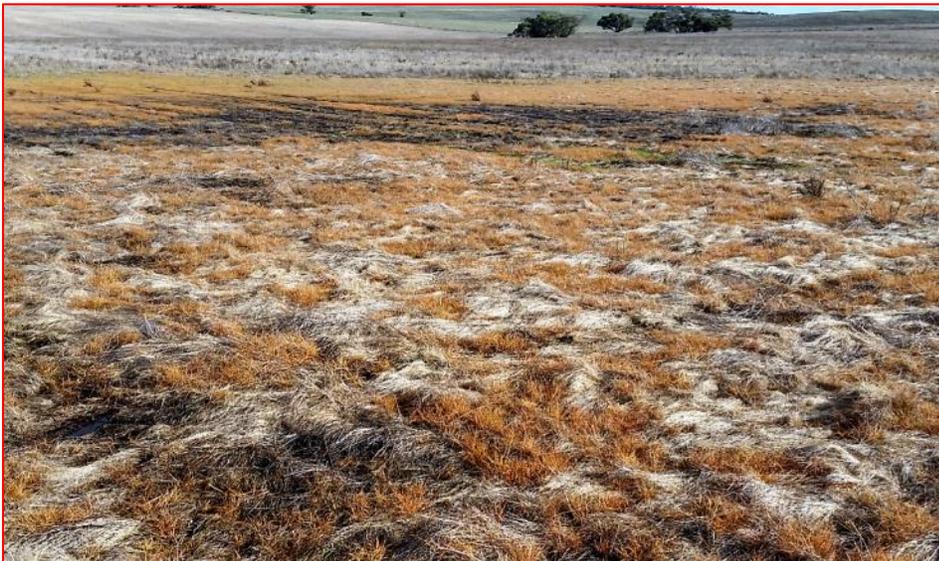
Photo 43. Developing waterlogged seep area surrounded by dry ryegrass

While this site does not have moisture probes or peizometer data recording, it is clearly experiencing similar issues as the other catchment monitoring sites of high subsoil moisture levels, lateral water movement and the accumulation of water surface water and waterlogging. The rainfall would be similar to both the Martin and Rose / Thomas sites.
