Re-use of Irrigation Drainage Water

Background

Saline irrigation drainage water is normally a waste product and releasing it directly back into the environment can have negative environmental impacts. The date palm (*Phoenix dactylifera*) has the ability to tolerate high salinity levels and drought therefore this project was an investigation in to re-using saline irrigation drainage water for irrigating date palms to grow a secondary crop, date fruit.

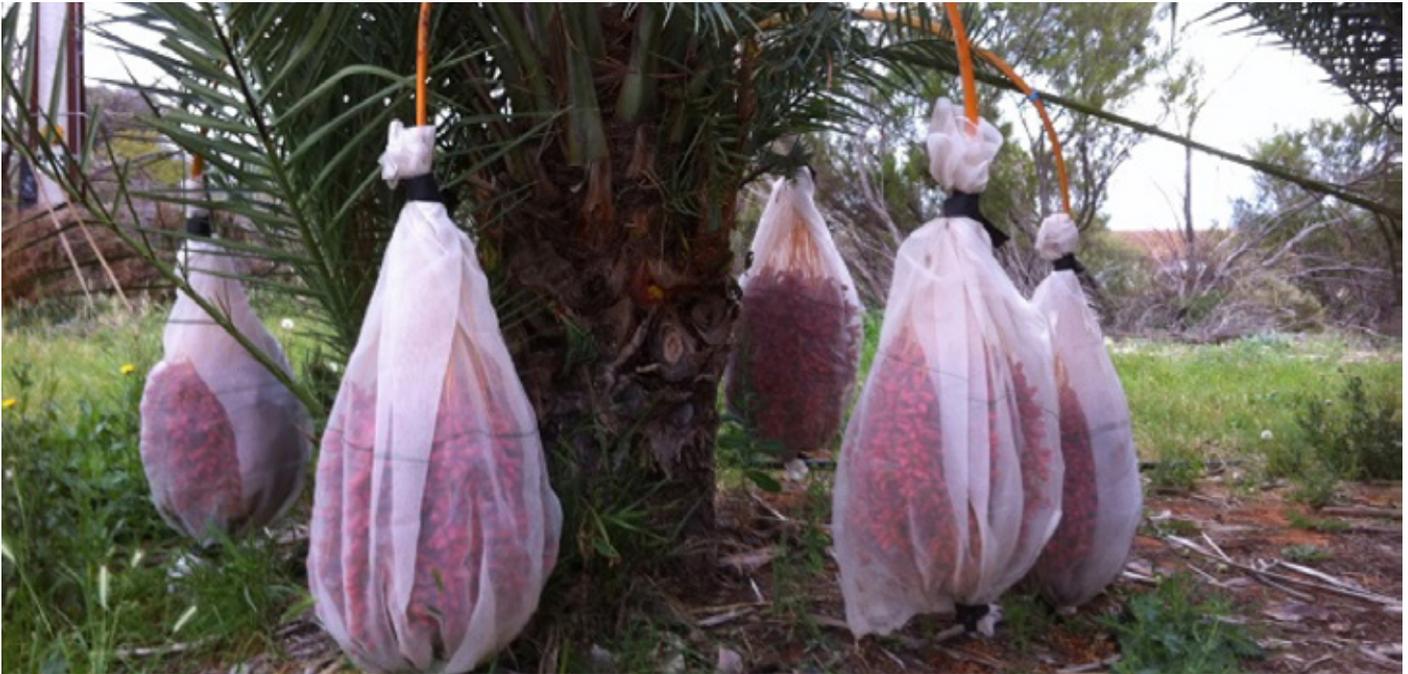
One of the female palms in fruit. The fruit are covered in protective bags to prevent bird and insect damage

The two female palms produced 5 fruit bunches and yielded 58.5 and 44kg. In comparison, commercial date growers would aim

Fruit quality was assessed against commercial fruit quality and was found to be similar although Calcium levels were on the low side due to nutrient deficiency. In general, the growing conditions were favourable for date fruit production.

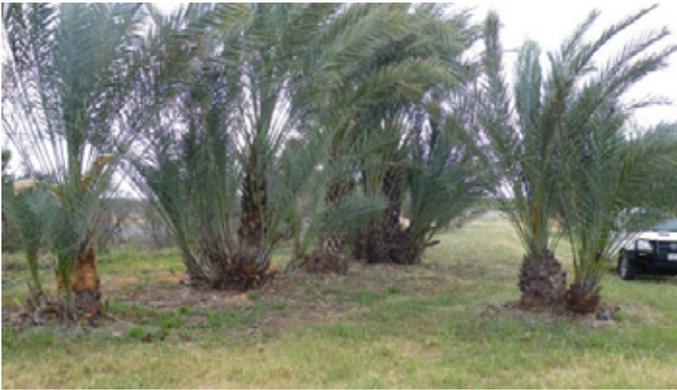
The date palms after pruning ready for irrigation

A small existing planting of five date palms was pruned back in 2013 in preparation for commercial production. In October 2014, water meter and sprinklers were installed to measure and deliver the re-used water on the date palms.
