Gully erosion

Land assessment in southern South Australia

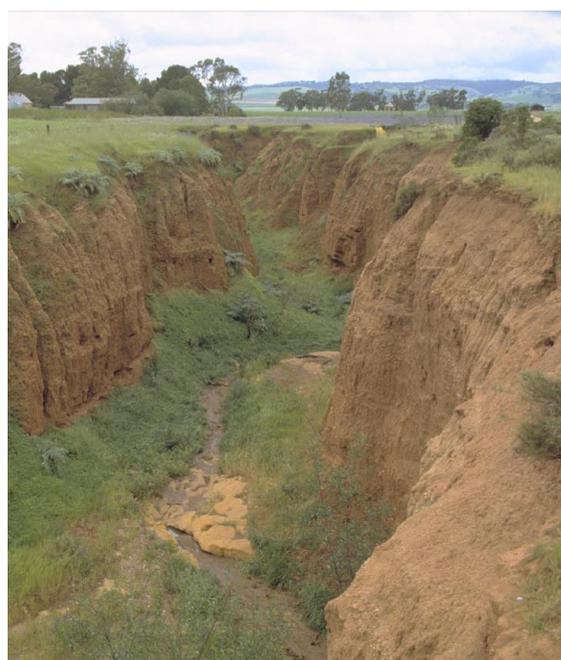
Severe gully erosion is a safety hazard and a major limitation to potential productive land use. It requires ongoing costly management.

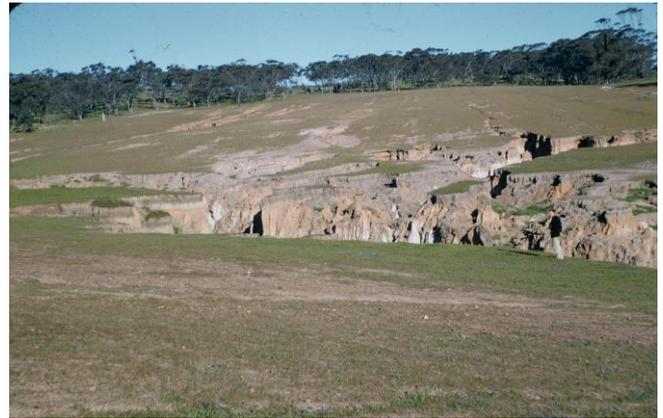
Gully erosion has severely degraded the value of this landscape
