TRAFFICABILITY ASSESSMENT

VARIOUS STUDY LOCATIONS - COORONG

Department of Environment and Natural Resources

REPORT NO. 4768001

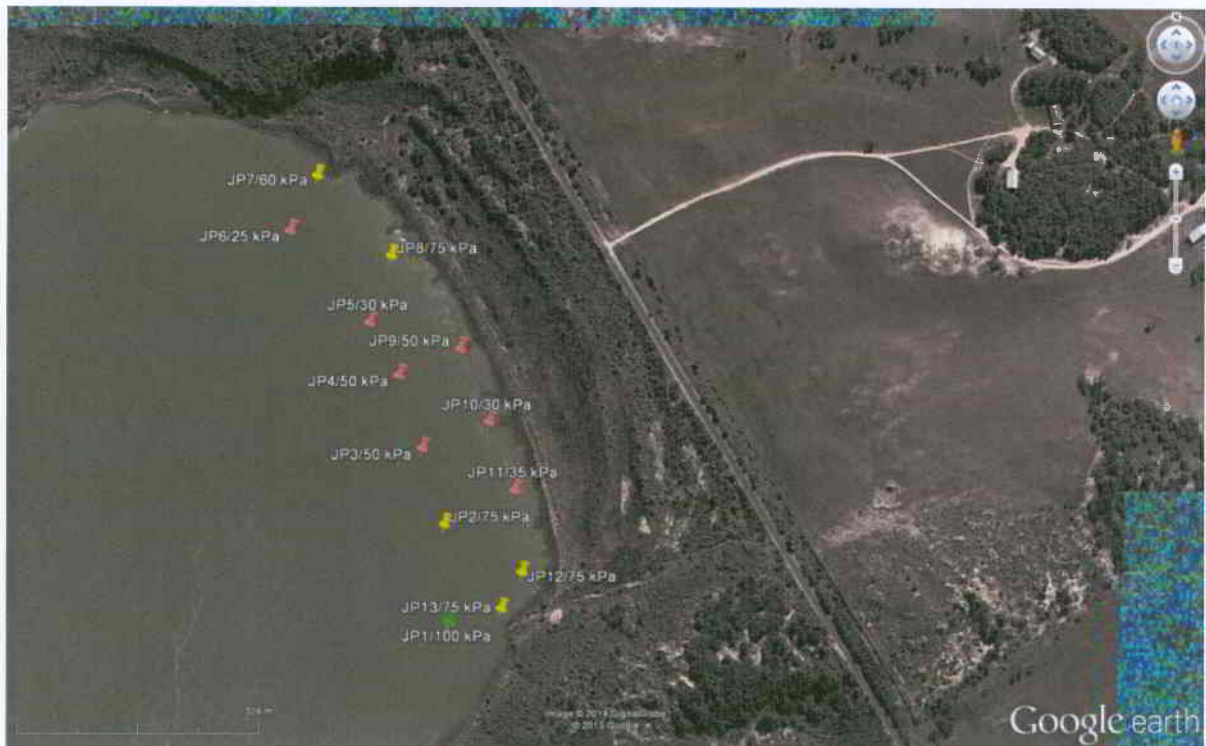
Figure 7 Jack Point test locations and estimated Bearing Pressure in kPa

Thirteen DCP tests were performed over the study area, the results of which can be found in APPENDIX C – DCP and BEARING CAPACITY CHARTS

In this area the DCP testing indicated that bearing capacity ranged from 25 to 100kPa with no apparent pattern to the results. It does not appear that close to shore has better bearing capacity than near the water edge. Again, the results may improve as the lake dries up. The average of all results was 56kPa.

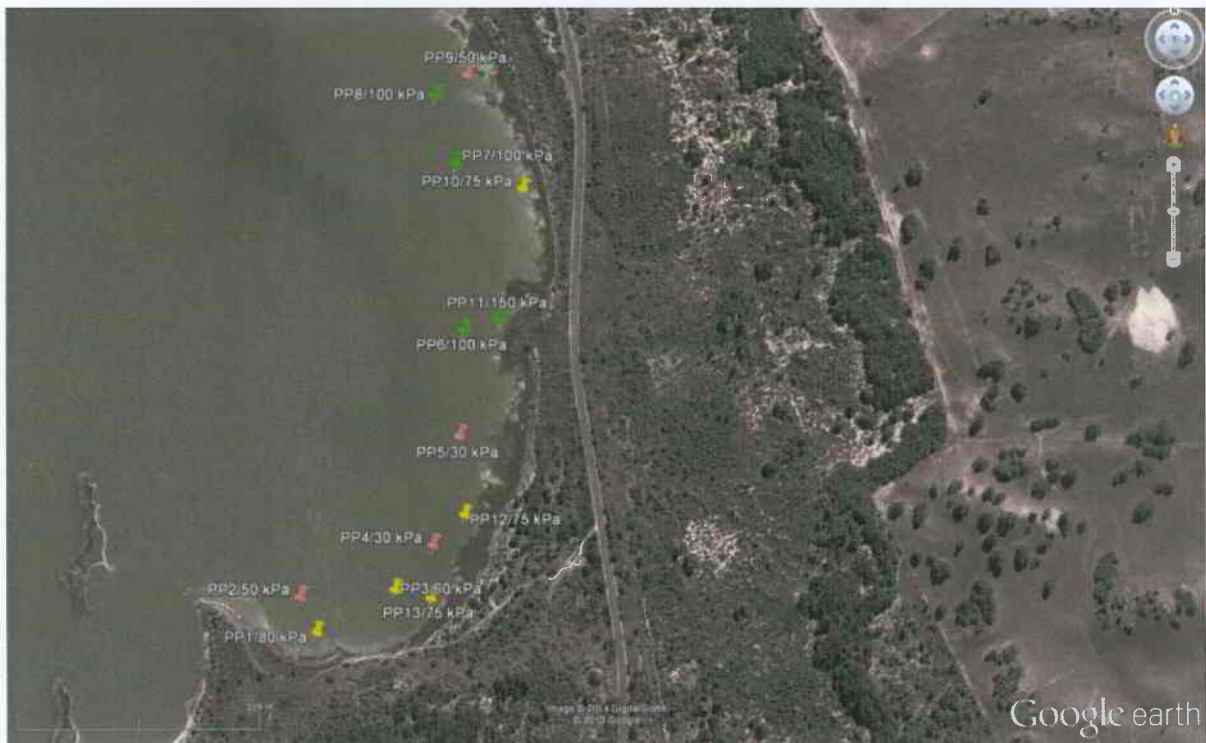
Figure 8 Policemans Point test locations and estimated Bearing Pressure in kPa

Thirteen DCP tests were performed over the study area, the results of which can be found in APPENDIX C – DCP and BEARING CAPACITY CHARTS

Thirteen DCP tests were carried out in this area with results indicating bearing capacity from 30 to 150kPa, with the average 75kPa.

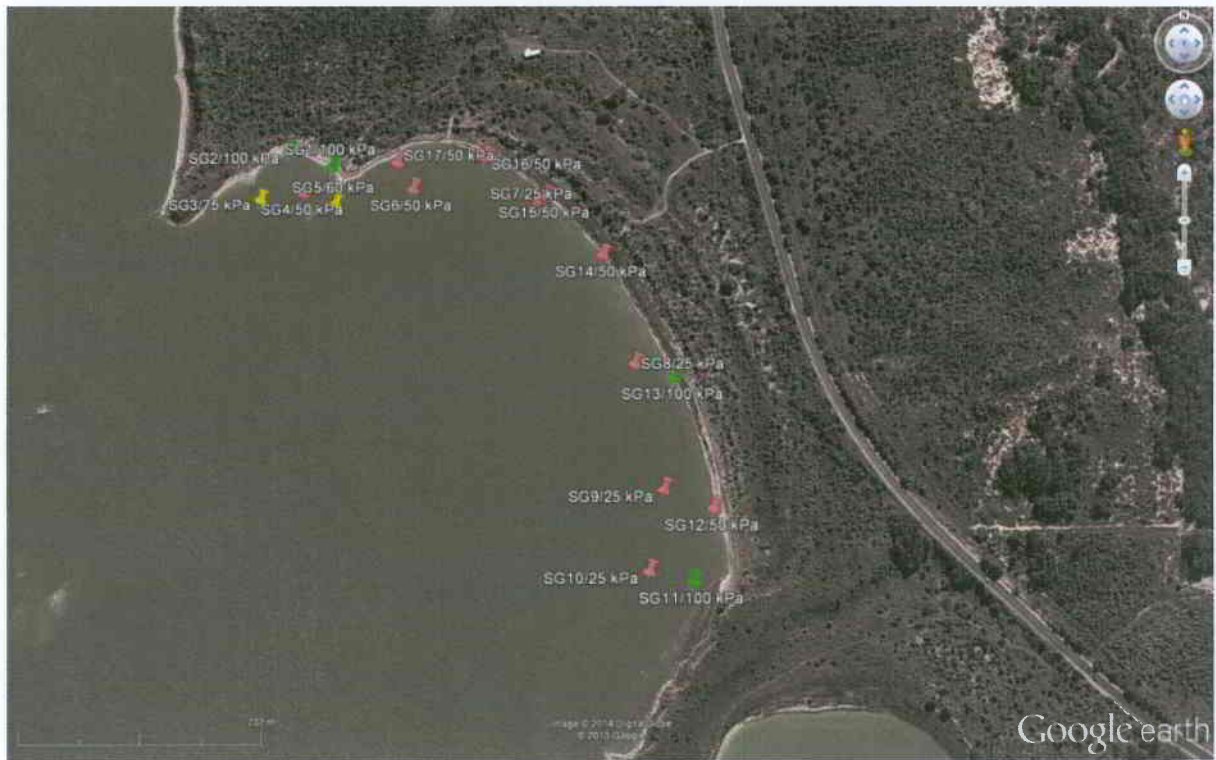
Figure 9 Sea Gull Island test locations and estimated Bearing Pressure in kPa

Seventeen DCP tests were performed over the study area, the results of which can be found in APPENDIX C – DCP and BEARING CAPACITY CHARTS

Seventeen DCP results indicate bearing capacity is extremely variable with values ranging from 25 to 100kPa with an average value of 58kPa.

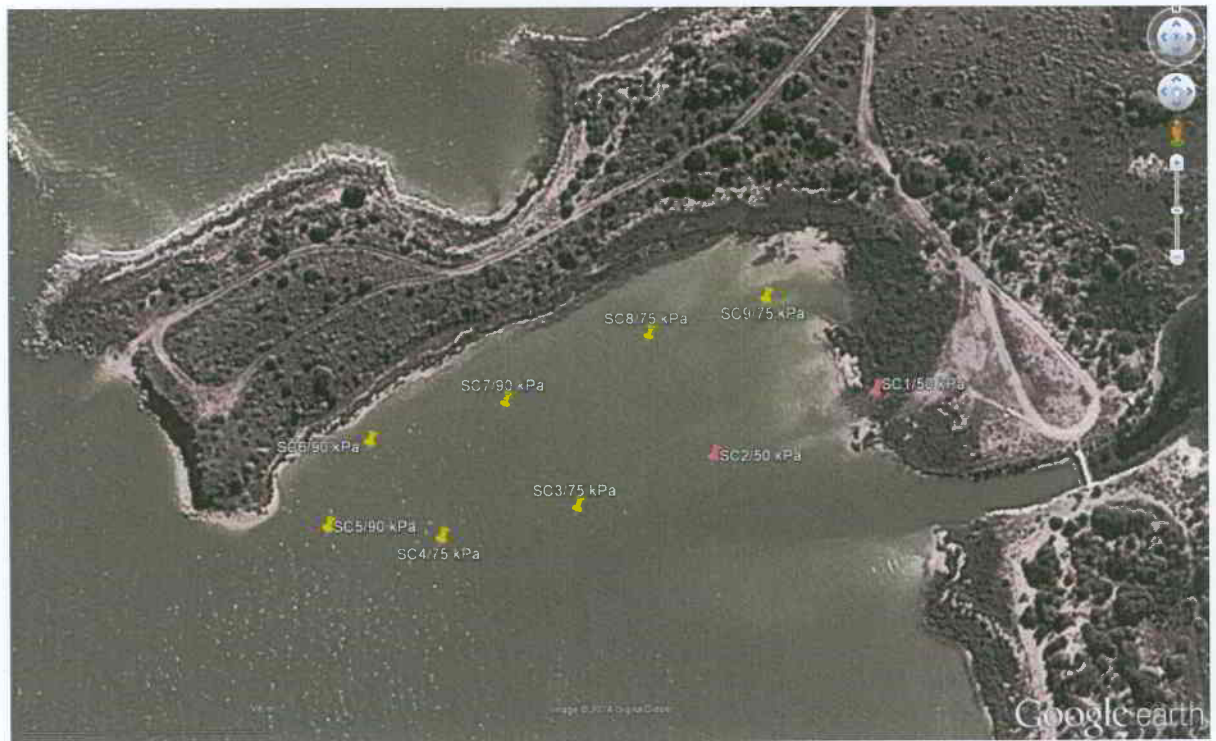
Figure 10 Salt Creek test locations and estimated Bearing Pressure in kPa

Nine DCP tests were performed over the study area, the results of which can be found in APPENDIX C – DCP and BEARING CAPACITY CHARTS

In this area nine DCPs were carried out indicating bearing capacity ranging from 25kPa to 90kPa available bearing capacity in all areas tested vary quite significantly from test site to test site with values averaging 50 to 75kPa.
