Environment Protection Authority

A freshwater release from the Morella Basin, through Salt Creek & into the Coorong South Lagoon

December 2014

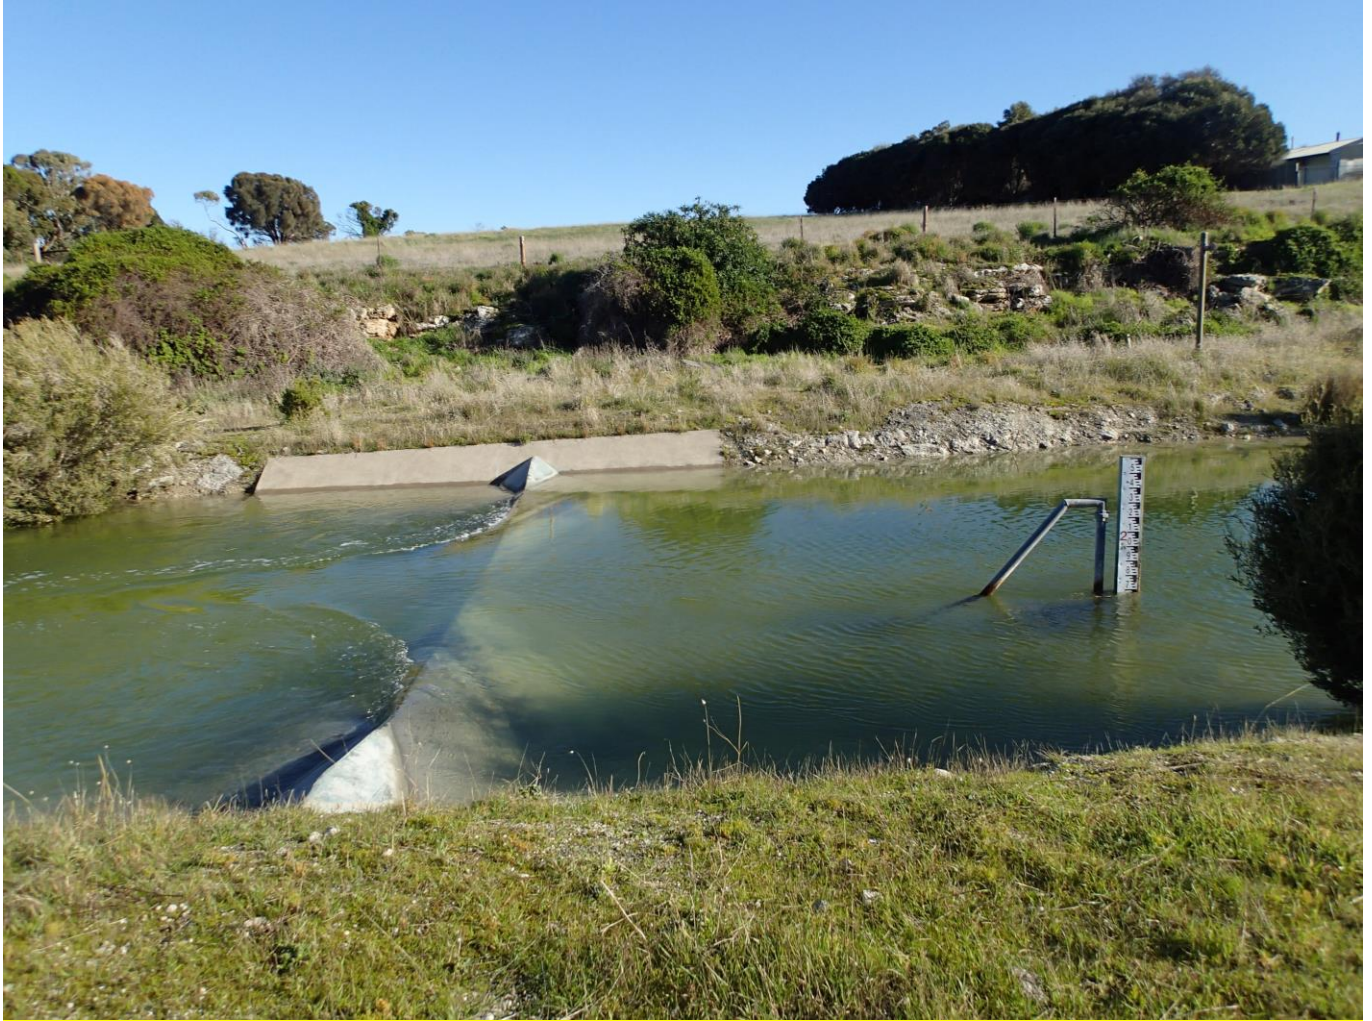
Figure 1: Salt Creek in the States South East. All freshwater released from Morella Wetland through Salt Creek and into the Coorong's South Lagoon flows over the pictured concrete flow gauge (or wedge). On the downstream side of the flow gauge, a small pipe fills a composite sampler nearby (not pictured).

During winter and spring, fortnightly water quality monitoring was undertaken throughout the South Lagoon. Surface water profiles and depth profiles were collected at ten sites (Figure 1) in the Coorong itself, and two sites within Salt Creek (Table 1). Field measurements were taken using YSI pro plus and Sonde multi-parameter meters, and samples were taken for analyses at the Australian Water Quality Centre (NATA accredited laboratory) – see Table 2.

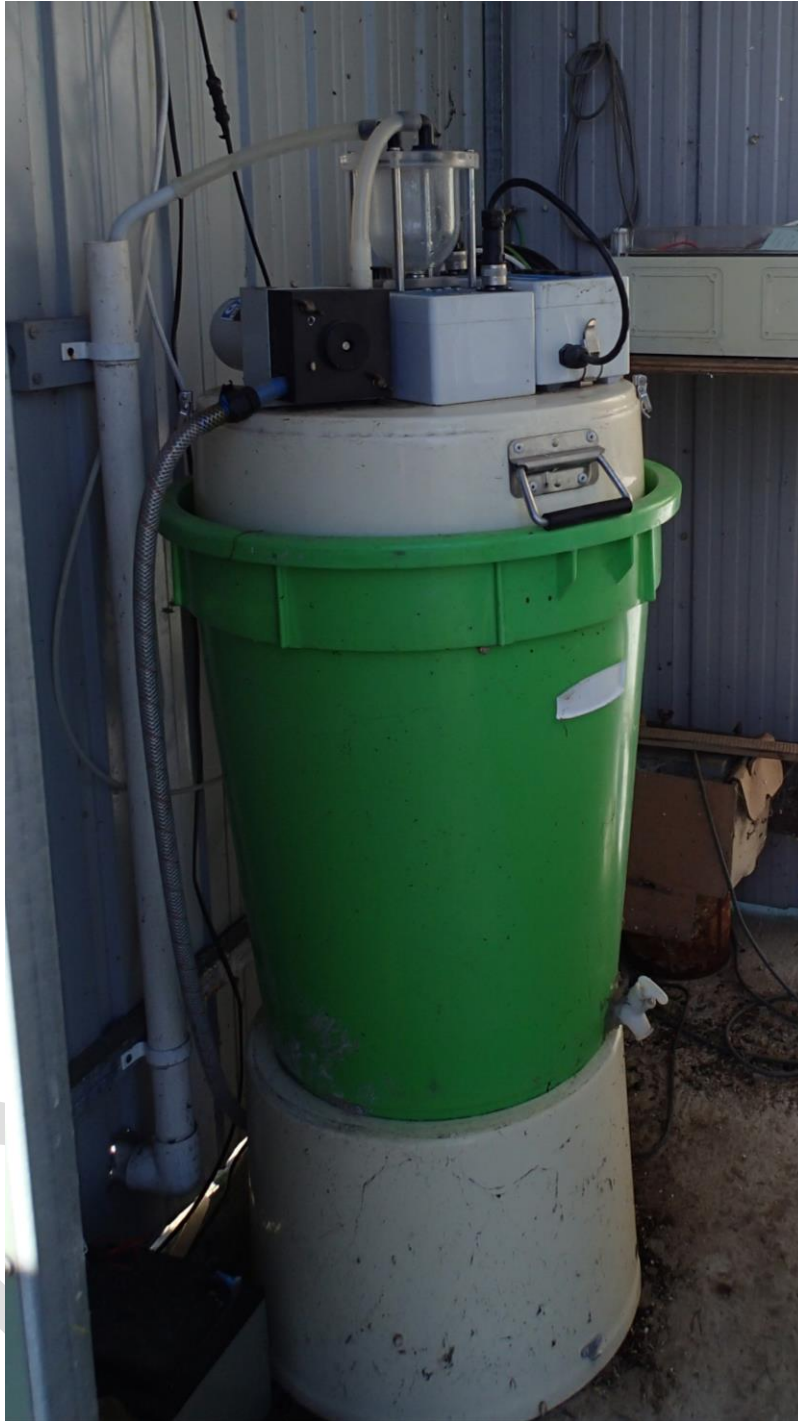
Figure 2: The composite sampler installed at the Salt Creek Flow Gauge. The peristaltic pump at the top of the bucket draws a small volume of water into the clear acrylic bowl. Once a rinse has taken place, a tap at the bottom of the acrylic bowl lets a set volume fall into the green bucket every 24 hours.

Site Name	Easting	Northing	Collection Method
Morella Basin @ Outlet Regulator	380179	6001380	Sampled once (grab sample) on 1 st monitoring event (Monday 21 July), prior to release
Morella Creek @ Flow Gauge (Composite Sampler) (Figure 2)	378811	6001360	Sample in the composite sampler collected on 2 nd and subsequent monitoring events.
Morella Creek @ Flow Gauge (Figure 1)	378811	6001360	Grab sample in Salt Creek (by the Flow Gauge) collected on 2 nd and subsequent monitoring events.
Coorong central lagoon 3.2km South Salt Creek	377570	5997290	Collected by boat
Coorong Sub Lagoon 12 Sth Salt Creek	377597	6000430	Collected by boat
Coorong central lagoon 1.8km west Salt Creek	375882	6000470	Collected by boat
Coorong central lagoon @ Snipe Point	374406	6002900	Collected by boat
Coorong central lagoon @ Seagull Island	372453	6005680	Collected by boat
Coorong Sub Lagoon 10 Nth Jack Point	369342	6010970	Collected by boat

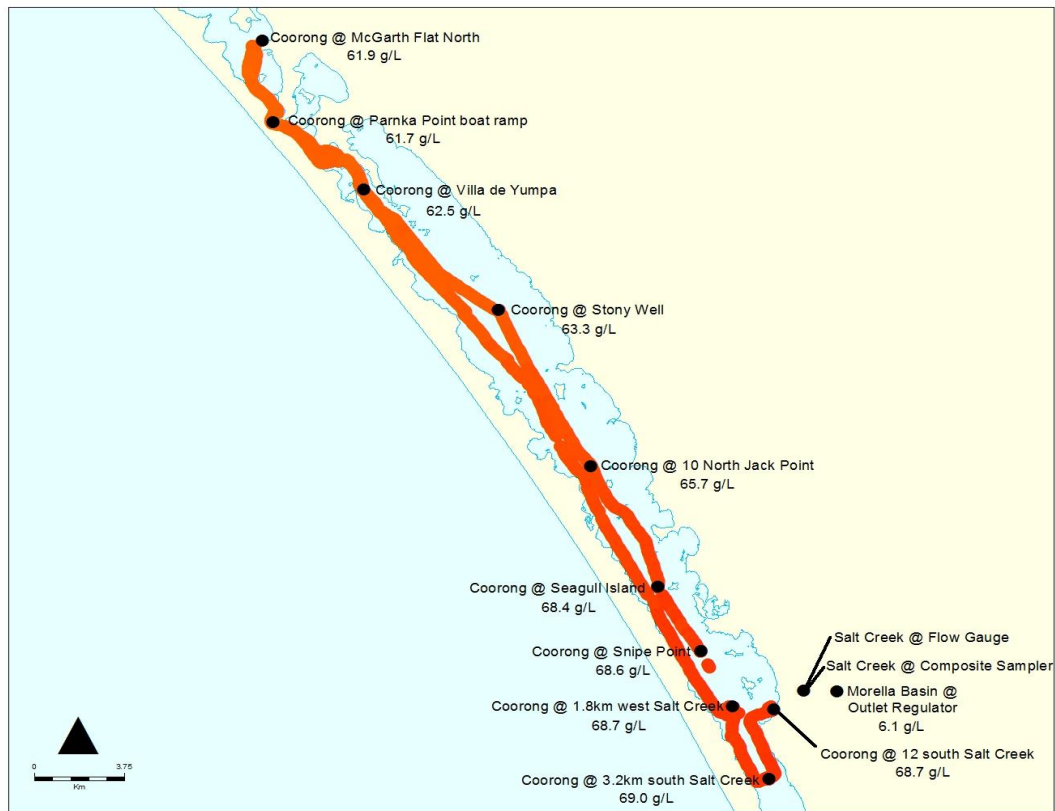
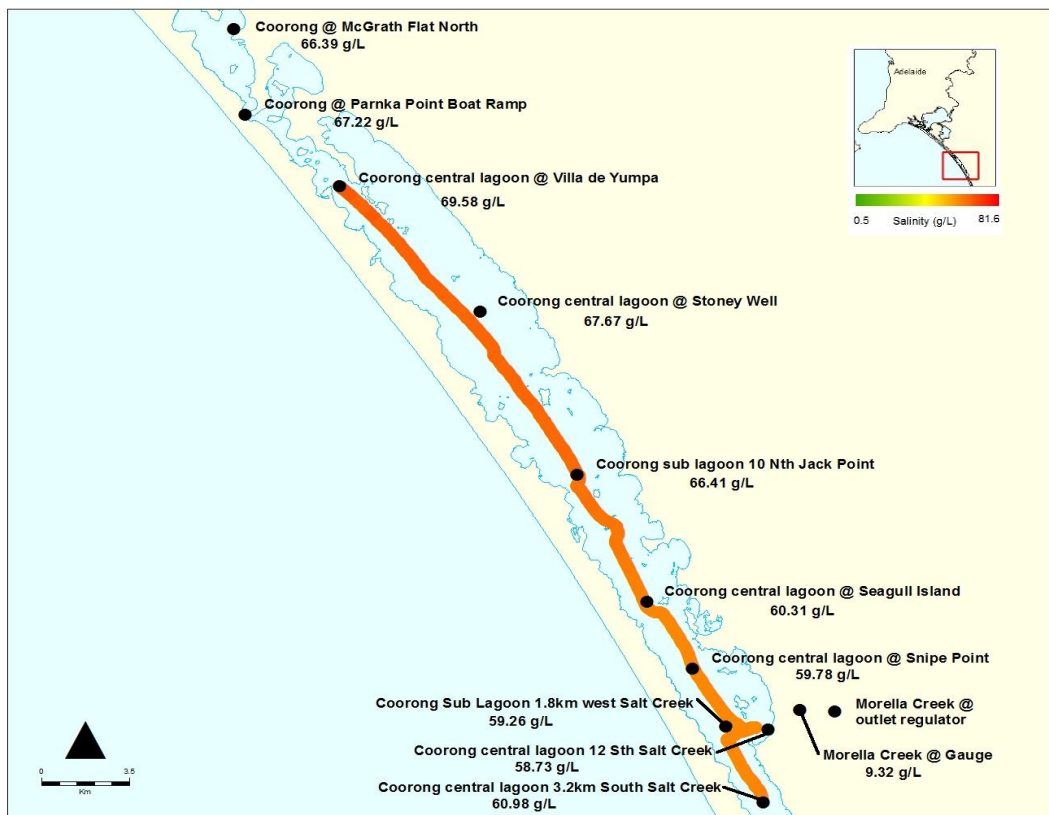
Figure 4: Water quality transects taken on the surface of the Coorong South Lagoon, a) in July and b) October.

Water levels in the Coorong can vary, with water level variation over the course of the experiment demonstrated in Figure 3. The water level variation did have an influence on the connection between the two lagoons, and our ability to access both. In Figure 4, the transect reaches beyond the “Needles”, or the small opening which restricts connection between the North and South Lagoons of the Coorong. This was passable in July, and sites such as McGrath Flat North and Parnka Point Boat Ramp were sampled via boat. Over several weeks, the Needles were impassable using the same small rigid-hull inflatable. Over the four month period, it was possible to reach Villa de Yumpa by boat, although water was in some parts less than 30cm in depth.

Pre-release, an obvious salinity gradient was present (Figure 4) with salinity increasing with distance away from the freshwater influence of the North Lagoon. Salinity ranged from 62.5 g/L in Villa de Yumpa and increased to 69.0 g/L in 3.2km South Salt Creek (3.2km south of the Salt Creek township, and the site furthest south). This is a pre-release gradient of 6.5 g/L over a distance of 31km (a change of +0.2 g/L per km). Over the course of the 99 days, flow peaked in mid-August before falling away (Figure 5). This contributed to a decrease in salinity gradient, with Villa de Yumpa and 3.2km South Salt Creek recording 64.65 and 63.66 g/L on the 18th of August. This equated to a negative gradient of -0.99 g/L over the 31km (or -0.033 g/L per km).
