## **GWLAP Community Acid Sulfate Soil Monitoring** **August 2009 to April 2015**

Author: Regina Durbridge

Community acid sulfate soil monitoring results for 5 of the original 51 community monitored sites which incorporates results from the first 2 years of the project for these sites.

**An initiative funded by the Goolwa to Wellington Local Action Planning Association Inc. (GWLAP)**

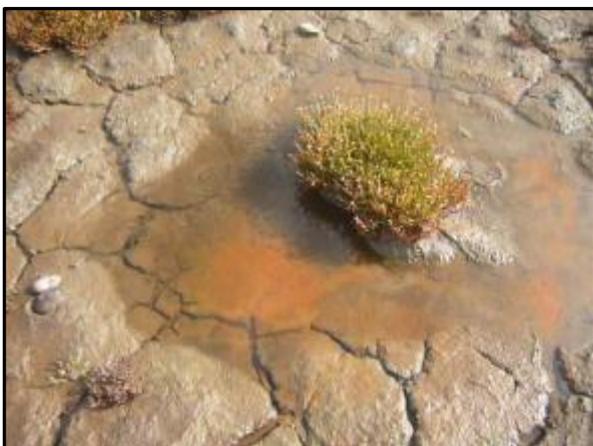
Figure 2. Characteristic red staining of sulfuric soil

Soils that fringe and are below the waterline of Lakes Alexandrina and Albert (Lower Lakes) are loaded with sulfidic materials. When exposed to air, these materials oxidise to produce sulfuric acid. As this happens, the soils shift from being "sulfidic" to becoming "sulfuric" - the latter being characterised by a pH <4. These acid sulfate soils (ASS) may pose a localised and regional environmental hazard, including, potentially, mobilisation of heavy metals by acid digestion of clay minerals and ecological damage and water quality issues due to the low pH.

Soils of less than pH 4 are considered sulfuric.

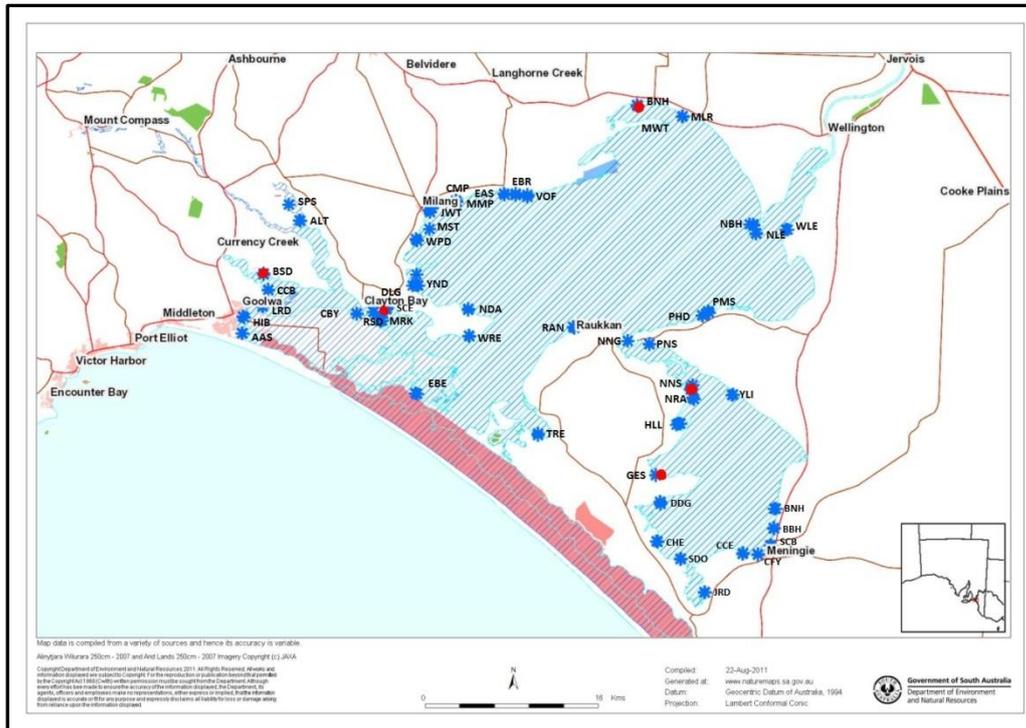
Figure 4. Lower Lakes Community Acid Sulfate Soil Monitoring sites

The five sites that are currently being monitored annually are highlighted in red in Figure 4 below.

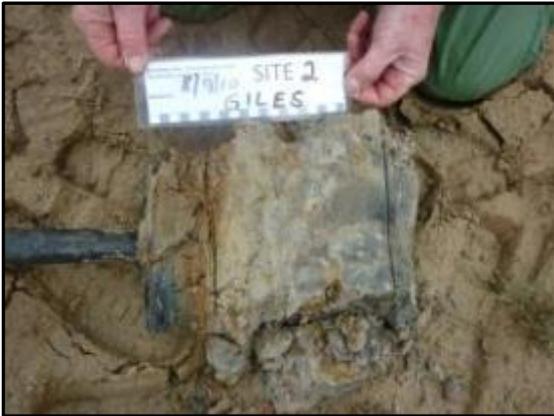
Figure 5. Original method of soil samples extraction

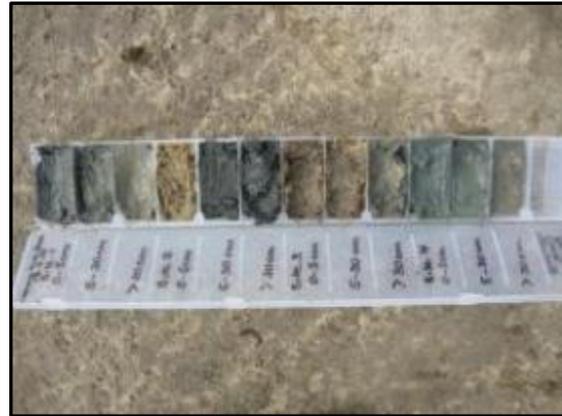
Figure 6. Soil samples in chiptrays.

- Soil pH measurement using Merck pH indicator strips of three layers (upper 5 cm, 5 – 30 cm and below 30 cm)
- Removal of layer samples and storage in chiptrays
- Upper 5 cm and lower 30 cm soil layer descriptions

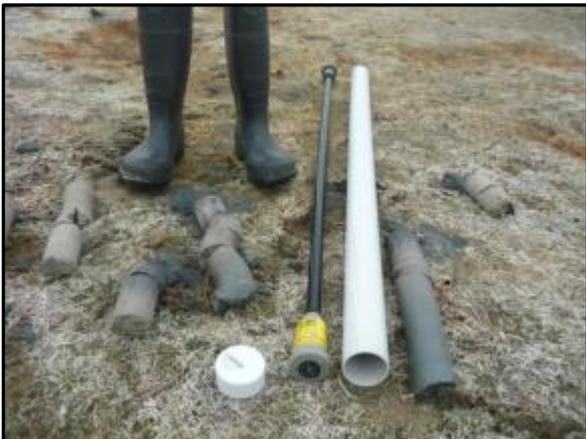
Figure 7. Community developed soil extractor for deeper water monitoring

Due to increased water levels the original soil sod retrieval method was altered with the Signal Point Riverine Environment Group developing their own deep-water soil auger which was endorsed by the CSIRO. This allowed the original survey sampling sites to still be monitored.

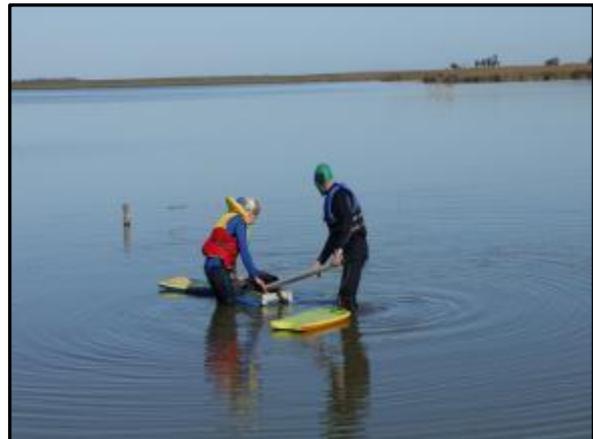
Figure 8. Soil samples being removed from deeper water

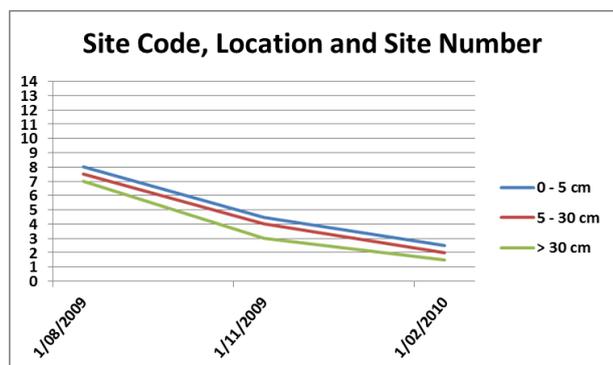
Figure 9. Sample Soil pH Graph

Site Name & Site Number

pH is on the vertical axis

Date surveyed is on the horizontal axis

The results displayed are for the 3 different soil levels which start with the top 0 – 5 cm 5 – 30 cm and > 30cm. for each sampling site.

The soil pH field results collected by the community for the ongoing 5 sites are able to be viewed in the graphs below in the following format. See Figure 9. Sample graph.

Each site has a page with pH graphs which document the soil pH levels for the 3 or more soil sites sampled; The blue line is the results for the top 0 – 5 cm of soil, the red line is the results for the middle 5 – 30 cm and results for below 30cm are in green.

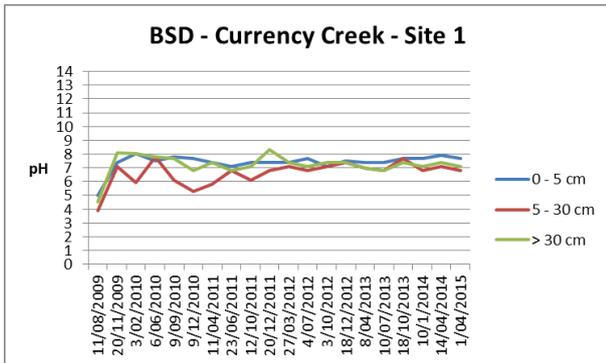
Figure 10. BSD Soil pH Graph Site 1. E 0301140 N 6072856

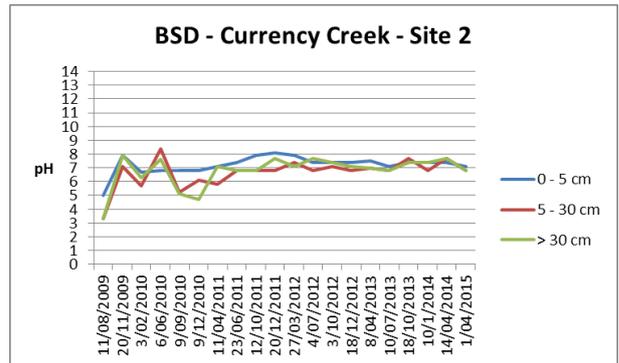
Figure 11. BSD Soil pH Graph Site 2. E 0301141 N 6072860

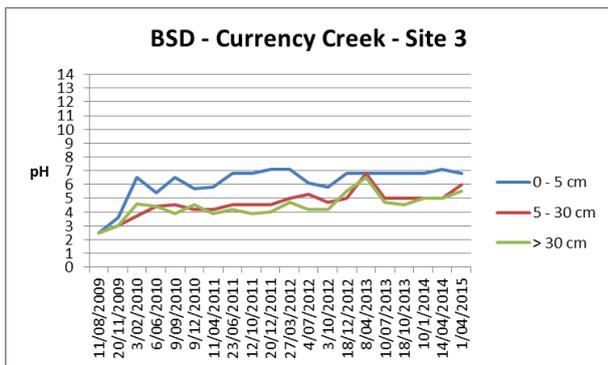
Figure 12. BSD Soil pH Graph Site 3. E 0301131 N 6072914

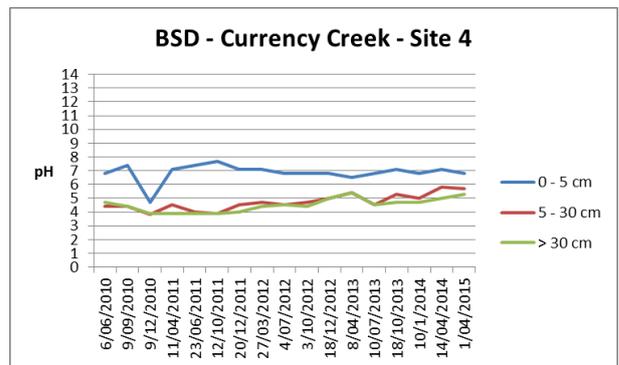
Figure 13. BSD Soil pH Graph Site 4. E 0301132 N 6072947 (between site 3 & old shoreline).

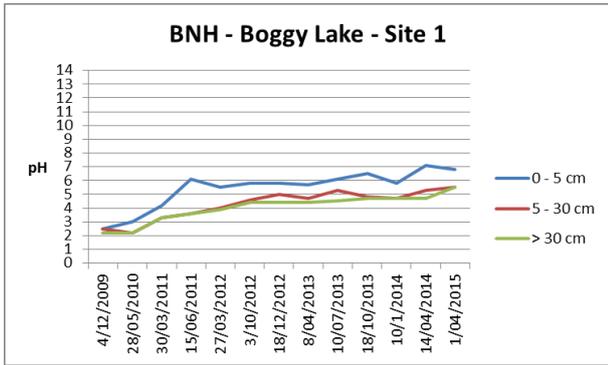
Figure 16. BNH Soil pH Graph Site 1. E 0335071 N 6090586

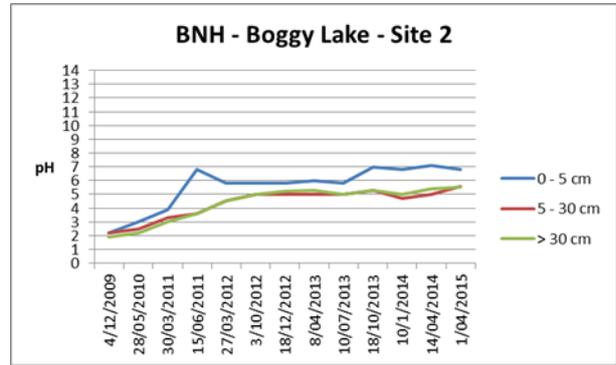
Figure 17. BNH Soil pH Graph Site 2. E 0335053 N 6090658

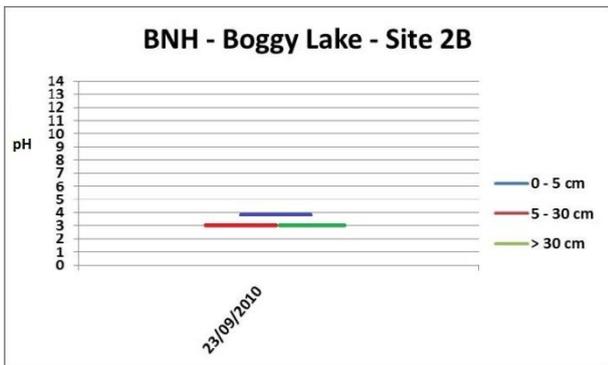
Figure 18. BNH Soil pH Graph Site 2B. 0335052 N 6090699

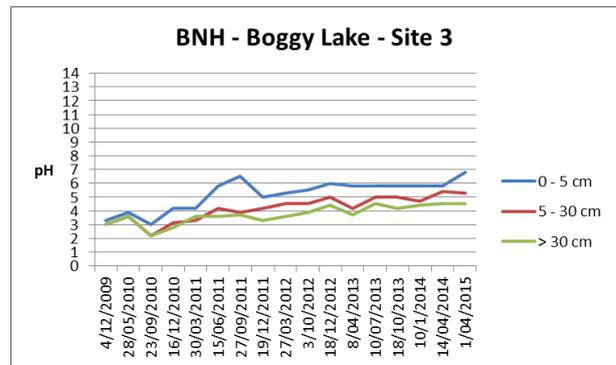
Figure 19. BNH Soil pH Graph Site 3. E 0335035 N 6090731

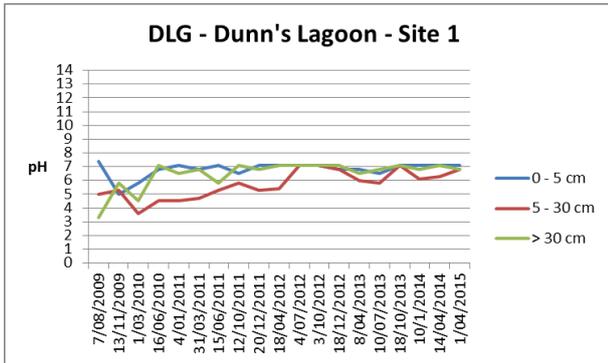
DLG Soil pH Graph Site 1. 0312787 N 6070292

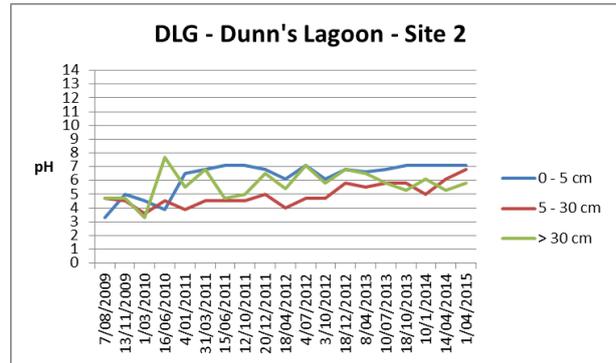
DLG Soil pH Graph Site 2. E 0312782 N 6070330

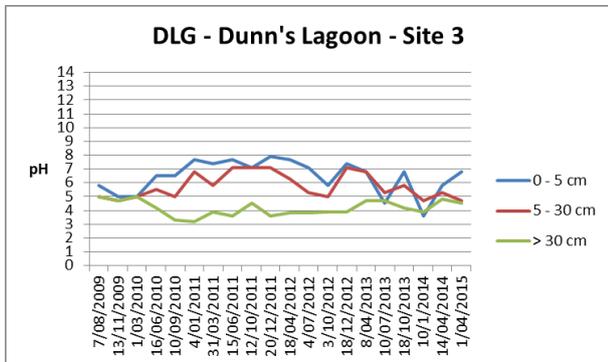
Figure 22. DLG Soil pH Graph Site 3. E 0312768 N 6070396

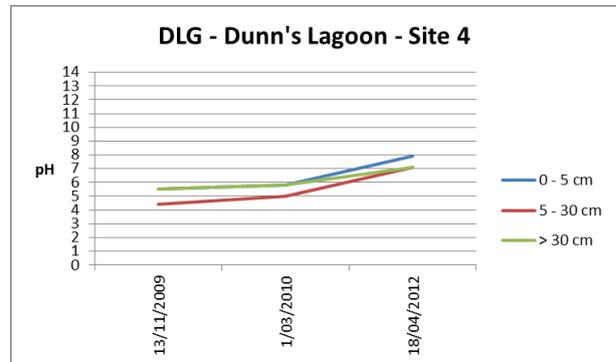
Figure 23. DLG Soil pH Graph Site 4. E 0312784 N 6070199

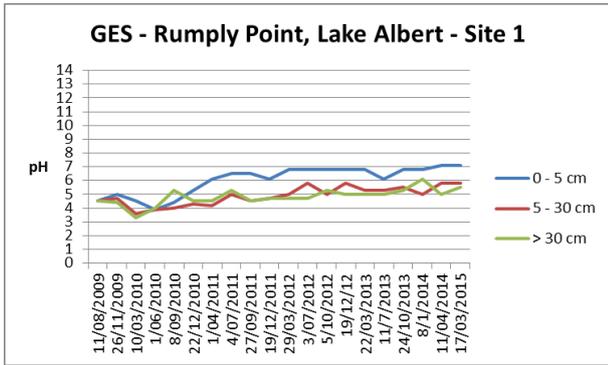
GES Soil pH Graph Site 1. E 0338765 N 6056162

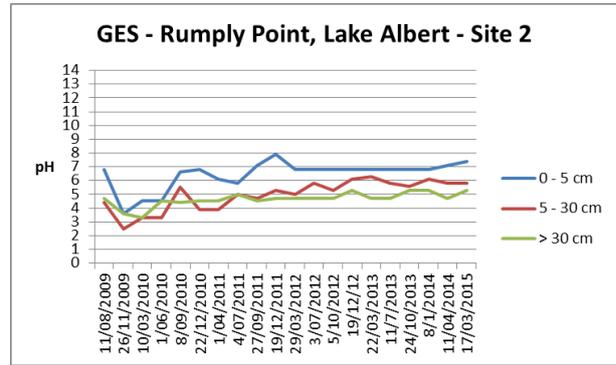
GES Soil pH Graph Site 2. E 0338759 N 6056147

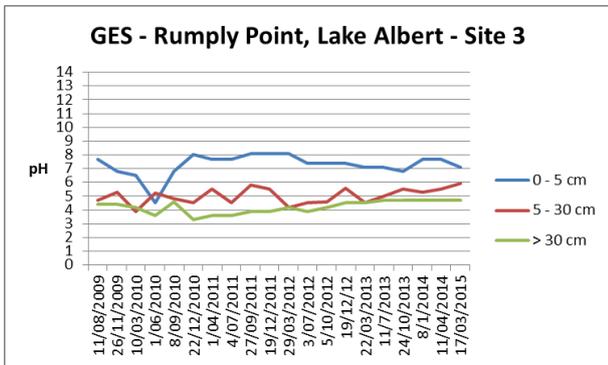
Figure 26. GES Soil pH Graph Site 3. E 0338748 N 6056097

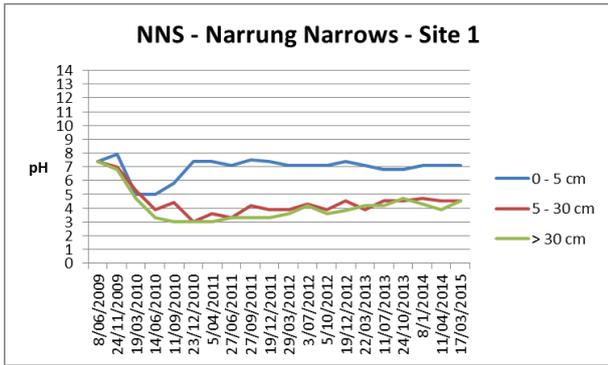
Figure 29. NNS Soil pH Graph Site 1. E 0341588 N 6064518

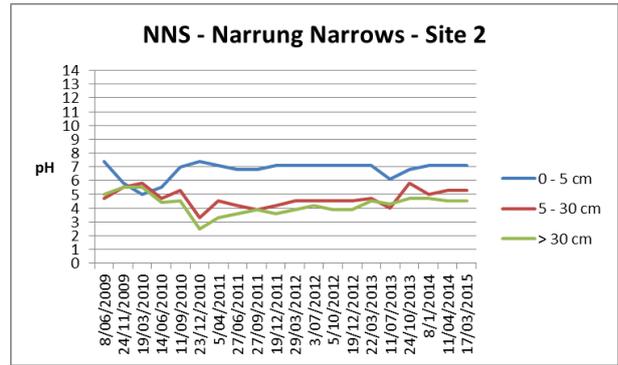
Figure 30. NNS Soil pH Graph Site 2. E 0341548 N 6064455

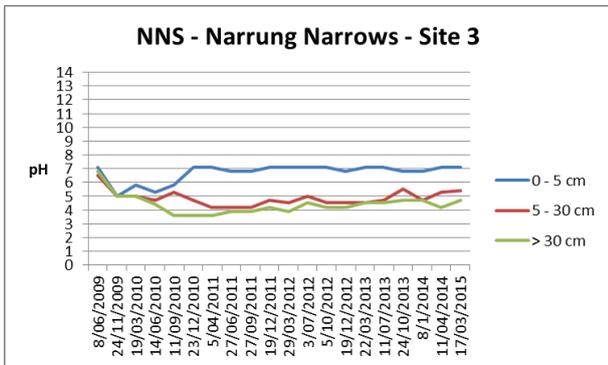
Figure 31. NNS Soil pH Graph Site 3. E 0341496 N 6064315

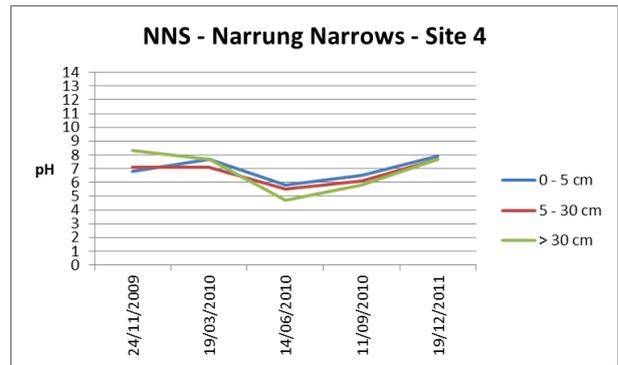
Figure 32. NNS Soil pH Graph Site 4. E 0341685 N 6064779
