# Investigation and Assessment of Mallee Dune Seepages

SAMDB Project 07690-9081

**Chris Henschke and Rebecca Tonkin**

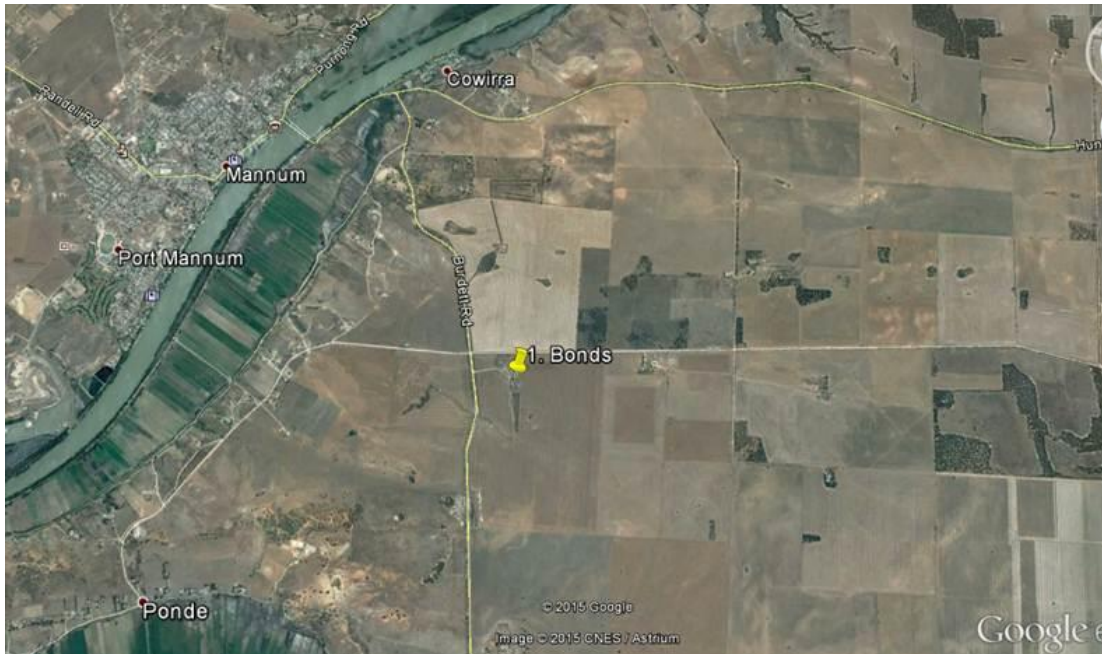
**Figure 3. Location of Bonds dune seep case study site**

This property is located to the east of Mannum and is bounded by Cross Road and Burdett Road (Figure 3). A initial site inspection was carried out on 29/8/12 by R Tonkin (Rural Solutions SA), and B Lawson (SA MDB NRM Board). Another site inspection with NRM and RSSA staff was done on 3/2/15.

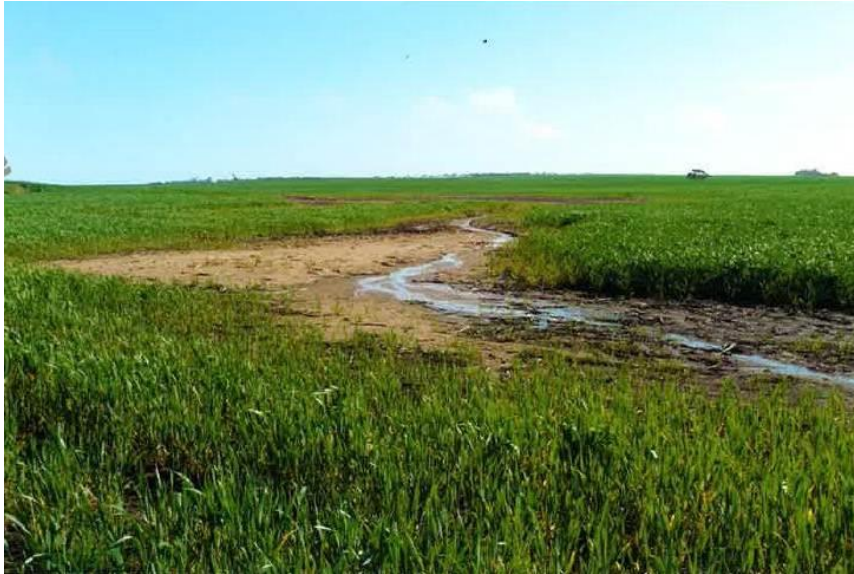
**Figure 4. Photo of seep taken by K Bond (August 2012)**

In previous years, the area had been prone to waterlogging but had fresh water and grew good crops. Salts are now being flushed from the more saline layers deeper in the soil profile, with increasingly concentrated mineral salts on the surface.

By 2010-11, the main seep area was unable to be sown with crops due to the wet and boggy soil. Cereal crops around the edge of the main seep had died off, probably due to waterlogging. The only plants able to grow near the seep were rye-grass and some thistles. The bare soil shows signs of crusting and white efflorescence (mineral salt accumulation).

This site would be ideal for a lucerne demonstration trial. A strategic block of lucerne (for hay) should effectively intercept midslope moisture flows and dry out the soaks in the main valley and developing seeps at the break in slope. A wetting agent would be required to get better establishment of lucerne in the non-wetting sands.

Using more water on the actual seep by revegetating the site with salt / waterlogging tolerant perennial species is likely to be successful. This may require a gradual approach, planting at the edges of the saline waterlogged area and moving in as the area becomes drier and less salty. Once plants have established and roots have accessed the deeper moisture, they should do well. Any salts that have accumulated on the ground surface should leach away over time with normal rainfall.

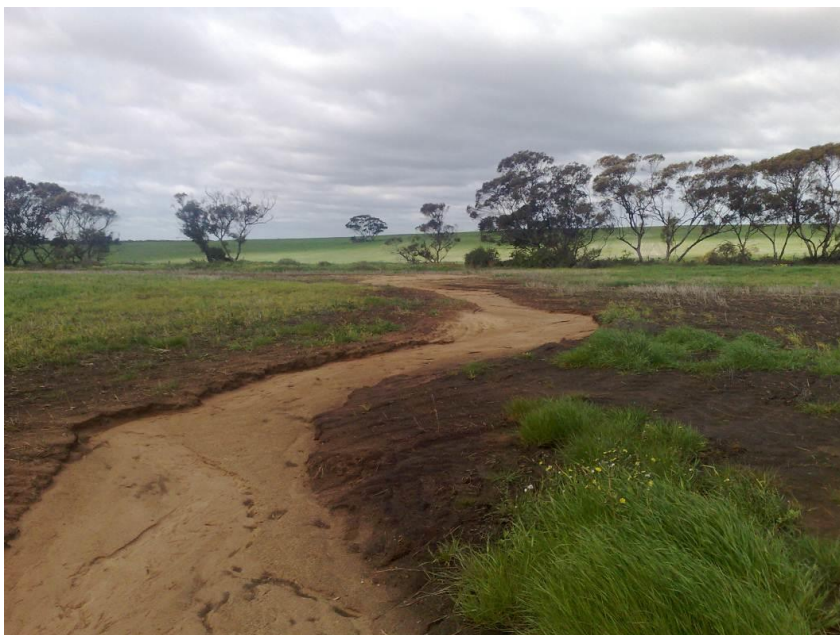
**Figure 5. Overflow point of the main seepage area at Bonds (August 2012)**

The water from the seeps accumulates in the main central valley. The depressions have an overflow point whereby when the fill-point is reached, they overflow to the next lowest level leaving eroded channels in the ground (Figure 5).

Soil pits dug with a spade in August 2012 showed that the general profile consists of a dark grey-brown sandy loam in the topsoil (0-15 cm), showing anaerobic staining from waterlogging. This sandy layer has a crust which may contain mineral salts. This lies over a leached light brown/white sandy layer at 15-40 cm and is saturated with water. After 40cm, there is a mixture of light clay (becoming heavier with depth) and calcrete. The calcrete may be in large rocks or soft gravel. Water seeped into the pit as it was being dug (in late August 2012). Water continues to pond in the low-lying areas until summer.

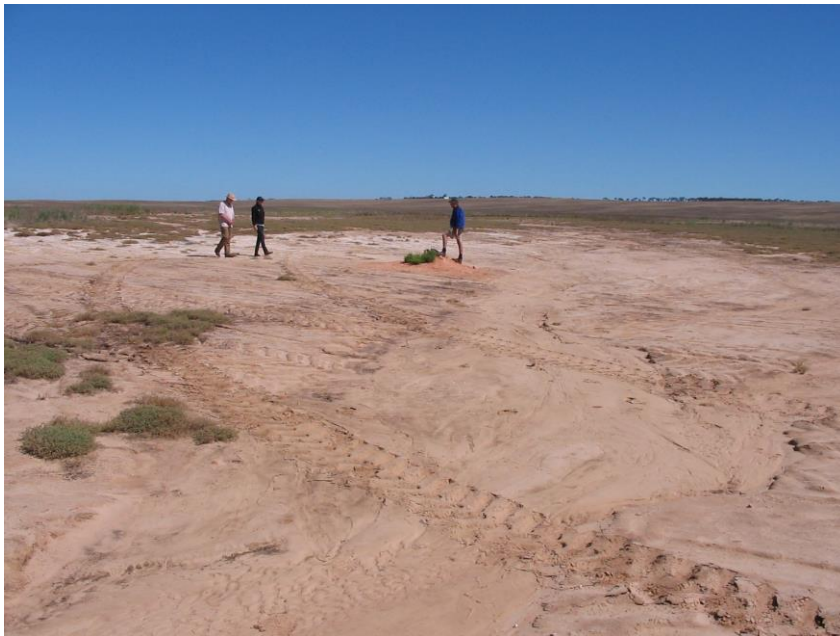
**Figure 6. Scald in main central valley with exposed Blanchetown Clay from pit (Feb 2015)**

Soil profiles examined during a site visit in February 2015 showed saturated clayey sands on top of calcrete. White efflorescence's noted on bare scalded patches are dominated by gypsum and carbonates with only small amounts of sodium chloride salts. A pit previously dug in a scald in the main central valley encountered red mottled heavy clay of the Blanchetown Clay (Figure 6).

A deeper groundwater system occurs in the area as indicated by old abandoned wells dug to 55m but having groundwater that is too saline for use. The deeper underlying groundwater system is not connected to the shallow flow system which is solely responsible for causing the dune seepage.

There may be multiple flow paths discharging to the main central valley with short flow paths (fresh water) from adjacent sand ridges and longer flow paths through the cores of the dunes originating from topographic highs. Over time, the cores of sand dunes can become saturated and provide a store of water for continuing discharge to seepage areas (Hall, 2015).

Increasing water use efficiency of crops grown will help to reduce recharge to the perched watertable. It may be necessary to use a summer cover crop such as millet around the seep to soak up excess water. Deep rooted perennial species such as lucerne would be able to access more moisture than annuals, however the continuous cropping rotation would have to be changed and this may not be profitable.

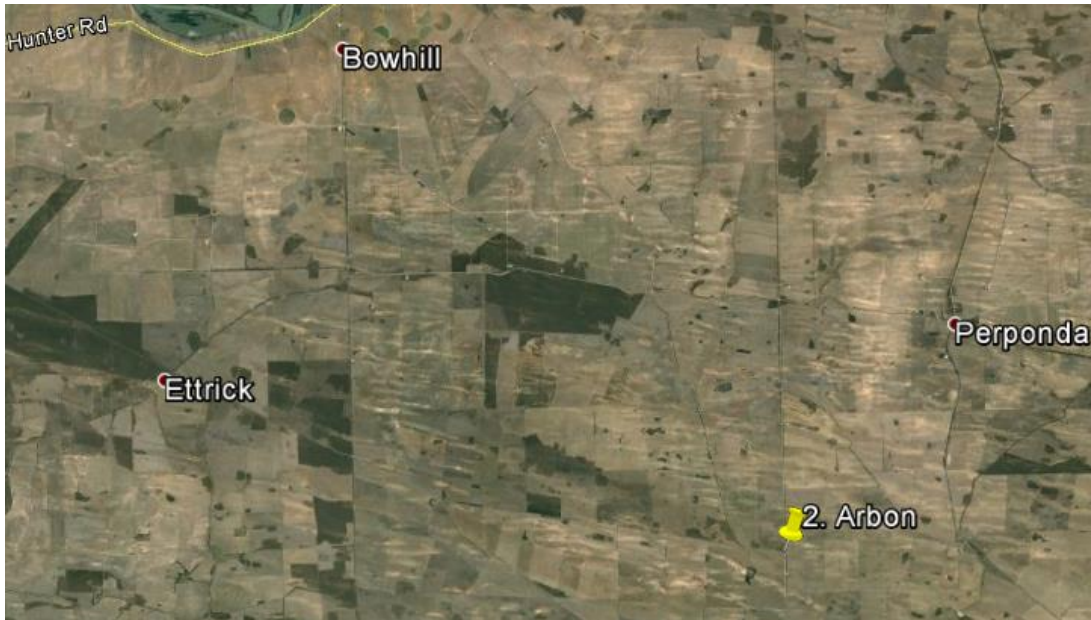
**Figure 7. Location of the Arbon dune seep case study site**

This site is located north of Wynarka on the property of David Herrmann, now David Arbon (see Figure 7). The property is located at Durdin Rd / Hundred Rd intersection. Rainfall is 325mm meaning all of the winter rainfall would be used by crops except on poorly productive sandhills.

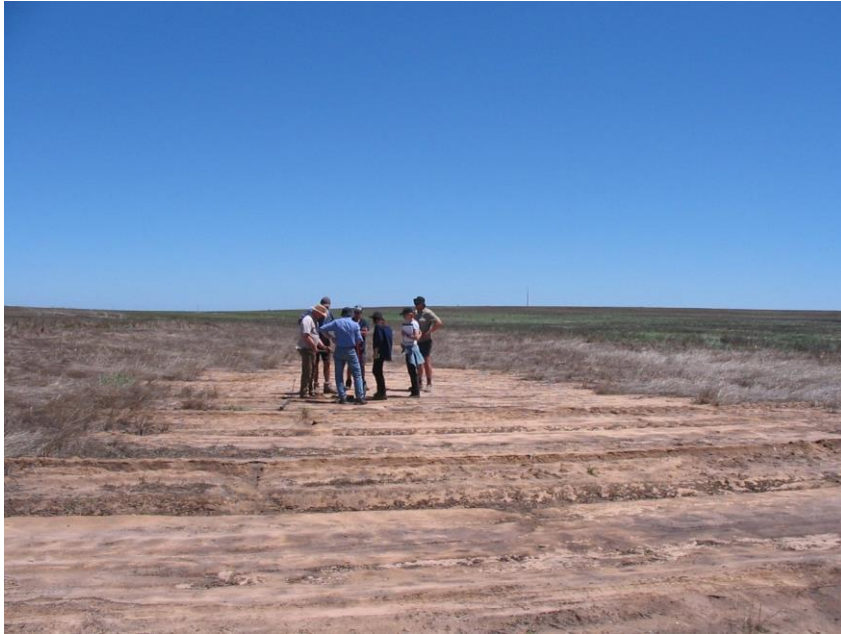
**Figure 8. Arbon dune seep demonstration site (Feb. 2015)**

Soil profiles comprise soft sand over clay on the slopes. The sand here is non-wetting and rainfall tends to puddle on top but eventually soaks down into the soil. There is no visible white salt efflorescence's at the soil surface in bare areas at this site.

Examination of the soil profile in the seep (Figure 8) showed brown sand to 30cm, with moist sandy loam at 30-60cm. A red light clay with small amounts of calcrete occurs at 60cm then grading to a wet heavy clay. A light sodic clay (saturated) occurs at around 1m depth.

Summer cropping (sorghum) although rarely attempted in this area, could have potential in areas of the landscape with moist subsoils. The New Horizons program is looking at trials to increase the productivity of deep sandy soils and outcomes should be applicable to this site.

Strategic tree planting will be aligned with existing fencelines to intercept midslope moisture flow and dry out soaks from forming downslope.

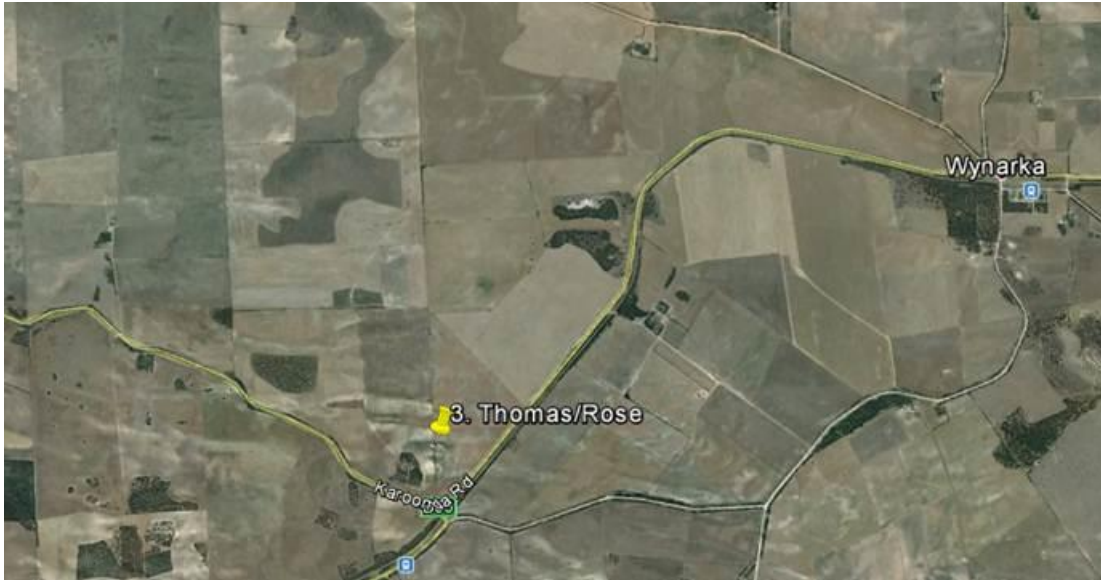
**Figure 9. Location of Thomas / Rose dune seep case study site**

The property on which this seepage occurs is located around 7km south west of the township of Wynarka (Figure 9). It is currently being leased by Peter Rose. Seepages also occur on an adjoining property, previously leased by Peter Blackett and now leased by Andrew Thomas.

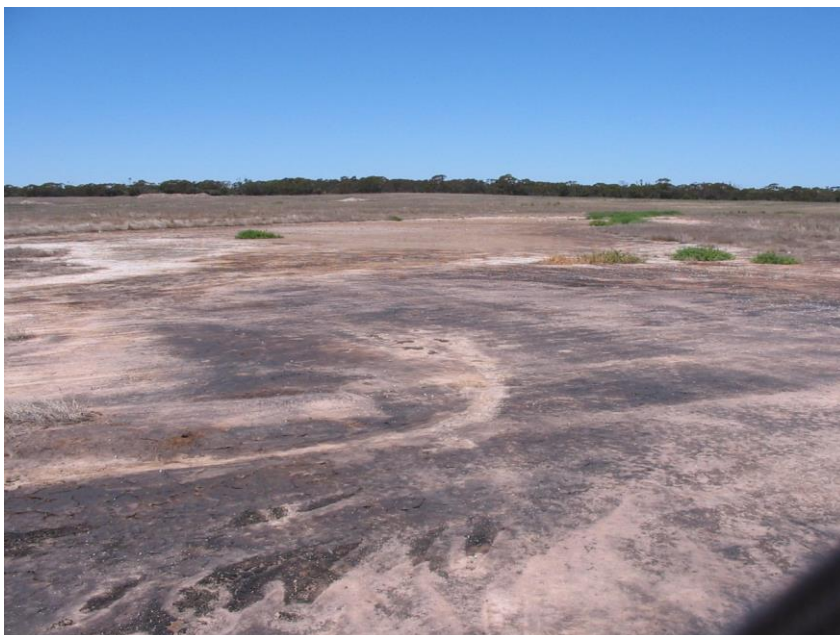
**Figure 10. Scald caused by seepage, P Rose, Wynarka (Feb 2015)**

The seepage problem first appeared around 2005. Up until about 2008 this area grew good crops although tending to be boggy. By 2011 the area was too wet to drive on and gradually turned saline. Currently the ground is bare and scalded with visible mineral salt crystals (Figure 10). The surrounding area is too soft for machinery to be driven over for most of the year and so cannot be sown to crops or pasture. No plants are growing on the most severely affected areas. Rye-grass, brome, and thistles grow prolifically on the fringes of the scald.

The main seep on this property is characterised by a surface crust and white efflorescence at the soil surface. There is some black anaerobic staining as well. The white efflorescence's are possibly composed of gypsum, carbonates and minor sodium chloride. It is possible that in older seeps, some of the calcrete has dissolved over time (James Hall, pers comm). The swale area may be part of an historical watercourse as is the situation at Bonds (James Hall, pers comm).

Soil pits dug with a spade in the seep in October 2011 showed that the general profile consists of a dark grey-brown sandy loam in the topsoil (0-15 cm), showing anaerobic staining from waterlogging (Figure 11). There is a surface crust which contain mineral salts. The soil becomes moist below 10cm. This lies over damp reddish brown sandy light clay (15-30 cm). Below 30cm, there is a mixture of light clay (becoming heavier with depth) and calcrete. The clay varies from reddish-brown at about 30cm to cream/yellow/grey further down the profile as more lime is mixed with the clay. The calcrete may occur as stones and rocks on higher ground or as soft gravel in the scalded area.

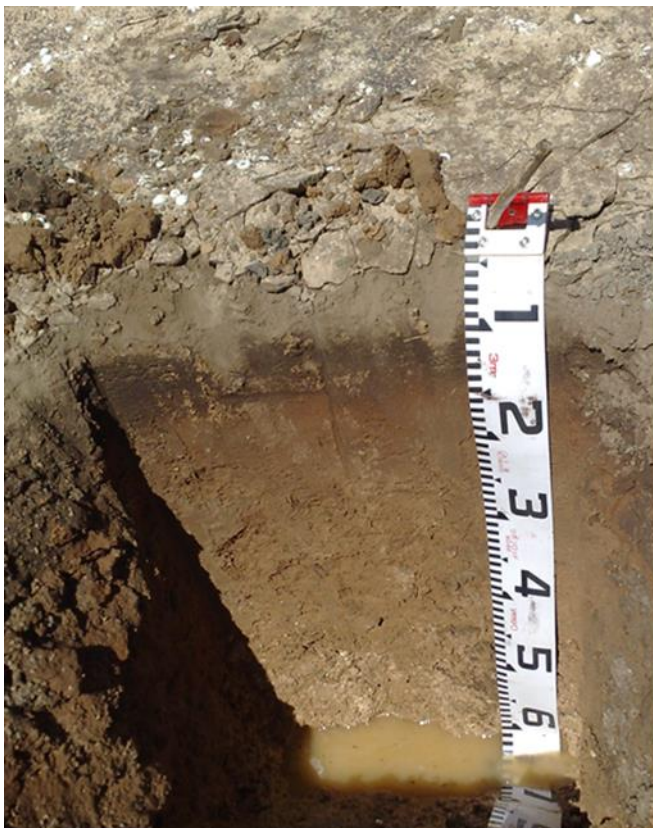
**Figure 11. Shallow watertable exposed in scald at Wynarka (Oct 2011)**

The watertable was 0.6m below the surface in November 2011 (Figure 11). Because of the wetness of the profile, even in summer, only small amounts of rain (e.g. 10mm) is enough to saturate the seep and surrounding land.

Soil samples taken from the 0-10cm and 40-50 cm layers in the profile in October 2011 showed relatively high salinity in the topsoil, but much lower salinity at around half a metre (Table 2). This indicates that mildly saline water has been wicked up from the lower layers in the soil and the water evaporated, leaving increasingly concentrated mineral salts on the surface.

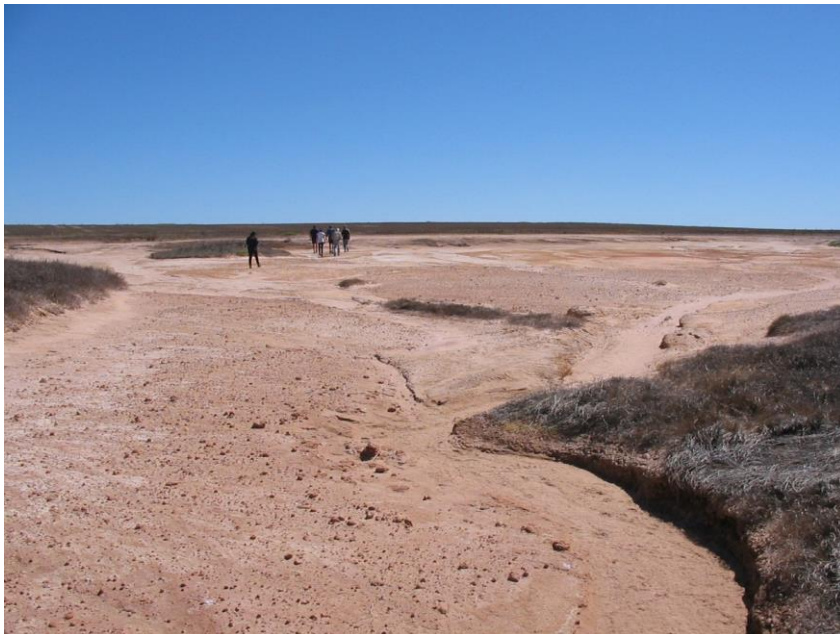
**Figure 14. Dune seepage, S Pope, Karoonda**

A number of seepage areas have been developing around the sides of large sandhills on this property. One example of a mid-slope scald is shown in Figure 14. A dam downslope of the scald became saline over time due to concentration by evaporation and then silted up due to erosion of the scalded area. The highly eroded seep is still continuing to spread back up the slope. Features of this severely degraded area include a fluffy surface due to flocculation, white efflorescence and crusting, black organic staining and unusual bright green organic tinges in the sand just below the surface.

Soil profiles in affected areas comprise of sandy loams with a dark anaerobic staining indicating waterlogged conditions. The topsoil is underlain by pale brown saturated sand, containing water which appears to be quite fresh. The perched watertable overlays red slightly mottled calcareous light to medium silty clay at 30 to 40cm.

Currently the site is instrumented with soil moisture probes and an automatic rain gauge.

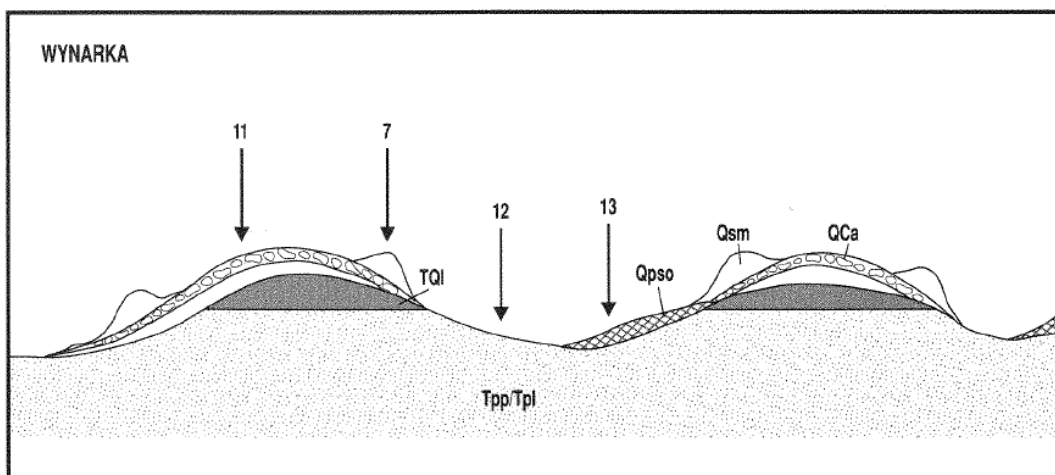
Figure 17. Geological cross-section of the Wynarka Land System (after McCord)

The landscape (Figure 17) is characterised by undulating rises and flats with rounded sandhills. It occurs in the Wynarka to Karoonda area and both the Rose and Pope farms are located in this land system. The flats are underlain by *Blanchetown Clay* or sediments of the *Loxton/Parilla Sand*.

The slopes and rises are comprised of rubbly calcareous sandy loams. Remnants of an old calcreted land surface occur. The sandhills comprise brown loose sand over red clayey sand, often as lamellae in a sandier matrix. The key in Figure 17 includes Qpso (colluvium).
