Mallee Dune Seeps

Land, Soil and Water Investigations of Dune Seepage Systems in the South Australian Murray Mallee

September 2015

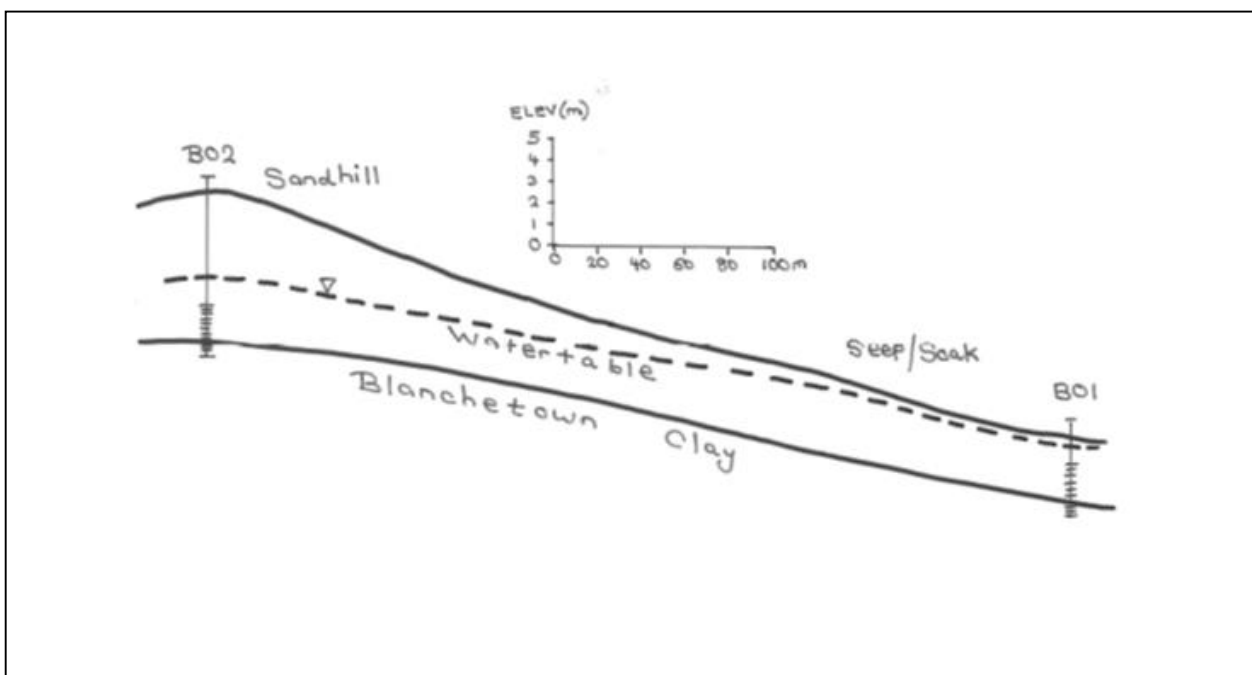
Figure 3: a hydrological cross-section of the lower hillslope section of the Bond subcatchment (from Henschke 2015).

The drilling demonstrated that the main water-bearing system is at depth (e.g. about 6 m on the dunecrest), and that tight, mottled, heavy clay (Blanchetown Clay) forms the base of the subcatchment perched water system (see Figure 3). However, it seems that Blanchetown Clay is not continuous over the whole subcatchment. For instance, the main part of the seep is underlain by relatively thick heavy clay (as viewed from spoil at an excavation site in the seep), while the lower seep edge at site MDS-B01 is underlain by a thin heavy clay layer less than a metre thick (the clay seems to be 'lensing out'), while just a little further down-catchment, no surface expression of seepage is evident, and it is likely that no heavy clay is present.

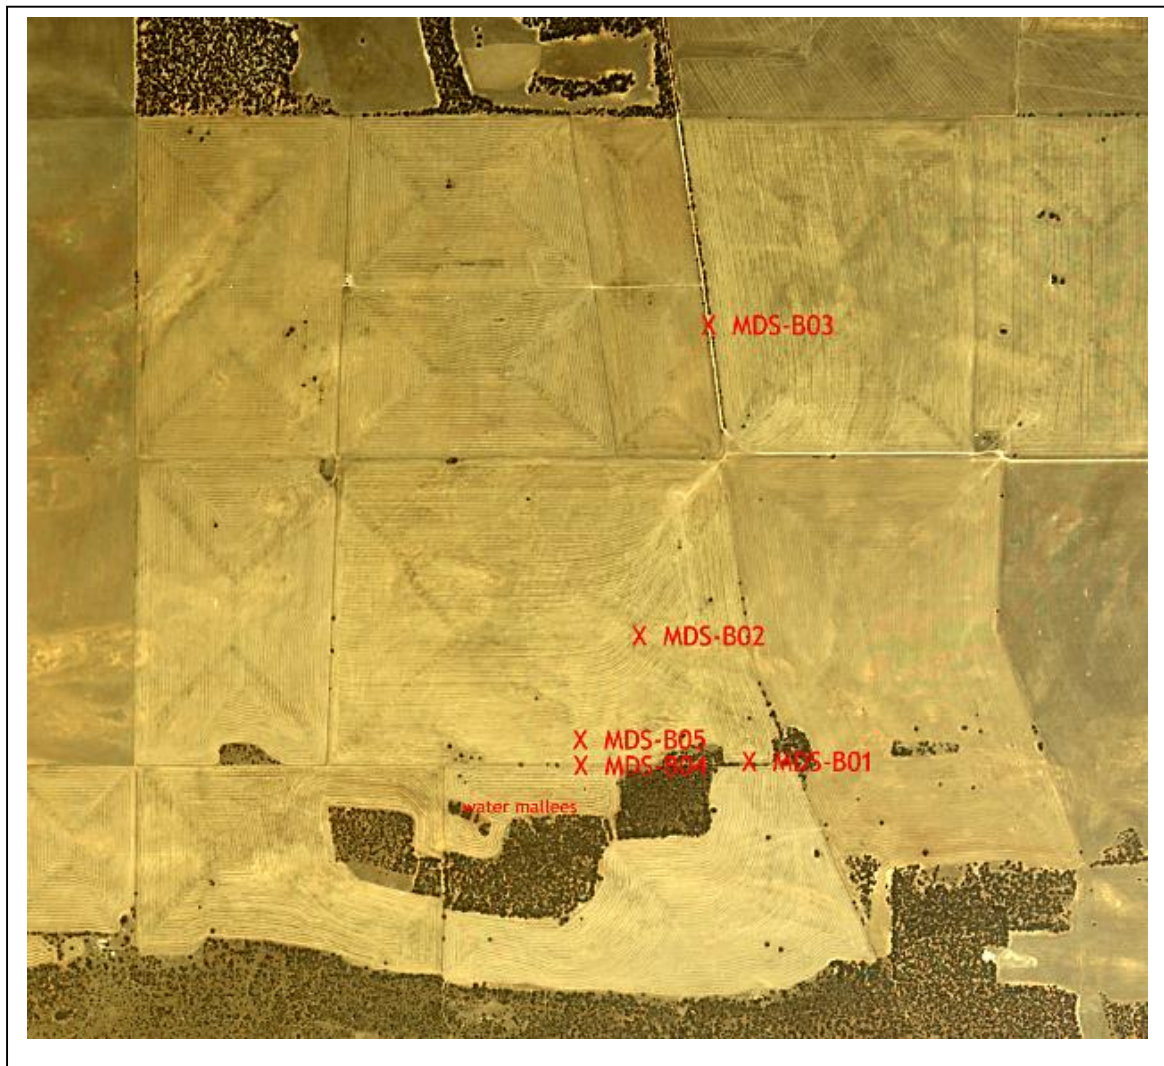
Figure 5: Bond Subcatchment (Mannum East) in the South Australian Murray Mallee: showing sites investigated via soil characterisation and drilling (with a 2001 aerial photograph as background).

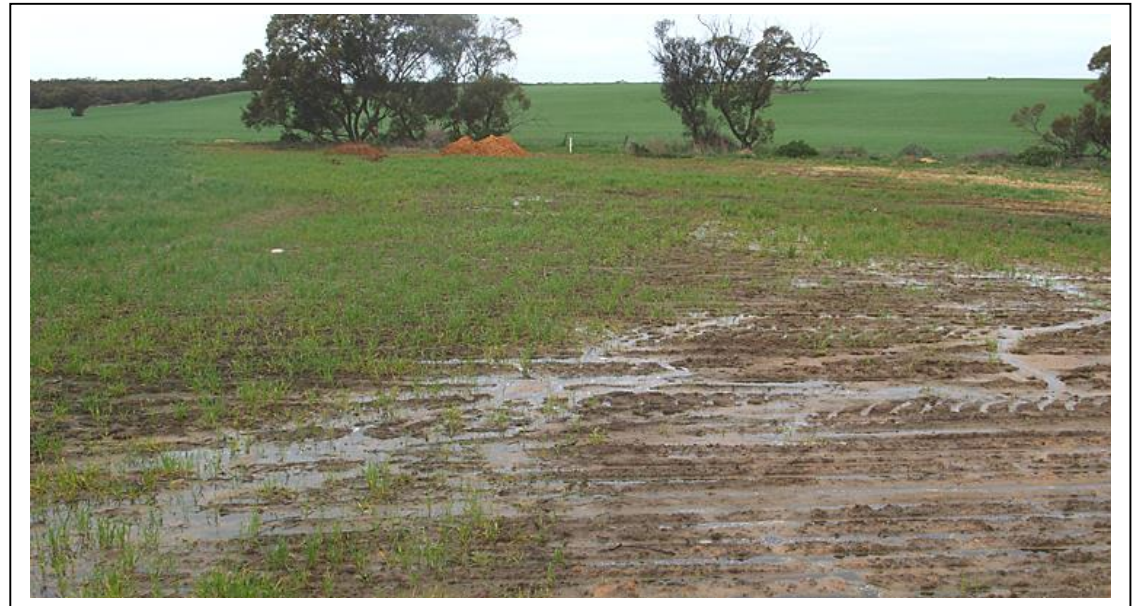
Laboratory Data – MDS-B01

Horizon	Depth cm	Texture	N NH4+ mg/kg	N NO3- mg/kg	pH H2O	pH CaCl2	CO3 %	EC 1:5 dS/m	ECe dS/m	Org C %	P Avail. mg/kg	P Buff Index	K Avail. mg/kg	S (KCl) mg/kg	Boron mg/kg	Trace Elements mg/kg (DTPA)				Sum cation s meq/100g	Exchangeable Cations meq/100g					ESP
																Cu	Fe	Mn	Zn		Ca	Mg	Na	K	Al	
A1	0–22	sl-	<1	10	9.8	8.7	0.24	0.35	4.67	0.32	43	32.4	218	52	9.31	0.36	19.8	1.5	3.2	6.5	2.14	1.04	2.72	0.56	0.08	41.6
A2	22–52	sl-	<1	17	9.5	8.4	0.62	0.42	5.95	0.19	30	27.9	179	65	9.15	0.42	19.2	0.7	0.6	8.6	3.89	0.83	3.29	0.43	0.15	38.3
Bt	52–70	lc	<1	10	9.8	8.7	10.5	0.51	3.05	0.21	7	131	442	56	14.99	0.51	9.7	0.7	0.8	20.1	7.46	4.68	6.73	1.13	0.09	33.5
Btk	70–100	cl	<1	11	9.7	8.4	24.6	0.40	2.73	0.24	2	168	571	65	16.83	0.57	9.9	0.6	1.1	21.8	6.75	7.90	5.56	1.46	0.08	25.6
C	100–140	cl	<1	7	9.5	8.4	47.7	0.52	2.40	0.13	<2	154	425	65	17.22	0.79	6.9	0.2	0.5	17.8	5.80	6.10	4.68	1.09	0.08	26.4
Approx. Critical/Ideal Values			-	-	6–8	5.5–7.5	0	<0.7–1.85	<4–8	>1–2	>25–35	100–200	>80–120	>6–8	1–15	>0.2	>2.5	>1–2	>0.5–1.0	>15	75% CEC	20% CEC	<6% CEC	5% CEC	<5% CEC	<6

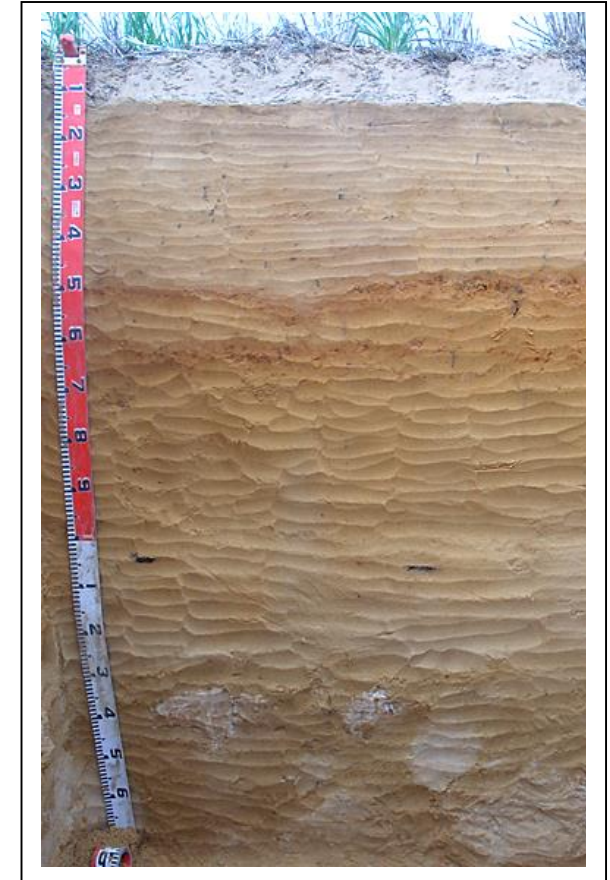
Depth (cm)	Description
0-12	Loose, dark yellowish brown, non-repellent, clayey sand with single grain structure. Abrupt boundary to:
12-50	Brownish yellow, loamy sand with single grain structure and minor heavier-textured lamellae. Abrupt boundary to:
50-68	Yellowish brown, clayey sand with single grain structure. Sharp boundary to:
68-100	Brownish yellow, clayey sand with single grain structure and 10-20% nodular non-clayey segregations with slightly higher clay content than the main soil matrix. Gradual boundary to:
100-130	Brownish yellow, moderately calcareous, clayey sand with single grain structure. Gradual boundary to:
130-175	Brownish yellow, moderately calcareous, light sandy clay with single grain structure and 10-20% hard carbonate fragments (20-60 mm diameter).

Calcareous, Arenic, **Brown-Orthic Tenosol**; thick, non-gravelly, sandy / sandy, deep.

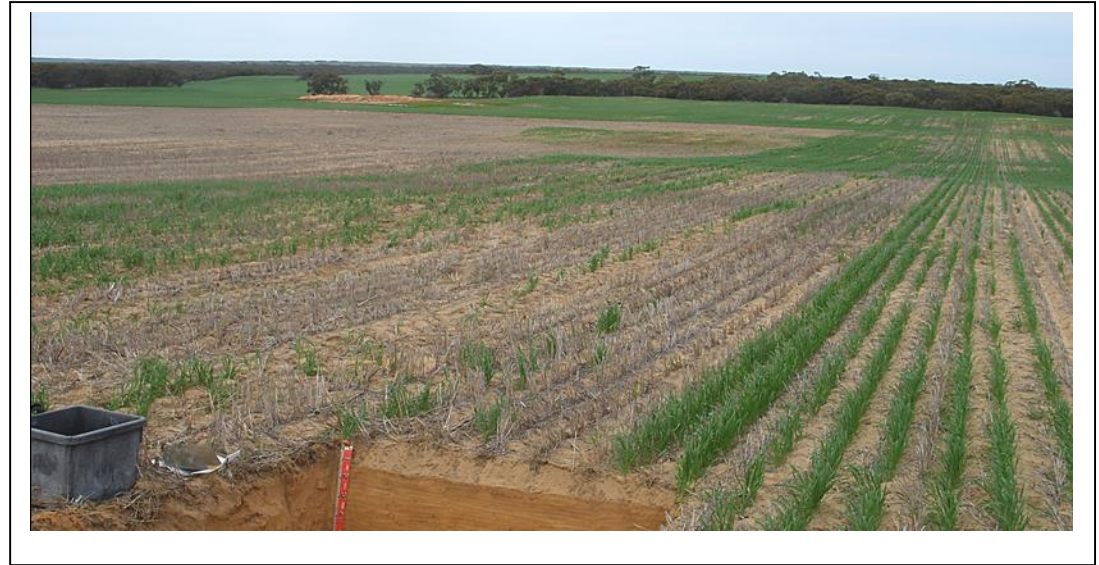
Laboratory Data MDS-B02

Horizon	Depth cm	Texture	N NH4+ mg/kg	N NO3- mg/kg	pH H2O	pH CaCl2	CO3 %	EC 1:5 dS/m	ECe dS/m	Org C %	P Avail. mg/kg	P Buff Index	K Avail. mg/kg	S (KCl) mg/kg	Boron mg/kg	Trace Elements mg/kg (DTPA)				Sum cations meq/100g	Exchangeable Cations meq/100g					ESP
																Cu	Fe	Mn	Zn		Ca	Mg	Na	K	Al	
A1	0–12	cs	1	26	6.0	5.2	0.2	0.06	0.66	0.62	25	15.9	121	2.6	0.44	0.24	42.8	1.99	2.48	3.6	2.49	0.74	0.04	0.25	0.06	1.1
A2	12–50	ls	<1	2	8.7	7.9	0.2	0.04	0.36	0.05	13	10.6	88	1.5	0.26	0.15	11.1	0.57	0.15	2.6	1.65	0.53	0.02	0.23	0.17	0.8
Bw1	50–68	cs	<1	1	7.7	6.7	0.2	0.02	0.32	0.06	3	15.7	159	1.1	0.52	0.09	5.80	0.40	0.19	5.4	3.26	1.41	0.04	0.41	0.24	0.7
Bw2	68–100	cs	<1	1	9.1	7.9	0.38	0.06	0.30	0.05	<2	13.4	97	1.6	0.56	0.19	4.22	0.36	0.15	6.1	4.27	1.26	0.04	0.25	0.30	0.7
Bk1	100–130	cs	<1	2	9.2	8.2	0.75	0.06	0.27	0.05	<2	13.8	90	1.4	0.60	0.16	5.15	0.35	0.16	5.6	4.02	1.01	0.03	0.23	0.29	0.5
Bk2	130–175	sl-	<1	3	9.4	8.4	4.37	0.09	0.40	0.05	<2	41.6	211	2.4	1.34	0.14	5.68	0.38	0.24	9.6	6.19	2.66	0.07	0.54	0.16	0.7

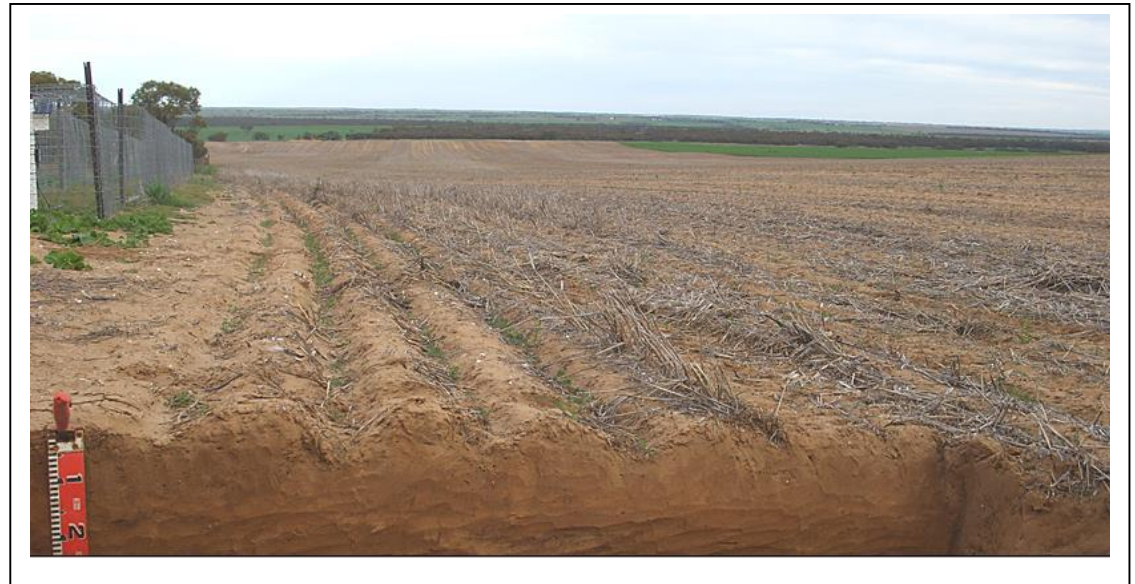
Laboratory Data – MDS-B03

Horizon	Depth cm	Texture	N NH4+ mg/kg	N NO3- mg/kg	pH H2O	pH CaCl2	CO3 %	EC 1:5 dS/m	ECe dS/m	Org C %	P Avail. mg/kg	P Buff Index	K Avail. mg/kg	S (KCl) mg/kg	Boron mg/kg	Trace Elements mg/kg (DTPA)				Sum cations meq/100g	Exchangeable Cations meq/100g					ESP
																Cu	Fe	Mn	Zn		Ca	Mg	Na	K	Al	
Ap	0–12	sl-	<1	15	7.8	7.2	0.26	0.06	0.73	0.64	24	16.8	203	2.9	0.62	0.23	11.3	0.70	2.32	6.6	5.30	0.76	0.04	0.45	0.04	0.6
A12	12–27	sl-	<1	7	8.8	8.0	0.23	0.06	0.53	0.41	22	15.8	194	2.8	0.75	0.50	9.49	0.22	0.73	6.6	5.39	0.61	0.02	0.49	0.08	0.3
A13	27–52	sl-	<1	8	8.6	7.7	0.27	0.05	0.58	0.41	12	17.2	210	2.2	0.94	0.25	9.02	0.24	0.23	7.2	5.96	0.62	0.03	0.44	0.11	0.4
Bw1	52–77	sl	1	5	8.8	8.0	0.32	0.07	0.50	0.21	4	20.7	129	2.5	0.71	0.13	16.8	1.41	0.19	5.6	4.32	0.69	0.05	0.33	0.17	0.9
Bw2	77–125	sl-	<1	9	9.2	8.3	3.86	0.08	0.48	0.17	<2	42.0	219	2.9	1.10	0.16	9.29	0.38	0.10	10.5	8.15	1.59	0.05	0.56	0.16	0.5

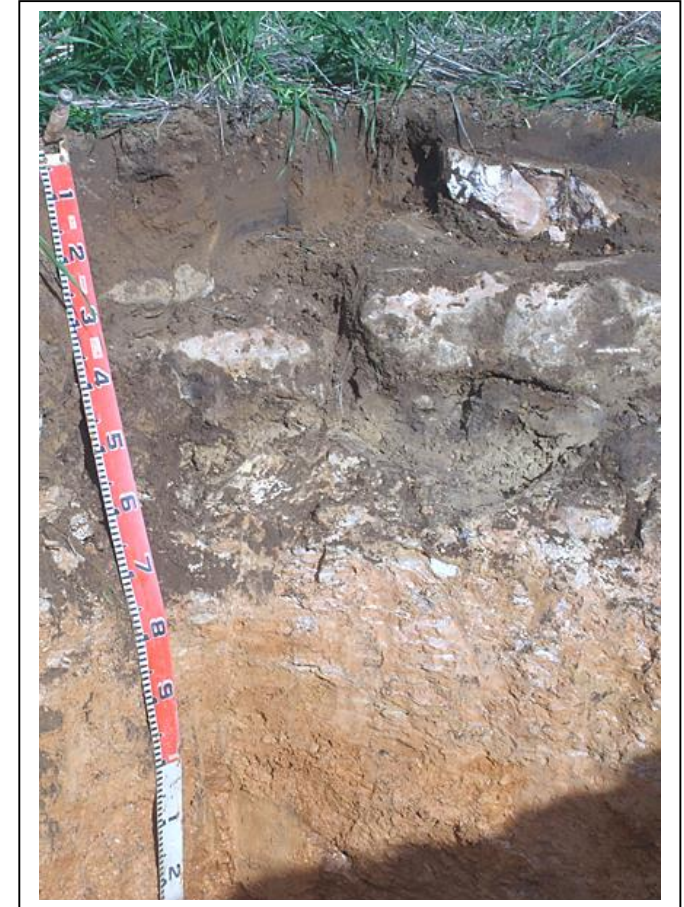
Depth (cm)	Description
0-12	Soft, dark brown, non-repellent, light sandy loam with weak structure. Clear boundary to:
12-22	Strong brown, light sandy loam with single grain structure and 10 – 20% hard carbonate fragments (>60 mm diameter). Abrupt boundary to:
22-45	Saturated, pale brown, slightly calcareous, slightly dispersive, bleached, light sandy loam with abundant hard carbonate fragments (>60 mm). Abrupt boundary to:
45-70	Calcrete pan. Clear boundary to:
70-90	Calcrete pan. Clear boundary to:
90-140	Brownish yellow, slightly calcareous, moderately dispersive, light sandy clay loam with weak structure.

Oxyaquic Hydrosol. Before becoming wet, the soil would have classified as a: Calcareous, Petrocalcic, **Bleached-Leptic Tenosol**; thick, gravelly, loamy / -, shallow.

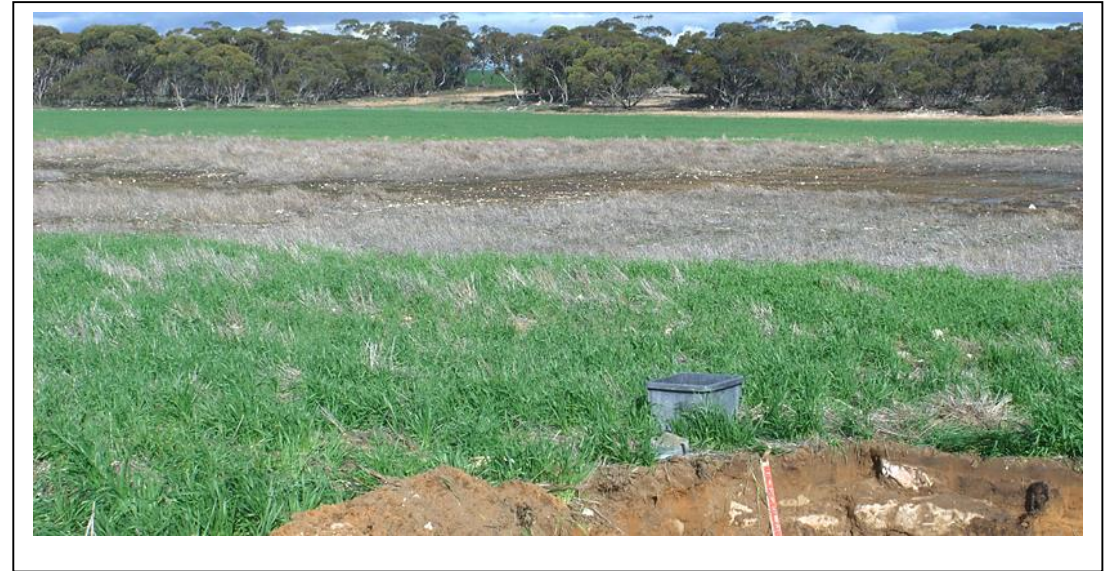
Laboratory Data – MDS-B04

Horizon	Depth cm	Texture	N NH4+ mg/kg	N NO3- mg/kg	pH H2O	pH CaCl2	CO3 %	EC 1:5 dS/m	ECe dS/m	Org C %	P Avail. mg/kg	P Buff Index	K Avail. mg/kg	S (KCl) mg/kg	Boron mg/kg	Trace Elements mg/kg (DTPA)				Sum cations meq/100g	Exchangeable Cations meq/100g					ESP
																Cu	Fe	Mn	Zn		Ca	Mg	Na	K	Al	
A1	0–12	sl-	2	41	8.5	7.9	0.35	0.21	1.47	1.12	38	19.0	276	11.0	2.48	0.35	16.9	1.74	4.70	8.4	5.55	1.41	0.68	0.71	0.05	8.1
A2	12–22	sl-	<1	12	9.5	8.5	0.37	0.11	1.44	0.19	24	25.1	229	7.9	3.31	0.34	11.5	0.24	0.71	5.6	3.24	0.80	0.92	0.54	0.14	16.3
A2k	22–45	sl-	<1	10	9.8	8.7	10.2	0.24	1.69	0.56	8	102.4	293	15.2	6.83	1.05	14.3	2.04	1.52	15.1	8.50	4.03	1.79	0.75	0.07	11.8
Bkm1	45–70	-	calcrete pan																							
Bkm2	70–90	-	calcrete pan																							
C	90–140	fscl-	<1	7	10.0	8.7	60.2	0.23	0.99	0.15	<2	159.7	406	11.6	9.61	0.60	9.2	0.48	0.83	14.5	5.91	5.32	2.19	1.04	0.02	15.1
Approx. Critical/Ideal Values			-	-	6–8	5.5–7.5	0	<0.7–1.85	<4–8	>1–2	>25–35	100–200	>80–120	>6–8	1–15	>0.2	>2.5	>1–2	>0.5–1.0	>15	75% CEC	20% CEC	<6% CEC	5% CEC	<5% CEC	<6

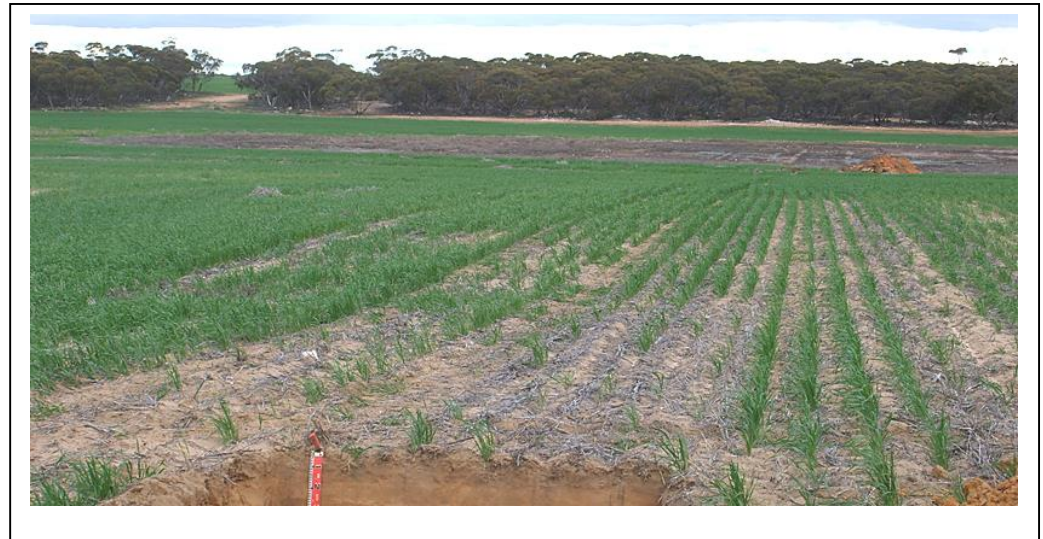
Laboratory Data – MDS-B05

Horizon	Depth cm	Texture	N NH4+ mg/kg	N NO3- mg/kg	pH H2O	pH CaCl2	CO3 %	EC 1:5 dS/m	ECe dS/m	Org C %	P Avail. mg/kg	P Buff Index	K Avail. mg/kg	S (KCl) mg/kg	Boron mg/kg	Trace Elements mg/kg (DTPA)				Sum cations meq/100g	Exchangeable Cations meq/100g					ESP
																Cu	Fe	Mn	Zn		Ca	Mg	Na	K	Al	
1A11	0–10	cs	2	18	6.0	5.0	0.24	0.06	0.53	0.64	22	12.4	123	2.3	0.30	0.52	42.0	3.02	2.07	2.5	1.61	0.52	0.02	0.25	0.07	0.8
1A12	10–30	ls	2	11	8.5	7.5	0.19	0.05	0.38	0.14	23	10.2	88	2.0	0.25	0.29	40.3	1.21	0.38	1.8	1.06	0.41	0.02	0.21	0.09	1.1
2A1	30–48	ls	<1	2	8.3	6.8	0.20	0.02	0.29	0.13	15	10.0	130	0.6	0.27	0.41	11.0	0.02	0.29	2.8	1.85	0.50	0.02	0.31	0.10	0.7
2A2	48–70	ls	<1	2	8.6	7.5	0.20	0.02	0.33	0.05	5	8.8	83	0.6	0.26	0.54	9.37	0.20	0.27	2.2	1.37	0.39	0.03	0.19	0.17	1.4
2A3	70–74	scl-	<1	3	8.9	7.6	0.25	0.06	17.7	0.06	<2	24.0	314	1.0	2.29	0.44	10.4	0.15	0.21	7.7	2.71	2.98	0.97	0.80	0.20	12.7
2Bt1	74–110	fscl+	<1	3	9.9	8.9	3.74	0.23	44.5	0.07	<2	76.9	492	2.4	10.8	0.82	9.24	0.42	0.44	16.0	6.33	5.74	2.46	1.26	0.17	15.4

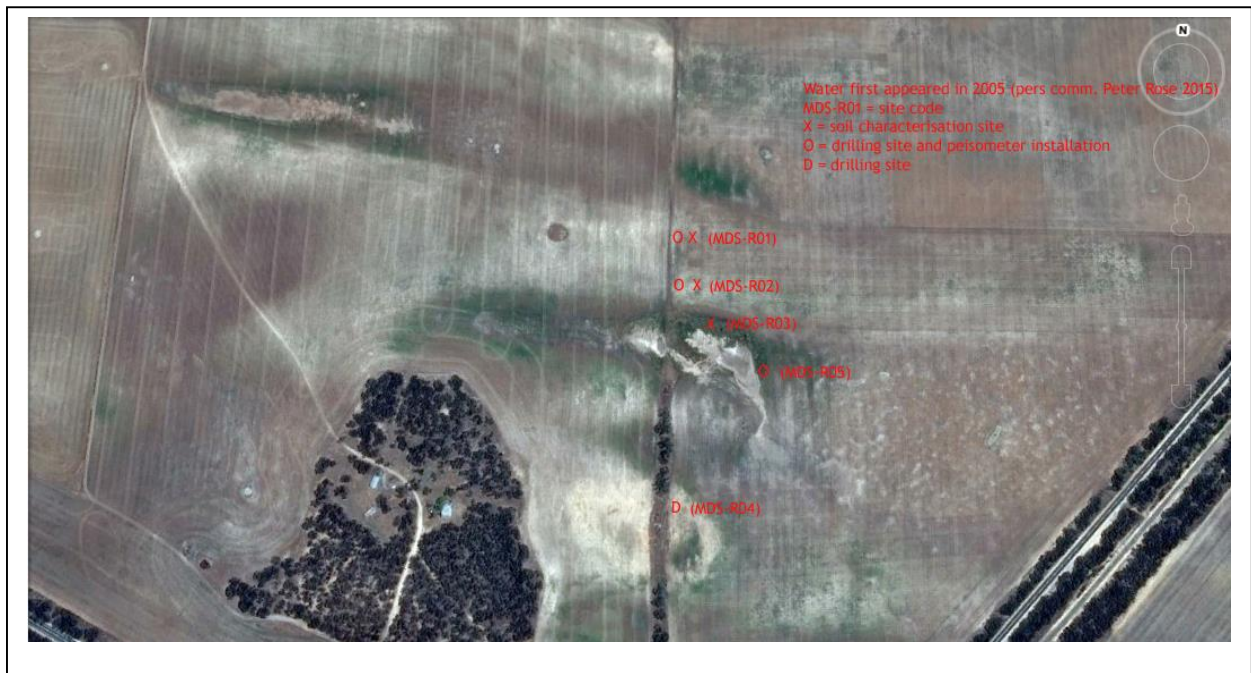
Figure 7: Rose-Thomas Subcatchment at Kulde in the South Australian Murray Mallee: showing sites investigated via soil characterisation and drilling (with a 2013 aerial image as background).

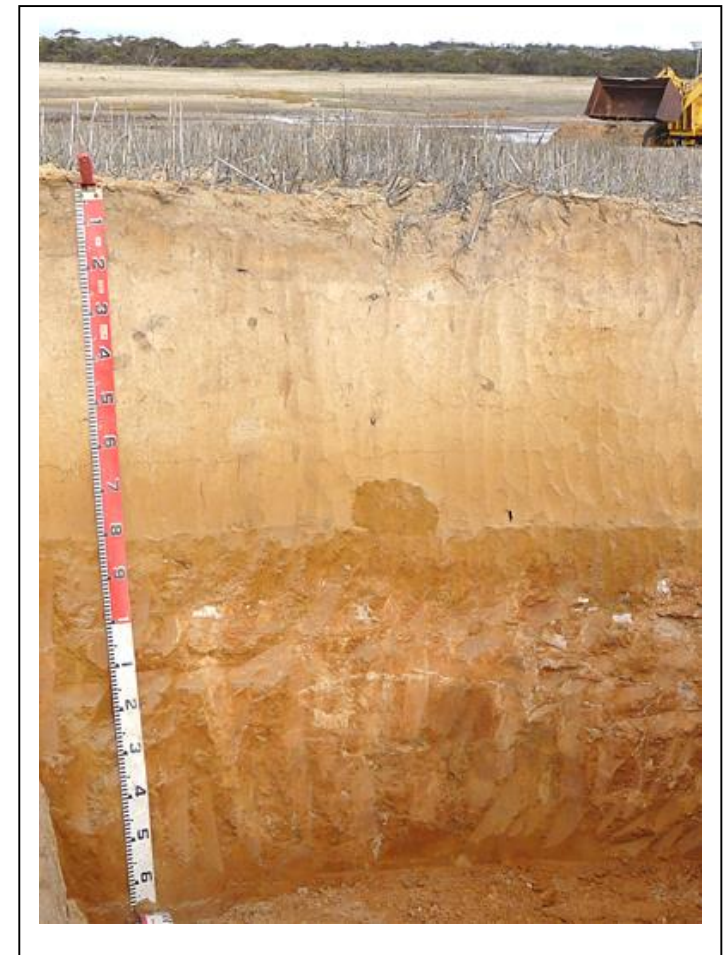
Depth (cm)	Description
0-18	Loose, water repellent, brown loamy sand with single grain structure. Abrupt boundary to:
18-60	Very pale brown and brownish yellow, sporadically bleached, sand with single grain structure. Clear boundary to:
60-80	Brownish yellow loamy sand with single grain structure and minor heavier-textured lamellae. Sharp boundary to:
80-98	Yellowish brown, strong brown and olive yellow, light clay with massive structure. Gradual boundary to:
98-120	Yellowish brown, strong brown and olive yellow, slightly dispersive, moderately calcareous, light medium clay with approximately 20% hard carbonate fragments (2-20 mm) and laminae, as well as massive structure. Gradual boundary to:
120-170	Yellowish brown, strong brown and olive yellow, slightly dispersive, fine sandy

medium clay with massive structure.

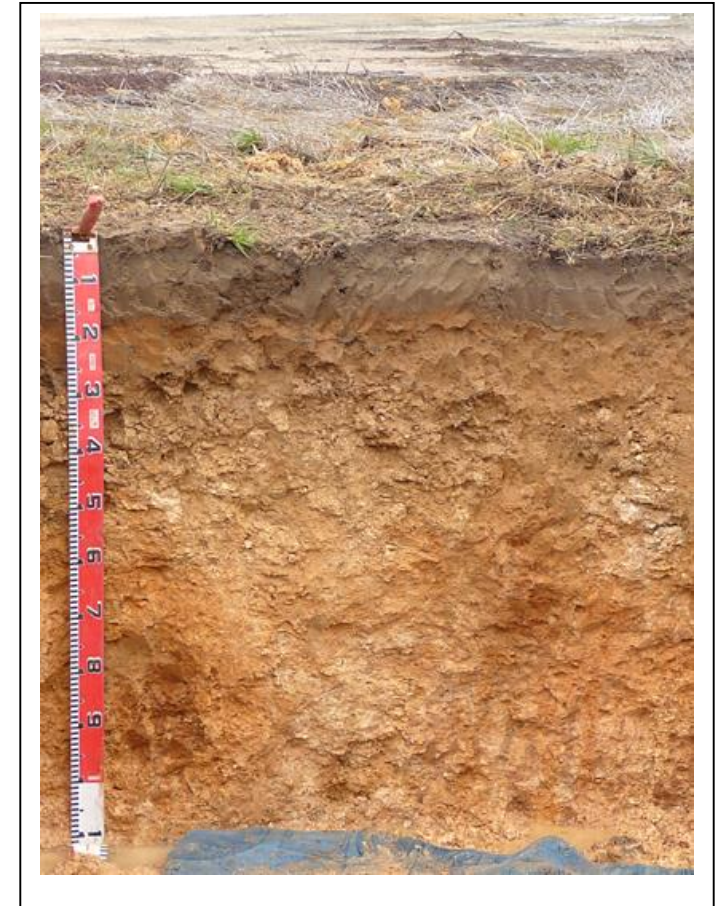
Depth (cm)	Description
0–15	Soft, dark brown, sandy loam with massive structure. Clear boundary to:
15–28	Slightly calcareous, brown sandy loam with massive structure. Clear boundary to:
28–47	Moderately calcareous, yellowish brown, heavy sandy loam with abundant hard carbonate nodules (20–60 mm). Clear boundary to:
47–62	Moderately calcareous, reddish yellow sandy clay loam with massive structure and abundant hard carbonate fragments (2–60 mm). Clear boundary to:
62–95	Highly calcareous, strong brown, yellowish brown and dark red, clay loam. Clear boundary to:
95–115	Highly calcareous, reddish yellow, pink and yellowish red, light clay with 20–50% hard carbonate fragments (6–60 mm).

Natric, Calcarosolic, **Oxyaquic Hydrosol**; thick, non-gravelly, loamy / clay loamy, shallow.
