Hughes Pump House, Verran Tce, Moonta, SA

former Hughes Pump House and Stack**CC:144****DESCRIPTION**

Abandoned mines in SA — addressing the problem

HUGHES PUMP HOUSE AND CHIMNEY

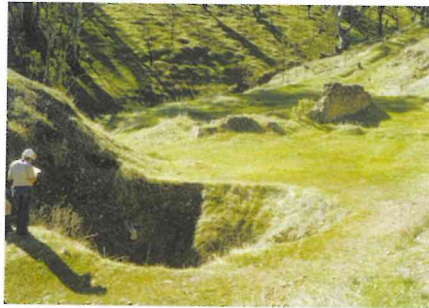
Main shaft of the Menzies Barossa Mine before safety fencing was installed. (Photo T15406)

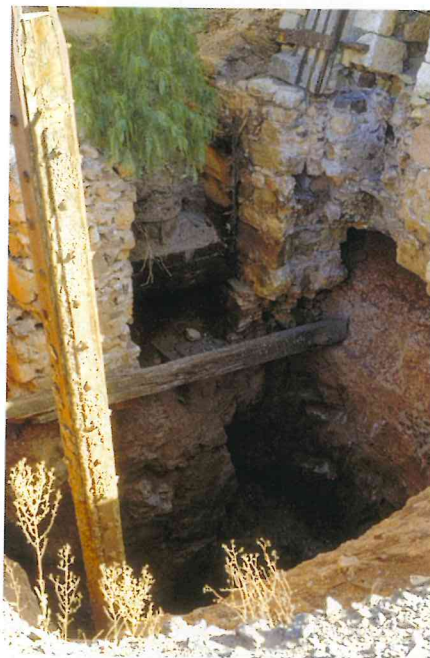
Hughes Shaft, Moonta Mines, before remediation work. (Photo 44039)

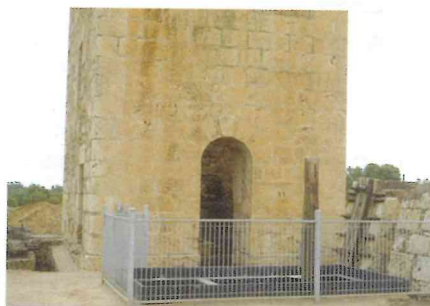
Hughes Shaft, Moonta Mines, after remediation work. (Photo 44040)

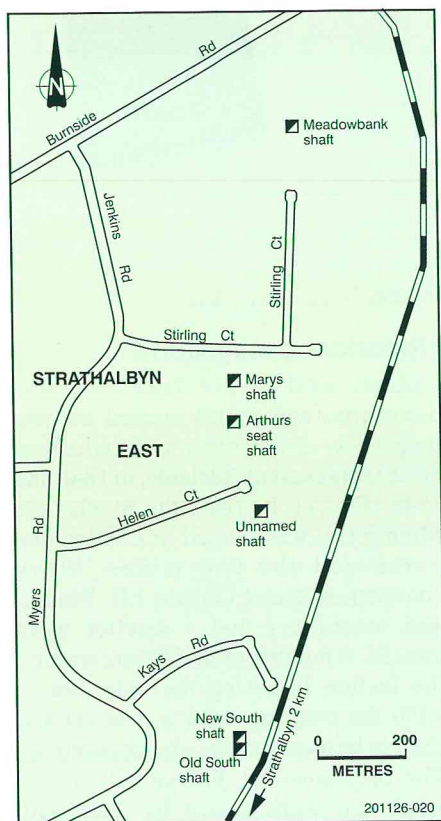
Fig. 1 Mine shaft locations in the vicinity of Strathalbyn.

Copper and silver-lead ore was discovered and mines opened on two properties ~2 km north of Strathalbyn, 50 km southeast of Adelaide, in 1846 and 1848 (Fig. 1). In 1849, the Strathalbyn Mining Co. was formed in London and purchased the two mines. Work commenced under Captain J.B. Pascoe, and machinery and a smelter were erected. A number of shafts were sunk on the incline following the lode, but in 1850 the company sank a new vertical shaft to be used specifically for pumping. The ore, however, proved difficult to smelt and work ceased by late 1850, when the company went into liquidation. The mine reopened in 1854 and new ore dressing machinery was brought from Cornwall. A new shaft was sunk but the ore again presented difficulties and work ceased by 1856. The mine was reopened again in 1906 and the old workings cleared out. Winding equipment was erected and the workings extended, but operations ceased in 1907.

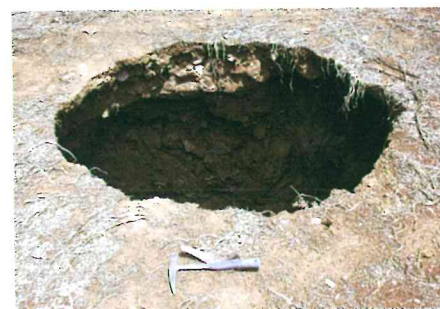
Pump Shaft at the Strathalbyn Mine, site of the February 2001 accident. (Photo 48419)

This shaft was the site of the accident and was not identified in the previous Department of Mines inspections, suggesting that it was covered prior to 1913. However, a vertical pump shaft is mentioned in contemporary newspaper references. The shaft is vertical, ~2x3 m, and remained hidden by shallow cover until February 2001. The landowner fell 14.4 m to water level then plunged a further 7 m below the water.

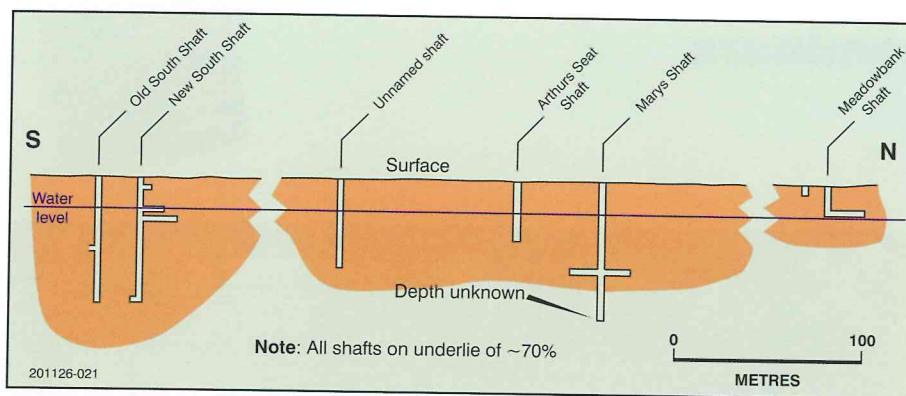
Fig. 2 North-south longitudinal section of the Strathalbyn Mine (reconstructed from Mining Reviews and newspaper reports).

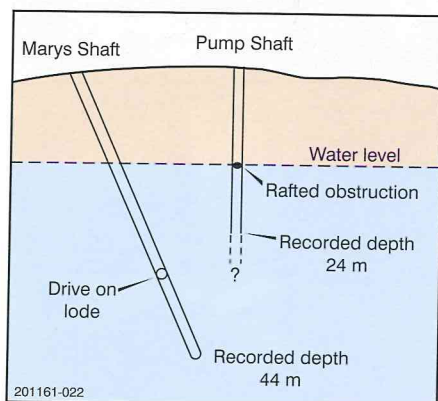
Fig. 3 Probable diagrammatic cross-section through Pump and Marys Shafts.

Following the landowner's rescue and, in the interest of public safety, PIRSA carried out a program to identify all shafts associated with the Strathalbyn Mine. Ground penetrating radar (GPR) proved effective in locating two filled shafts within ~50 m of the accident site (Fig. 3). A total of seven shafts were located, all but one of which could be correlated with the historic data. These shafts are:

Two filled underlie shafts with no surface evidence were located using GPR near the accident site. Other evidence, including the abundance of slag and the nearby vertical shaft, indicate that this area was the site of the initial copper mining activity during 1848–50.

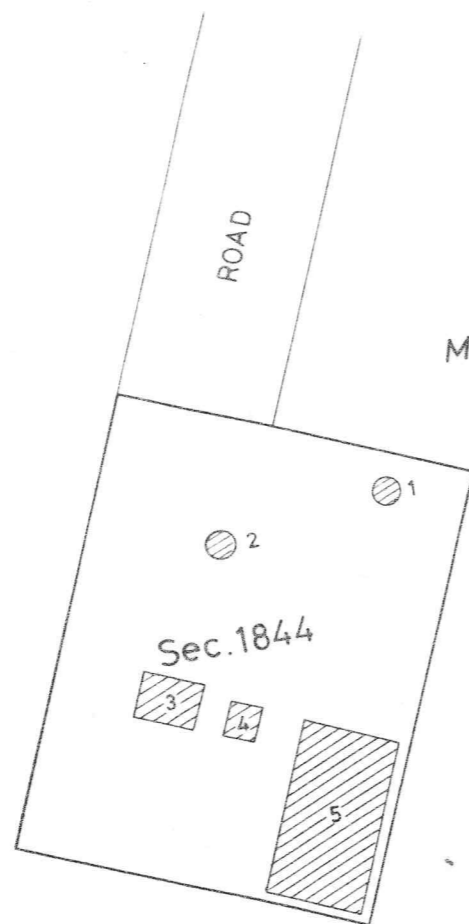
M.S. 931

1. STANDPIPE
2. CHIMNEY STACK
3. PUMP HOUSE
4. SHAFT
5. OLD ORE FLOOR
