"CHINAMAN'S WELL" AND STONE QUARRIES HISTORIC SITE  
COORONG NATIONAL PARK

South Australian Heritage Act 1978-82	Register of State Heritage Items ITEM EVALUATION SHEET Historic Site	Ref. No. 6825-10253
	Item "CHINAMAN'S WELL" HISTORIC SITE COORONG NATIONAL PARK	Status NTC, NER, RSHI
Age 1856+	Subject ORIGINAL USE: 0208 Well	Site Type -

# THE ARCHAEOLOGY OF CHINAMANS WELLS AND HACKS STATION: THE COORONG, SOUTH AUSTRALIA

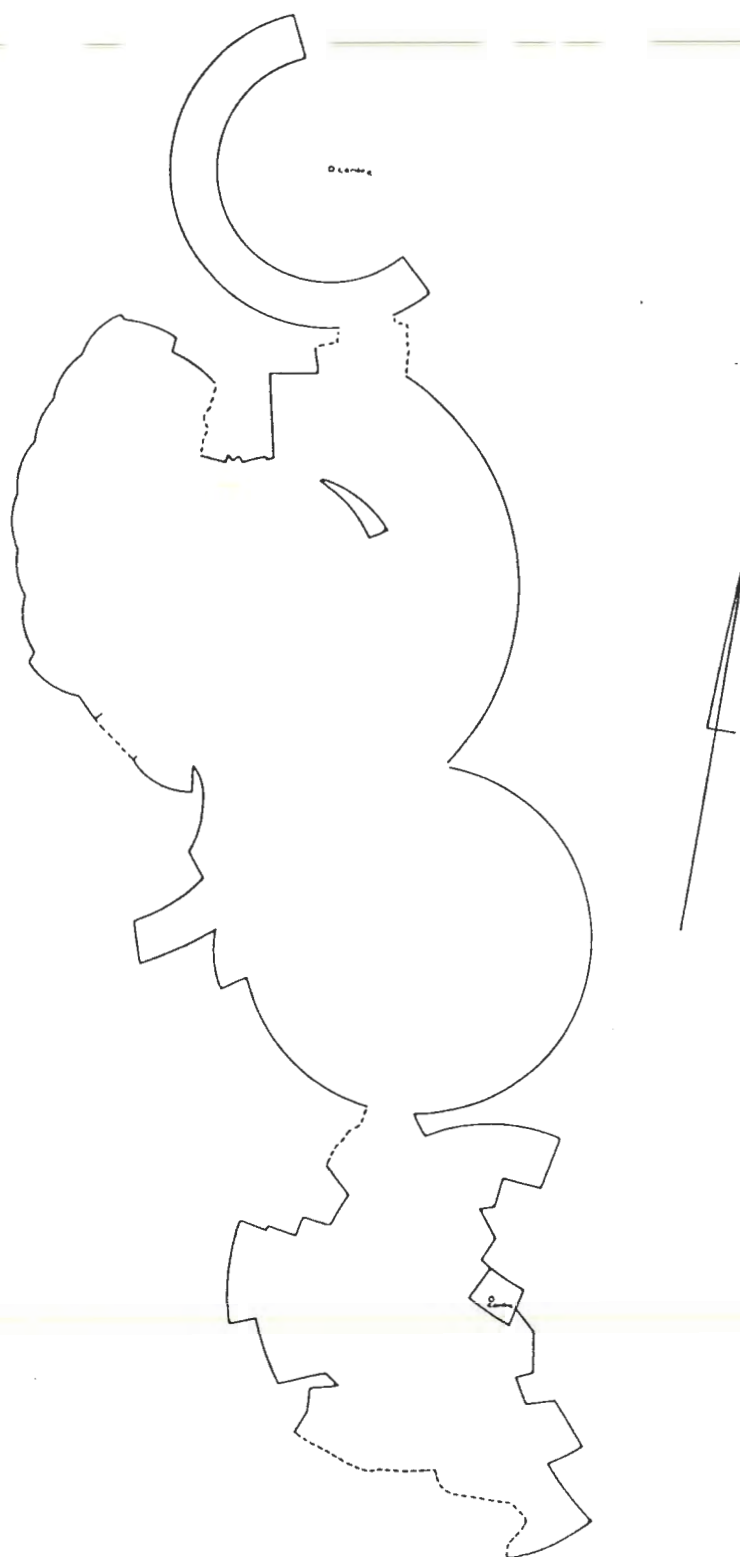
FIGURE 4

Outline of limestone quarry on western shore of salt lake near Chinamans Wells. Water laps quarry to right of illustration and vegetation extends to within 2m on left. Note four main arcate forms from which circular cuts through stone were made. The only two centering holes found are marked and the length of the cuttings is 21.5m.

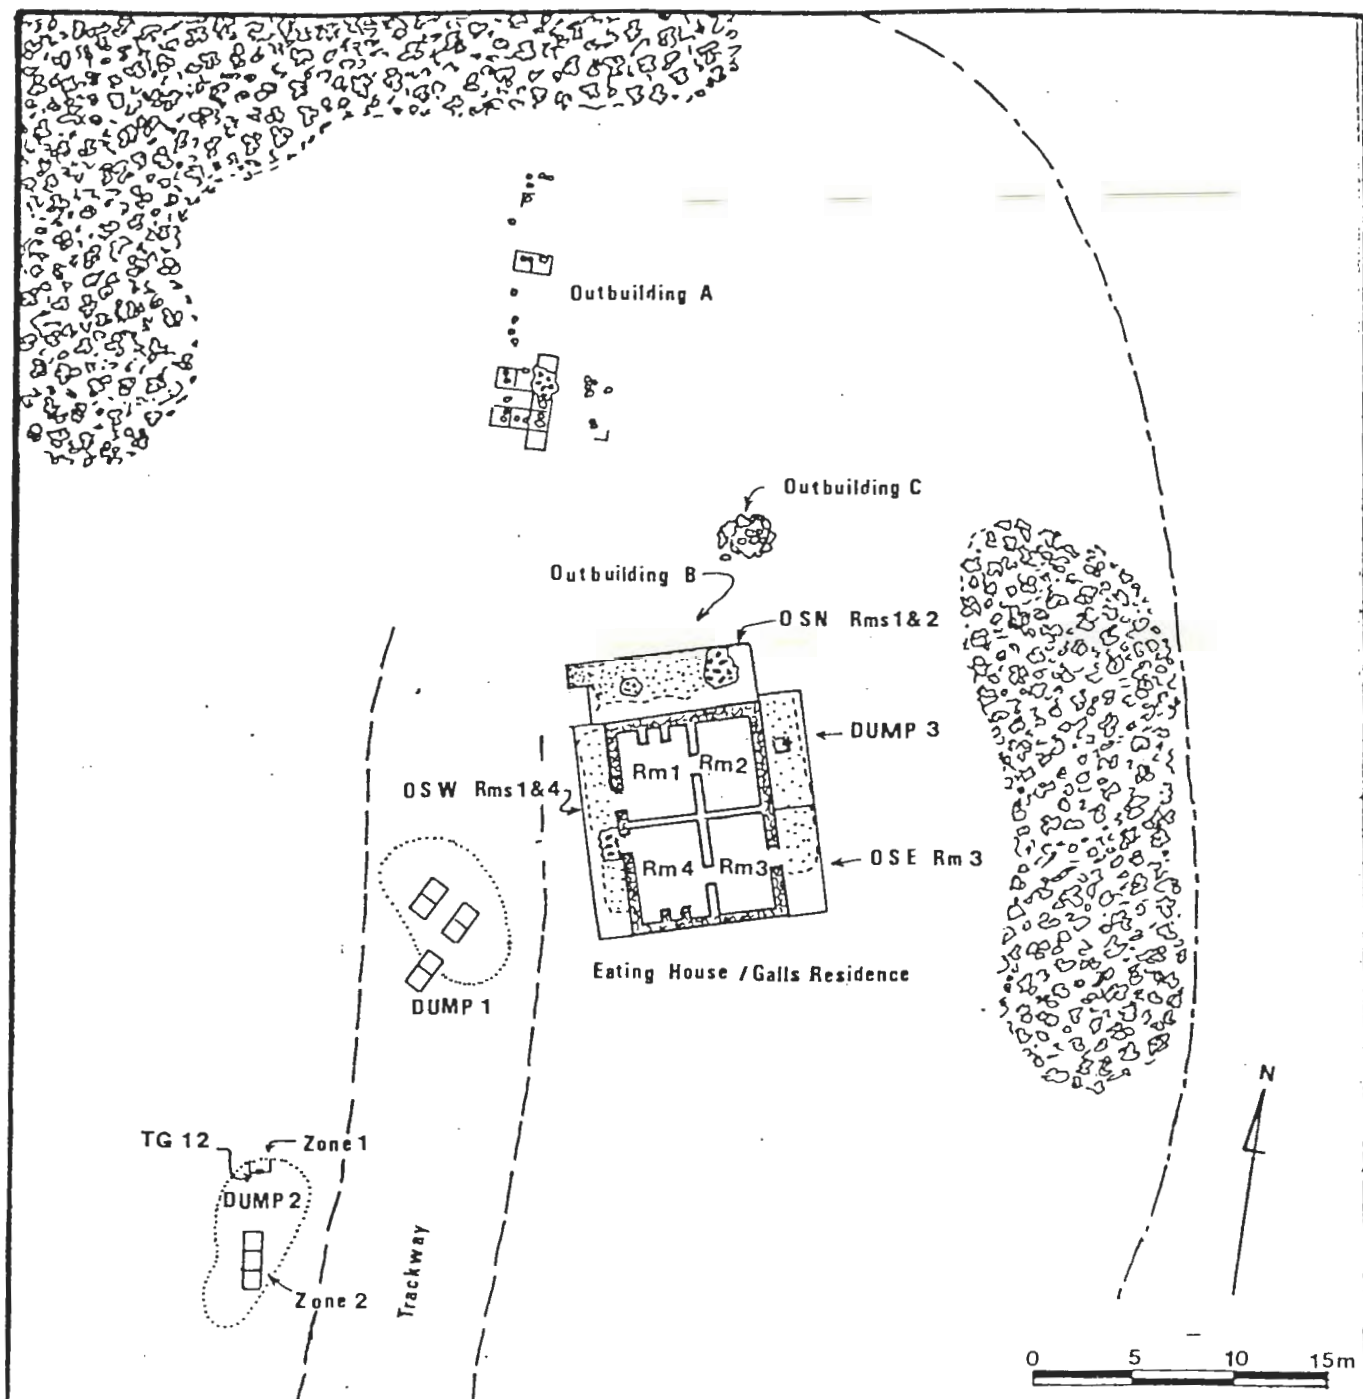
### CHINAMANS WELLS EATINGHOUSE /GALL'S RESIDENTIAL COMPLEX

- 1 Eating House - 11x8m Limestone foundations : 4 rooms
- 2 Outbuilding A - Size unknown: Flagstone, timber construction
- 3 Outbuilding B - Size unknown: limestone, rubble
- 4 Outbuilding C - 2m diam. : Limestone rubble: function unknown
- 5 Dump 1 - Kitchen domestic and construction refuse
- 6 Dump 2 - Kitchen domestic and construction refuse
- 7 Dump 3 - Kitchen and domestic refuse
- 8 TG12 - Telegraph posts and post base
- 9 Trackway - hard cemented sand layer

Eating House/Gall's Residence, outbuildings and domestic dumps at Chinamans Wells as known from field survey and archaeological excavations.

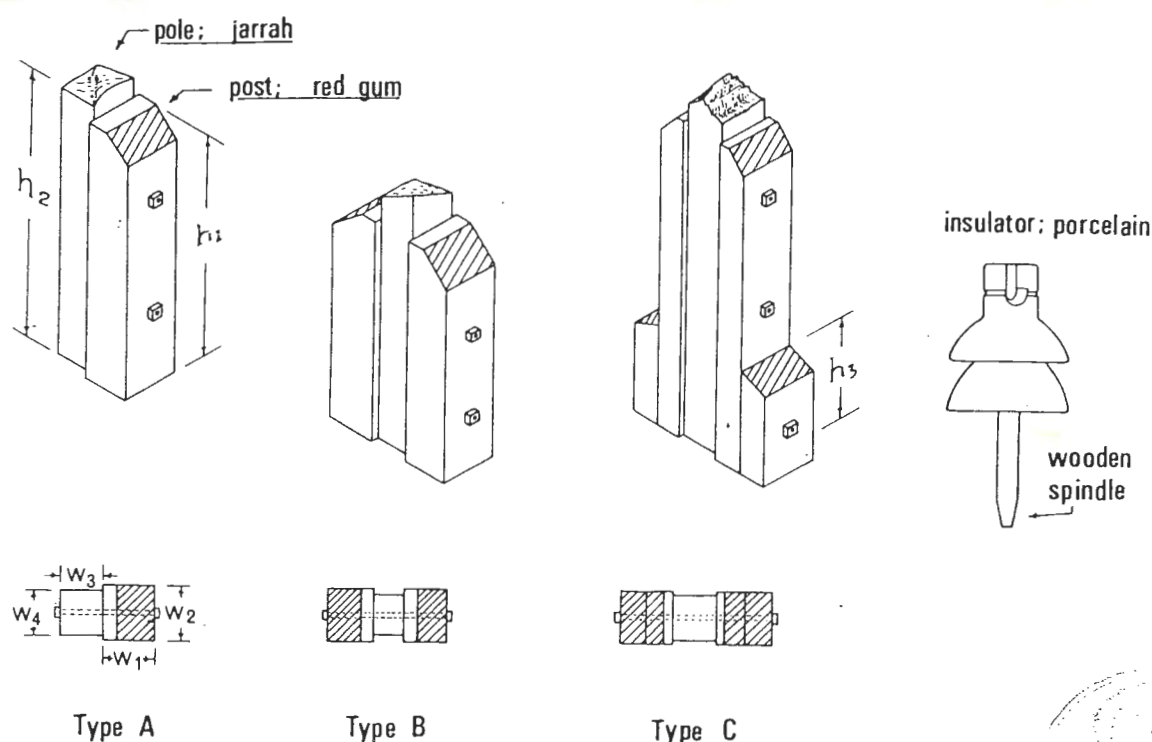
# TELEGRAPH POLE, POST, and INSULATOR DESIGN at CHINAMANS WELLS

FIELD NO.	Post $h_1$	Pole $h_2$	Post $h_3$	Post $w_1$	Post $w_2$	Pole $w_3$	Pole $w_4$	Type
TG 1	950	950	-	190	205	155	165	A
TG 2	-	700*	-	-	-	170	180	A?
TG 3	900	910	-	195	205	145	150	A
TG 4	915	975	-	195	190	155	155	A
TG 5	830	850	-	195	190	150	145	A
TG 6	920	955	-	185	180	150	150	A
TG 7	730	740	-	200	195	150	140	A
TG 8	-	300	-	-	-	155	150	A
TG 9	645	645	-	195	180	145	150	A
TG 10	930	300	-	-	200	-	-	A
TG 11	1185	1240	380	100	200	155	175	C
TG 12	-	-	-	100	180	170	-	B
TG 13	790	835	-	190	195	155	155	A
TG 14	-	-	-	190	195	155	155	B
TG 15	550	-	-	100	200	-	-	-

Design characteristics and principle dimensions of telegraph pole, post, and insulators at Chinamans Wells. Upper pole elements and cross beams are missing from the site.

of poles and posts which are fastened together with hand-made hardware, and miscellaneous wire and threaded timber insulator supports. Sub-surface repair and re-installation of base assemblies are evident.

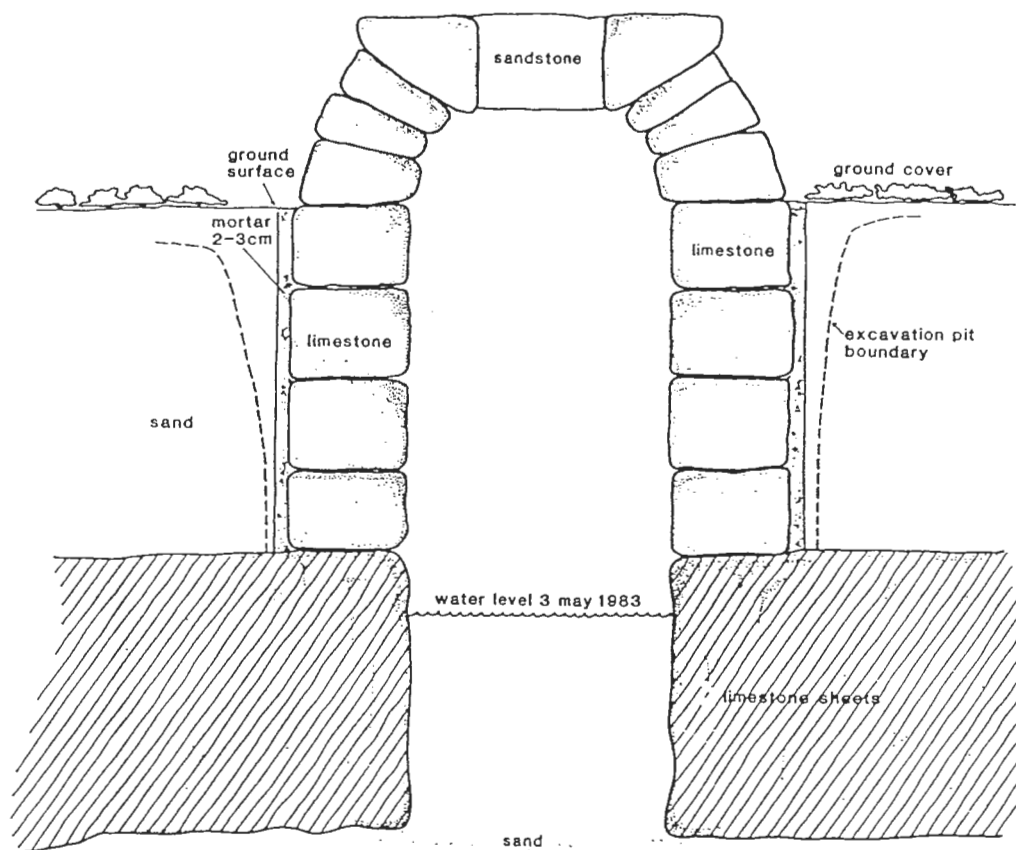
#### Dimensions

total height: 1.78m  
 outside diameter: 1.65m  
 inside diameter: 0.88m  
 cap diameter: 1.20m  
 entry hole diameter: 0.43m  
 no. of toe holds: 6

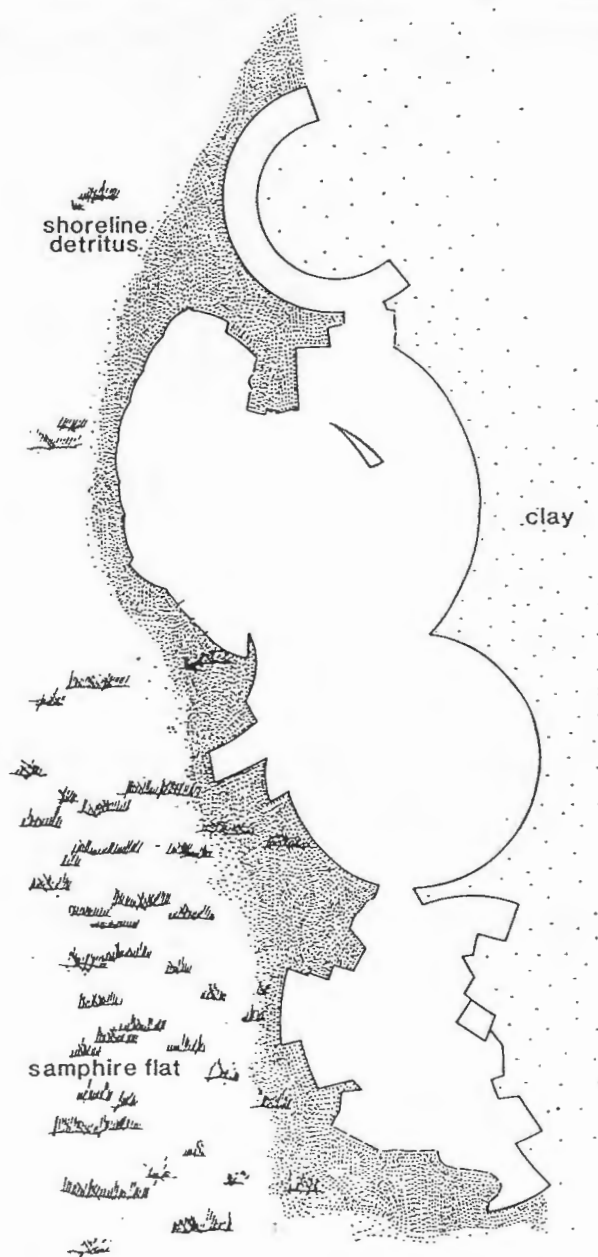
FIGURE 7 Map of Limestone Quarry No. 2 on western shore of salt lake, Chinamans Wells. Water laps arcuate cuttings from the right at the edge of limestone layer. Total length of cutting is 21.5m.

The striking pattern of curved cut marks, drill holes, and loose limestone blocks in the lake side quarries clearly illustrate both mass production and custom-made techniques used to manufacture stone blocks. A pilot hole was first drilled or chiselled into the rock face several inches deep to centre the initial cut. Then a chain or rope with one end anchored to the hole and the other attached to a chisel was stretched tightly to fix a radius for cutting a large arc across the limestone face. A hammer may have been used with the chisel, but the limestone is soft enough to cut by simply drawing a sharp tool firmly across the surface. The most common cuts made in this manner are perfect circles ranging in size from 4.3 to 4.5 m in diameter. Once two concentric arcs had been cut through the limestone to the underlying sand, and the end cuts had been made, the block could be readily lifted from the quarry floor. The blocks produced by this process had a perfectly symmetrical curvature, ranged in thickness from 12-25 cm, and exhibited end and side faces that were accurately cut at right angles. Depending on the radius chosen, standardized shapes and sizes were achieved simply and quickly. Successive rows of blocks could be cut from the one pilot hole until the desired amount of stone was obtained. The "lop-sided" shape of some circular cuts is the result of additional blocks being removed from outside a sector of the main 4.3 m cut, and this seems to have always involved custom-made blocks. The presence of "scallop" shaped cuts in the edge of one circle in Quarry 2 (see Plate 3) appears to be produced by hand quarrying in exactly this manner. There is also a low incidence of individual rows of blocks being carved from arcs which have centring holes that do not fall within the main circular cut.

While still moist, the limestone is particularly soft and can easily be shaped by any sharp steel tool, but once air-cured, it develops internal strength and a hard, weather resistant exterior that is ideal in building applications where load bearing requirements and mechanical vibration are

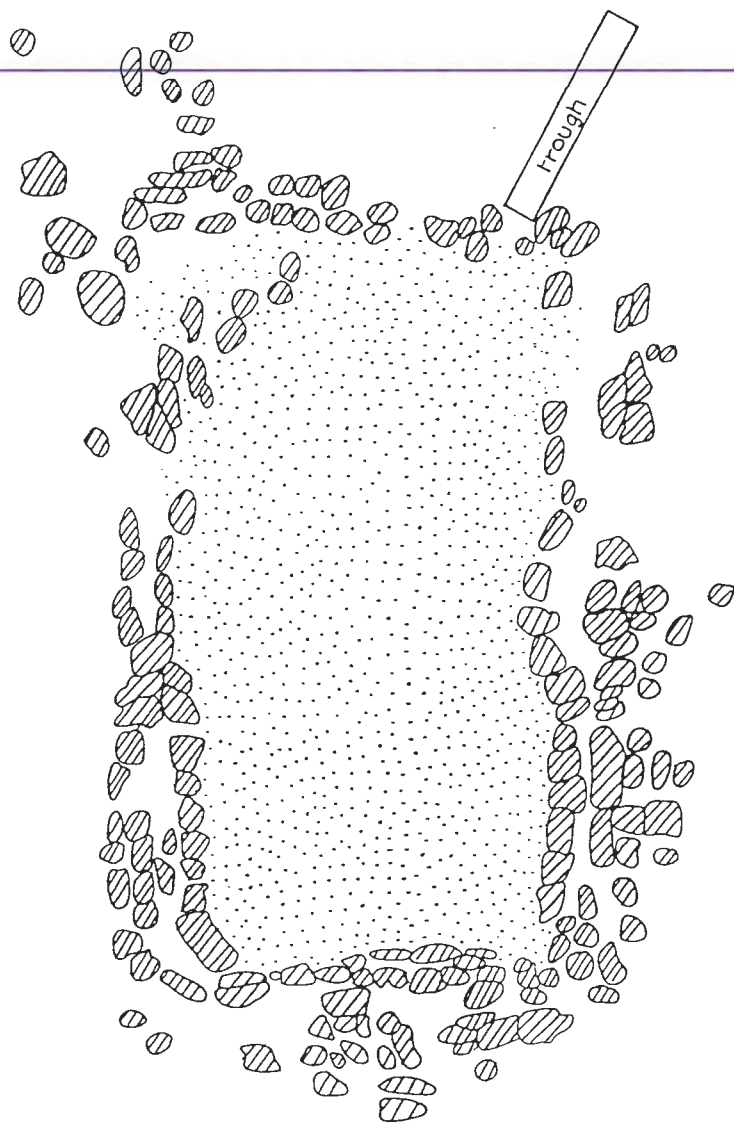
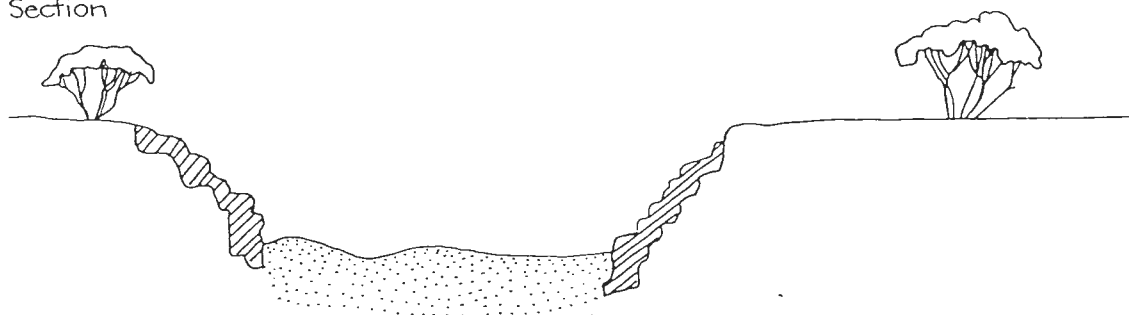
FIGURE 8 Plan and section of stone lined "wedge pit" shown in partially filled and collapsed state. Extra wide iron trough occurs at upper corner to conduct water into remaining trough system and tanks.

5. A wedge pit constructed in the 1860s for travelling stock is described. A whip, troughs, and fencing completed the installation. The report verifies its construction details, water rates, and repair schedules for various times during the 19<sup>th</sup> century.

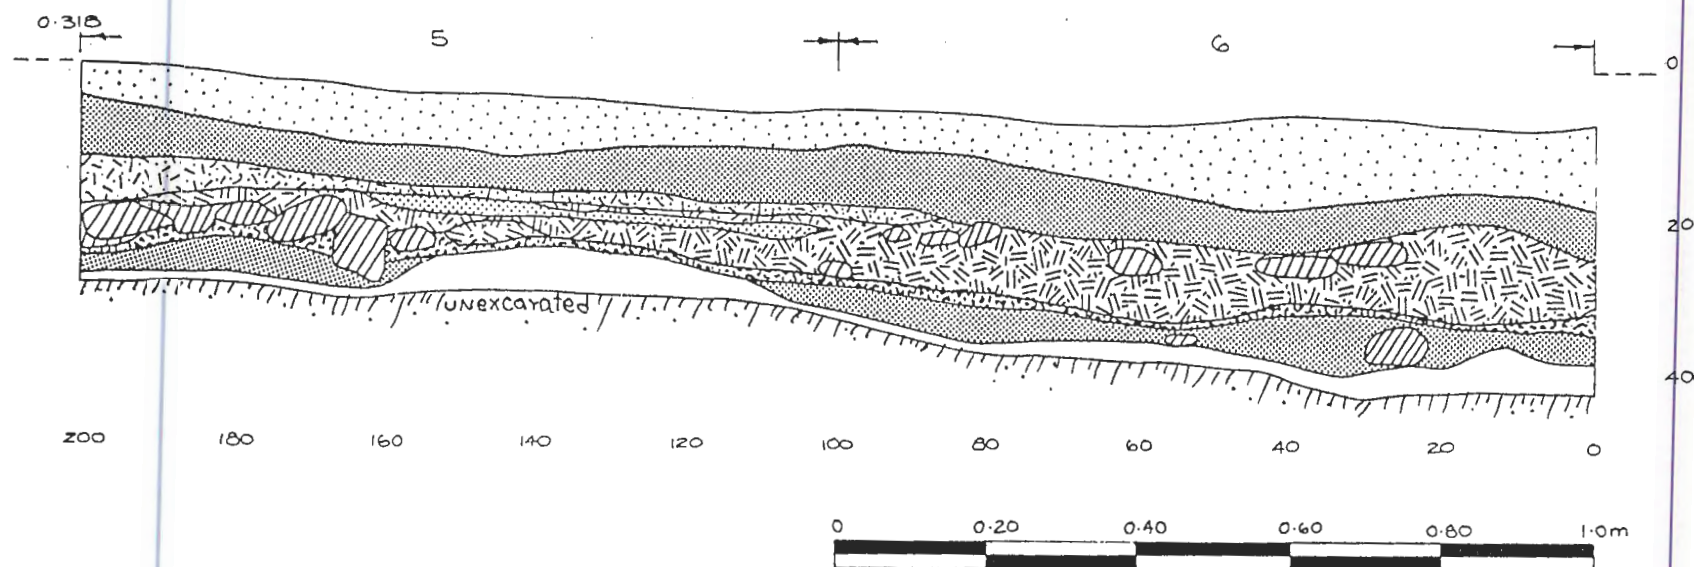
FIGURE 15 Cross-section of excavation through Dump 1 showing concentration of building rubble and associated household refuse. Layers labelled clay, charcoal, and dark sand contain domestic artefacts.

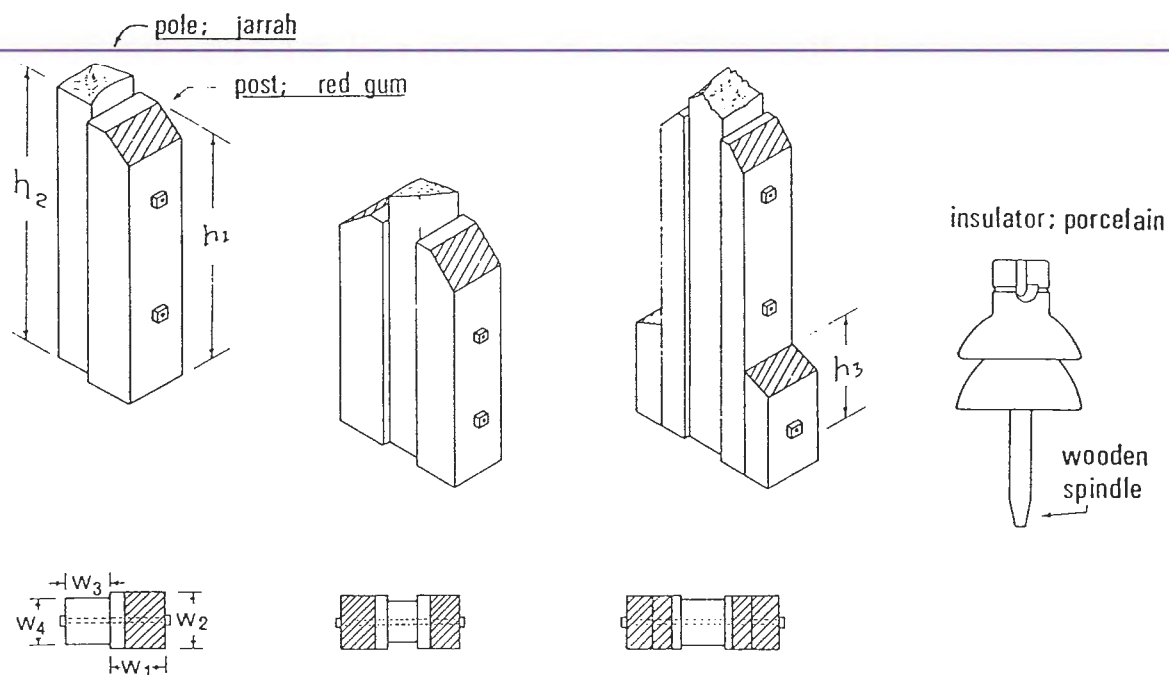
Field No.	Type A		Type B		Type C		Type	
	Post $h_1$	Pole $h_2$	Post $h_3$	Post $w_1$	Post $w_2$	Pole $w_3$	Pole $w_4$	Type
TG 1	950	950	-	190	205	155	165	A
TG 2	-	700*	-	-	-	170	180	A?
TG 3	900	910	-	195	205	145	150	A
TG 4	915	975	-	195	190	155	155	A
TG 5	830	850	-	195	190	150	145	A
TG 6	920	955	-	185	180	150	150	A
TG 7	730	740	-	200	195	150	140	A
TG 8	-	300	-	-	-	155	150	A
TG 9	64	645	-	195	180	145	150	A
TG10	930	300	-	-	200	-	-	A
TG11	1185	1240	380	100	200	155	176	C
TG12	-	-	-	100	180	170	-	B
TG13	790	835	-	190	195	155	155	A
TG14	-	-	-	190	195	155	155	B
TG15	550	-	-	100	200	-	-	-

TELEGRAPH POLE, POST, AND INSULATOR DESIGN  
AT CHINAMANS WELL

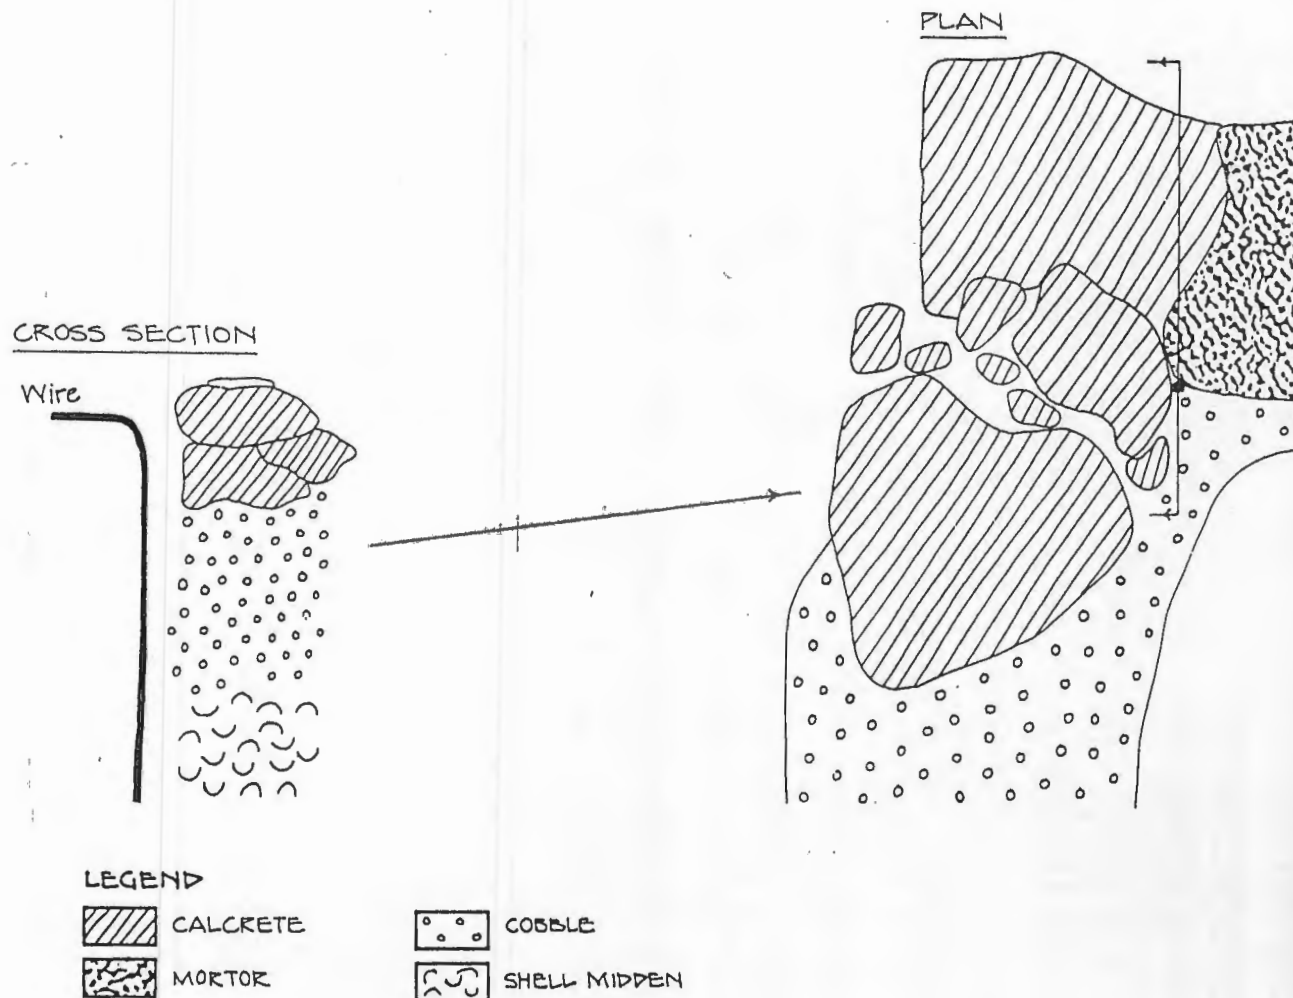
FIGURE Enlargement of northeast corner of Structure A showing construction details of masonry wall and wire fastener.

The remnants of Structure A consists of four foundation walls which form a square with outside dimensions measuring 3.0 x 3.1 m. Although all four corners of the structure are preserved and have been reinforced with additional masonry, a portion of the fourth wall is missing as a result of demolition. The structure is made from unmodified, naturally occurring calcrete boulders which are bonded by a lime-rich mortar to form solid walls 45 cm thick and two courses high through

out the extent of the ruin. Its upper edge appears to be intact and finished at the same elevation and the corner stones are roughly dressed. It was built on a rammed calcrete rubble base 25 cm thick which in turn was formed at the bottom of an excavation trench that cut some 40 cm into a shell-rich Aboriginal midden, referred to as HG 8 in the site plan. A thin layer of calcrete rubble with patches of pipeclay has been laid uniformly across the internal area of the structure at the same elevation as the upper edge of the masonry walls, presumably as a working surface or sub-floor weather seal. Discontinuity of this floor in the vicinity of the northern wall suggests that it, like the adjacent foundation wall, was also a victim of demolition. Heavy gauge wire attached at various points to the masonry fabric of the structure is probably designed to secure timber wall sections or possibly floor joists. A cross-section showing construction details of the foundation wall and the incorporation of a wire tie is depicted in Figure 21. There are no notches or other modifications to the foundation walls that could have supported a timber floor. There is a complete absence of masonry rubble around the structure, such as might occur from demolition, even if the calcrete were carefully salvaged for another building. This leads to the conclusion that the above-ground fabric of Structure A did not include stonework and was most probably timber or a similar light weight material.

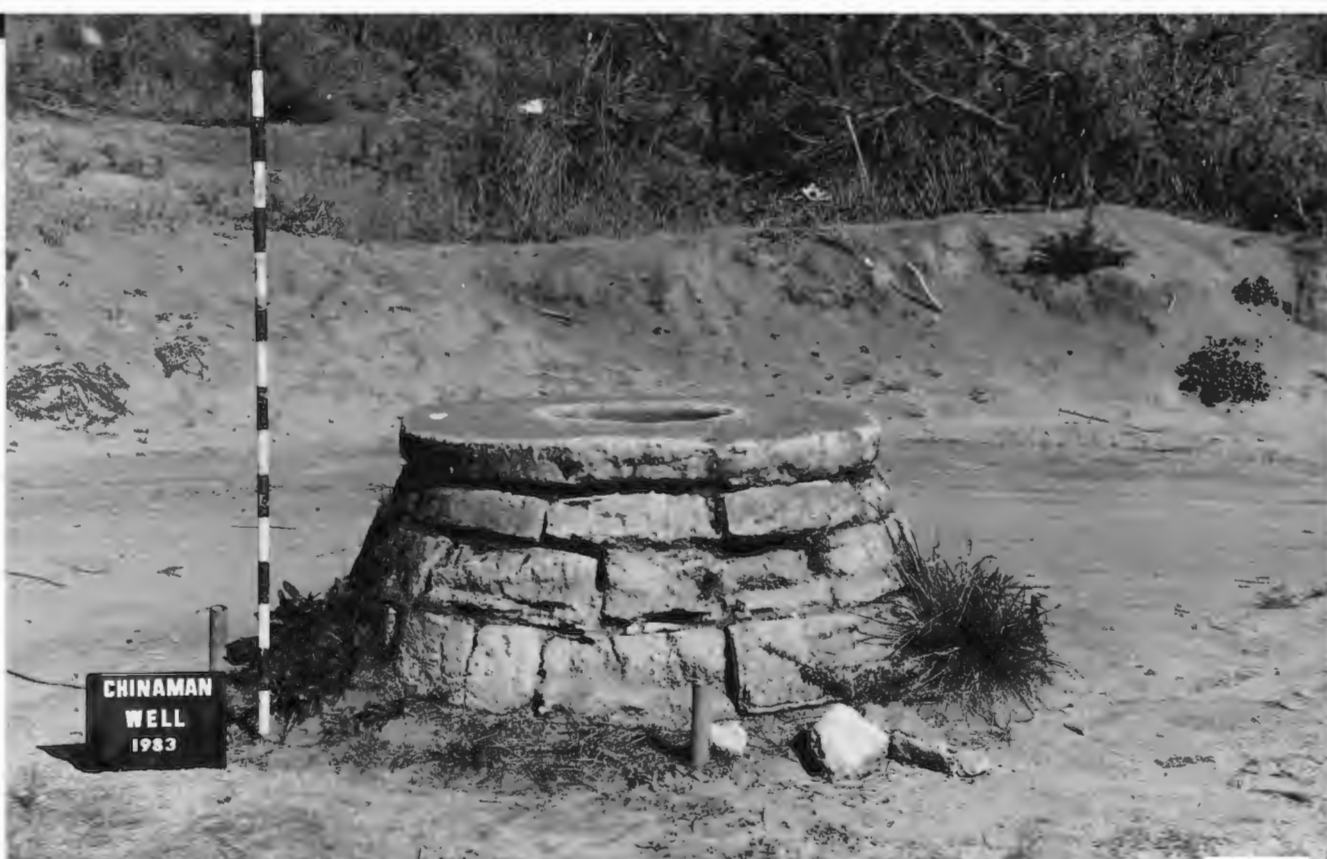
6824-10253 LIMESTONE WELL, CHINAMAN'S WELL HISTORIC SITE,  
COORONG NATIONAL PARK (RL)

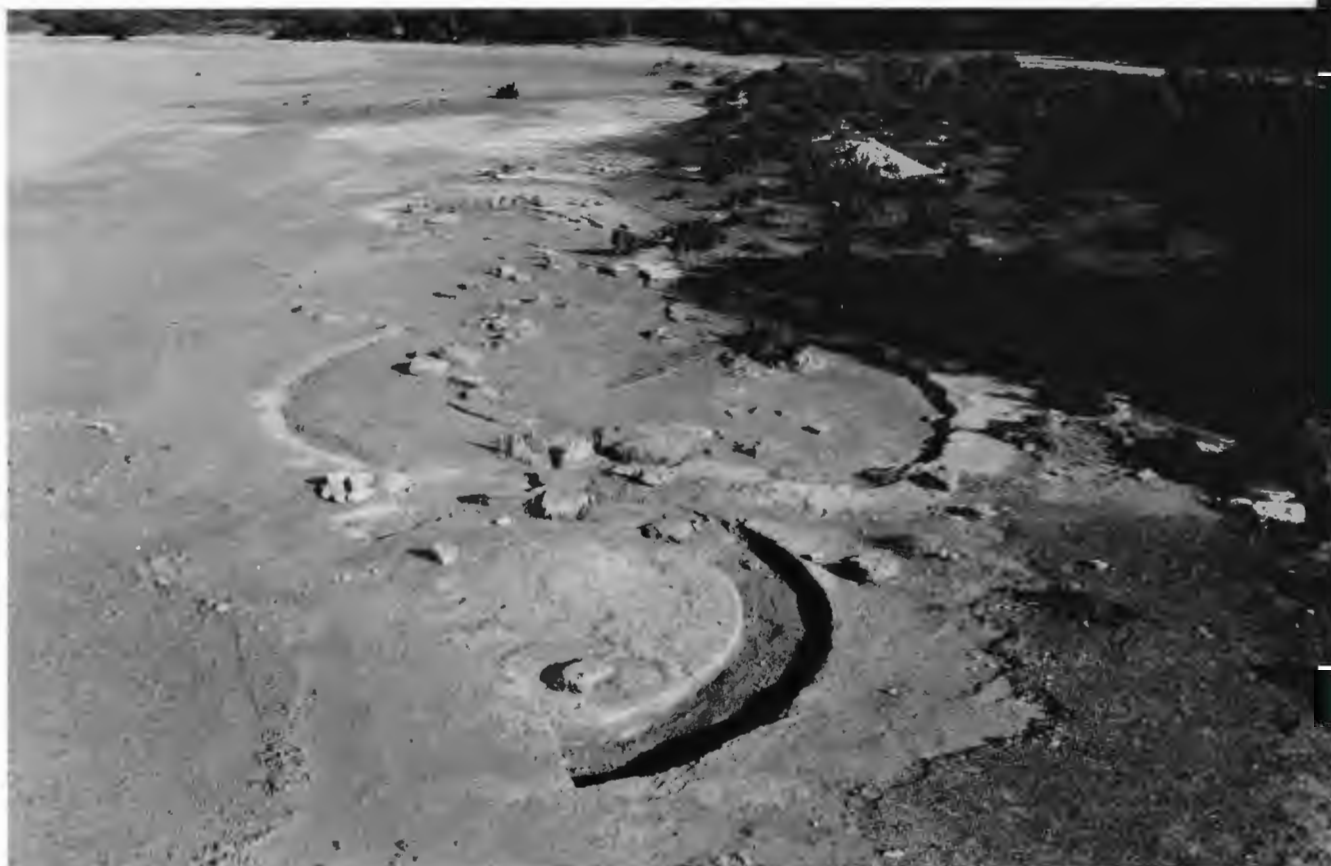
6824-10253 STONE QUARRY, WESTERN SHORE OF SALT LAKE, CHINAMAN'S  
WELL HISTORIC SITE, COORONG NATIONAL PARK, LOOKING SOUTH (RL)
