HERITAGE SURVEY ITEM IDENTIFICATION SHEET

PROJECT
HERITAGE SURVEY REGION 8

Item Ref. No. 49

ITEM NAME: Farm Complex
Former or other Andreas & Auguste Doecke Farm

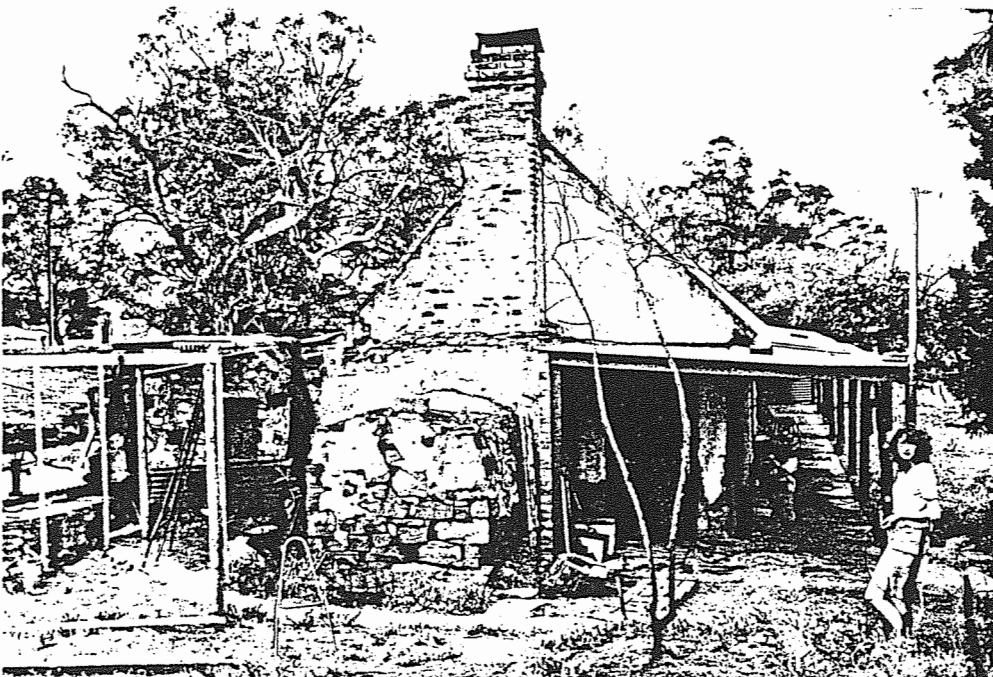
PHOTOGRAPH Film No. 576 Negative No. 3
Direction of view to S

In 1851 Andreas and Auguste Doecke joined the Wendish migration from Germany to S.A. In 1854 they bought land alongside a permanent spring in the St. Kitts Creek and in 1855-56 built the house, which survives (still occupied). The house is a typical long Wendish building of pug and pine construction. (It is still owned by the Doecke family).

"The main framework was built of split logs, after which clay mixed with 'Cocky chaff' was applied to the inside and outside of the walls, smoothed off and then whitewashed. Andreas would arise very early in the morning...cross the creek and carry the wet mud back to the building site by wheel barrow. The clay had to be applied before the heat of the day dried it out." The rear lean-to pug and pine section was added later, as was the verandah. There is also an attached bake-oven.

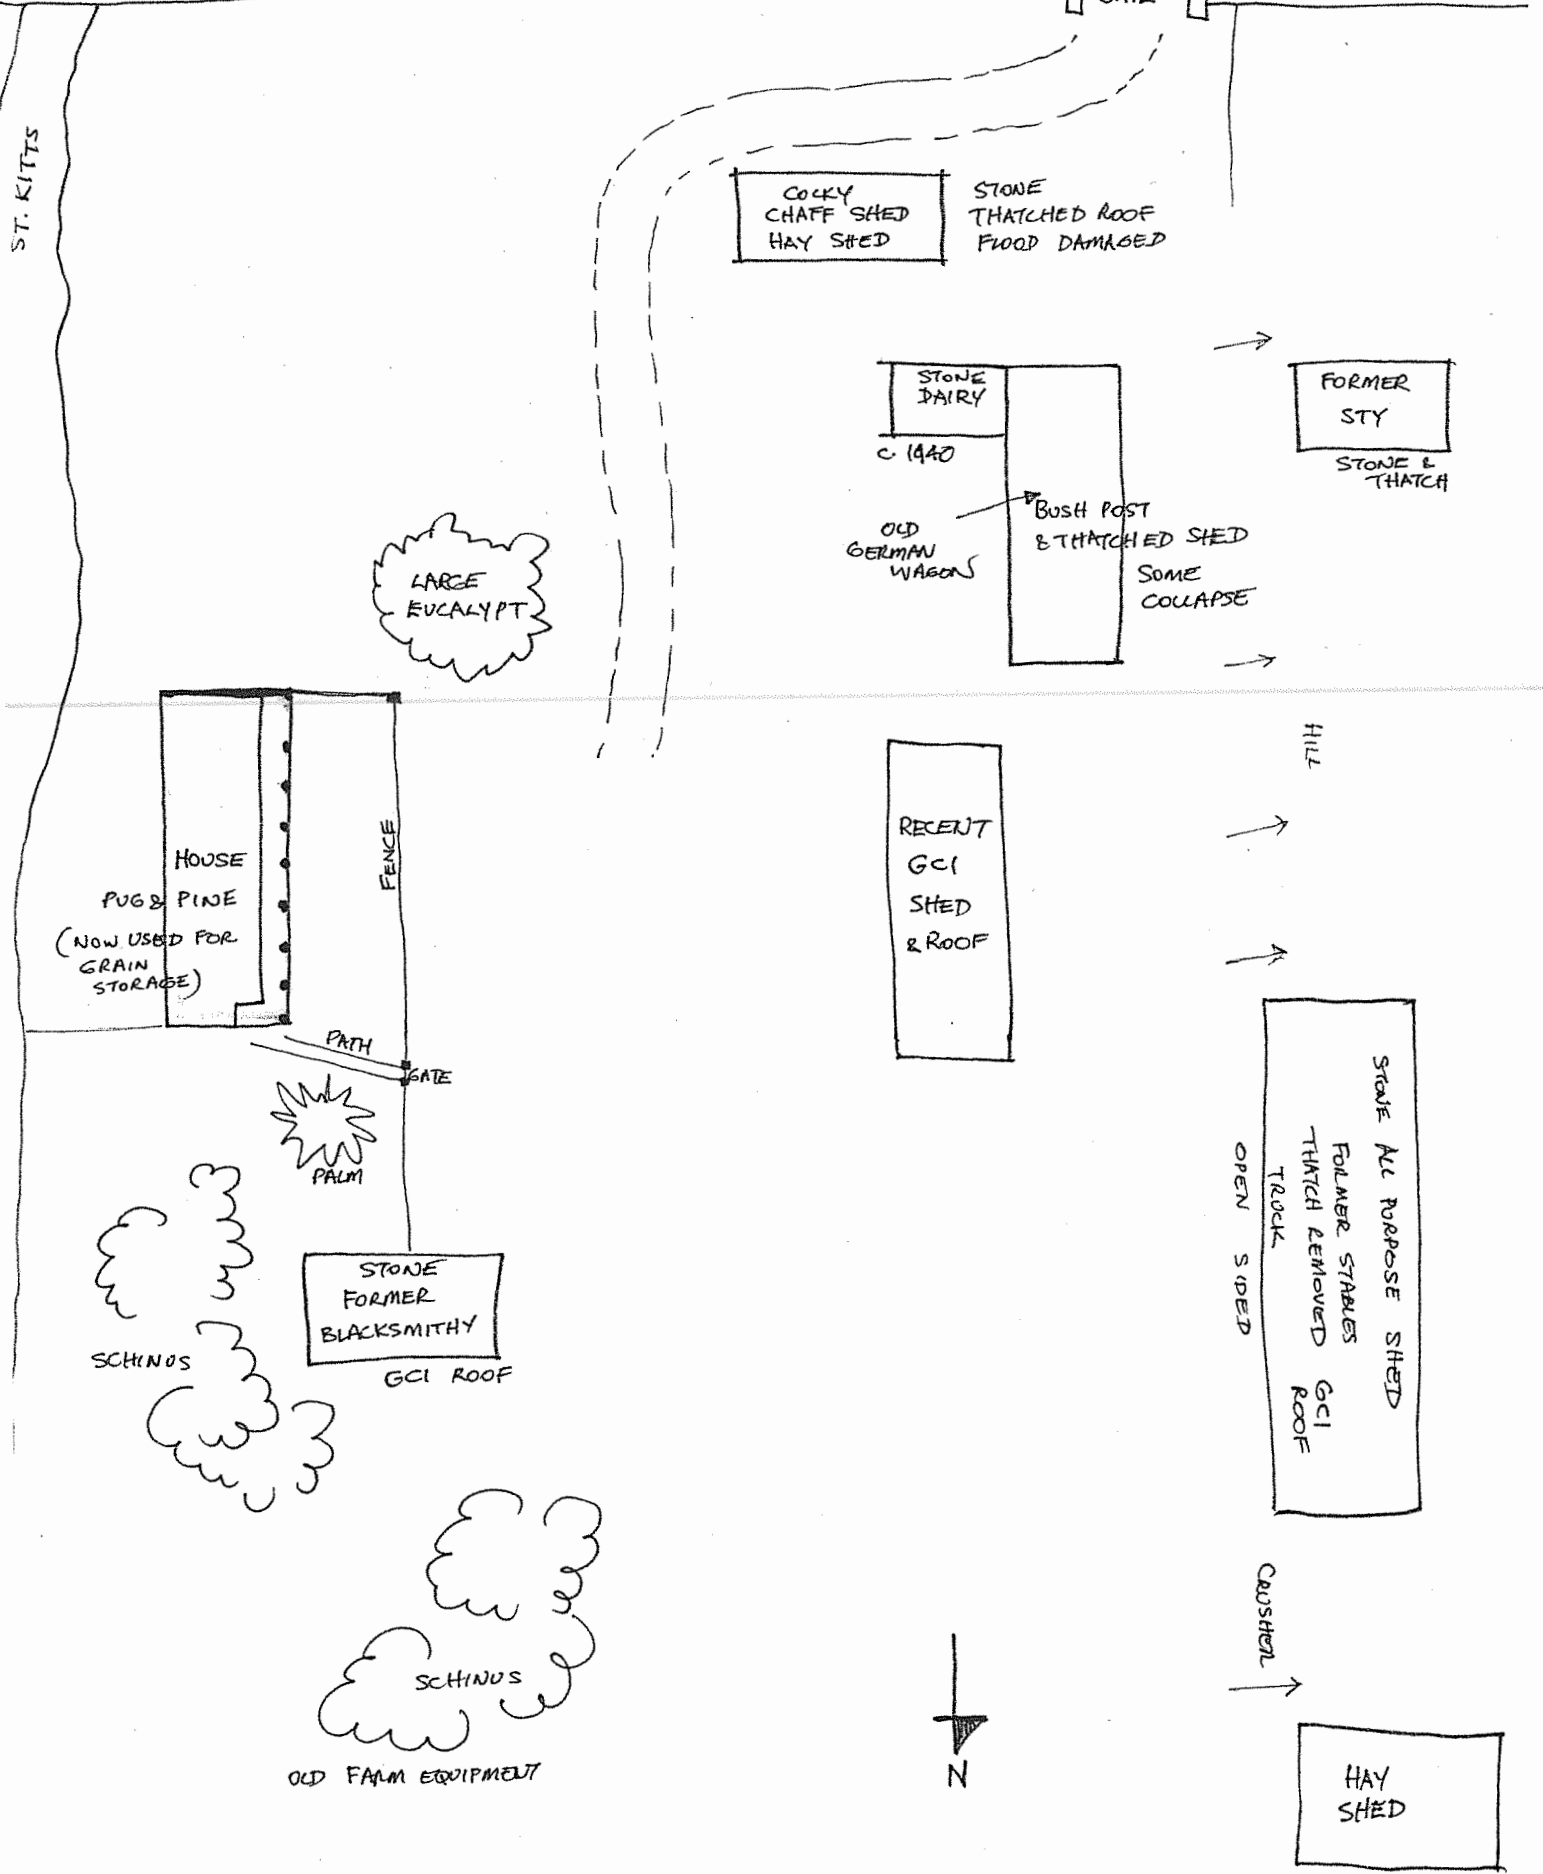
MAIN GROOP OF BUILDINGS
'SPRINGVALE' ST. KITTS
7 DEC. 1993

COCKY CHAFF SHED
HAY SHED

STONE THATCHED ROOF
FLOOD DAMAGED

STONE DAIRY
c 1940

FORMER STY
STONE & THATCH

BUSH POST & THATCHED SHED
SOME COLLAPSE
OLD GERMAN WAGON

HOUSE
PUG & PINE
(NOW USED FOR GRAIN STORAGE)

STONE FORMER BLACKSMITHY
GCI ROOF

FORMER STABLES
THATCH REMOVED
GCI ROOF
OPEN SIDED
TRUCK
