River Blackfish in Rodwell Creek, 2012-13 update

June 2013

Report to the Goolwa to Wellington LAP and South Australian Murray-Darling Basin NRM Board

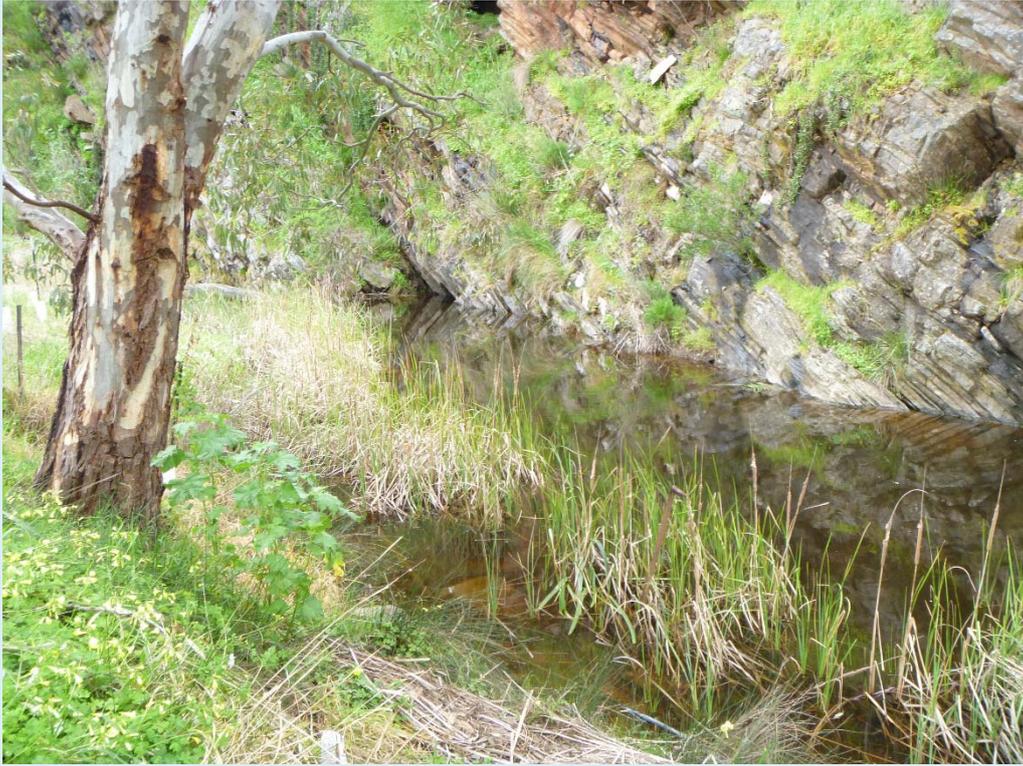
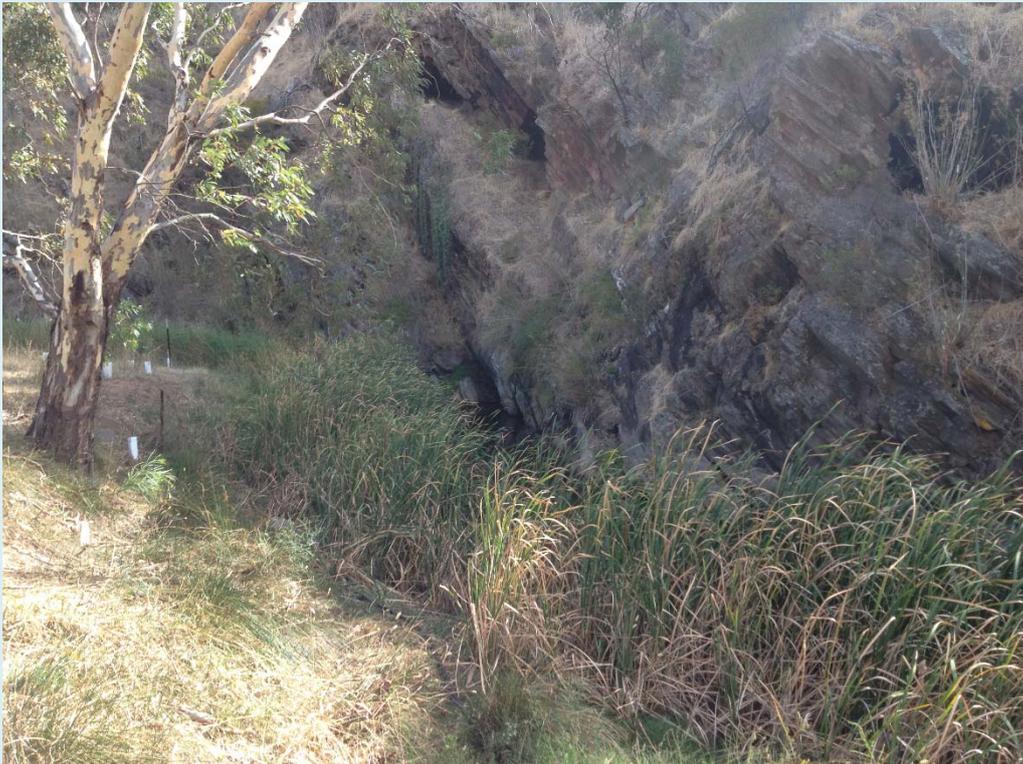
Cover photos Changes in the condition of the main pool on Rodwell Creek between October 2012 (top) and March 2013 (bottom).
