Conservation and Management of River Blackfish in Rodwell Creek, 2011-12

Nick Whiterod & Michael Hammer

Aquasave Consultants, Adelaide

June 2012

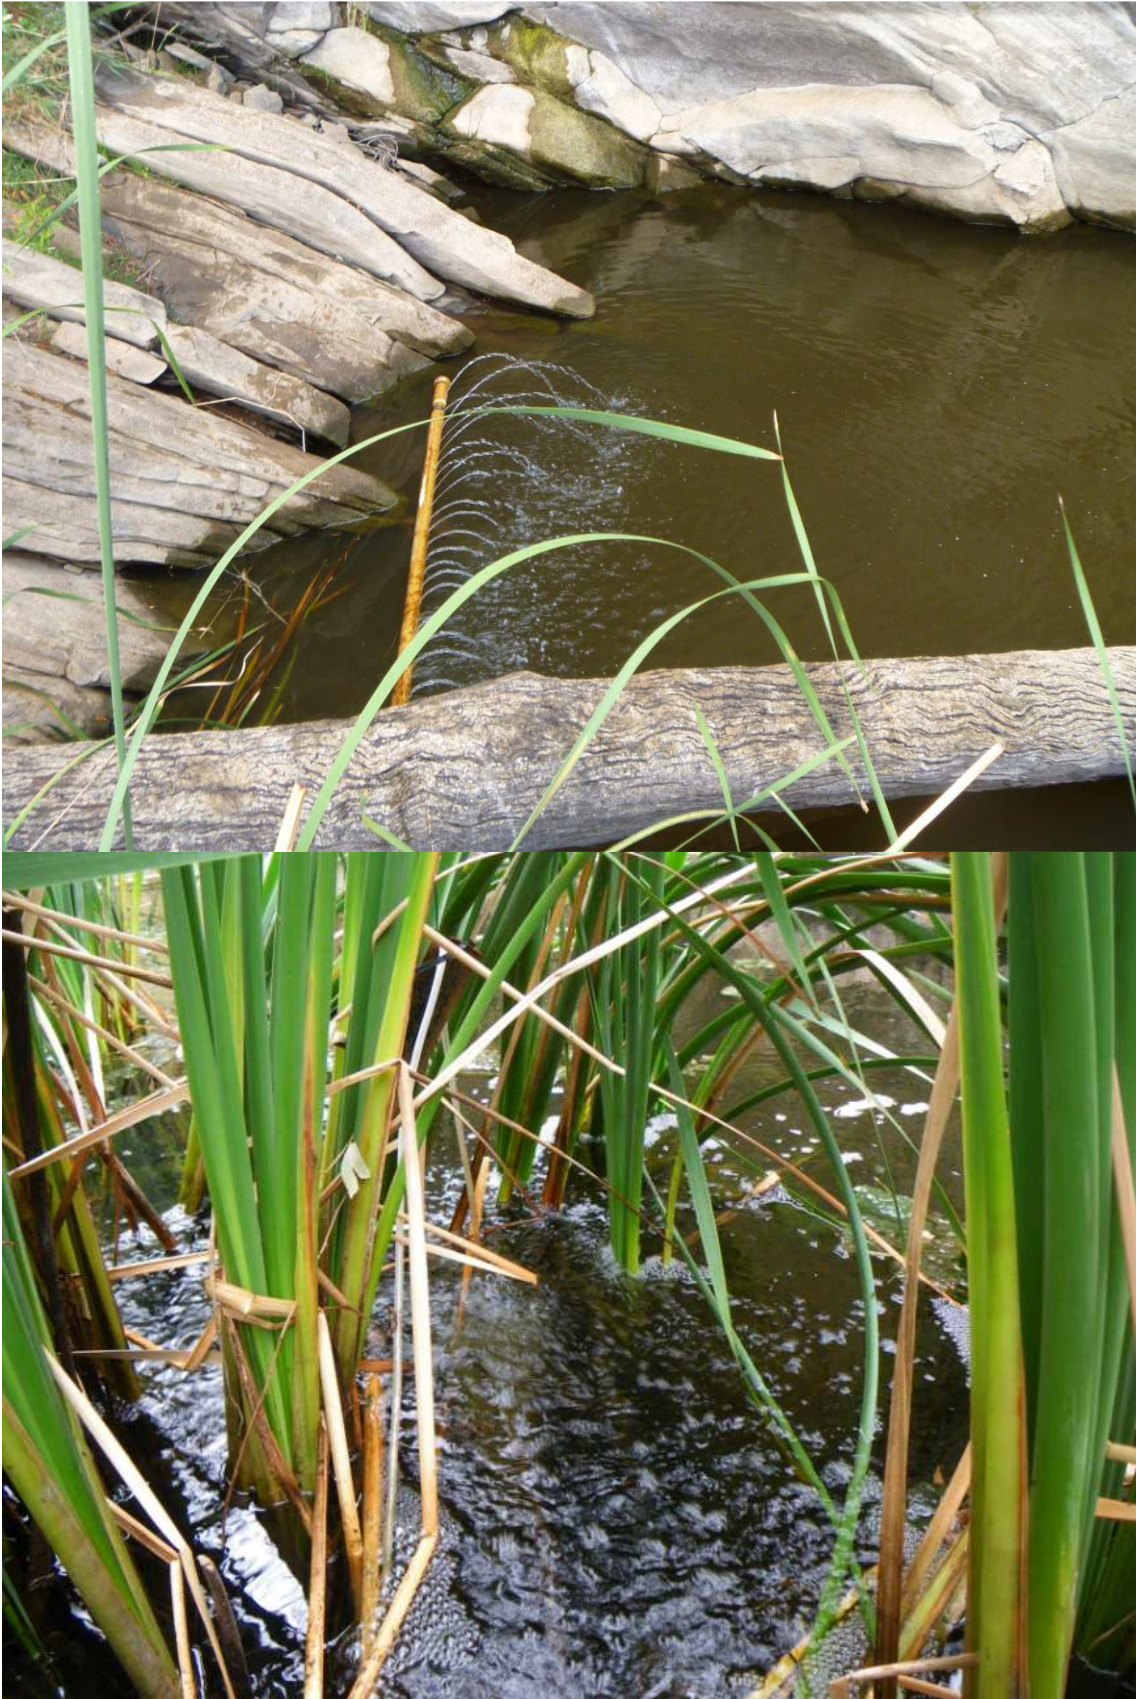
Summary of the management inventions at Rodwell Creek: environmental watering (top) and aeration (bottom).

Management intervention of the main pool was initiated when prevailing conditions reached alarm thresholds and involved aeration and environmental watering using pre-existing infrastructure and emergency fish transference (Hammer 2010). Environmental water is gravity fed from two rainwater tanks (total volume 30000L) via a spray bar at the top of the pool to reduce velocity and increase aeration. A water tanker delivers bore water with suitable water chemistry (low salinity, sulphides, and trace metals) to the rainwater tanks via a commercial supply. An aeration system was developed via a commercial pond aerator (Pond One 12000, 6600L hour⁻¹) located at the property residence and piped to the pool some 400m through 12mm poly pipe carefully trenched and configured to avoid damage during property maintenance and by natural means. Delivery to the pond was to three large airstones at 0.5m depth tide to star pickets.

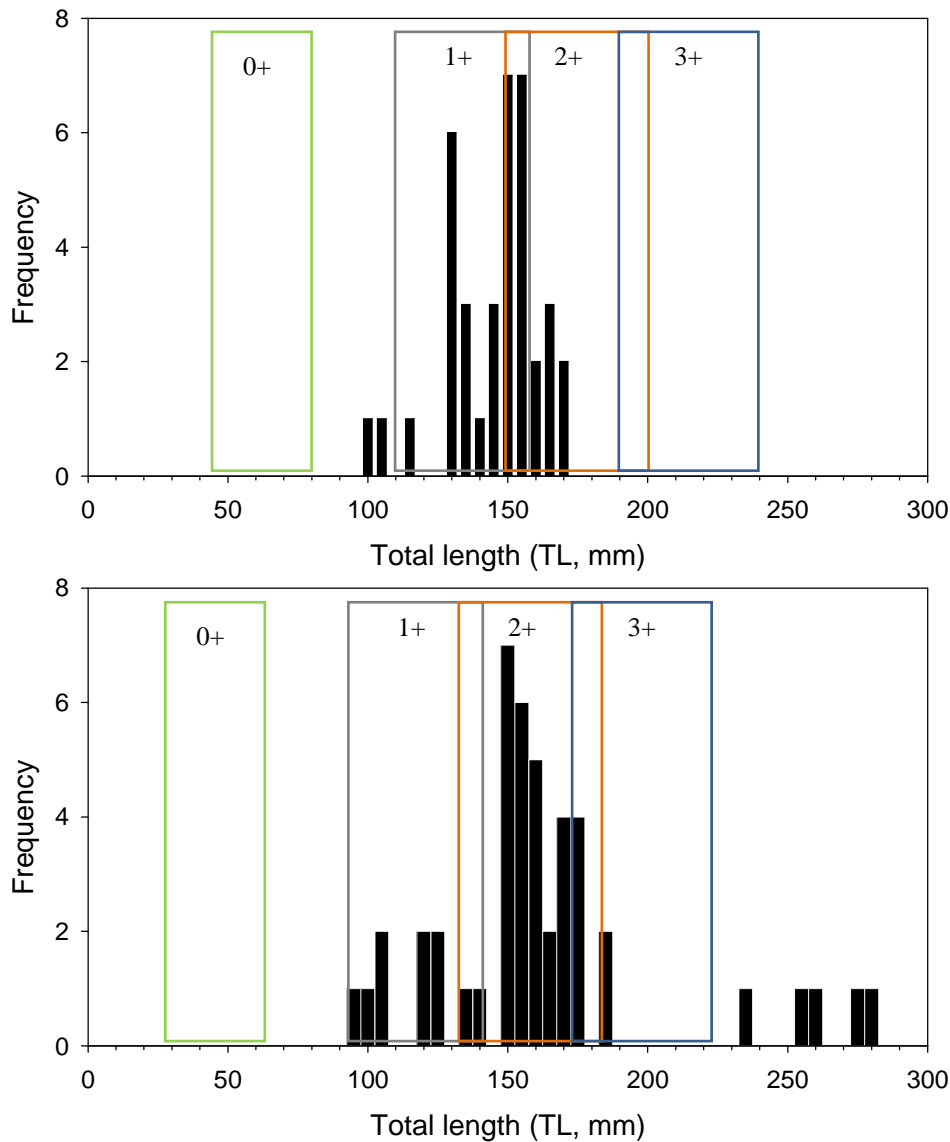
Figure 4 Length-frequency distribution of River Blackfish in pool 3 (top) and pool 6 (bottom) of Rodwell Creek during October 2011.

Figure 4 shows the length-frequency distribution of individuals sampled from pool 3 and 6 overlaid with the size ranges for age classes (up to 3 years old) obtained from the River Blackfish EMLR population model of Hammer (2006). Pools 3 and 6 contained mid-sized individuals (e.g. 1+ and 2+ fish) with pool 6 also containing older individuals (e.g. >3+ fish). The absence of individuals below 98mm in these pools indicates a lack of recent recruitment,

yet four of the seven individuals collected from the main pool were clearly new recruits (e.g. 42-75mm).

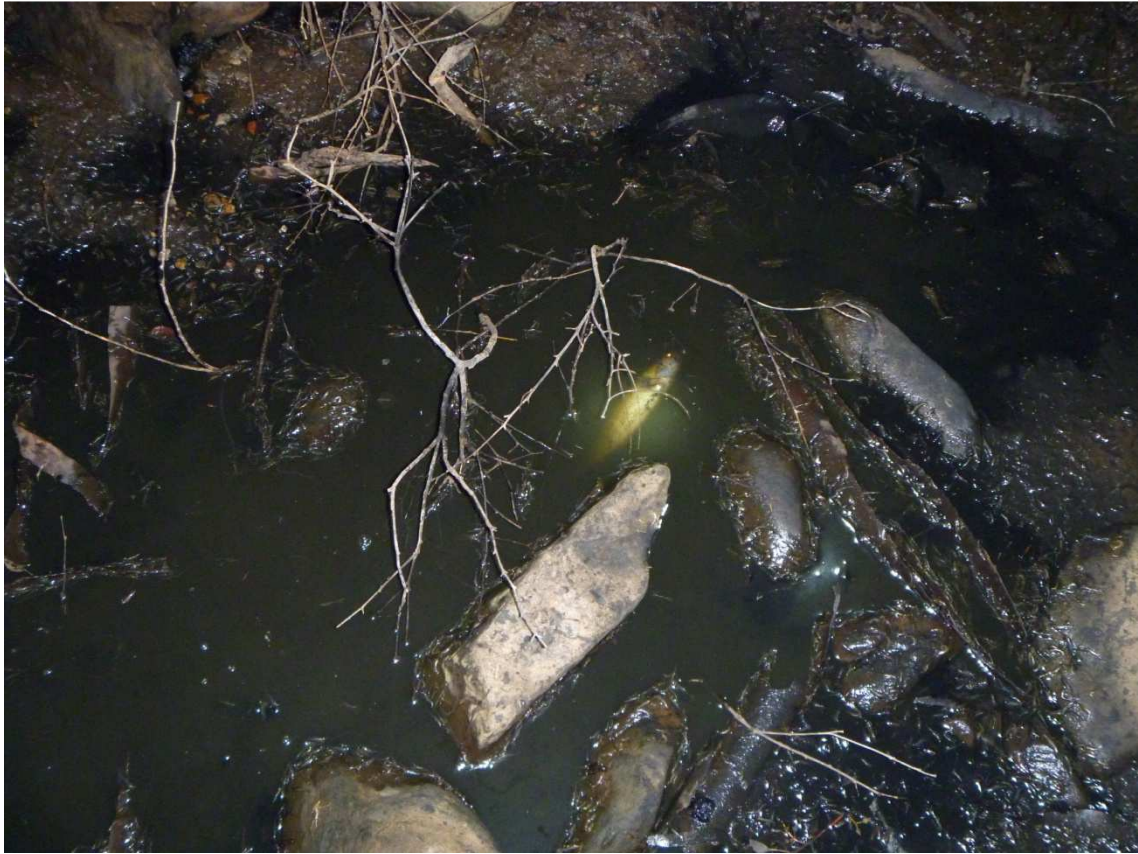
The severe deterioration of pool 6 on Rodwell Creek showing dead River Blackfish spotlighted.

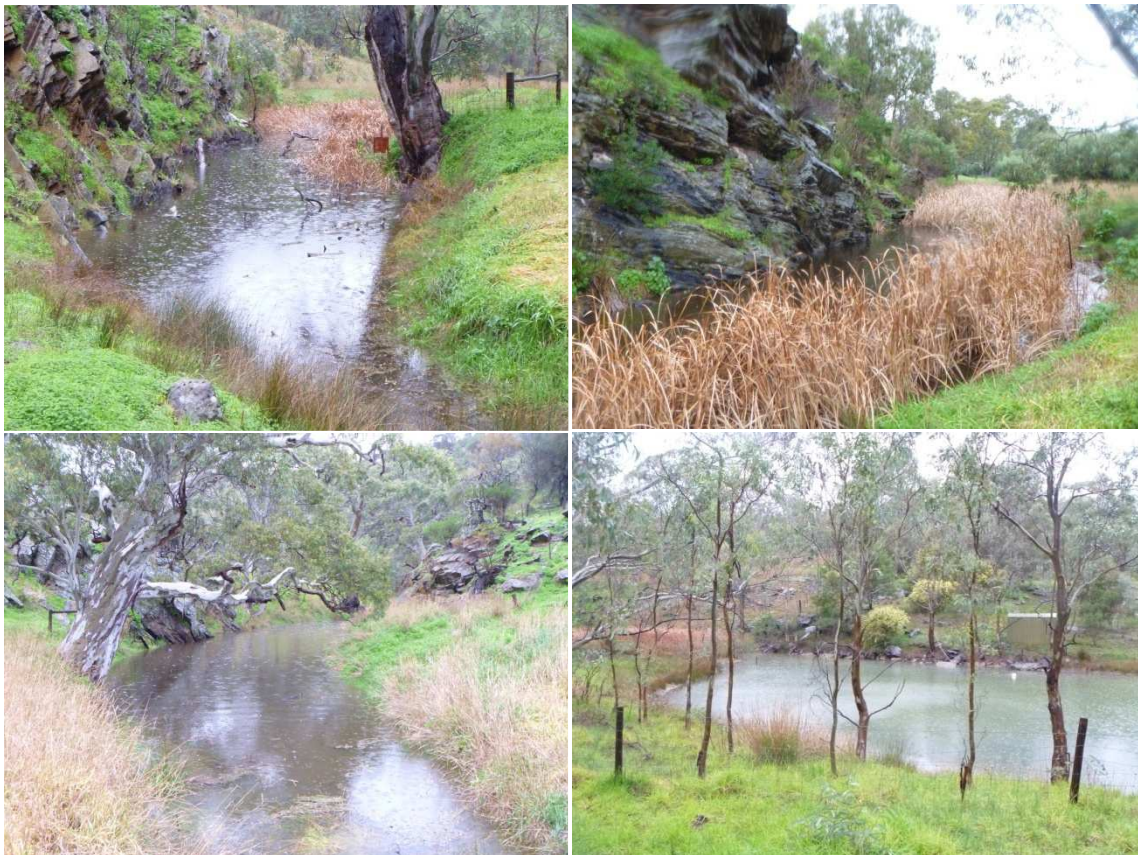
Status of pool 1 (top left), main pool (top right), pool 6 (bottom left) and the refuge pool (pool 16, bottom right) on Rodwell Creek in June 2012.

contrast to the main pool, the condition of the unmanaged pools (1, 3, 4, 5, 6) continued to decline over the critical period and by April 2012 conditions in pools 1, 4, 5, and 6 had collapsed. Indeed, pool 6 was almost dry and several dead River Blackfish were observed in the shallow, low DO and algal rich waters of pool 6 during fish monitoring in April 2012. Encouragingly, adequate conditions in pool 3 were maintained across the critical period. By June 2012, cooler weather and periods of high rainfall, and resultant creek flow, have acted to reset all pools in the section of Rodwell Creek with the main pool depth (1.76m), DO (7.5mgL⁻¹) and EC (4.0 mScm⁻¹) all at suitable levels.
