## Monitoring and Assessment of Reflooded Acid Sulfate Soil Materials in Currency Creek and Finniss River Region, South Australia

May 2011

Prepared for: Department of Environment and Natural Resources (DENR)  
Murray Futures Lower Lakes & Coorong Recovery Acid Sulfate Soils Research Program

Project Report Number R-325-8-6

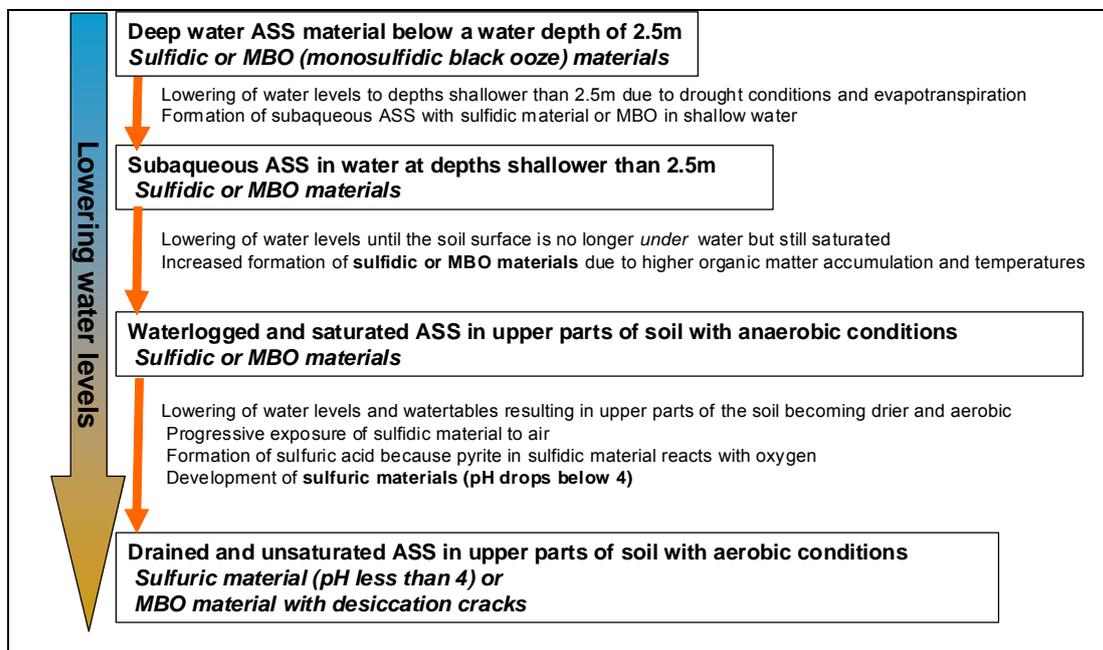
Figure 1-2: Generalised conceptual model showing the sequential transformation of four classes of acid sulfate soil due to lowering of water levels (from Fitzpatrick *et al.* 2008a,b,d).

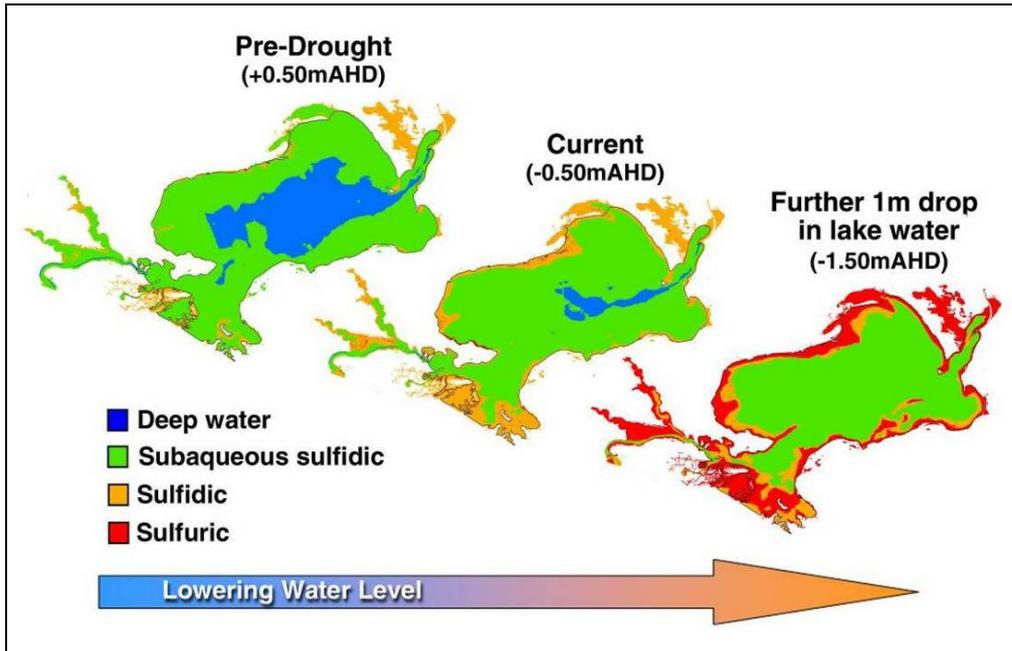
Figure 1-3: Predictive scenario maps depicting changes in acid sulfate soil materials at different water levels in Lake Alexandrina (+0.5 m AHD, -0.5 m AHD and -1.5 m AHD) from Fitzpatrick *et al.* (2008a,b,d; 2009c). Finniss River, Currency Creek and Goolwa Channel are the three extensions occurring on the left side of Lake Alexandrina.

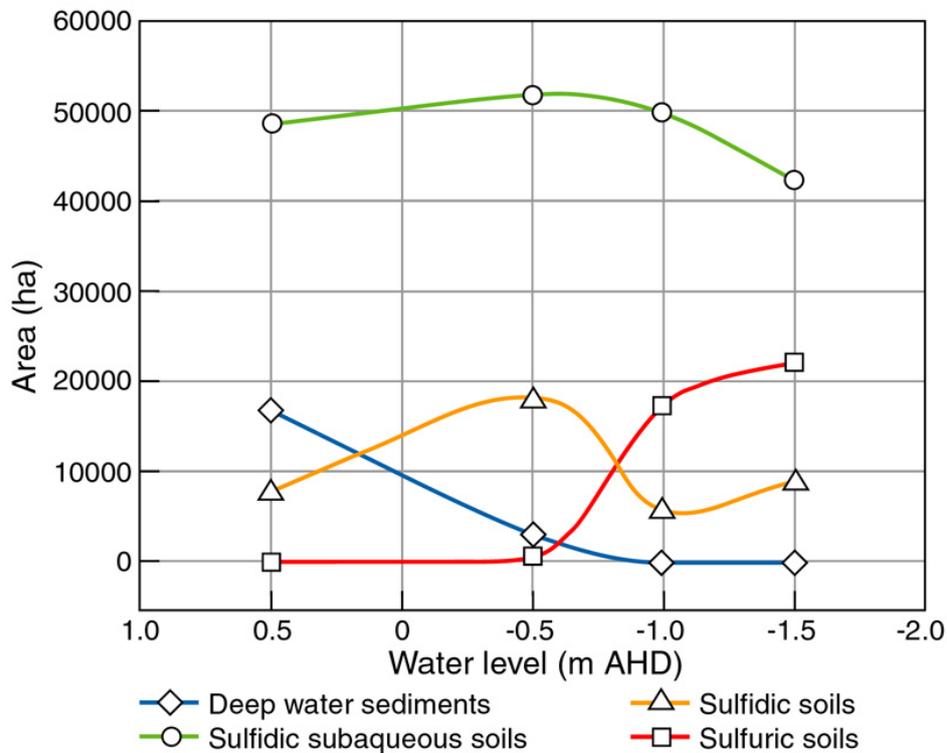
Figure 1-4: Graphic depiction of scenario changes in ASS material aerial extents at different water levels in Lake Alexandrina (+0.5 m AHD, -0.5 m AHD and -1.5 m AHD) from Fitzpatrick *et al.* (2008a,b,d; 2009c).

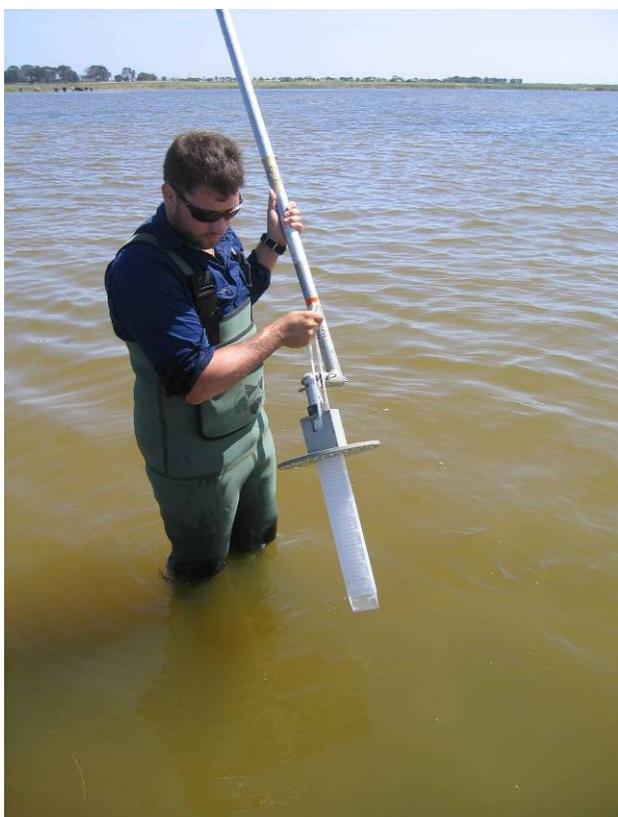
Figure 2-1. Soil pore water sampler (white plastic with 36 cells) carefully pushed into the sediment to a set depth.

On retrieval, the exterior of the cells' membrane was cleaned with a jet of deionised water from a spray bottle. A syringe was then used to pierce the membrane and extract the solution which was rapidly placed into pre-labelled vials and placed on ice to be transported to the laboratory for testing.

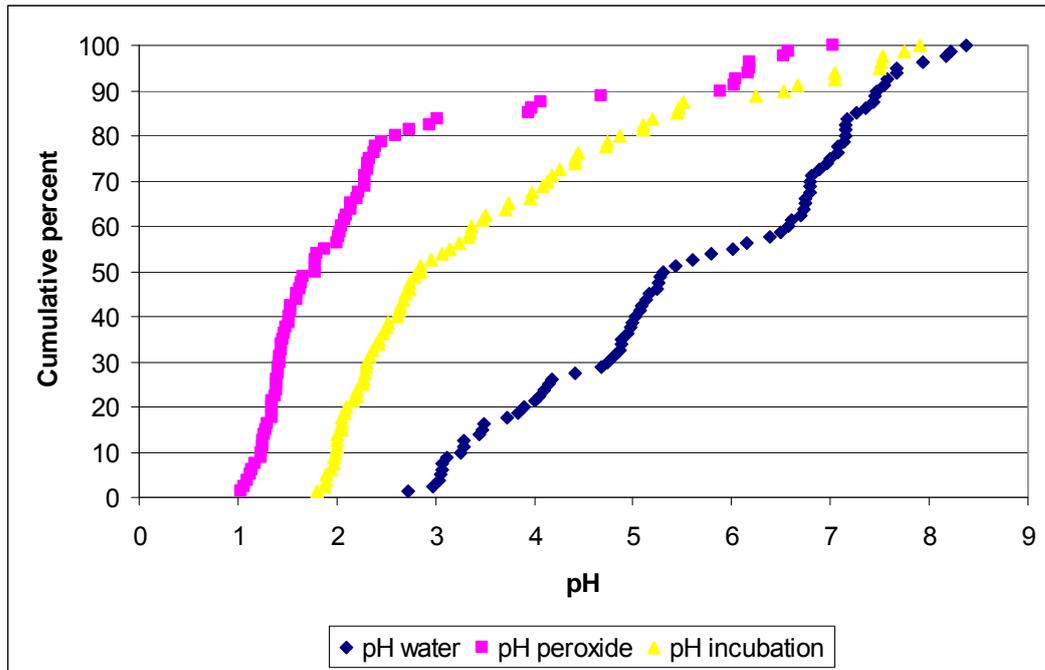
Figure 3-2. pH data results plotted as a cumulative percentage.

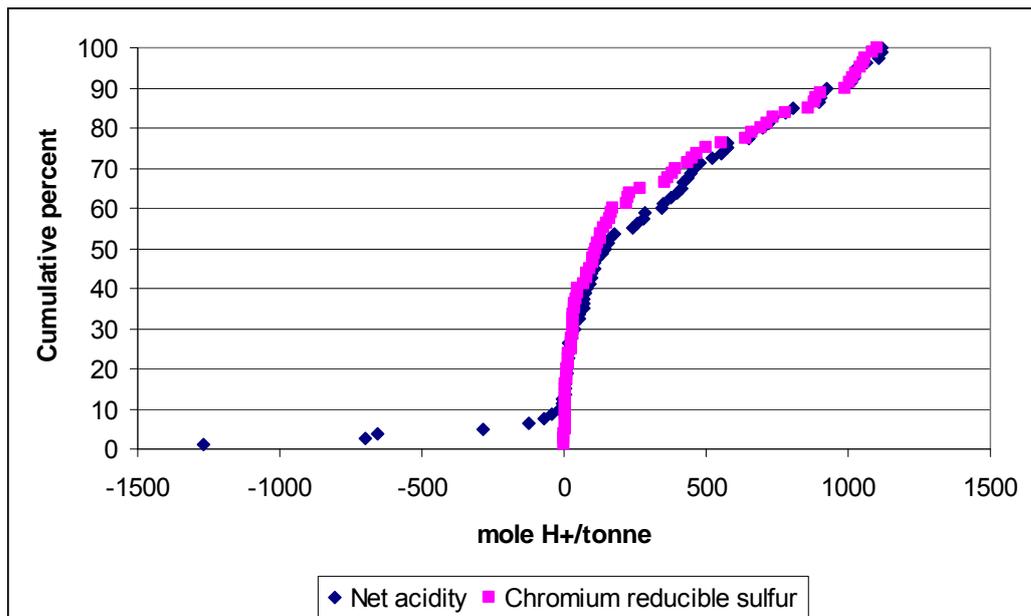
Figure 3-3. All net acidity and chromium reducible sulfur results plotted as a cumulative percentage.

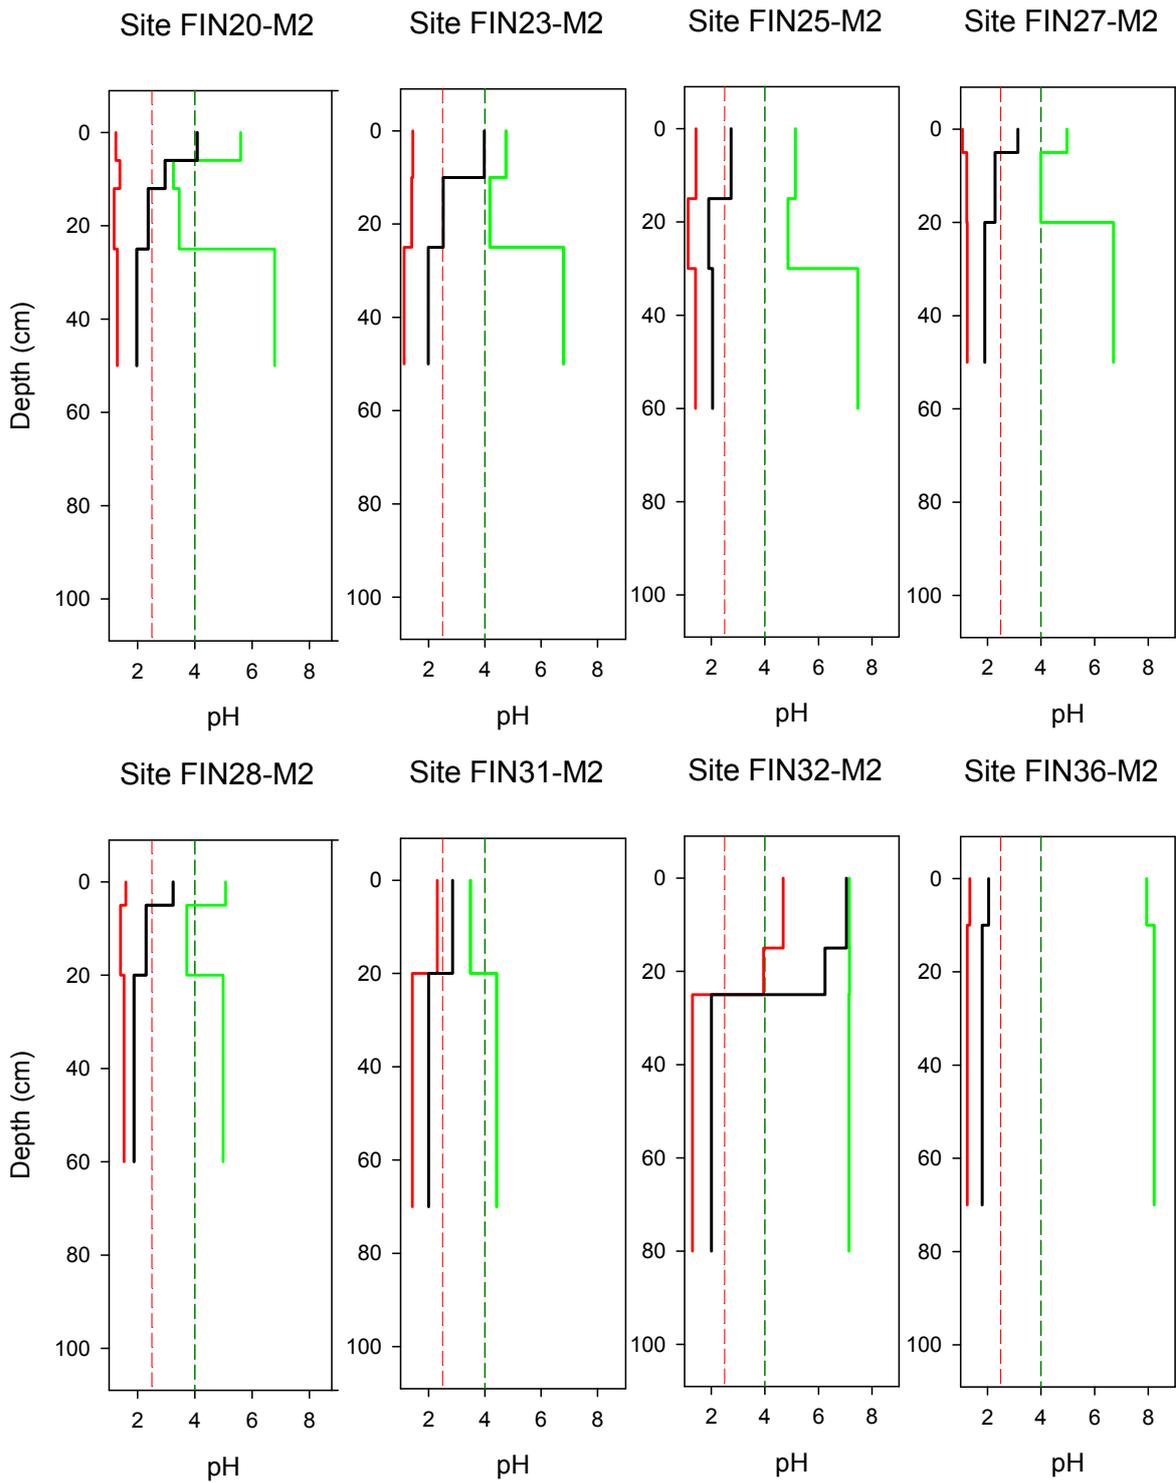
Figure 3-4. Finnis River pH depth profiles.

Showing soil pH ( $pH_W$  as green line), peroxide treated pH ( $pH_{OX}$  as red line) and ageing pH ( $pH_{incubation}$  after 9 weeks as black line). Critical  $pH_W$  and  $pH_{incubation}$  value of 4 (black dashed line) and critical  $pH_{OX}$  value of 2.5 (red dashed line).

Chip tray soil samples were aged and measured for pH after nine weeks of incubation. The  $\text{pH}_{\text{incubation}}$  values ranged from 1.02 (FC1019 surface scrape) to 8.40 (CUR16 60-65 cm). Fifty-six of the 80 samples (70%) from 23 soil profiles, dropped to  $\text{pH}_{\text{incubation}}$  below 4.0. Samples occurred throughout the soil profiles.

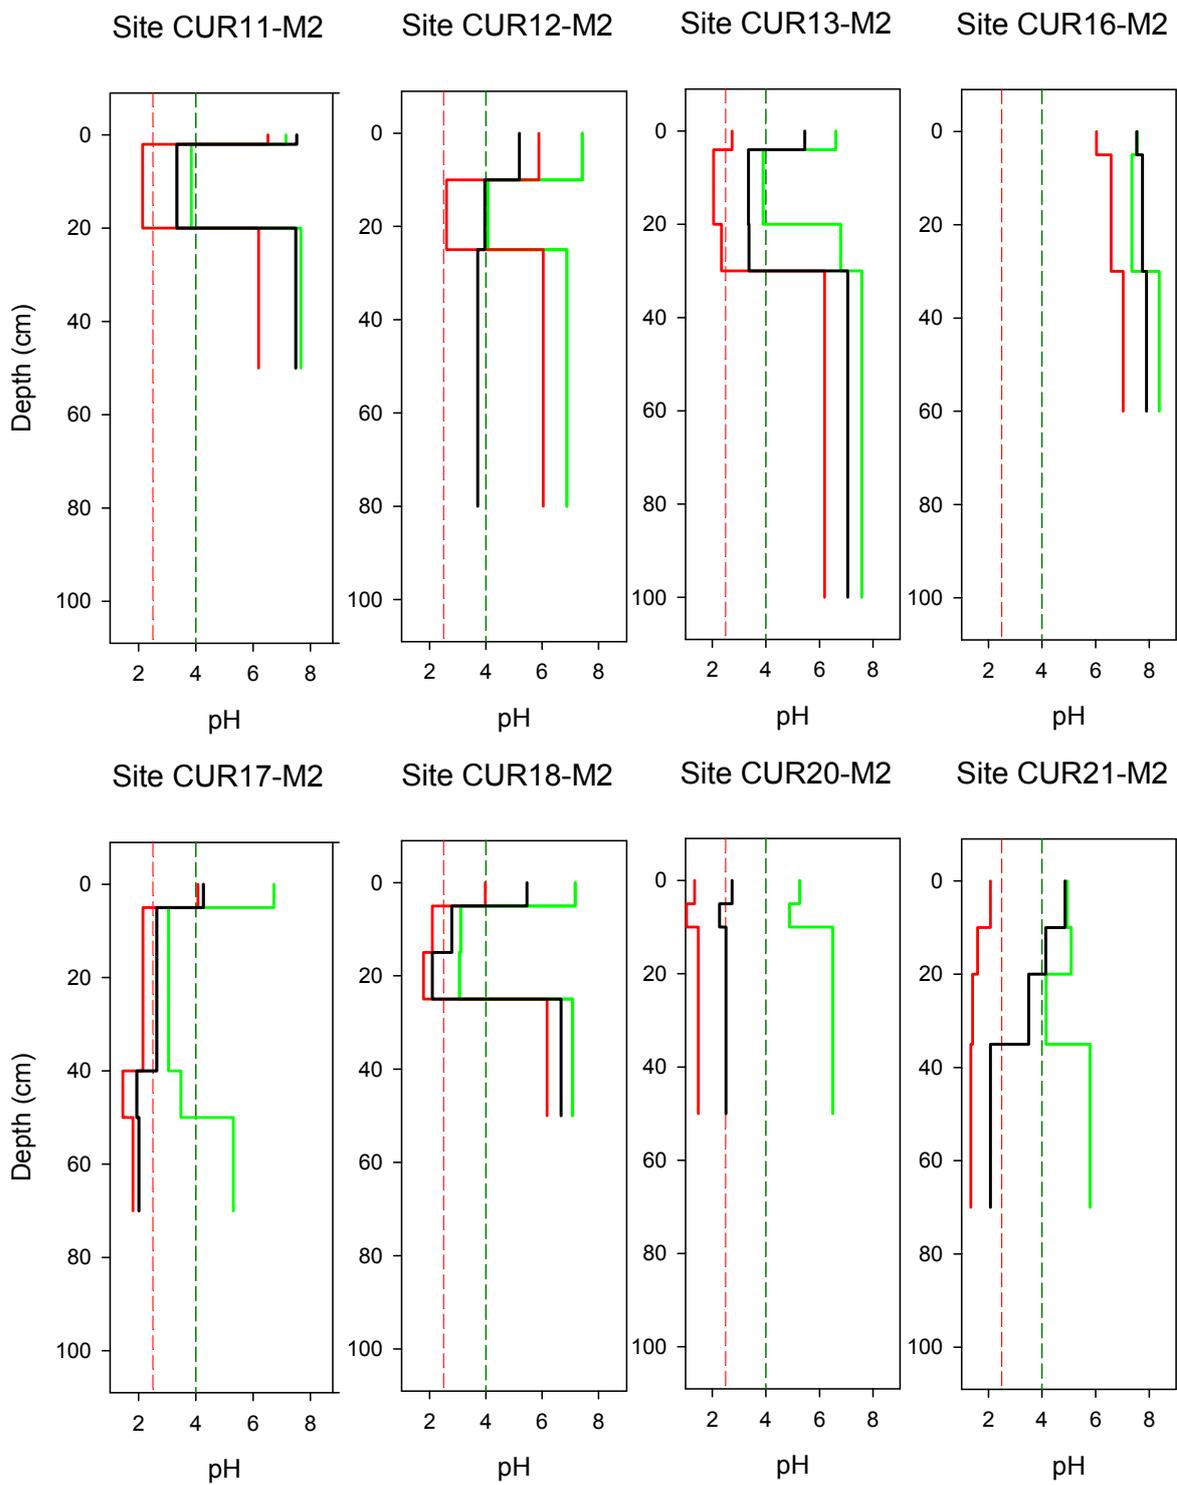
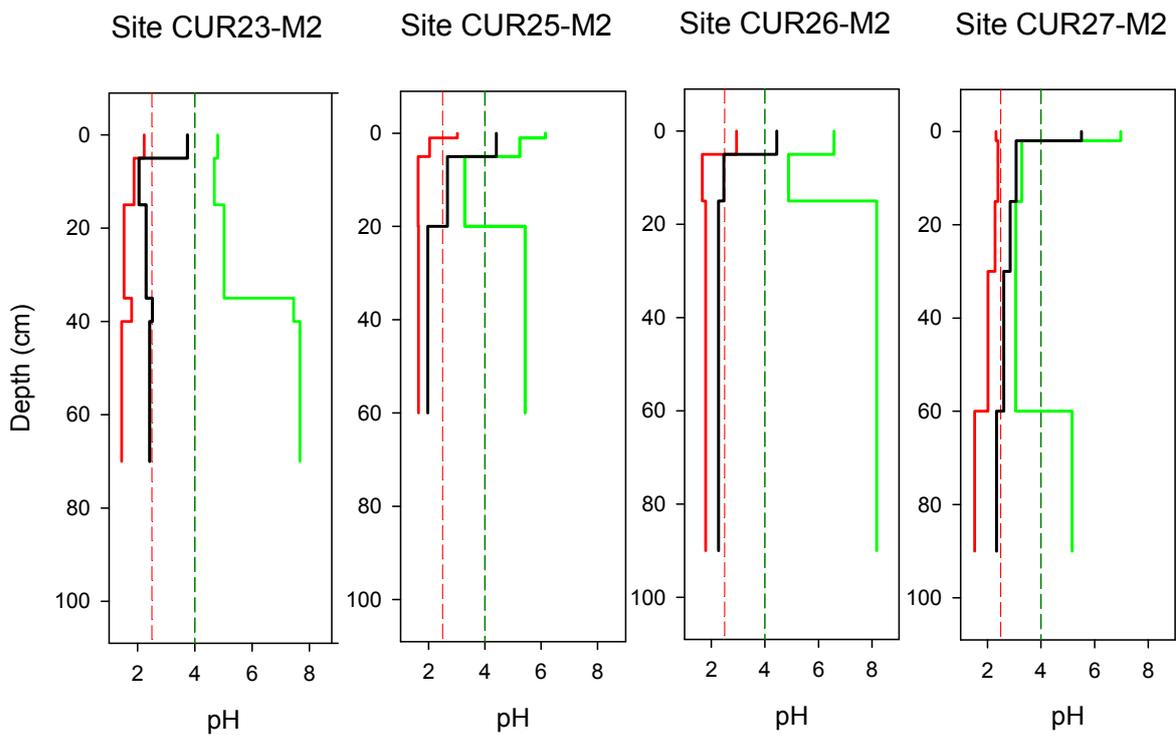
Figure 3-5. Currency Creek pH depth profiles.

Showing soil pH ( $pH_W$  as green line), peroxide treated pH ( $pH_{OX}$  as red line) and ageing pH ( $pH_{incubation}$  after 9 weeks as black line). Critical  $pH_W$  and  $pH_{incubation}$  value of 4 (black dashed line) and critical  $pH_{OX}$  value of 2.5 (red dashed line).

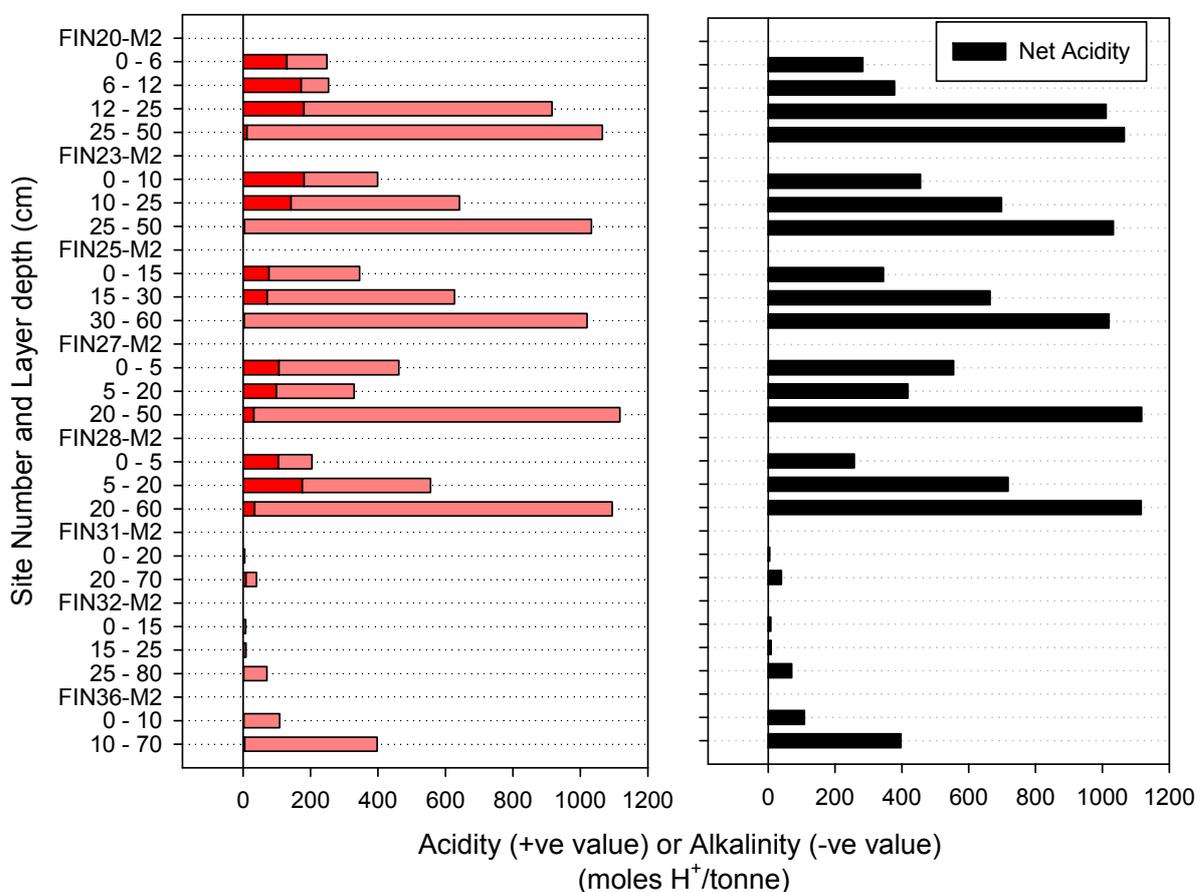
Figure 3-7. Finniss River depth profiles of Net Acidity (NA) shown on the right. The left side shows the components TAA (red bar), AGP as S<sub>CR</sub> (pink bar).

The net acidity values ranged from -1271 (CUR11 20-50cm) to 1117 (FIN27 20-50cm) moles  $H^+$ /tonne. Seventy of the 80 samples (88%) had a positive net acidity. Ten samples had a negative net acidity indicating where there was excess acid neutralising capacity. All of these samples occurred in the Currency Creek area and at different depth ranges that included surface and deep subsoil layers.

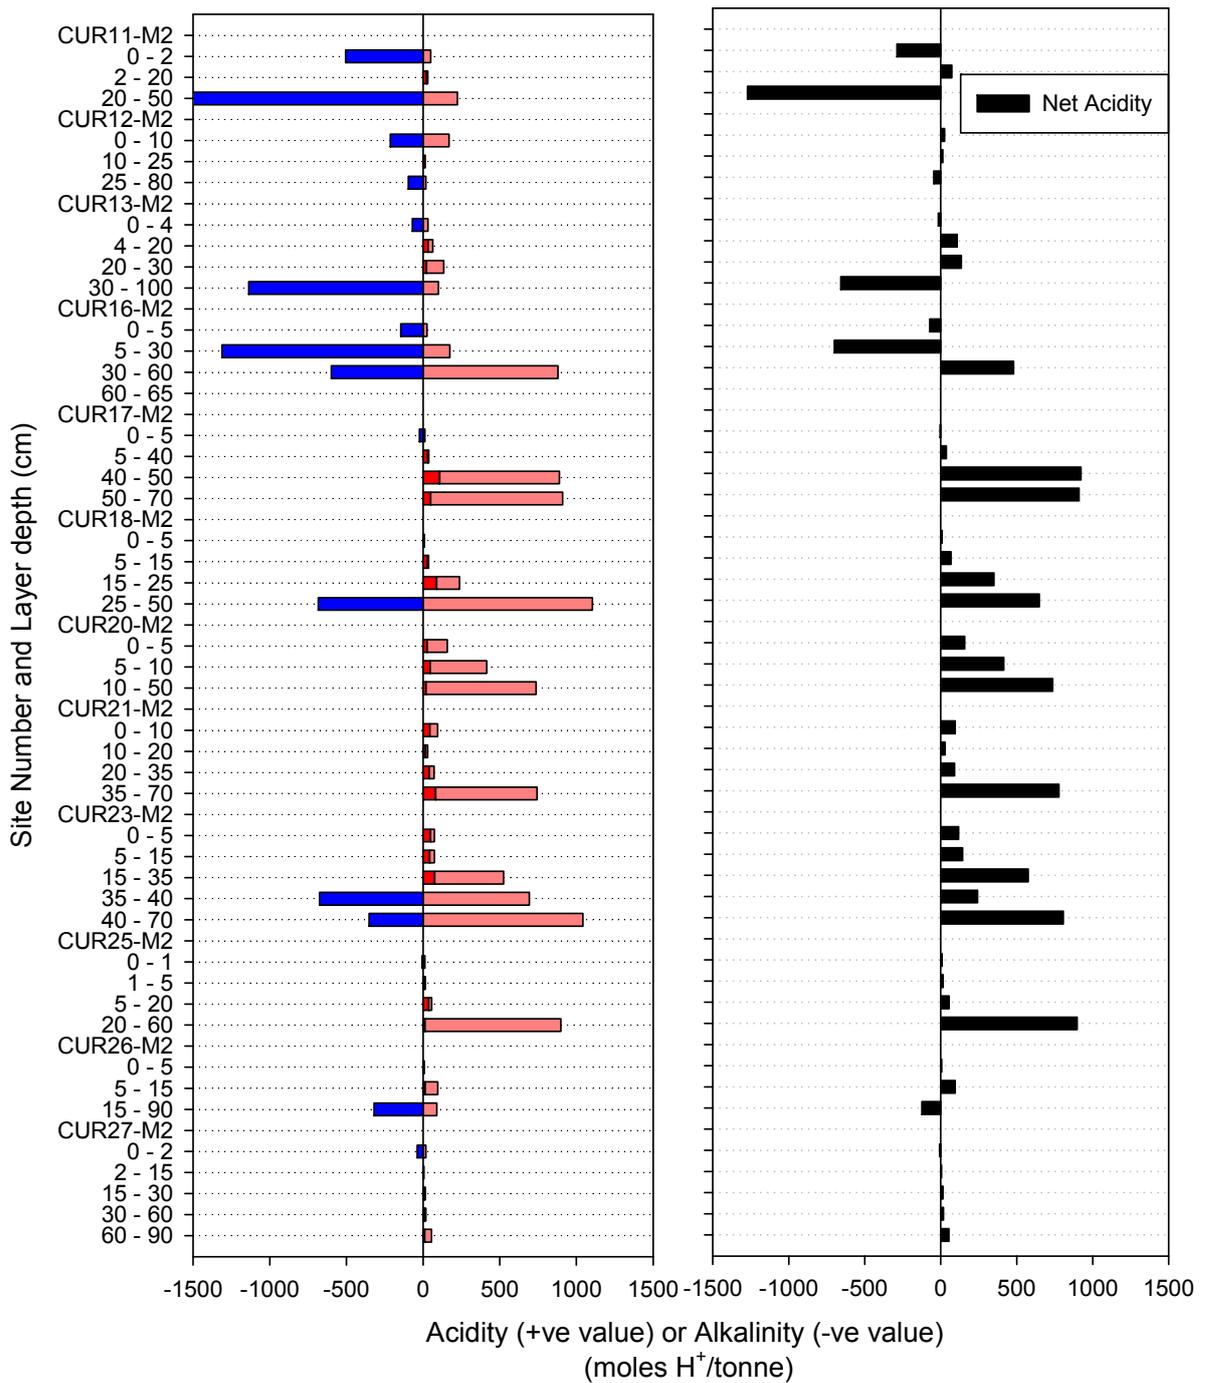
Figure 3-8. Currency Creek depth profiles for Net Acidity (NA) shown on the right. The left side shows the components TAA (red bar), AGP as  $S_{CR}$  (pink bar), and ANC (blue bar).

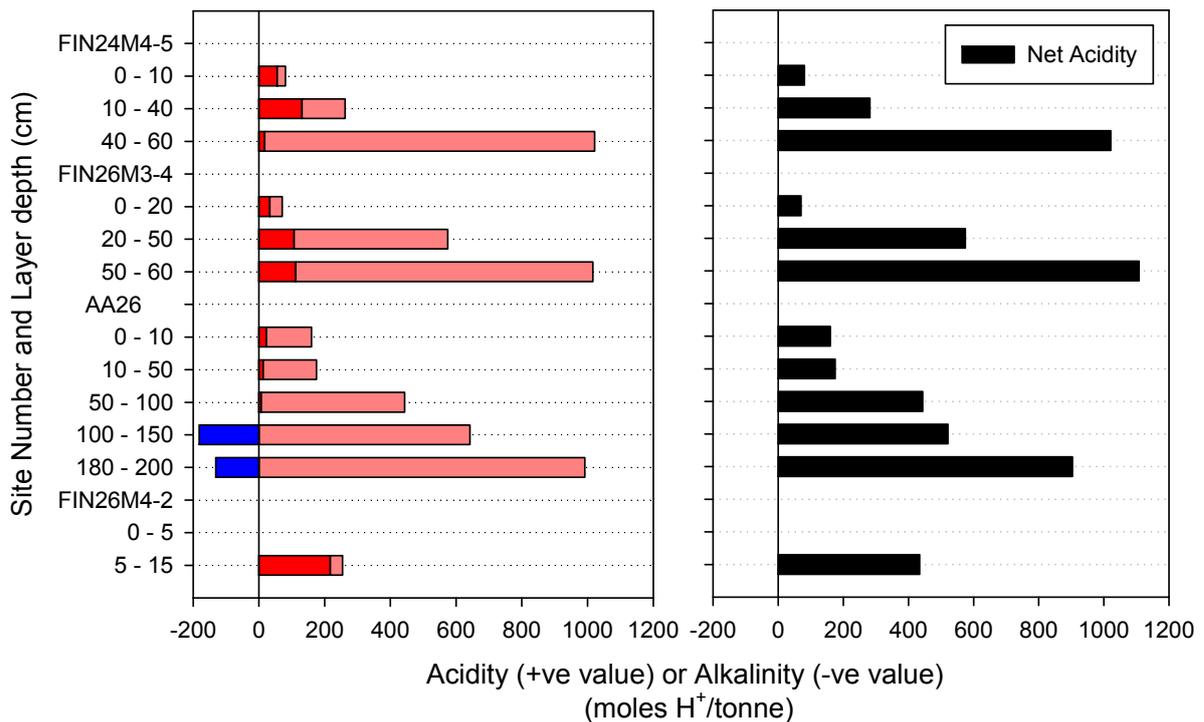
Figure 3-9. Wally's Landing depth profiles for Net Acidity (NA) shown on the right. The left side shows the components TAA (red bar), AGP as S<sub>CR</sub> (pink bar), and ANC (blue bar).

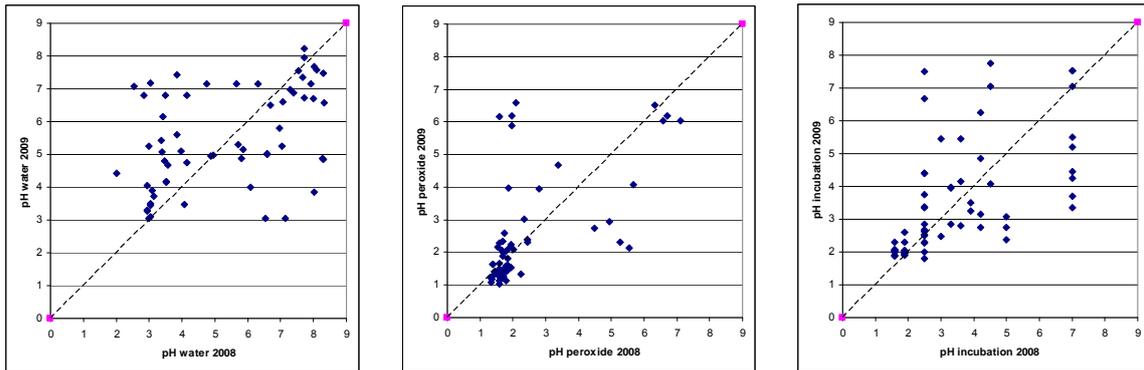
Figure 3-10. pH data comparison between 2008 and 2009 survey data for pH<sub>W</sub>, pH<sub>OX</sub>, and pH<sub>incubation</sub> (dashed line shows 1:1).

No obvious patterns or trends can be seen in the data set when plotted as a whole and could be due to soil variability. Further exploratory data analysis would be recommended to identify if stratifying the data according to position of the soil layer in the profile or general location identifies trends.

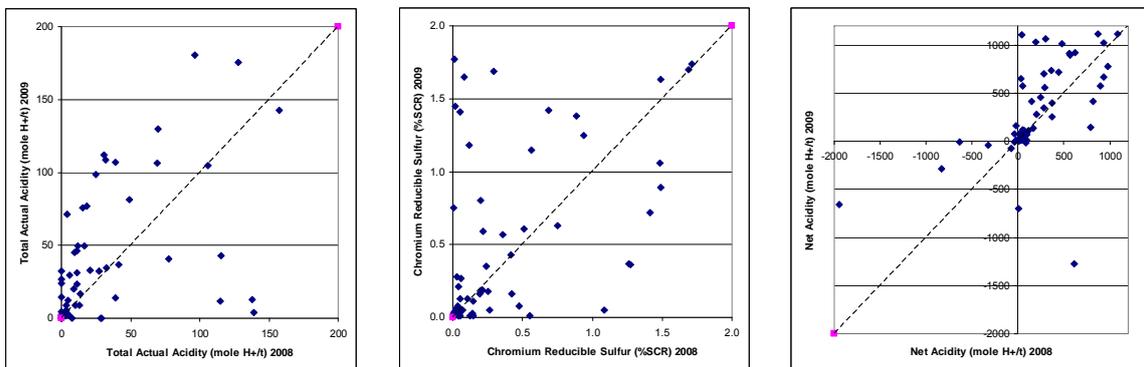
Figure 3-11. Acid base accounting parameter comparison between 2008 and 2009 laboratory data for total actual acidity, chromium reducible sulfur and net acidity (dashed line shows 1:1).

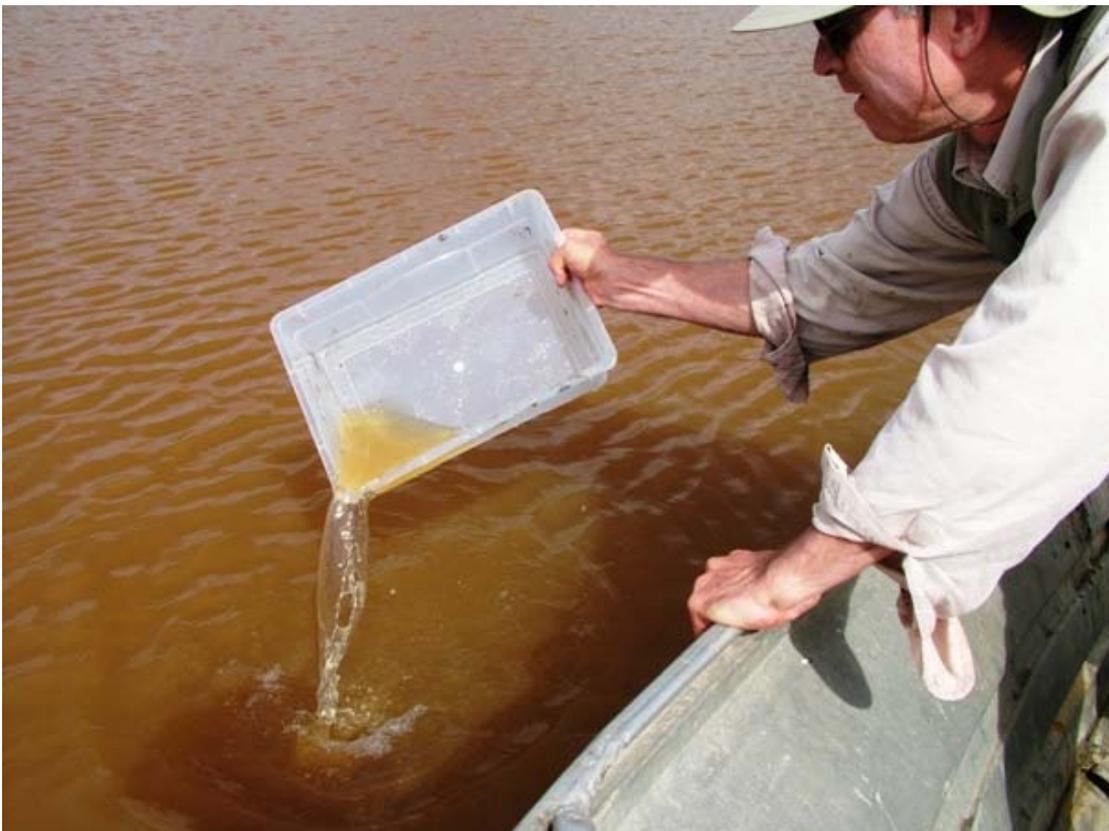
Figure 4-2. Surface water at site FC1009 / FIN20 (see Figure 4-1) showing an “orange” reddish-brown colouration of water most likely due to a mixture of iron rich mineral precipitates (e.g. oxyhydroxysulfate mineral, schwertmannite and ferrihydrite), aluminosilicate clays and possibly orange coloured algae.

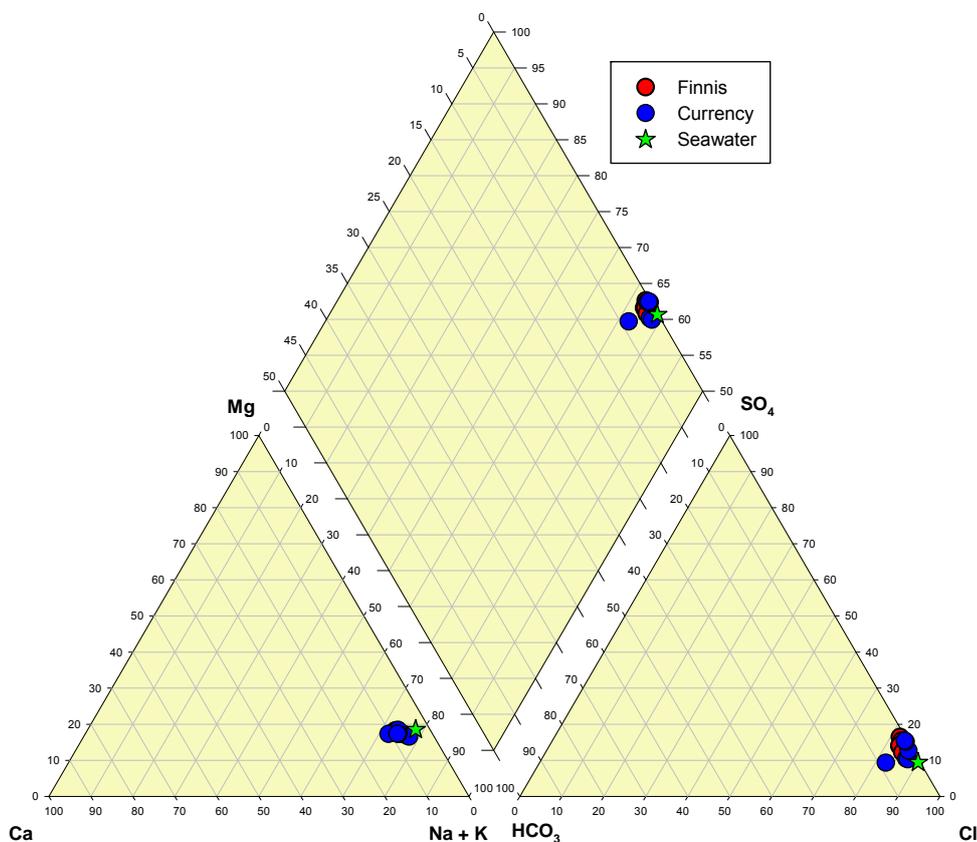
Figure 4-3. Piper plot showing the relative proportions of major solutes in the surface waters of Finnis River and Currency Creek.

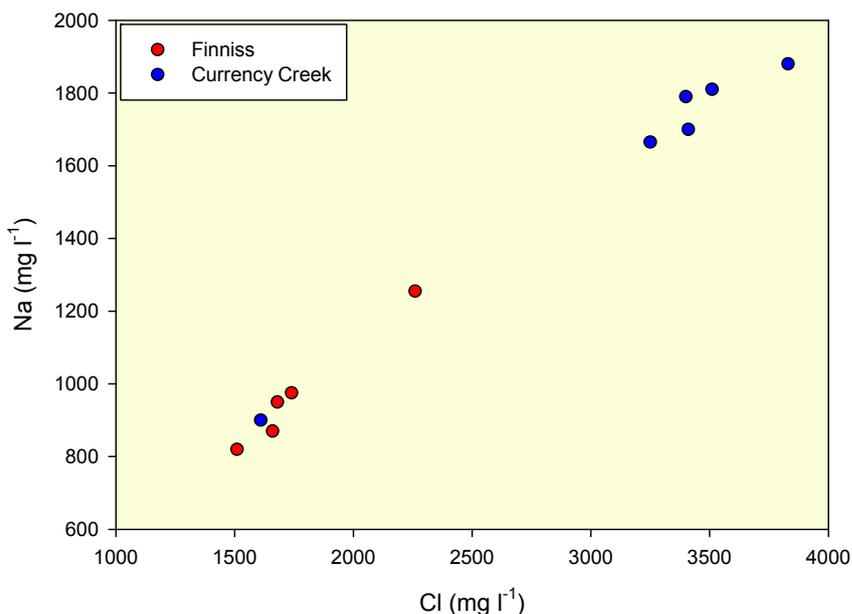
Figure 4-4. Plot of Na vs. Cl for surface waters showing typically higher concentrations in Currency Creek.

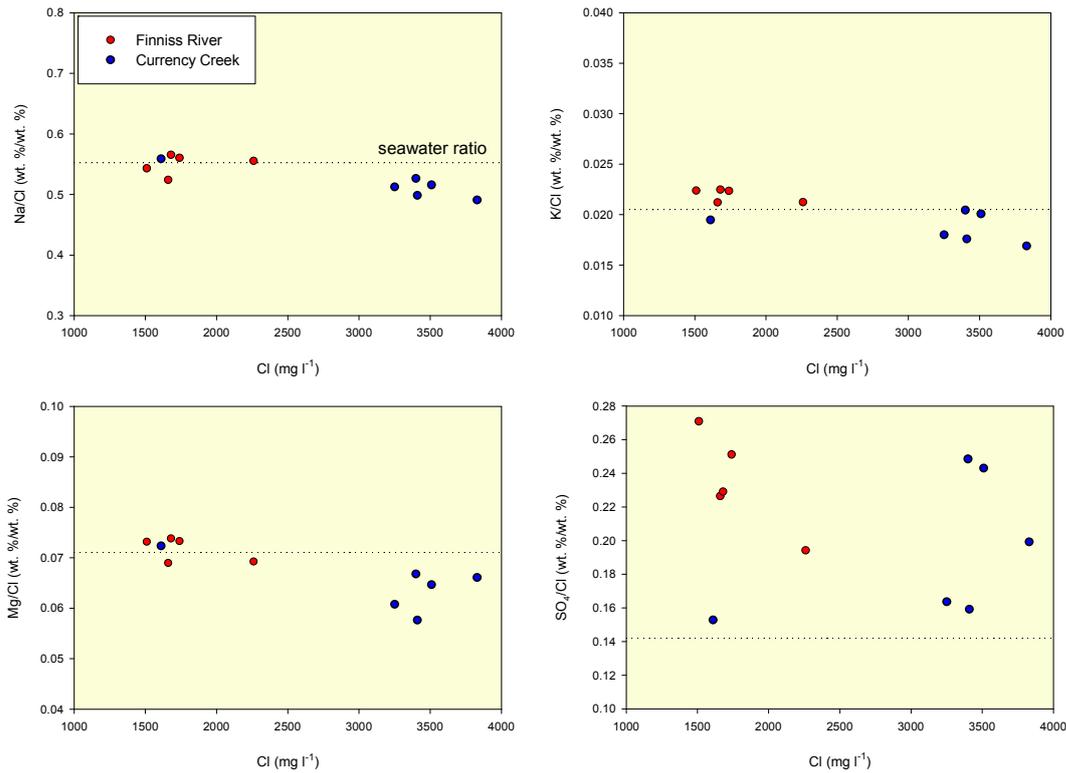
Figure 4-5. Ratio plots for major element/chloride ratios plotted against Cl as an indicator of salinity.

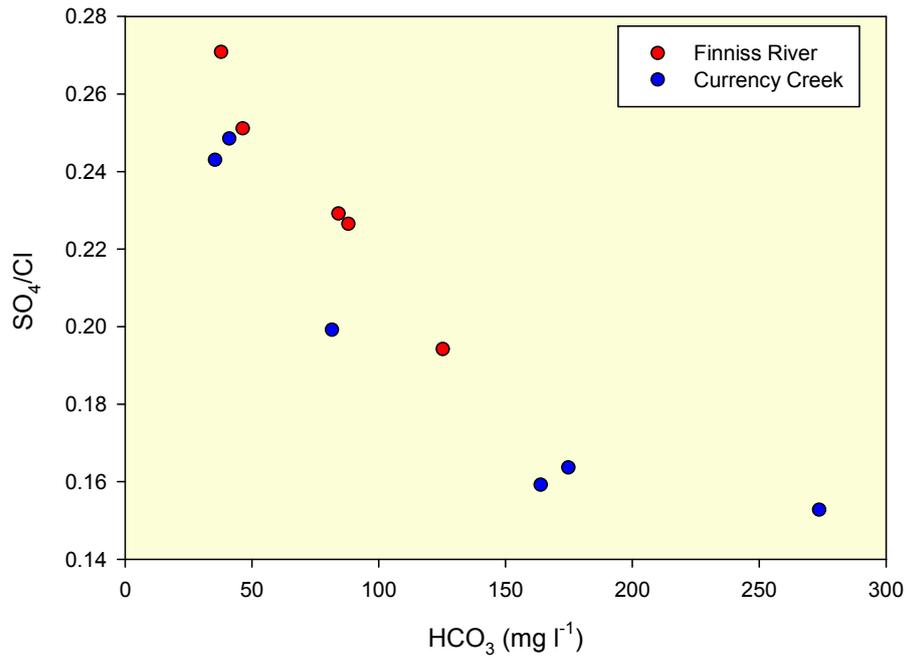
Figure 4-6. Negative correlation between SO<sub>4</sub>/Cl ratio (i.e. excess SO<sub>4</sub> from soil-water interaction) and alkalinity. The dissolution of hydroxysulfate minerals, which generate acidity can thus explain the variations in alkalinity across the area.

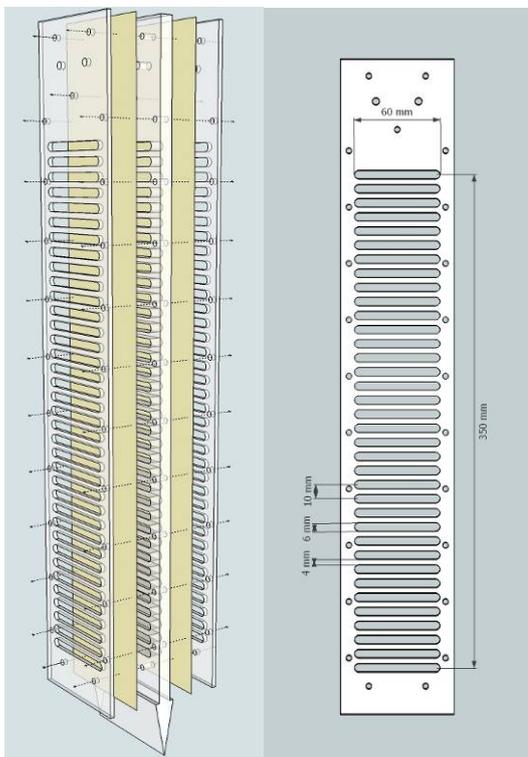
Figure 5-1. 3D to-scale diagram of peepers used in this study. The polysulfone membrane is coloured yellow in diagram for clarity (usual colour is white).

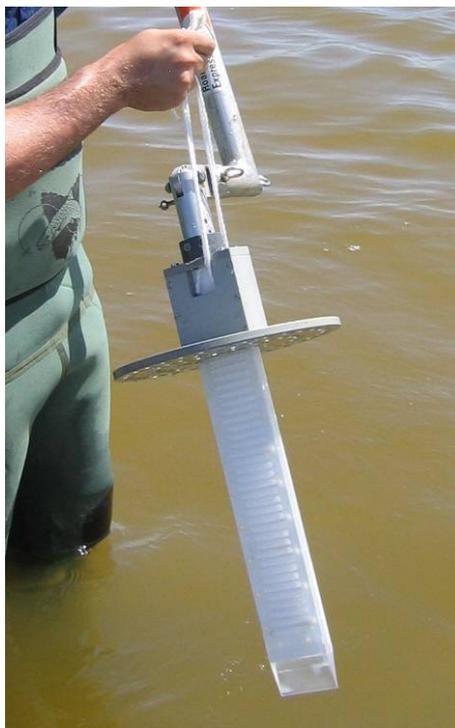
Figure 5-2. Photo showing lower end of specialised peeper installation apparatus with peeper ready to be deployed.

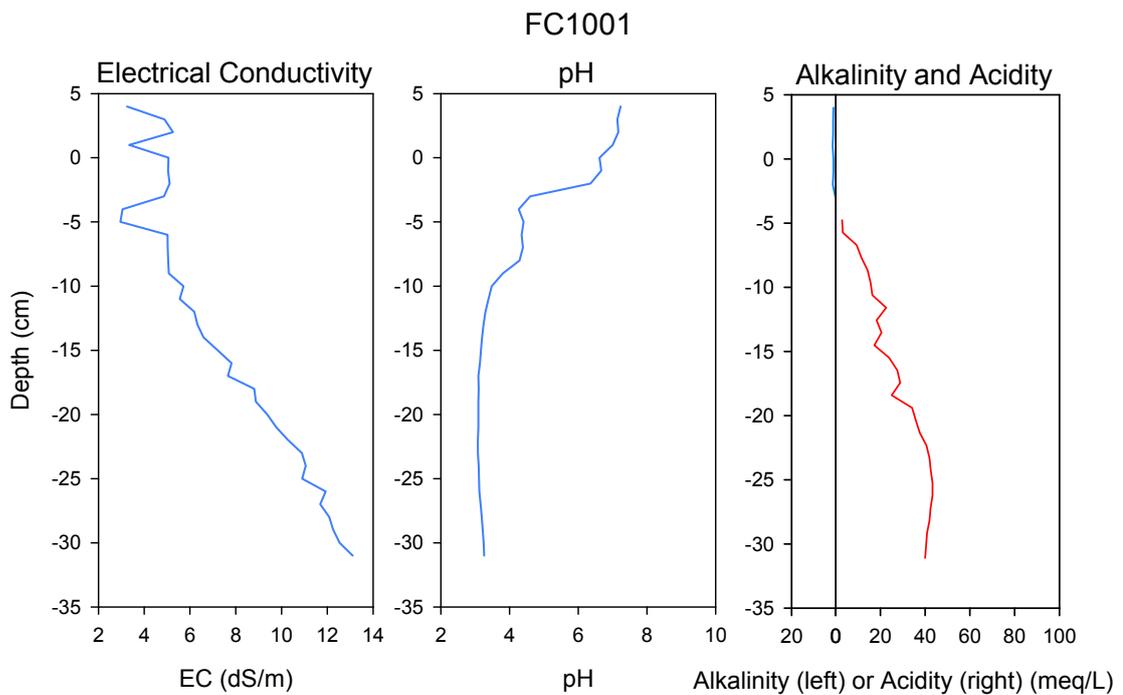
Figure 5-4. Plots of EC, pH, alkalinity, and acidity with depth for site FC1001 (FIN28).

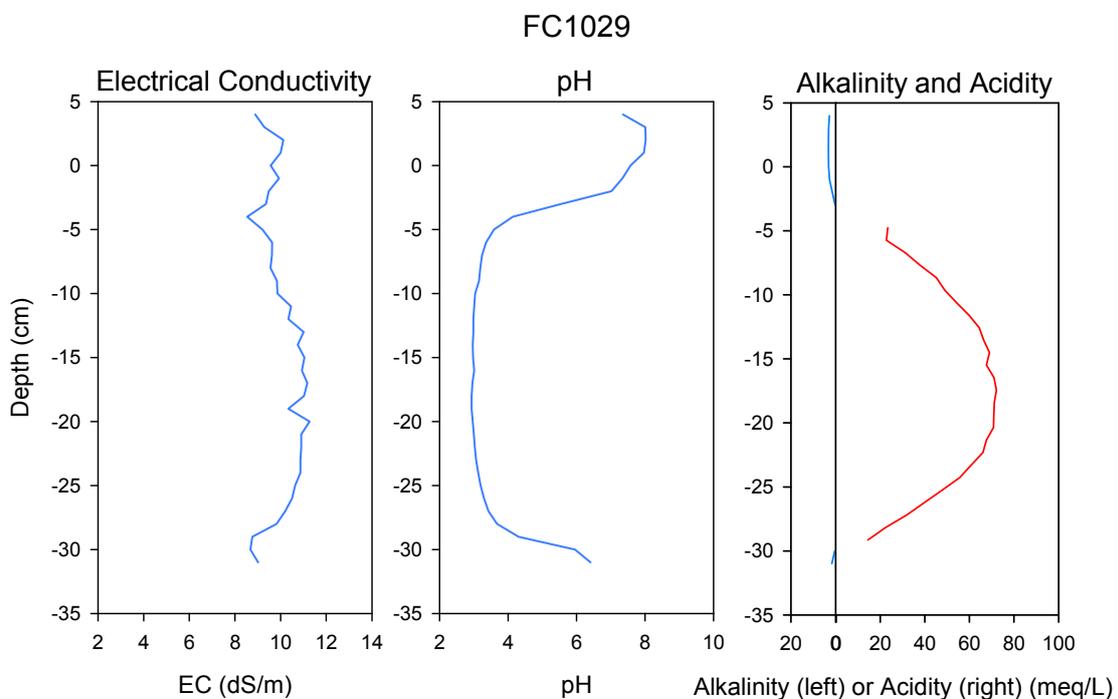
Figure 5-5. Plots of EC, pH, alkalinity, and acidity against depth for site FC1029 (CUR18).

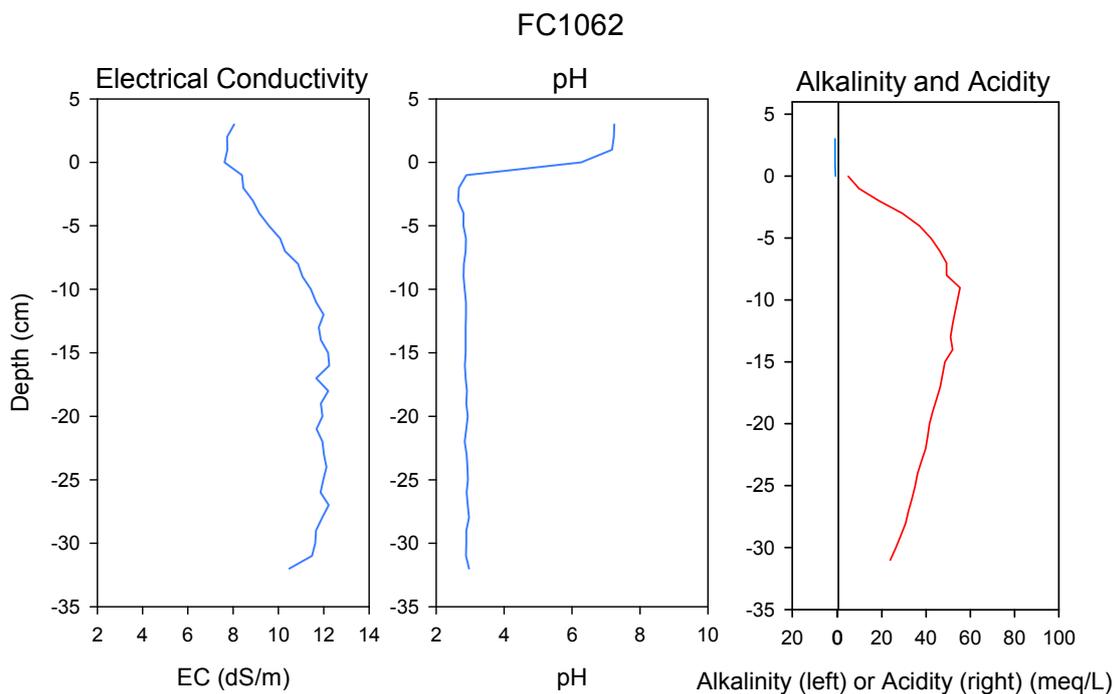
Figure 5-6. Plots of EC, pH, alkalinity, and acidity against depth for site FC1062 (CUR25).

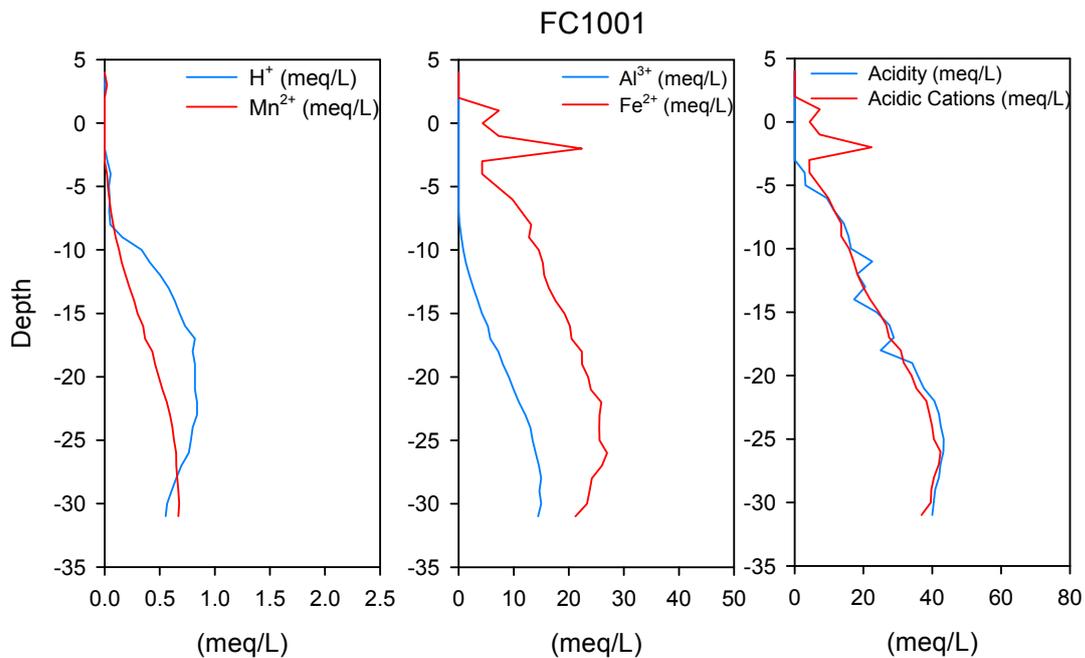
Figure 5-8. Individual acidic cation profiles for H<sup>+</sup>, Mn<sup>2+</sup> (left), Al<sup>3+</sup> and Fe<sup>2+</sup> (middle) and summed concentrations of acidic cations against acidity (right) for site FC1001.

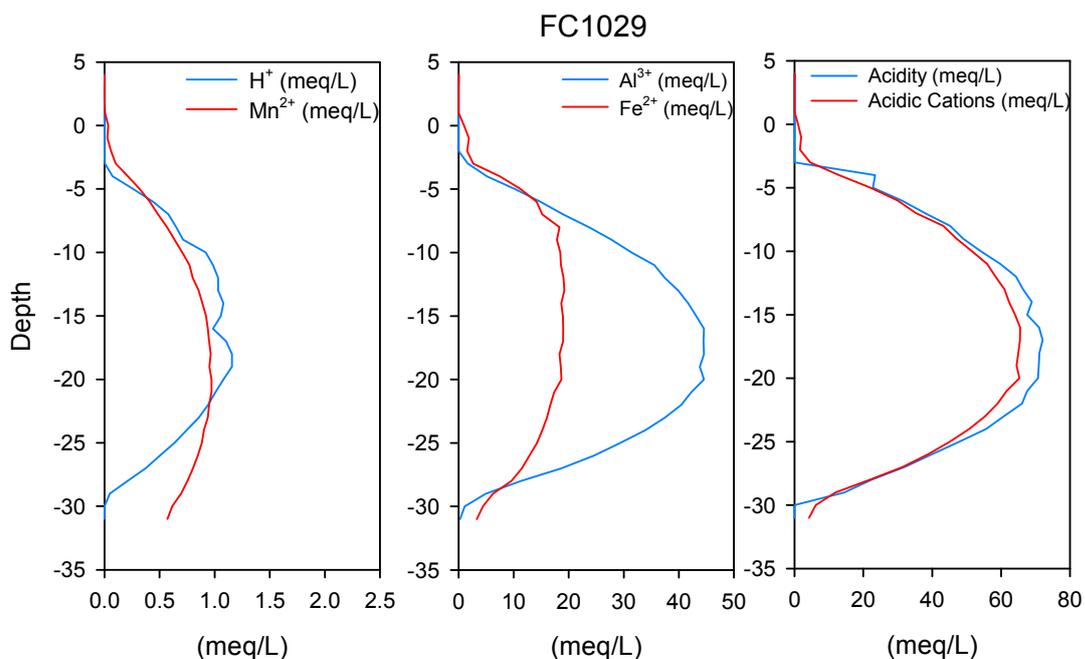
Figure 5-9. Individual acidic cation profiles for H<sup>+</sup>, Mn<sup>2+</sup> (left) Al<sup>3+</sup> and Fe<sup>2+</sup> (middle) and summed concentrations of acidic cations against acidity (right) for site FC1029.
