## Monitoring and Assessment of Reflooded Acid Sulfate Soil Materials in Currency Creek and Finniss River Region, South Australia

May 2011

Prepared for: Department of Environment and Natural Resources (DENR)  
Murray Futures Lower Lakes & Coorong Recovery Acid Sulfate Soils Research Program

Project Report Number R-325-8-6

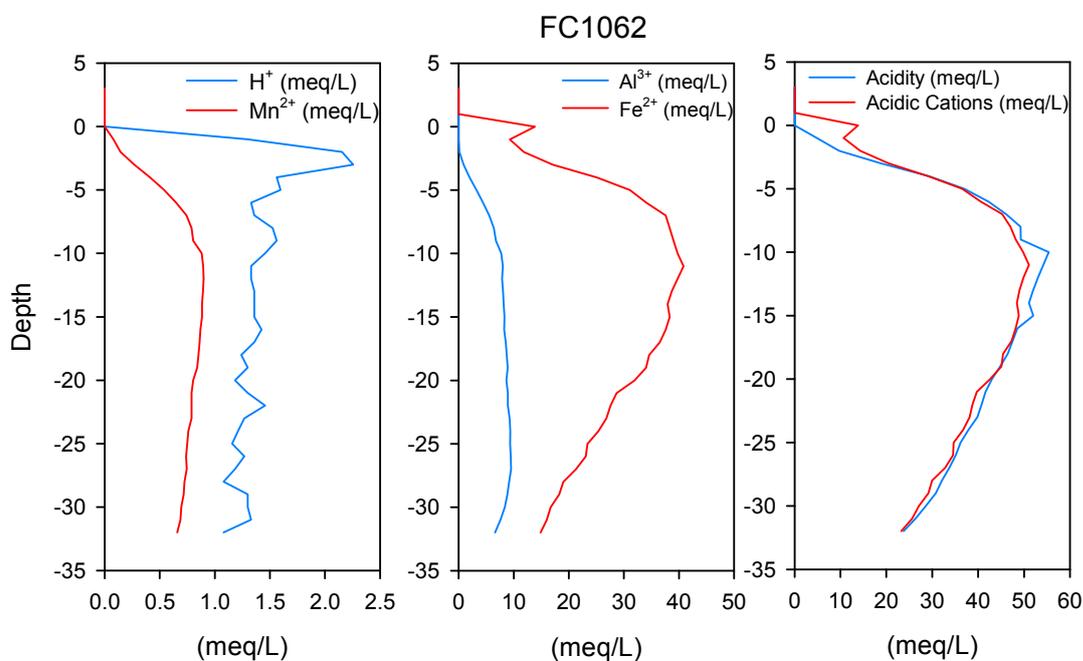
Figure 5-10. Individual acidic cation profiles for  $H^+$ ,  $Mn^{2+}$  (left)  $Al^{3+}$  and  $Fe^{2+}$  (middle) and summed concentrations of acidic cations against acidity (right) for site FC1062.

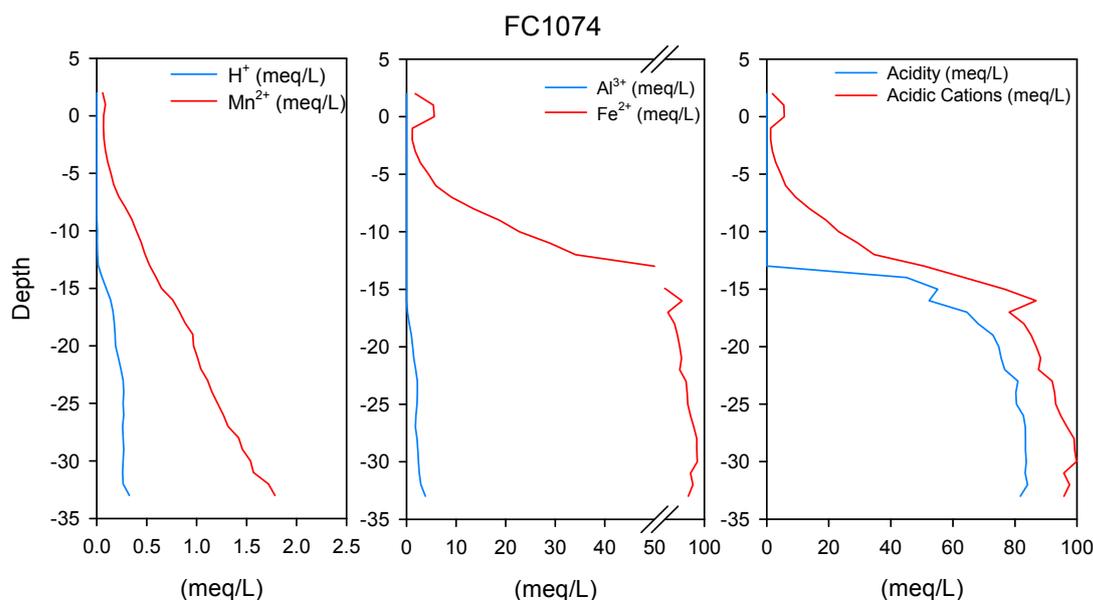
Figure 5-11. Individual acidic cation profiles for  $H^+$ ,  $Mn^{2+}$  (left)  $Al^{3+}$  and  $Fe^{2+}$  (middle) and summed concentrations of acidic cations against acidity (right) for site FC1074.

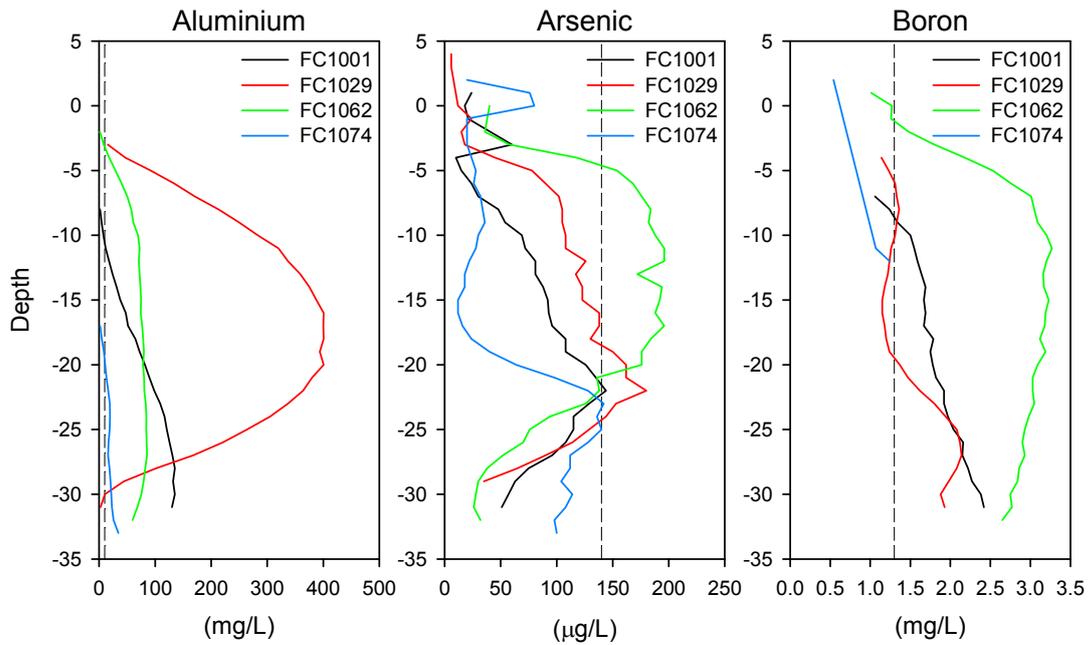
Figure 5-12 Profiles of aluminium (left), arsenic (middle), and boron (right) for each of the four sites. The black, dashed line represents the relevant ANZECC WQ guideline trigger value for 80% species protection.

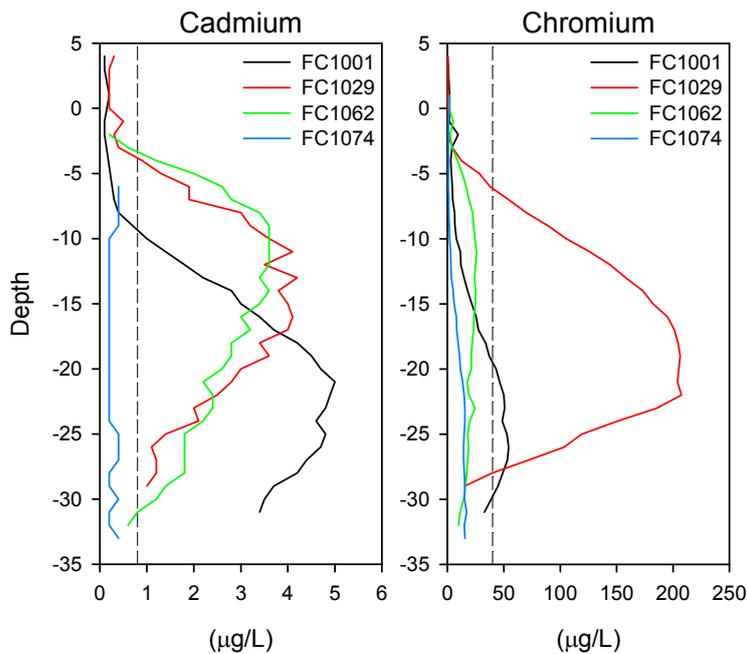
Figure 5-13. Profiles of cadmium (left), and chromium (right) for each of the four sites. The black, dashed line represents the relevant ANZECC WQ guideline trigger value for 80% species protection.

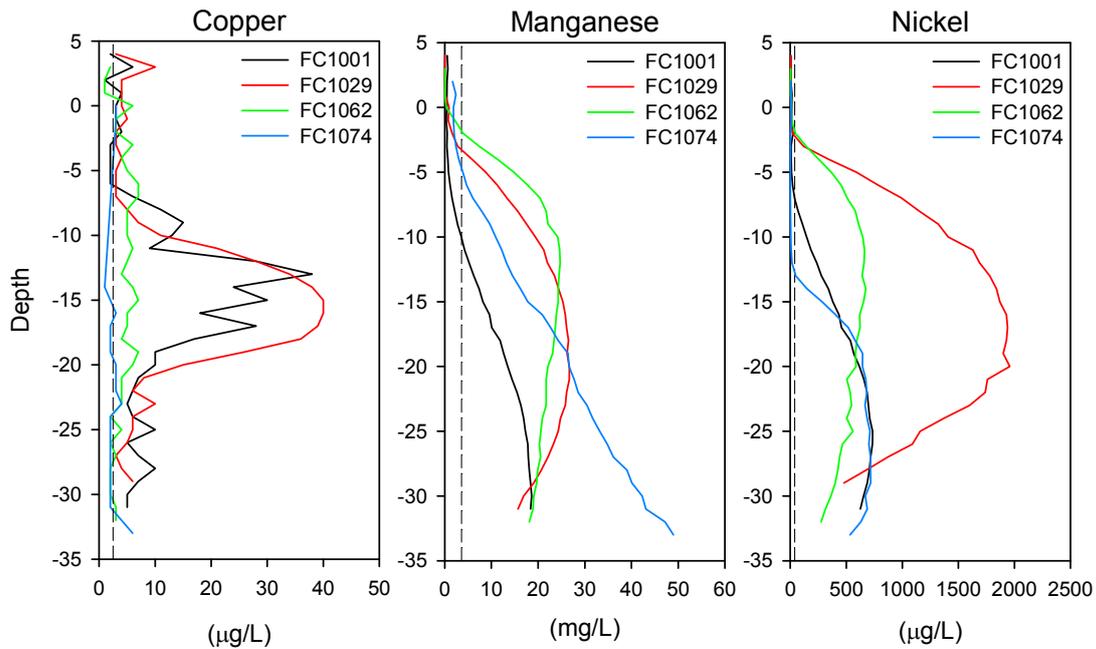
Figure 5-14. Profiles of copper (left), manganese (middle), and nickel (right) for each of the four sites. The black, dashed line represents the relevant ANZECC WQ guideline trigger value for 80% species protection.

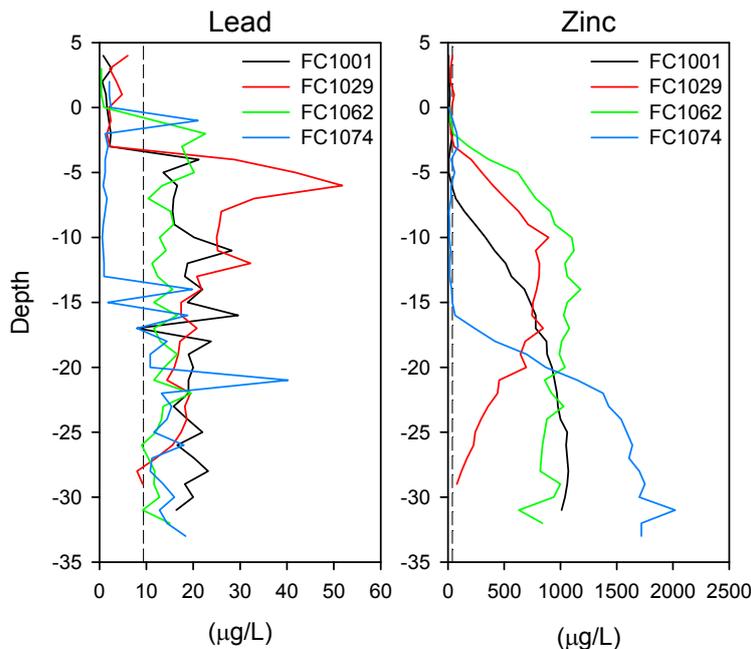
Figure 5-15. Profiles of lead (left), and zinc (right) for each of the four sites. The black, dashed line represents the relevant ANZECC WQ guideline trigger value for 80% species protection.

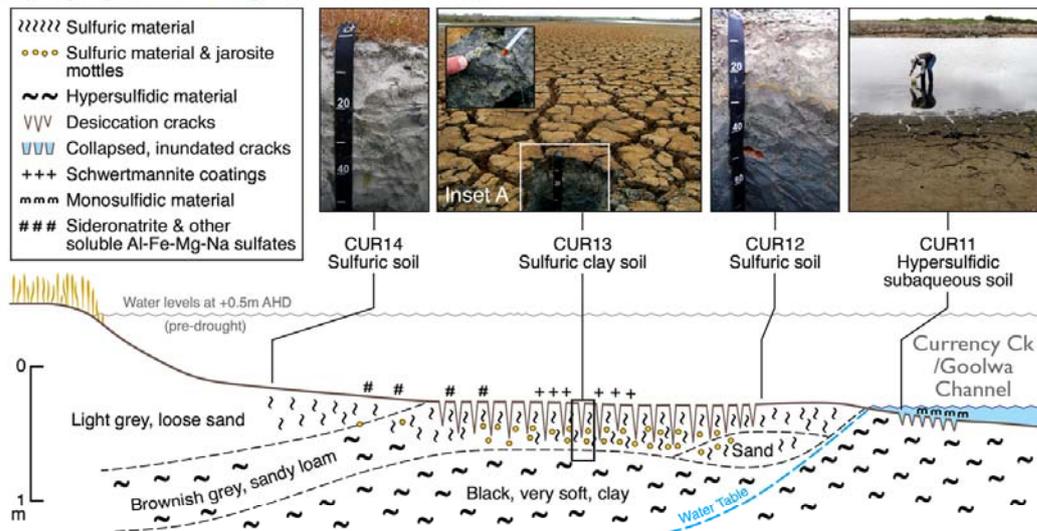
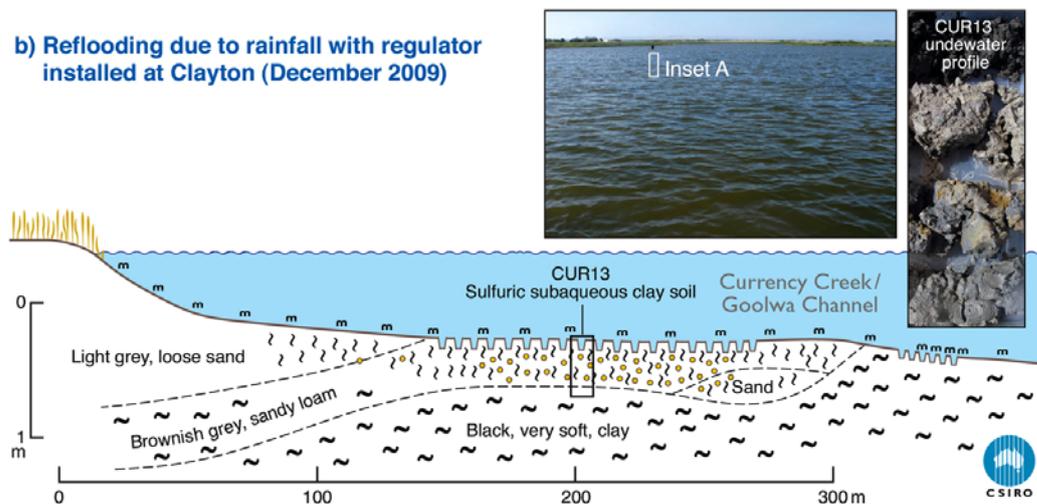
**a) Drying due to drought (November 2008)**

**b) Reflooding due to rainfall with regulator installed at Clayton (December 2009)**

Figure 6-1. Photograph and conceptual cross-section diagram of Acid Sulfate Soil of the subtype “Sulfuric cracking clay soil” in the dry river bed of Currency Creek, near north Goolwa (Site No CUR 13 sampled in November 2008), looking west towards to the Adelaide Hills, South Australia. This shows: (i) trans-horizon polygonal cracks with very coarse columnar ped structures; the result of desiccation and dewatering of a former “Hypersulfidic subaqueous clayey soil” during drying cycles due to recent extreme drought conditions; (ii) surface coating of the reddish-brown mineral, schwertmannite, which has a pH ranging between 3.0 and 3.6 (sulfuric material), (iii) sulfuric material (pH < 4) with pale yellow mottles of natrojarosite in a dark grey clay matrix between 10 cm to 30 cm, and (iv) very dark grey hypersulfidic material (iron sulfides) at depth (> 30 cm). The lower photograph and conceptual cross-section diagram is taken at same locality in December 2009 after reflooding following winter rainfall runoff from adjacent catchments and construction of Clayton and Currency Creek water regulators.

Hills, South Australia. This shows: (i) trans-horizon polygonal cracks with very coarse columnar ped structures; the result of desiccation and dewatering of a former “Hypersulfidic subaqueous clayey soil” during drying cycles due to recent extreme drought conditions; (ii) surface coating of the reddish-brown mineral, schwertmannite, which has a pH ranging between 3.0 and 3.6 (sulfuric material), (iii) sulfuric material (pH < 4) with pale yellow mottles of natrojarosite in a dark grey clay matrix between 10 cm to 30 cm, and (iv) very dark grey hypersulfidic material (iron sulfides) at depth (> 30 cm). The lower photograph and conceptual cross-section diagram is taken at same locality in December 2009 after reflooding following winter rainfall runoff from adjacent catchments and construction of Clayton and Currency Creek water regulators..... 53

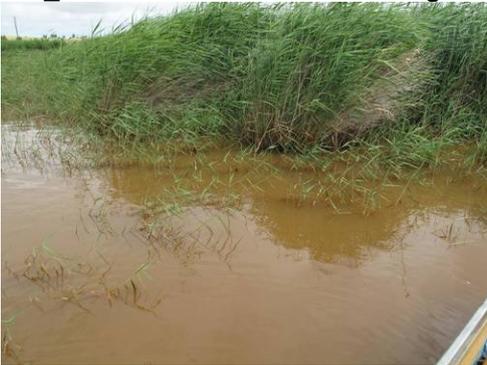
FIN\_20 – wetland 2009; see also Figure 4-2

**Finniss River: Airstrip site** –closest site to main bank adjacent to airstrip with very wide cracks still clearly evident under 60 cm water. **Subaqueous.**

At site FIN 20, deep cracks in the re-flooded soils were noted during sampling. A distinct orange-brown colouration of the water indicated the presence of abundant Fe-rich suspended sediments, most likely the ferric oxyhydroxysulfate mineral schwertmannite (Figure 4-2). Measurement of field parameters showed that the water in the cracks (CRACK in Table 4-1) had a much higher SEC (27000  $\mu\text{S cm}^{-1}$ ) and lower pH (5.23) than the overlying water (5890  $\mu\text{S cm}^{-1}$  and 6.32 respectively). Dissolved oxygen was present in all surface waters, but was low at site FC1009.

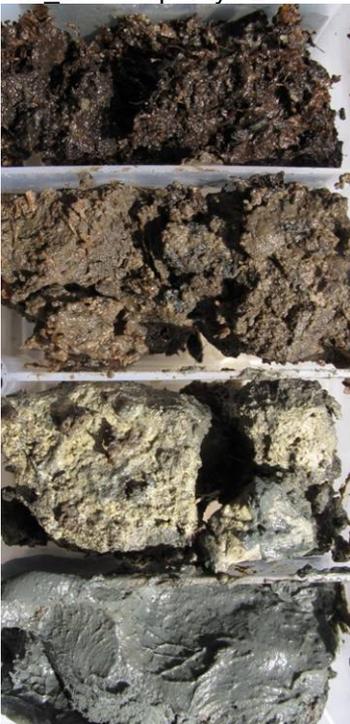
**Finniss River: Airstrip site** –middle site near Phragmites with cracks still clearly evident under 80 cm water.  
**Subaqueous.**

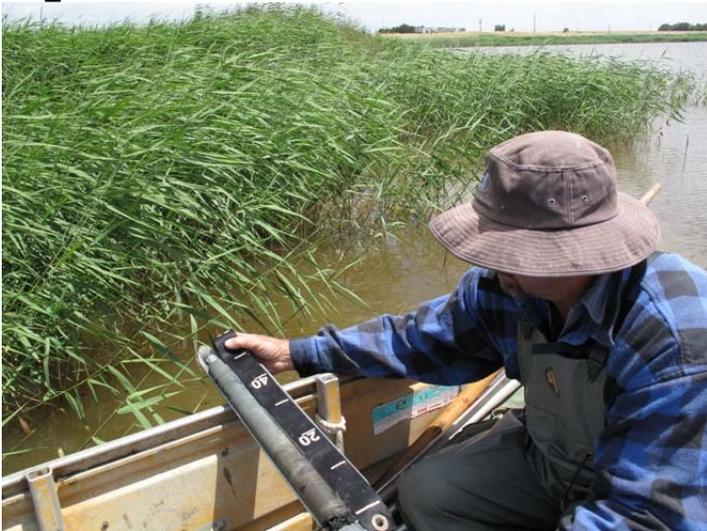
**Finniss River: Airstrip site** –furthest site from main bank; just outside the main entrance waterway / channel of whole wetland with some cracks still clearly evident under 90 cm water. **Subaqueous.**  
FIN\_25 – wetland - 2009

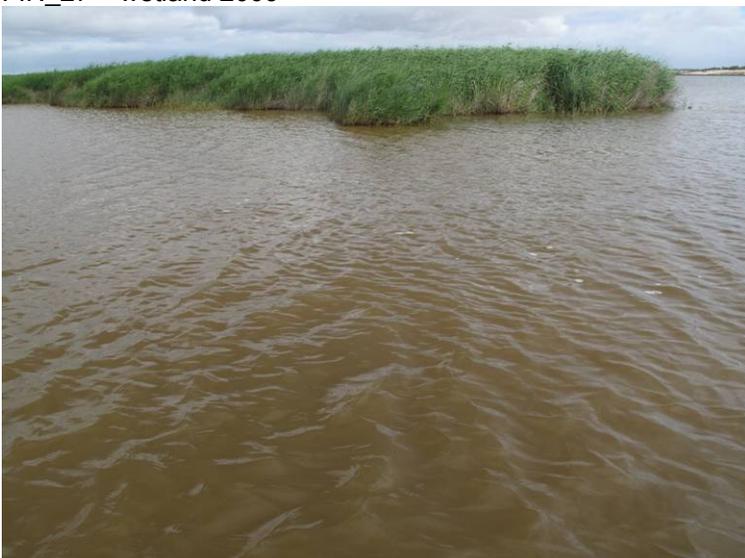
**Finniss River: Finniss River Estate (Peter Elmes) site** –furthest site from main bank; just outside the main entrance waterway / channel of whole wetland with few cracks evident because of organic mulch on surface under 100 cm water. **Subaqueous.**  
FIN\_27 – wetland 2009

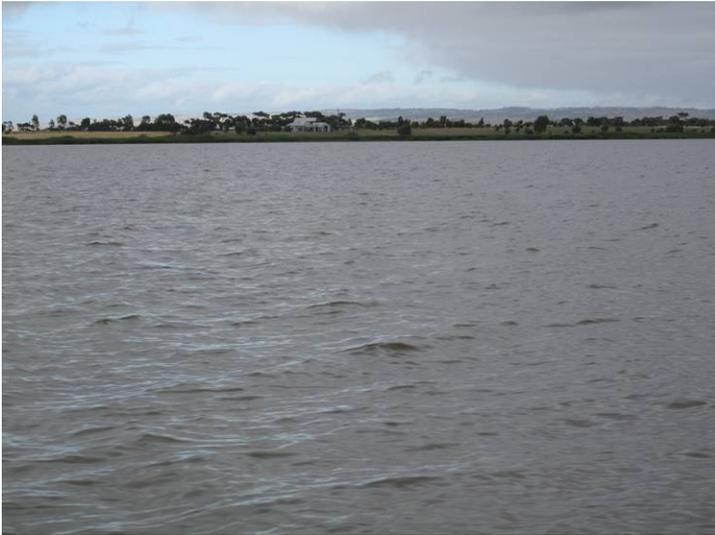
**Finniss River: Finniss River Estate (Peter Elmes) site** –nearest site from main bank; in main wetland or back swamp with many cracks evident under 120 cm water. **Subaqueous.**  
FIN 28 wetland 2009

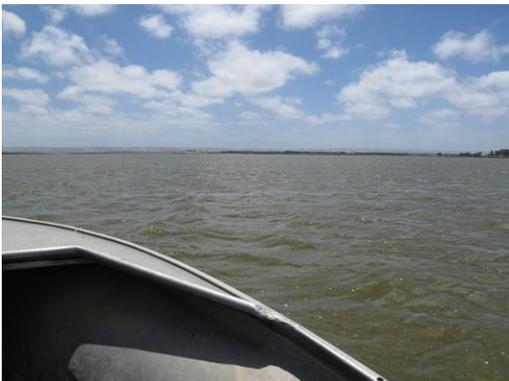
**Finniss River:** Midway on old shoreline 50m from water edge under 100 cm water. **Subaqueous.**  
FIN\_31 view of sampling site

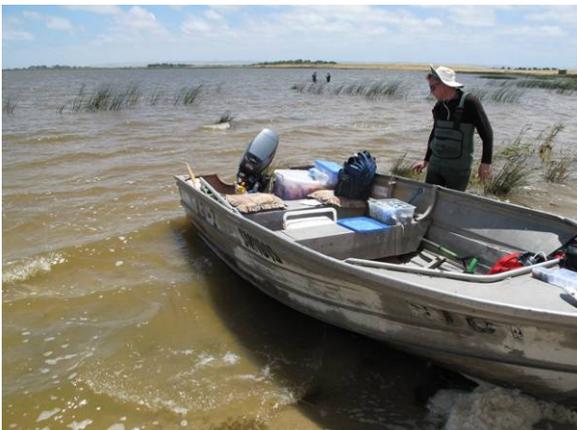
**Finniss River:** high, in reeds before step up under 20 cm water. **Subaqueous.**  
FIN\_32 near site

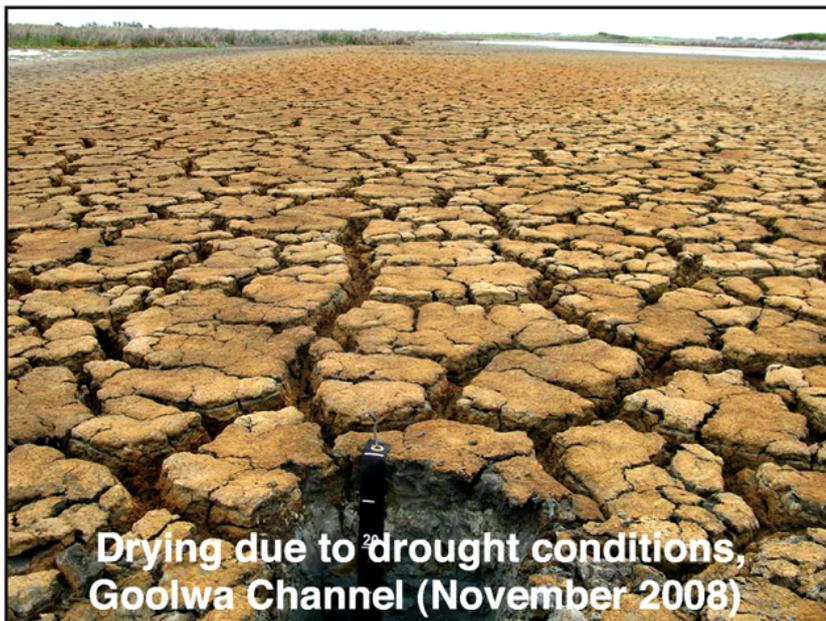
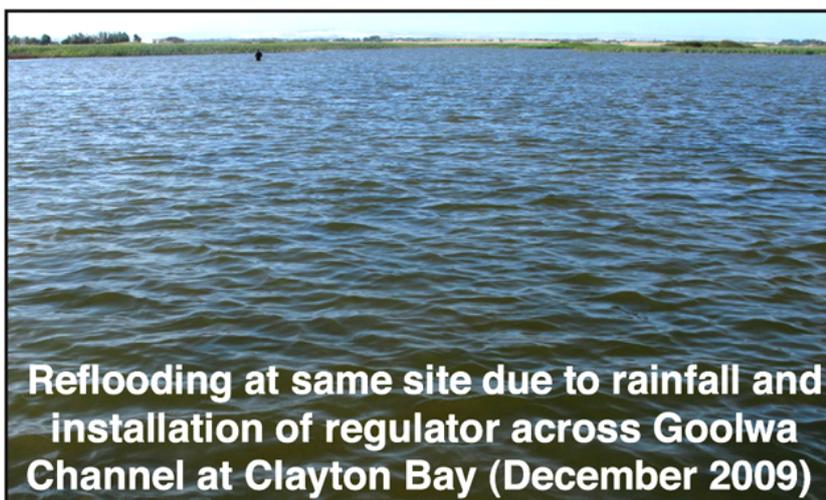
**Top photograph** “Sulfuric cracking clay soil” subtype in the dry river bed of Goolwa Channel - Currency Creek area, near north Goolwa (No CUR 13 sampled in November 2008), looking west towards to the Adelaide Hills, South Australia. This shows: (i) trans-horizon polygonal cracks with very coarse columnar ped structures; the result of desiccation and dewatering of a former “Hypersulfidic subaqueous clayey soil” during drying cycles due to recent extreme drought conditions; (ii) surface coating of the reddish-brown mineral, schwertmannite, which has a pH ranging between 3.0 and 3.6 (sulfuric material), (iii) sulfuric material (pH < 4) with pale yellow mottles of natrojarosite in a dark grey clay matrix between 10 cm to 30 cm, and (iv) very dark grey hypersulfidic material (iron sulfides) at depth (> 30 cm).

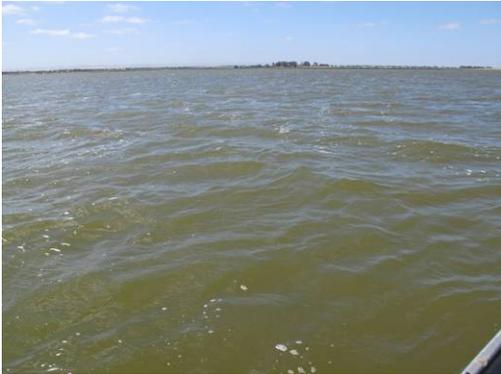
**Goolwa Channel transect:** closest site from main bank - midway to steep up into reeds  
 no cracks evident under 50 cm water. **Subaqueous.**  
 CUR 18 - site

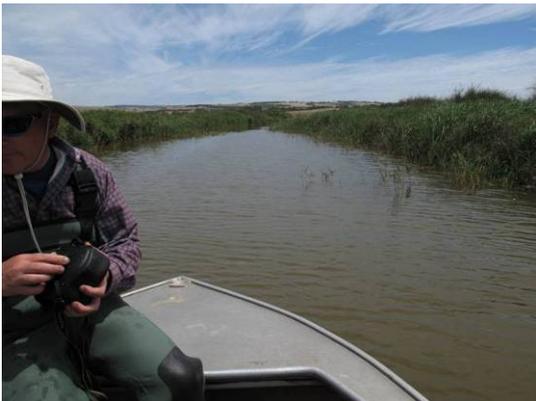
**Currency Creek:** 2m into main water channel under 130 cm water. **Subaqueous.**  
 CUR 20 near site

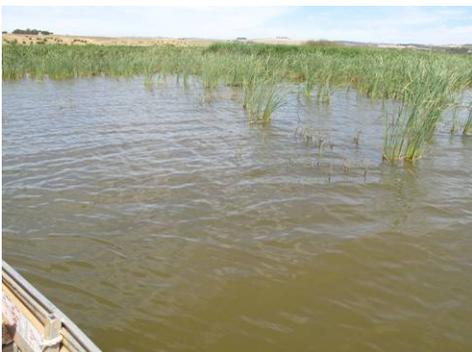
**Currency Creek:** near reeds, 20m from main water channel under 50 cm water. **Subaqueous.**  
 CUR 21 near site

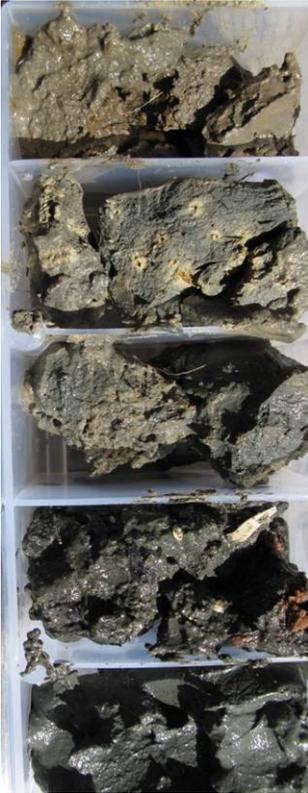
**Currency Creek:** Near water edge Under 95 cm water. **Subaqueous**  
CUR 23 chip tray samples

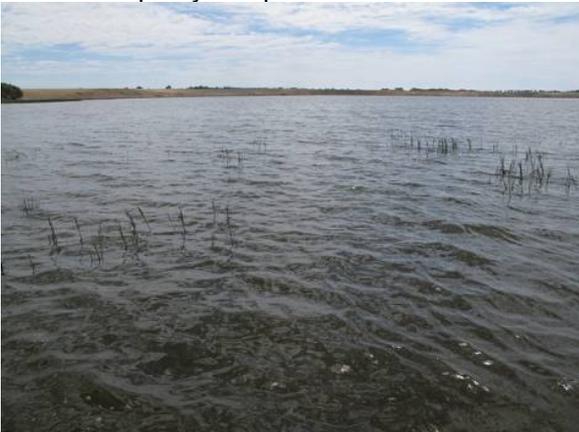
**Currency Creek:** high, 20m in wetland from step up to reeds along water edge under 50 cm water. **Subaqueous**  
CUR 25 chip tray samples

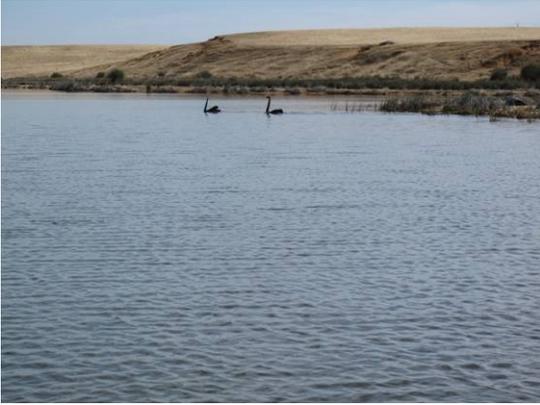
**Currency Creek: Jetty + vineyard + homestead view site** 80m plus from jetty / shore under 150 cm water. **Subaqueous.**  
CUR 26 wetland site CUR 26 chip tray samples

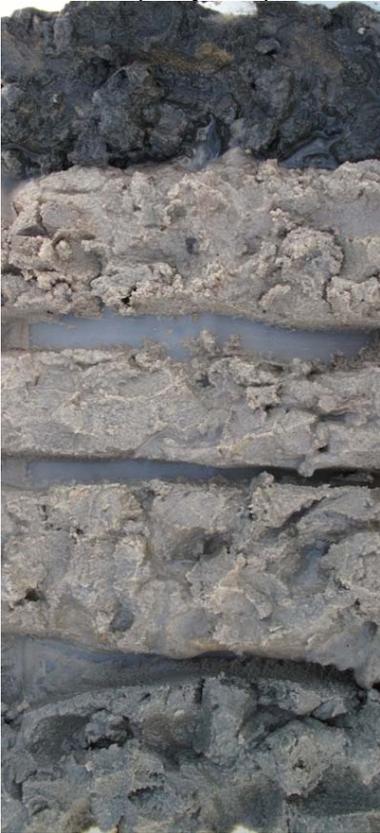
**Currency Creek: Jetty + vineyard + homestead view site** 10m from reeds under 80 cm water. **Subaqueous.**  
CUR 27 chip tray samples
