Mallee Dune Seeps Drilling and Well Installation Report Pope Subcatchment

A report produced for Natural Resources South Australian Murray–Darling Basin by Juliet Creek Consulting Pty Ltd.

March 2016

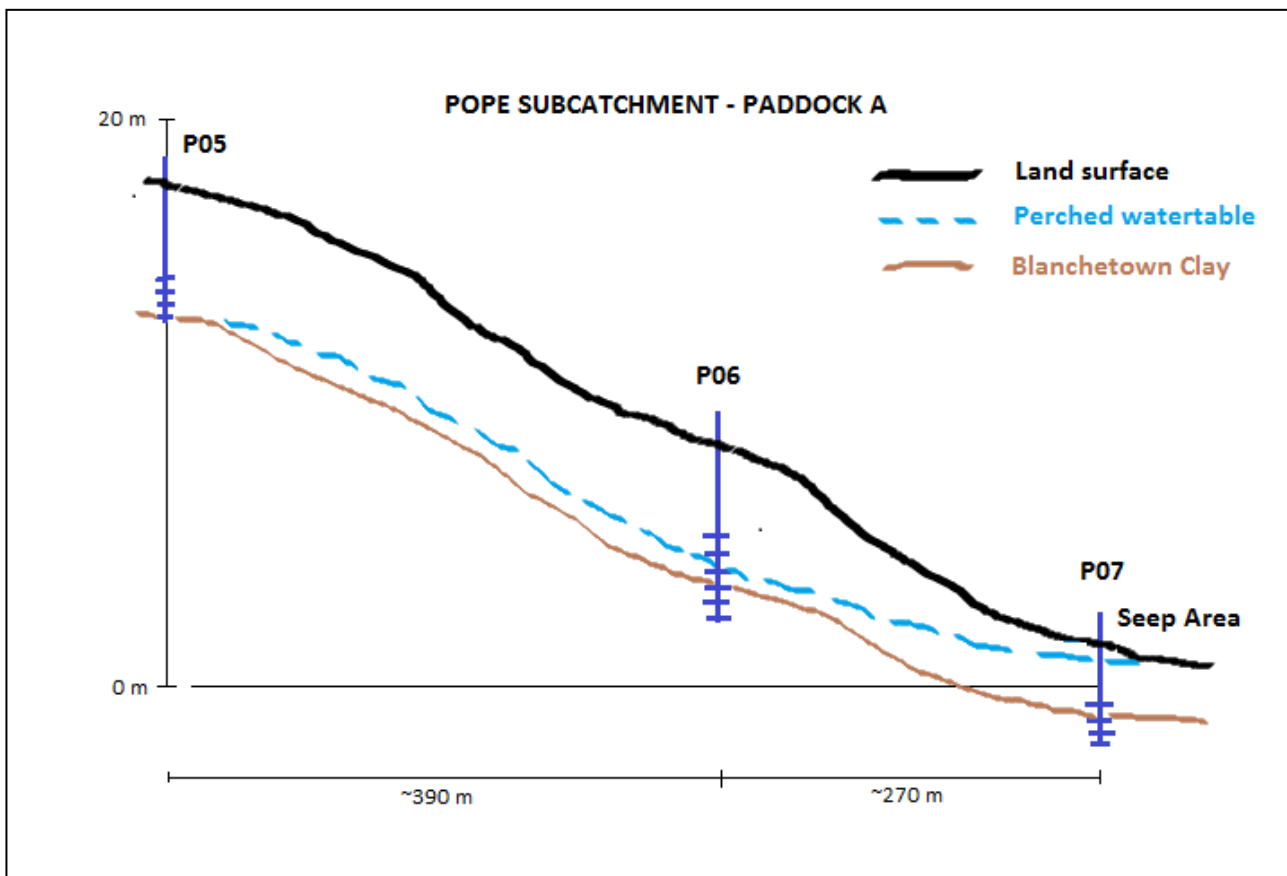
Diagram 1 Hydrological cross-section of the long slope of Paddock A in the Pope subcatchment.

Drilling has also confirmed that Blanchetown Clay (see Hall et al. 2009) forms the base of the local perched groundwater system. Depth to Blanchetown Clay has been measured between 4 and 7 m at upper and mid slope sites, and between 2 and 3 m at seep area sites (see **Appendix 2**). Having Blanchetown Clay as the system base correlates with findings at the Kulde and Mannum East subcatchments. At all three subcatchments it has been determined that the majority of the excess water moves laterally at depth along the Blanchetown Clay. This has been found to be a year-long event, at least from mid to lower slopes. A much lesser but not insignificant proportion of excess subcatchment water likely moves upon subsoil surfaces at much shallower depth – but seasonally when subsurface soils are saturated and probably only for short periods. These findings have implications for the siting and selection of deep-rooted perennials and for overall farm planning.

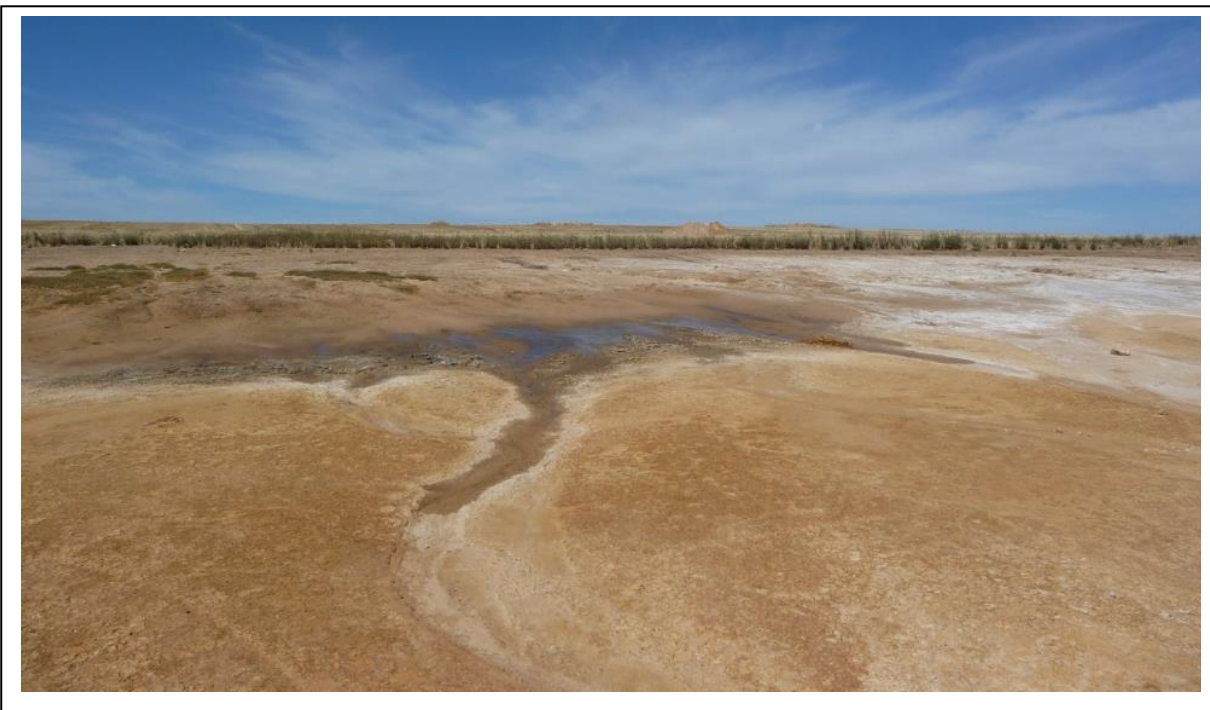
Figure 2 Scene of the severe dune seep at the Pope subcatchment in the summer of 2015–16, below the investigated toposequence of soil characterisation sites (see Hall 2016). Note the bare scalded surface, water seeping from the soil, and the barley crop in background. The seep area is expanding upslope.

Three holes were drilled along a toposequence in 'Paddock A' on the northern side of the area investigated (Sites MDS P05, P06 and P07), ending with the main farm seep (see **Figure 3**). While two holes were drilled in 'Paddock B' on the southern side of the area investigated (Sites MDS P08

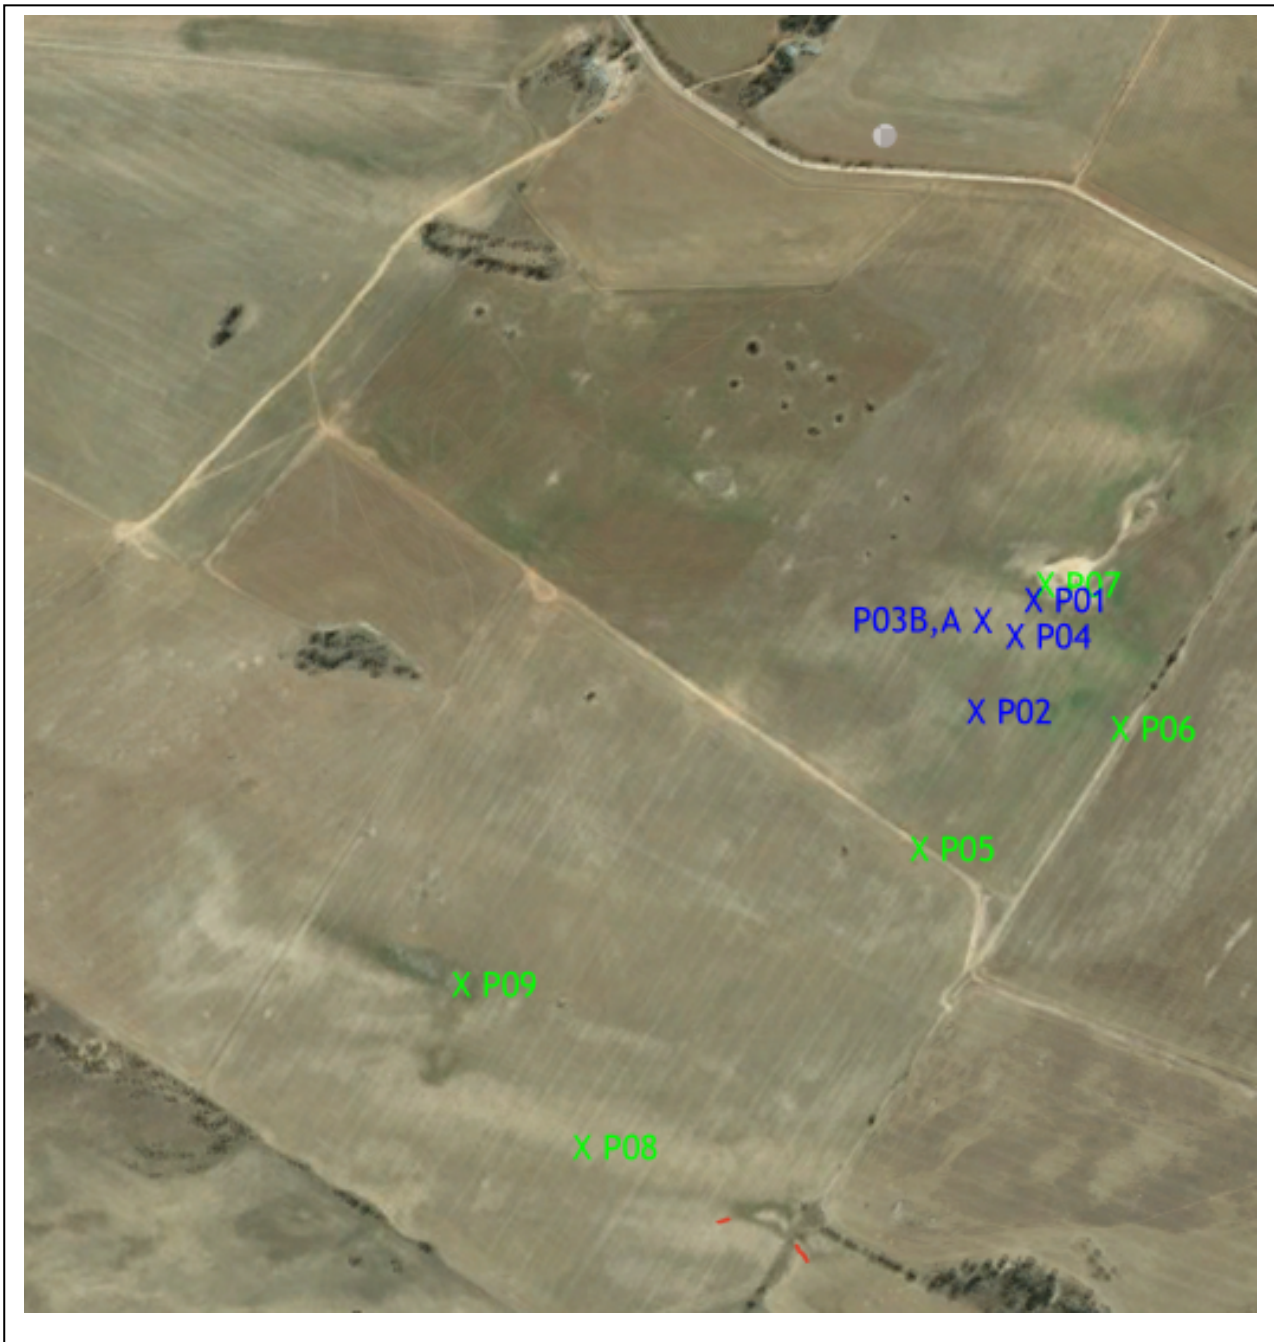
Figure 3 Pope subcatchment near Karoonda in the South Australian Murray Mallee showing approximate locations of soil characterisation sites (in blue – see Hall 2016) together with drilling and well establishment sites (in green). Sites P05, P06 and P07 are situated within 'Paddock A', with drainage from P05 toward P07 and the main farm seep; while sites P08 and P09 are situated within 'Paddock B', with drainage from P08 to P09. A 2001 aerial photograph merged with a 2013 photo is shown as background. Seeps show as bare or darker areas in the landscape.

^B The datum for elevation is taken from the bare eroded area in the middle of the main farm seep a few metres northeast of Site P07 (see **Figure 3**).

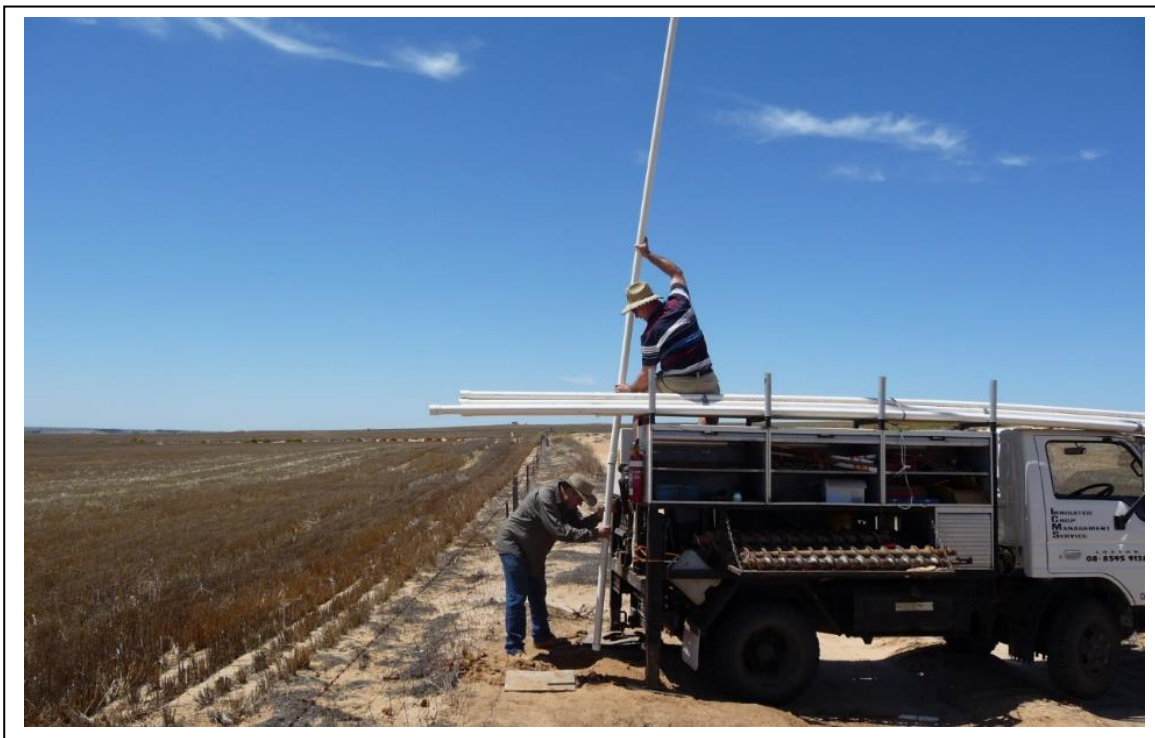
Figure 4 Installation of piezometer well tubing at Site MDS-P05.

The last ~30 cm of material (~440–470 cm) was Blanchetown Clay, which forms the aquatard upon which a moist to wet but not saturated layer was observed.

Casing	50 mm class PN18 PVC-U
Screen	Vertically slotted for 1.5 m (3.19–4.69 m depth)
Gravel pack	Washed gravel to cover the screen
Bentonite seal	Bentonite pebbles poured down to form watertight seal above the gravel pack to within 0.2 m of the ground surface
Riser height	Piesometer tube is 1.0 m above ground surface.

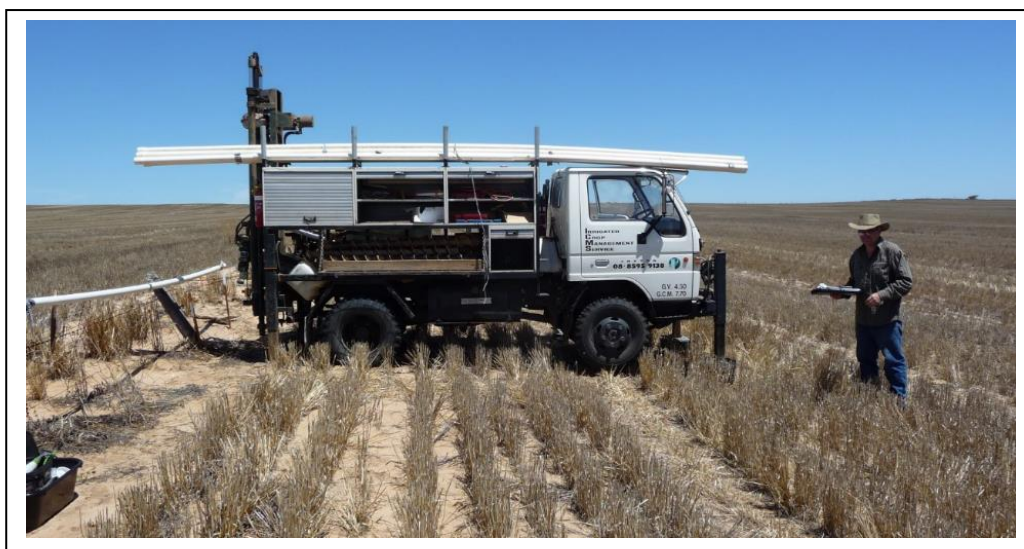
Figure 5 Drilling at Site MDS-P06.

From ~470–620 cm is Blanchetown Clay, as observed on the lowest auger sections when they were retrieved. However, this heavy clay material did not travel-up the auger, which makes depths of upper materials uncertain. The Blanchetown Clay forms the aquatard upon which a saturated layer was observed. After installation, free water was observed in the well.

Casing	50 mm class PN18 PVC-U
Screen	Vertically slotted for 3 m (3.2–6.2 m depth)
Gravel pack	Washed gravel to cover the screen
Bentonite seal	Bentonite pebbles poured down to form watertight seal above the gravel pack to within 0.2 m of the ground surface
Riser height	Piesometer tube is 0.98 m above ground surface.

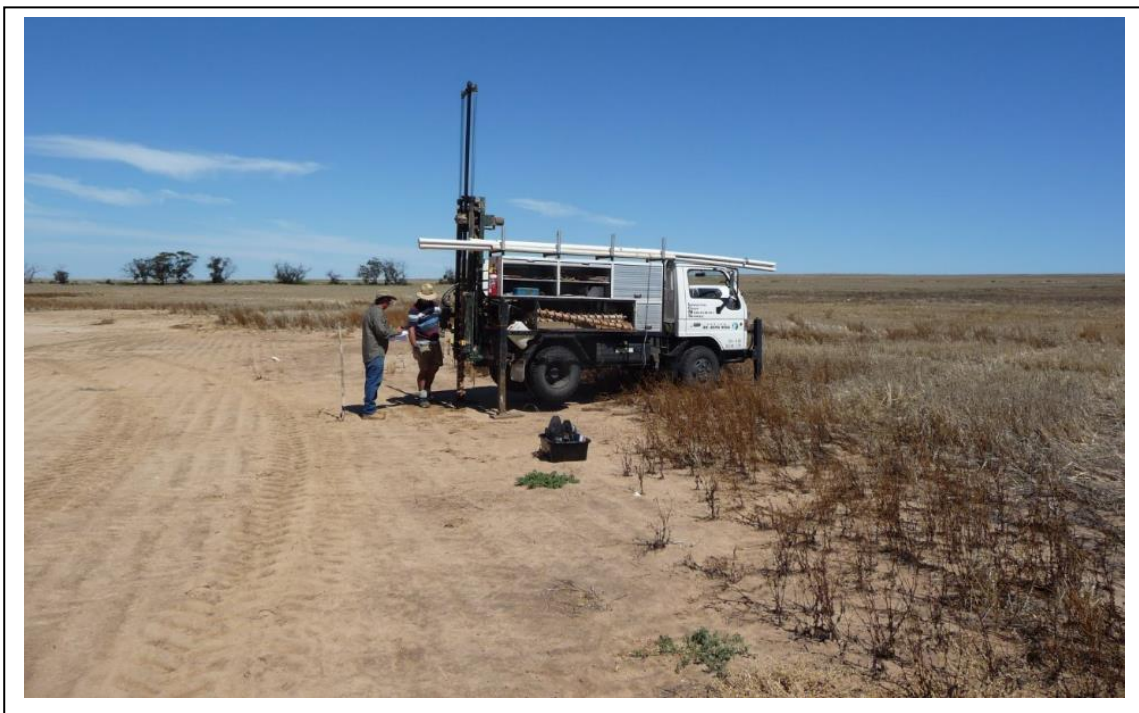
Figure 6 Drilling at Site MDS-P07.

From ~260–350 cm is Blanchetown Clay. The Blanchetown Clay forms the aquatard upon which the saturated layers of the seep were observed.

Casing	50 mm class PN18 PVC-U
Screen	Vertically slotted for 1.5 m (2.0–3.5 m depth)
Gravel pack	Washed gravel to cover the screen
Bentonite seal	Bentonite pebbles poured down to form watertight seal above the gravel pack to within 0.2 m of the ground surface
Riser height	Piesometer tube is 1.0 m above ground surface.

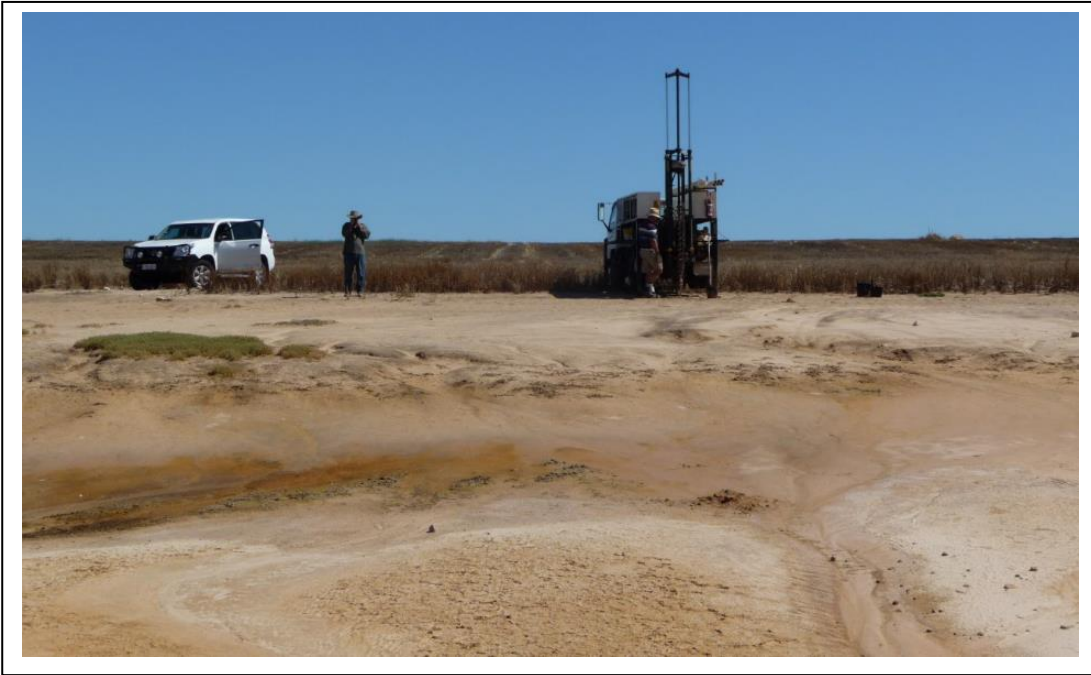
Figure 8 Drilling at Site MDS-P07 – looking upslope.

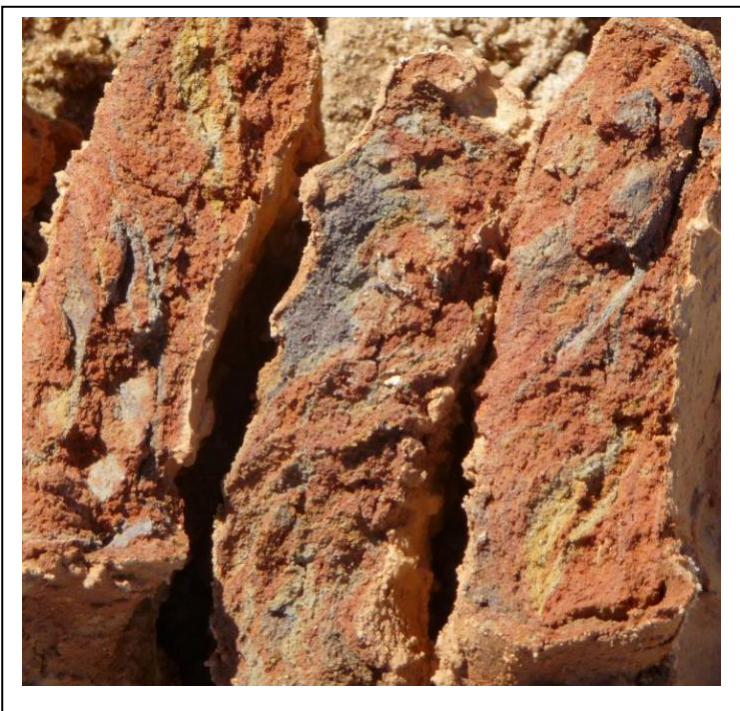
Figure 7 A close-up of Blanchetown Clay from Site MDS-P07.

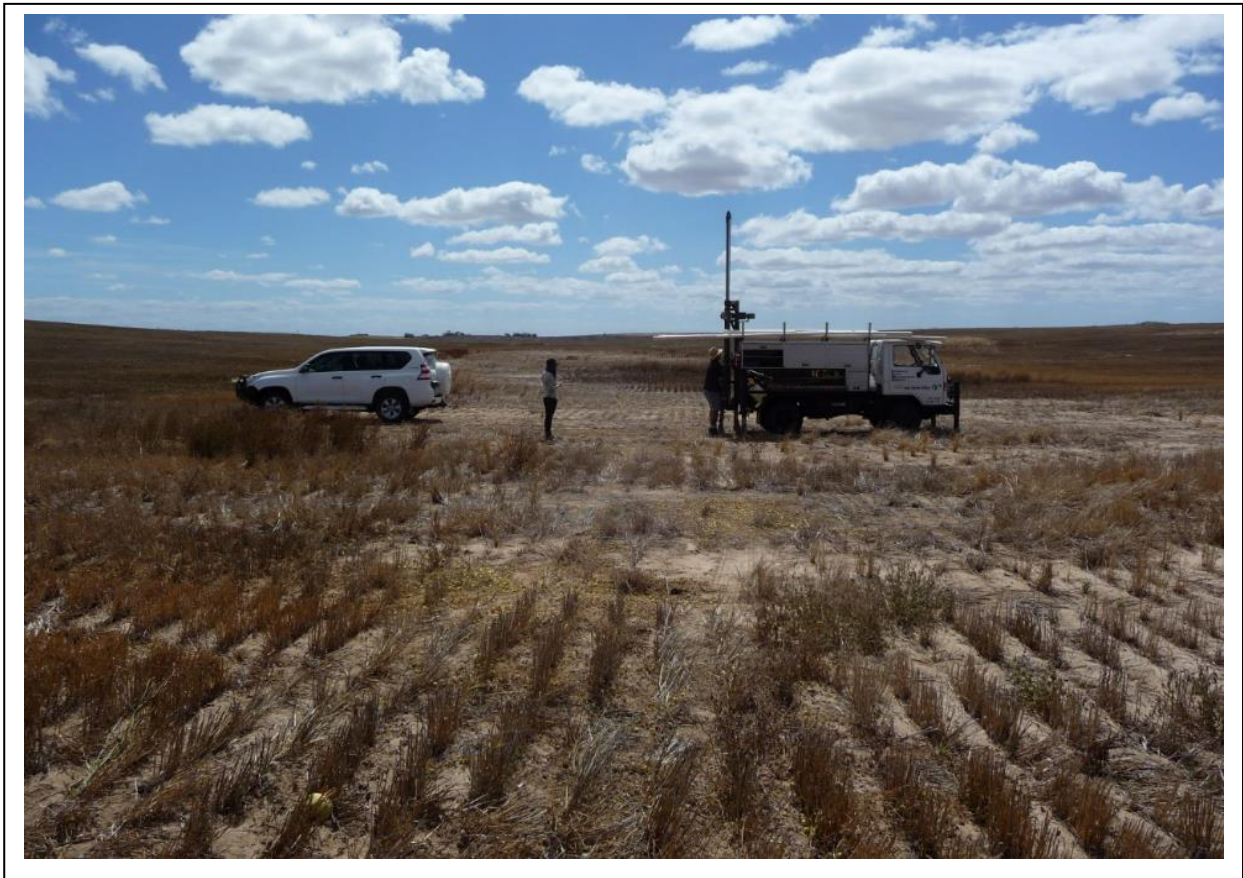
Figure 9 Drilling at Site MDS-P09.

The Blanchetown Clay forms the aquatard upon which the saturated layers of the seep were observed.

Casing	50 mm class PN18 PVC-U
Screen	Vertically slotted for 1 m (1.42–2.42 m depth)
Gravel pack	Washed gravel to cover the screen
