Mallee Dune Seeps  
Soil Characterisation and Land Unit Mapping  
Rose-Thomas Subcatchment

James A Hall  
Principal and Director, Juliet Creek Consulting Pty Ltd  
June 2015

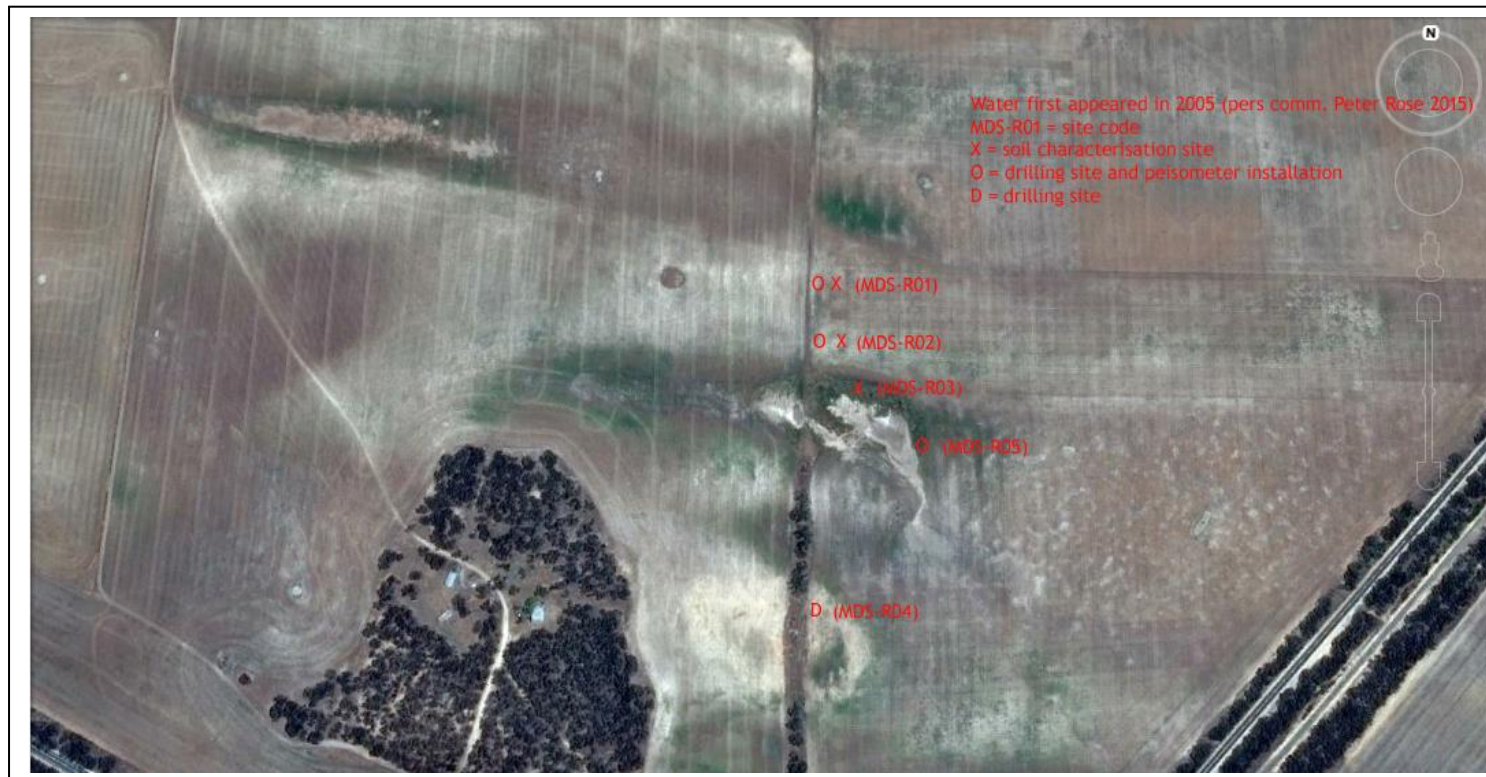
**Figure 1: Rose-Thomas Subcatchment at Kulde in the South Australian Murray Mallee: Showing Sites Investigated via Soil Characterisation and Drilling (showing a 2013 aerial image as background).**

This report is based upon initial investigations at the Rose-Thomas subcatchment area at Kulde, in the South Australian Murray Mallee (see Appendix 1, Figure 1 and Appendix 2), done in conjunction with Rural Solutions SA as part of an SA MDB NRM Board project.

Additional investigations (e.g. see Appendix 1, Figure 1) – such as drilling (to determine the nature of deeper materials and whether deeper perched water is present) and the installation of peisometer monitoring wells – will add to the overall ‘picture’ of mallee dune seep systems, and will be more fully reported upon, together with soil characterisation, API and assessments of relevant reference information, in subsequent reporting for the SA MDB NRM Board.

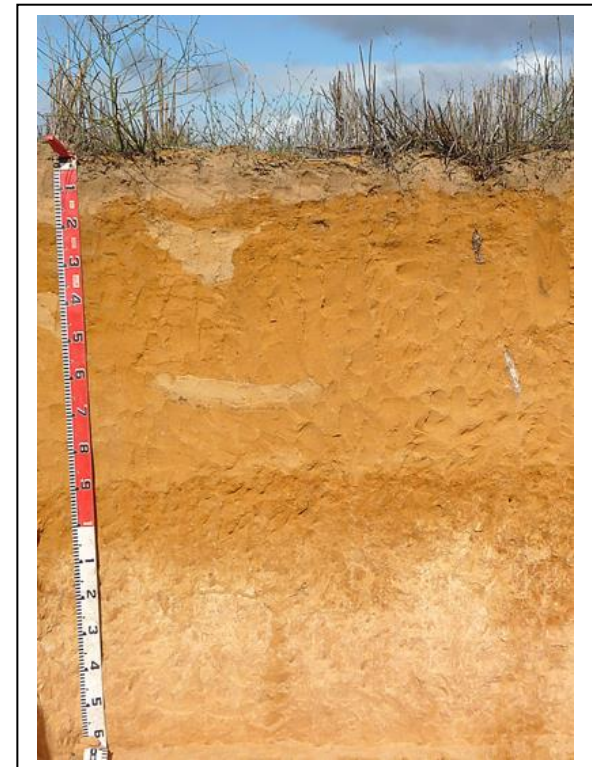
### SAND OVER SANDY LOAM / OVERLYING A BROWN MOTTLED SANDY CLAY LOAM

Medium thickness sandy surface soil on sandy loam subsoil which overlies brown mottled sandy clay loam with fine carbonate at depth.

Depth (cm)	Description
0–12	Loose, brown loamy sand with single grain structure. Abrupt boundary to:
12–14	Light yellowish brown, bleached, loamy sand with single grain structure. Abrupt boundary to:
14–30	Brownish yellow, light sandy clay loam with heavier-textured, dark yellowish brown lamellae and massive structure. Gradual boundary to:
30–60	Brownish yellow, sandy loam with a few heavier-textured lamellae and massive structure. Gradual boundary to:
60–90	Yellowish brown, sandy loam with massive structure. Abrupt boundary to:
90–110	Slightly calcareous, brownish yellow, strong brown and olive yellow, light sandy clay loam with massive structure. Clear boundary to:
110–165	Highly calcareous, reddish yellow, light sandy clay loam with massive structure.

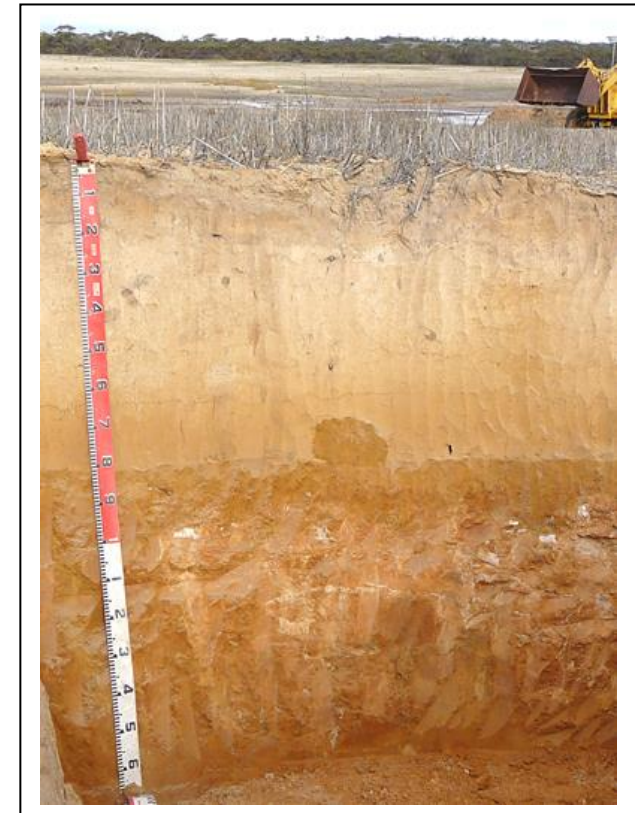
## VERY THICK BLEACHED SAND OVER BROWN MOTTLED CLAY

Very thick sandy topsoil with some bleaching, overlying slightly dispersive brown mottled clay subsoil with fine and hard carbonate.

Depth (cm)	Description
0-18	Loose, water repellent, brown loamy sand with single grain structure. Abrupt boundary to:
18-60	Very pale brown and brownish yellow, sporadically bleached, sand with single grain structure. Clear boundary to:
60-80	Brownish yellow loamy sand with single grain structure and minor heavier-textured lamellae. Sharp boundary to:
80-98	Yellowish brown, strong brown and olive yellow, light clay with massive structure. Gradual boundary to:
98-120	Yellowish brown, strong brown and olive yellow, slightly dispersive, moderately calcareous, light medium clay with approximately 20% hard carbonate fragments (2-20 mm) and laminae, as well as massive structure. Gradual boundary to:
120-170	Yellowish brown, strong brown and olive yellow, slightly dispersive, fine sandy medium clay with massive structure.

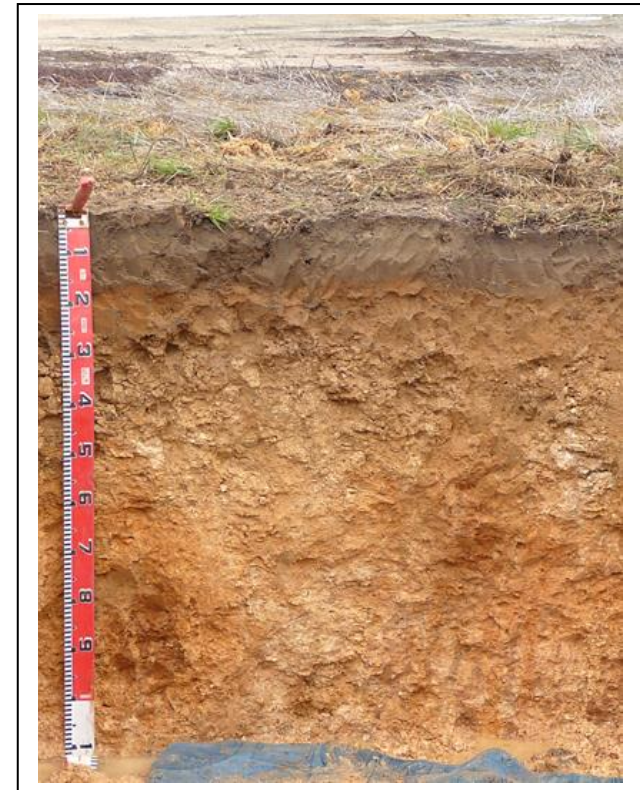
## WET SANDY LOAM OVER SANDY CLAY LOAM

Thick sandy loam topsoil with abundant hard carbonate in the lower part, over sandy clay loam subsoil with fine and hard carbonate.

Depth (cm)	Description
0–15	Soft, dark brown, sandy loam with massive structure. Clear boundary to:
15–28	Slightly calcareous, brown sandy loam with massive structure. Clear boundary to:
28–47	Moderately calcareous, yellowish brown, heavy sandy loam with abundant hard carbonate nodules (20–60 mm). Clear boundary to:
47–62	Moderately calcareous, reddish yellow sandy clay loam with massive structure and abundant hard carbonate fragments (2–60 mm). Clear boundary to:
62–95	Highly calcareous, strong brown, yellowish brown and dark red, clay loam. Clear boundary to:
95–115	Highly calcareous, reddish yellow, pink and yellowish red, light clay with 20–50% hard carbonate fragments (6–60 mm).
