Monitoring Mallee Seeps

Project 1403C for the
South Australian Murray-Darling Basin
Natural Resources Management Board
Progress Report Jan-June 2016

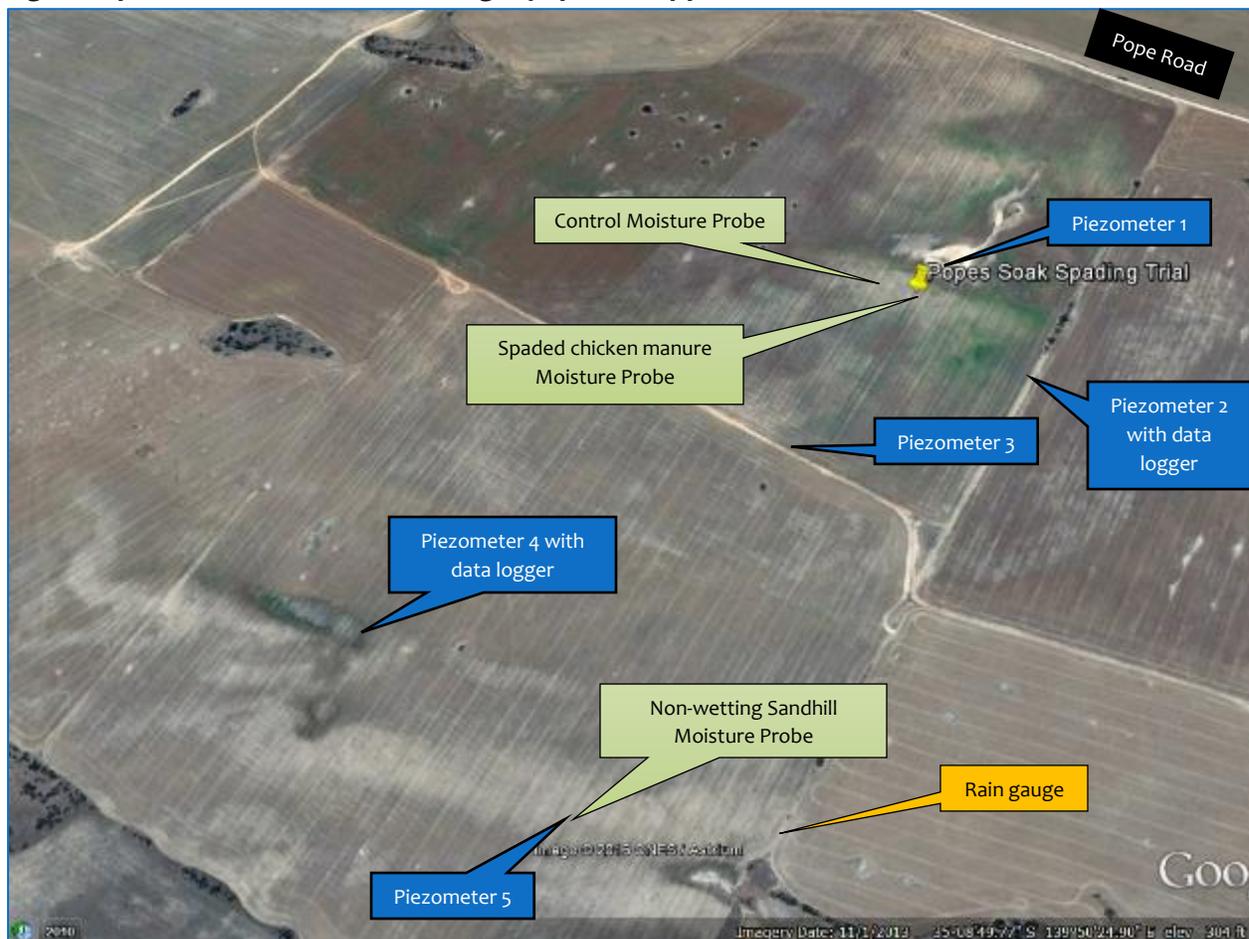
Fig 1. Pope soak site with monitoring equipment approx. locations

Since the harvest of the Spading trial last year, the site monitoring has been focused around the soil moisture probes and piezometers. Figure 1 shows the general locations of all of the monitoring points including moisture probes, piezometers and the tipping bucket rain gauge. Only 2 of the 5 piezometers have data loggers attached at present. It will be important that the remaining piezometers are fitted with data loggers as soon as possible to maximize data gained to better understand the soil moisture dynamics of the catchment.

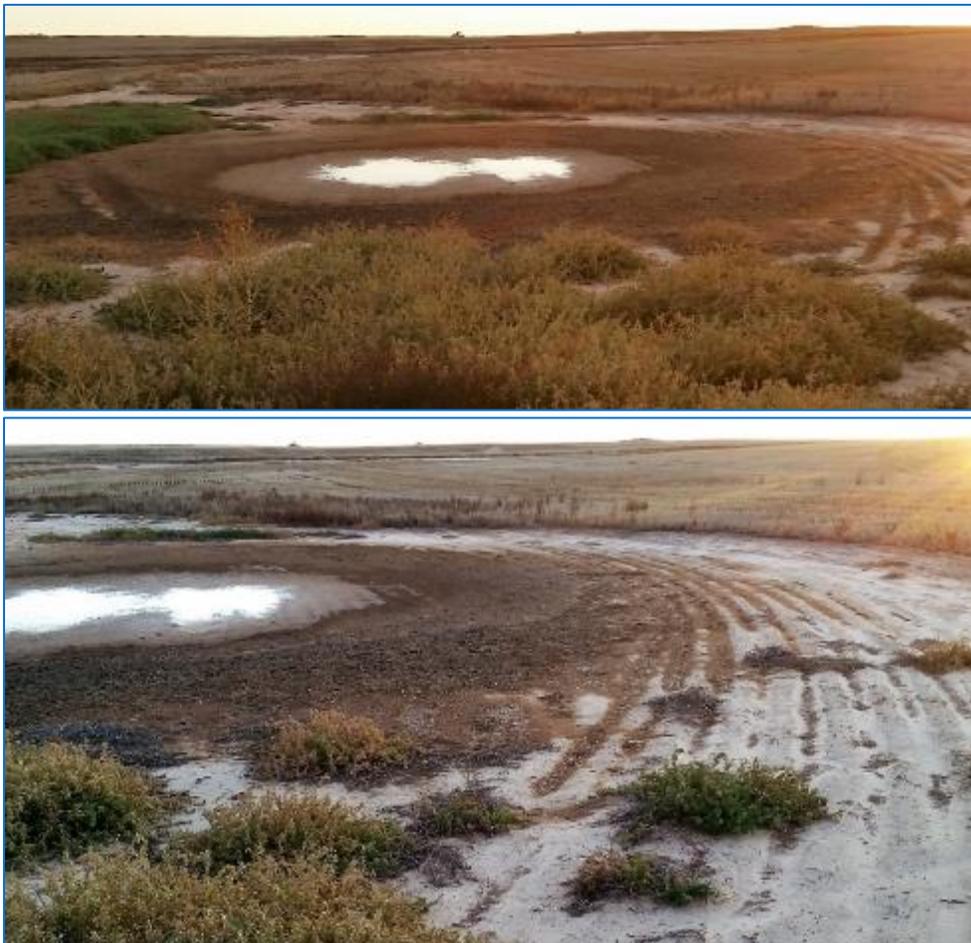
Fig 12-13. Small seep at base of main seep area after summer rain, Feb 10, 2016

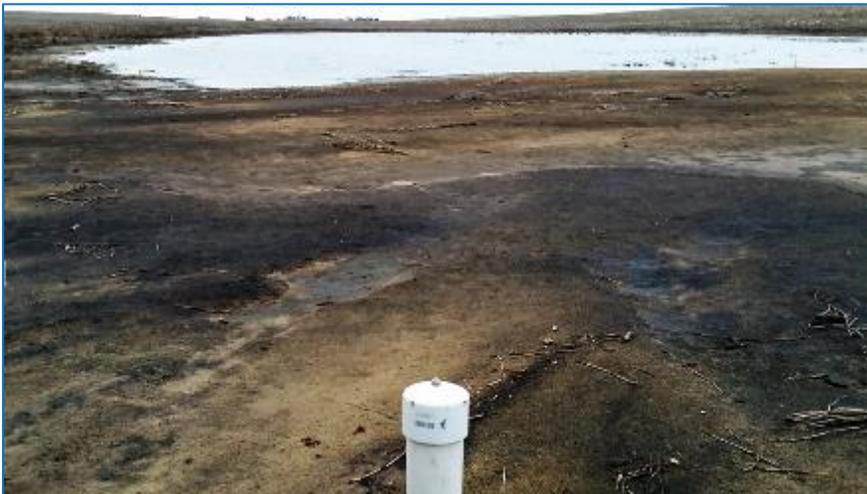
Fig 15. Evidence of moisture rise and fall at Piezometer 4 seep, May 2016

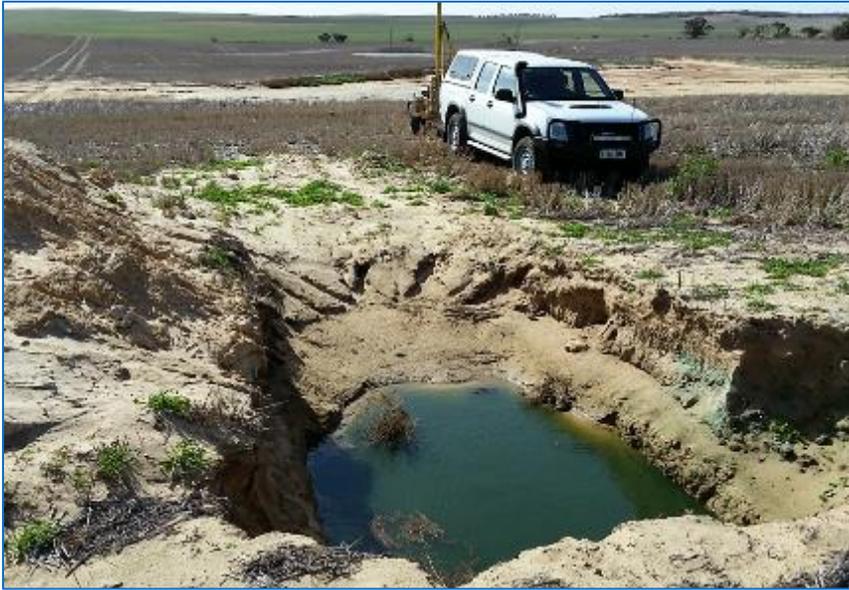
Fig 17. Soil pit above main seep, filled with water after March rain, May 12, 2016

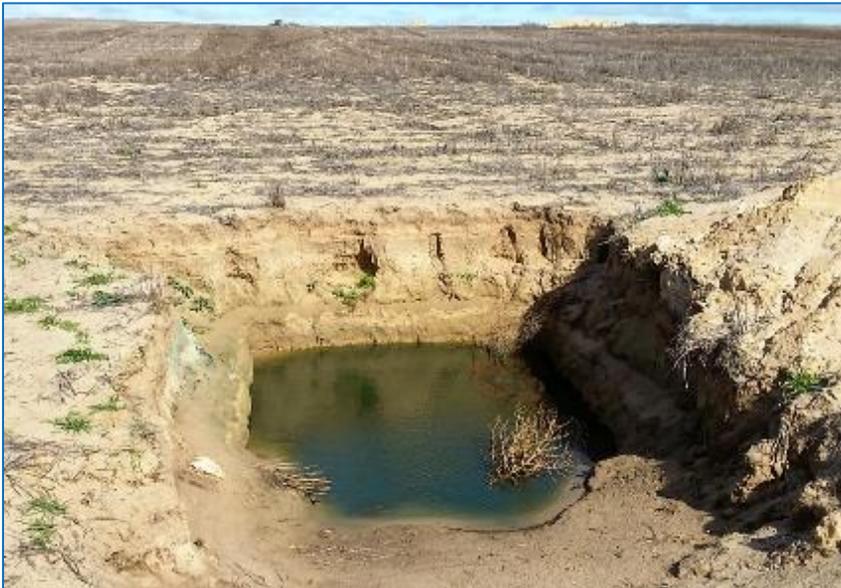
Fig 18. Soil pit above main seep, filled with water after March rain, May 12, 2016

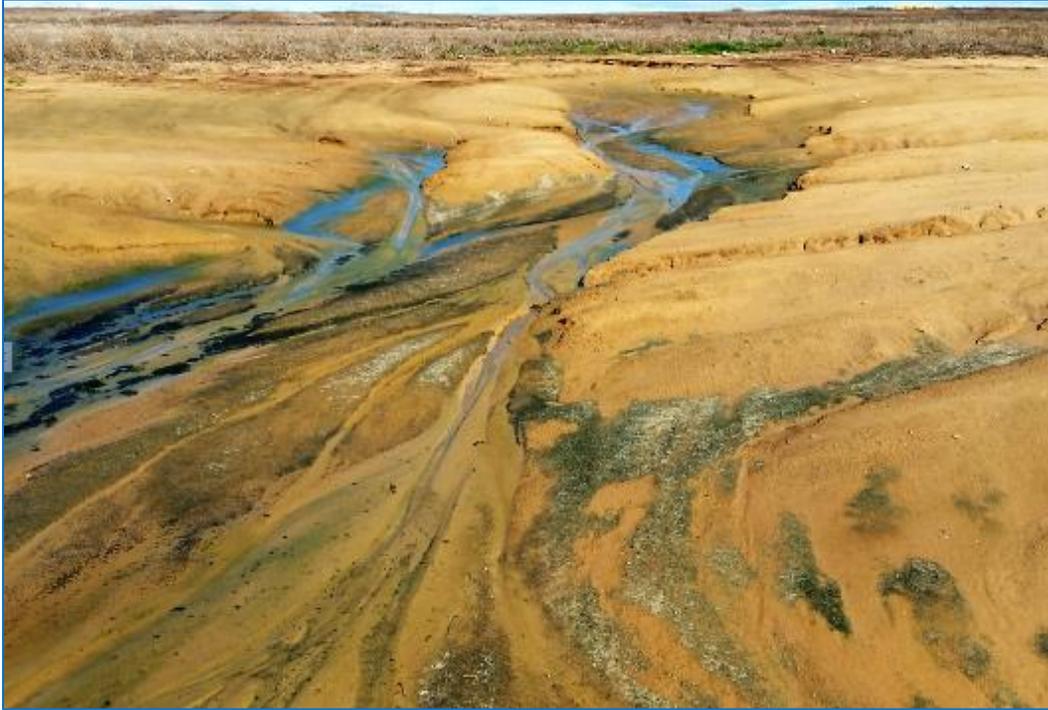
Fig 19. Moisture flowing still draining out of sand into soak, May 12, 2016

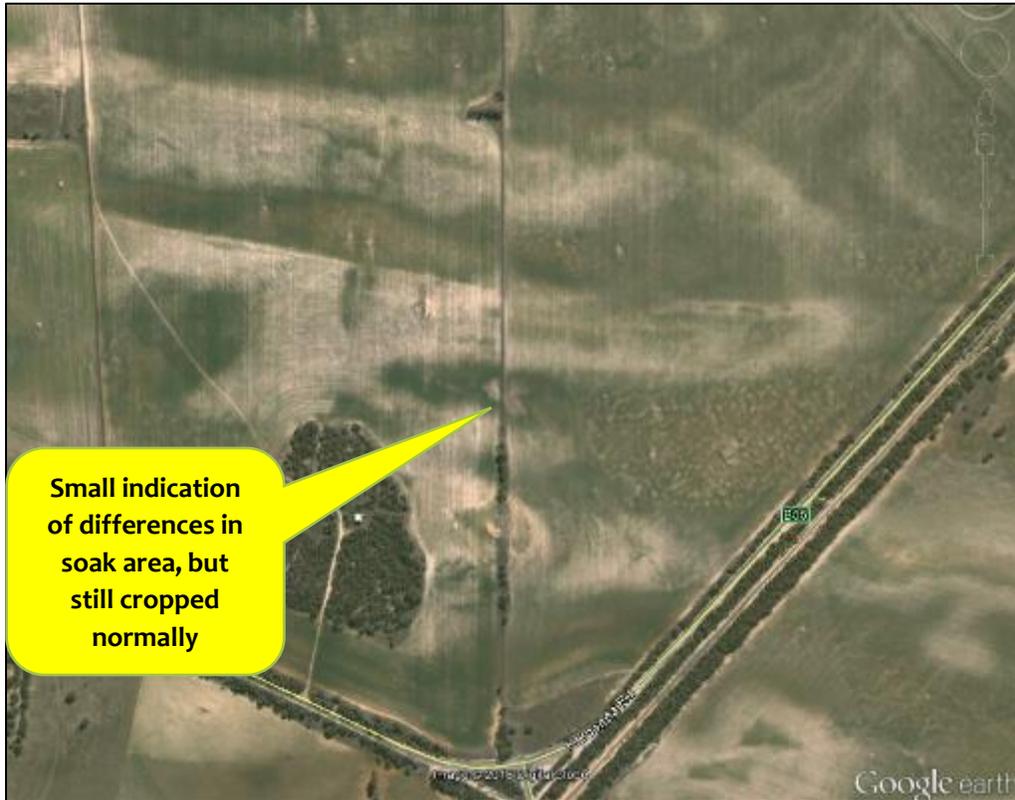
Fig 25. Immediate catchment area 2006 still being cropped through.

Figures 25-27 show the development of the seeps in this immediate catchment between 2006 and 2013, according to Google Earth imaging. The farmers said that the most dramatic change happened after the wet season of 2010.

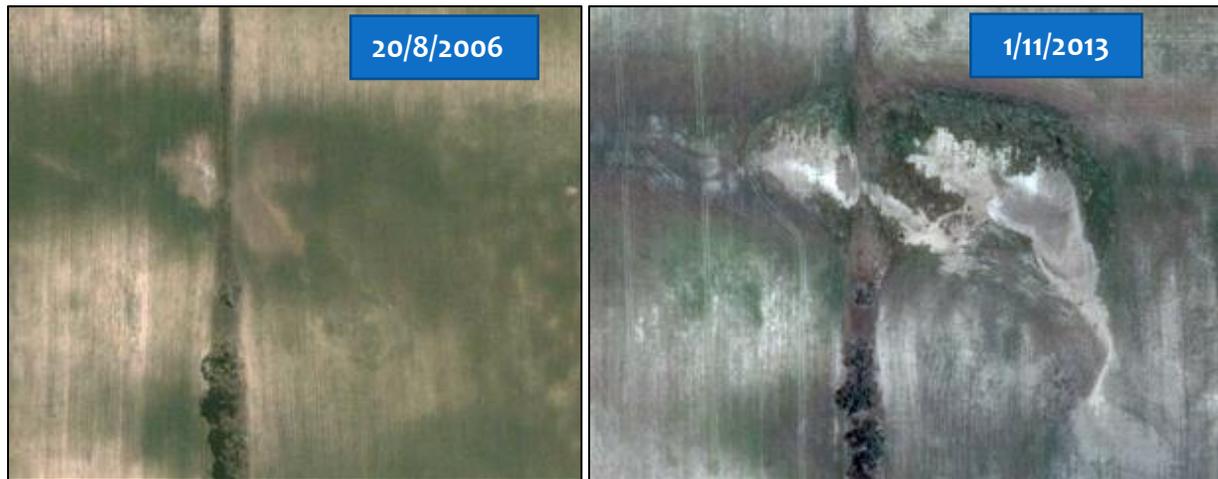
Fig 27. Google earth comparisons of main seep area showing extensive spread of scald

The bare areas of accumulating salt crystals at this site are of major concern, and should be addressed in the coming year by establishing salt tolerant ground cover species to minimise evaporation effects.

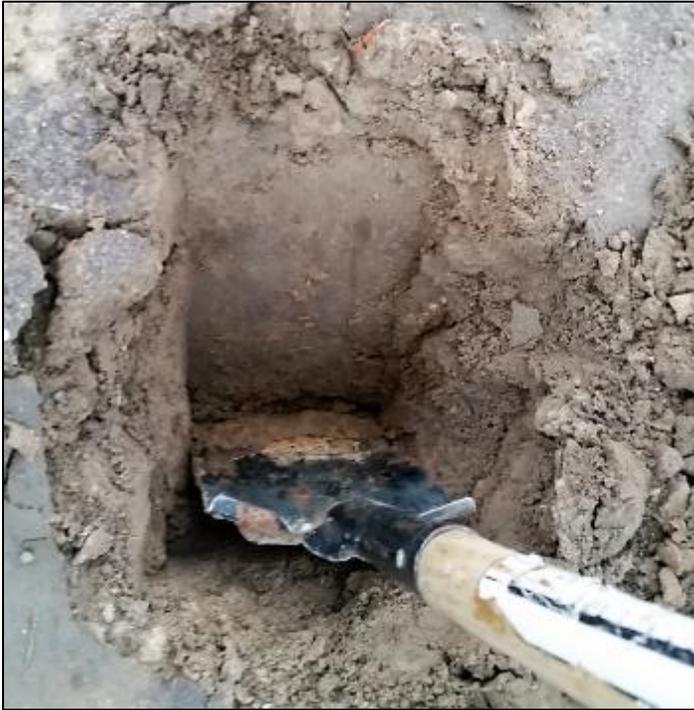
Fig 38. No sloppy clay for at least 30cm depth in scald at end of the overflow area

The main features of the photographs is the ponded water at the main seep which remains after peaking soon after the March rain. The overflow area shown in Figures 37 and 38 has not maintained saturated soil near the surface due to its sandy nature. This is in contrast to the emerging seep area on the north side where the soil moisture appears to be maintained due to the red clay base at 20-30cm depth.

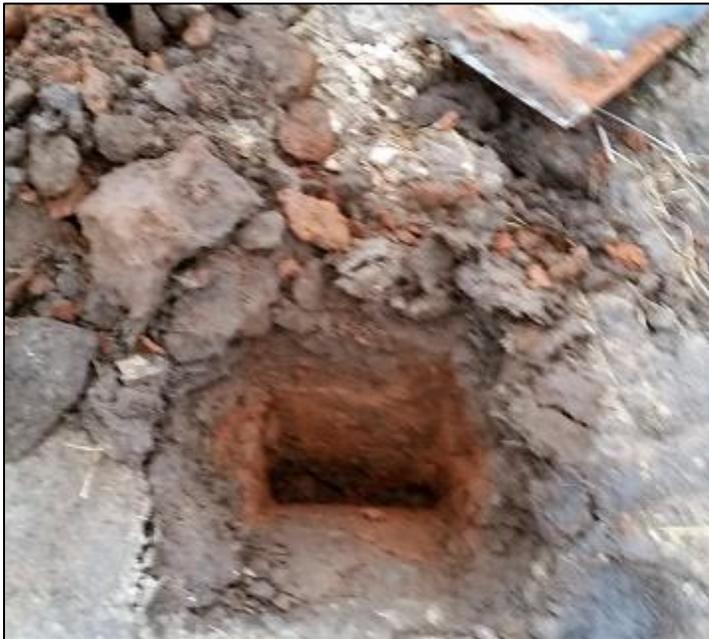
Fig 44. Sloppy red clay evident at 20-30cm at emerging seep scald. May 11, 2016

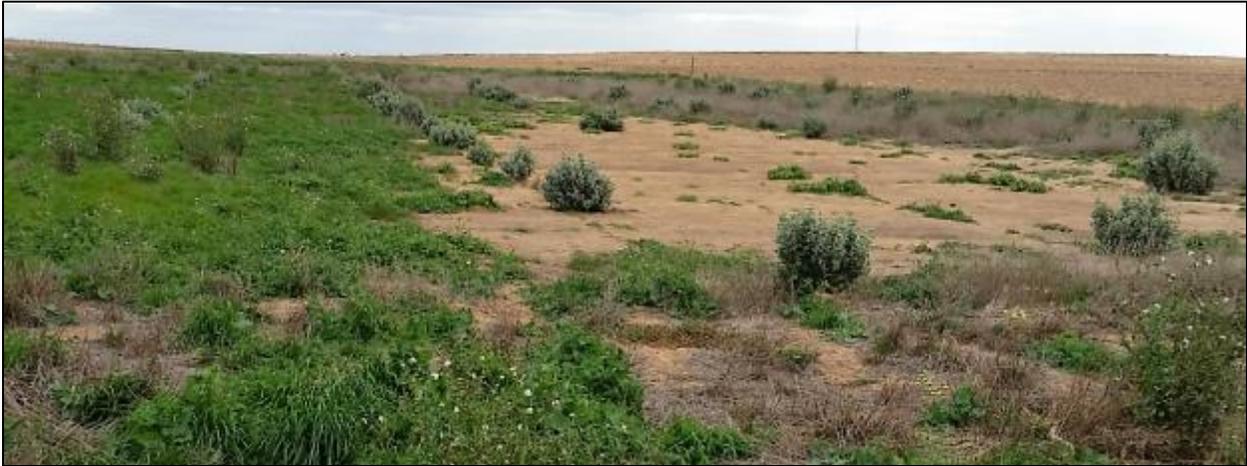
The main saltbush area has shown about a 44% survival rate, growing reasonably well through the scalded and edge of seep areas, but poorly on the strips moving up the sandhill (Figs 49 and 50). This strongly supports the decision to target the activity where the water is accumulating in the soak (to maximize growth and grazing), rather than the sandhill, which although may be contributing much of the moisture, is very difficult to establish. This site could benefit from replanting of saltbush seedlings in some of the gap areas.

Fig 49. Good establishment through most of the saltbush planting, May 2016

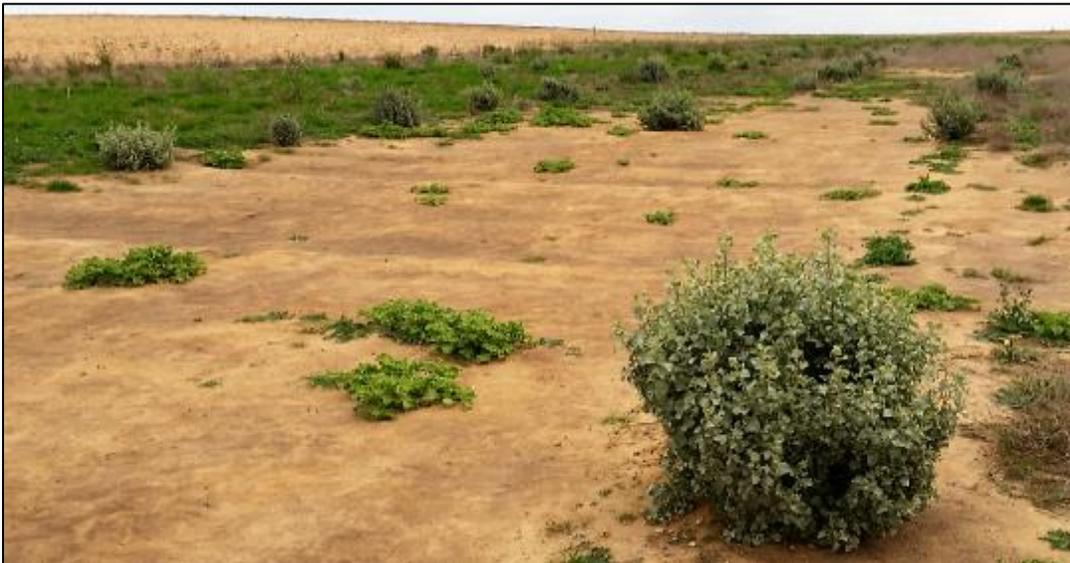
Fig 50. Good establishment through most of the saltbush planting, edge of sandhill, May 2016

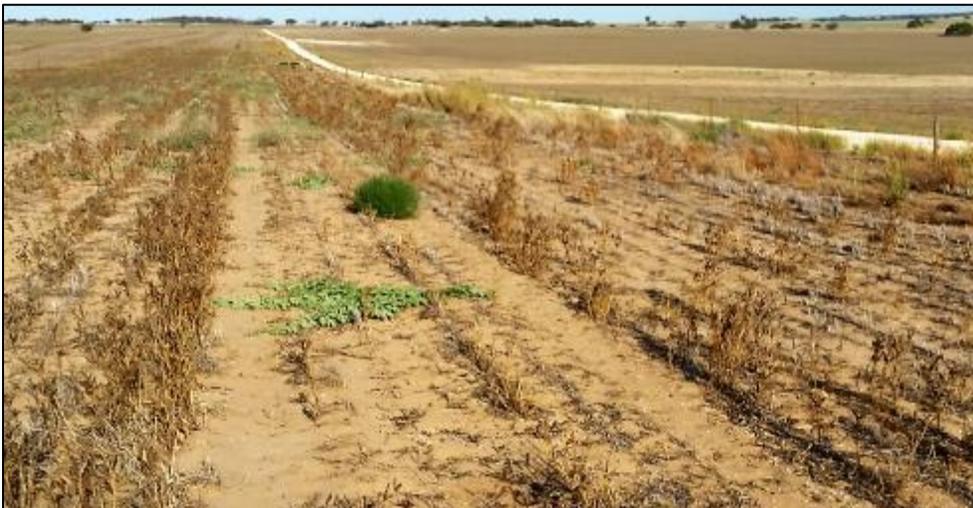
The five rows of tree planting along the fence line has been fenced (Figs 51-53), but has also suffered from very poor survival rates. While the farmers did water trees during winter and spring, they said it was very difficult to get the water to soak in, rather than run off. This may have been improved with a better basin created around each tree at sowing (which did happen to some extent, but was not easily sustained), and possibly the use of tree guards. Plant establishment is very poor at the western end deeper sandy rise.

Fig 51. Tree planting area along fence above seep area with very poor survival, Feb 2016

The farmer is hoping to replant trees through this area, but would benefit from any assistance in achieving this. It is hoped that this tree plantation will help to intercept the movement of water across the perched water table and surfacing at the seep area below, which is now full of thick ryegrass for much of the year, due to the extra moisture. This is nowhere near the bottom of the catchment. If more trees can be used to replace the dead seedlings in 2016, it would require more attention to strategic watering and tree guards to ensure a higher rate of plant establishment. The weed population of melons, lupins, capeweed, turnip and thistles will need to be controlled.

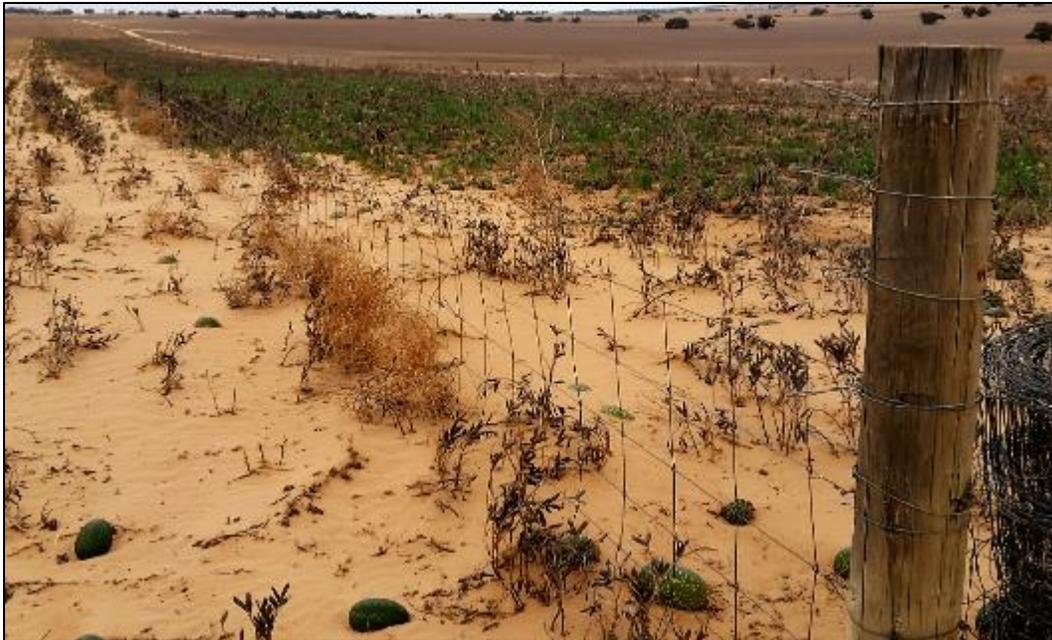
Fig 53. Poor sand making plant survival very difficult, Feb 2016

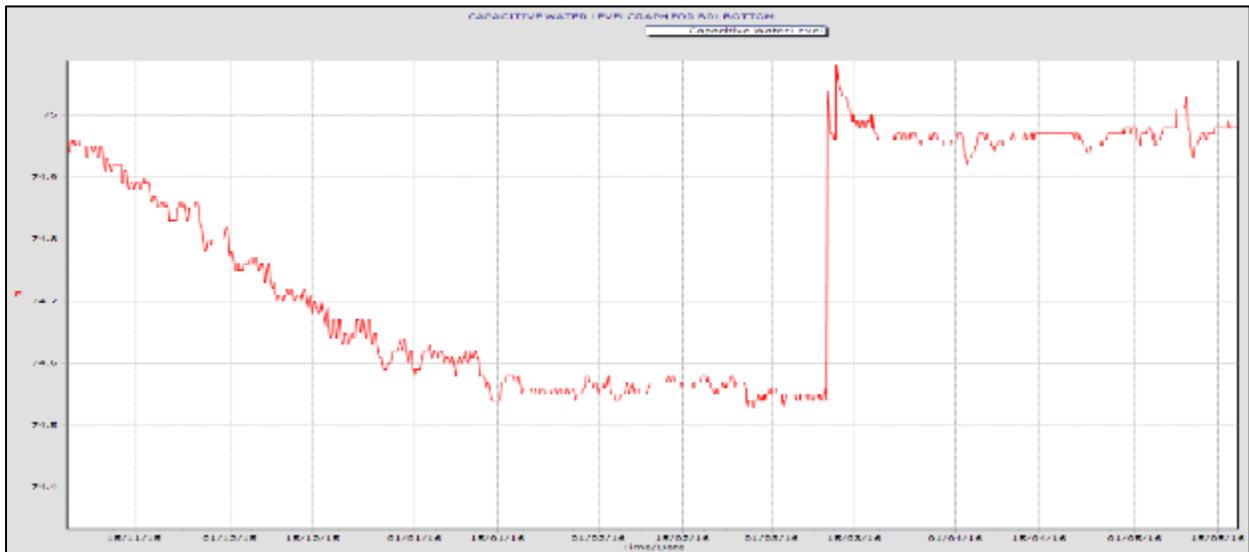
Fig 59. Piezometer readings for Bottom soak area, Nov 2015 - May 2016

The piezometer reading at the base of the soak area (Fig 59) shows that the perched water table was slowly declining over the summer, and that none of the summer rainfall events of up to 12mm were large enough to cause substantial lateral moisture movement in the catchment. However, the March rainfall lead to a very swift rise in water table of approximately 40cm, as evidenced by the nearby pit water level changed (Figs 66-68).

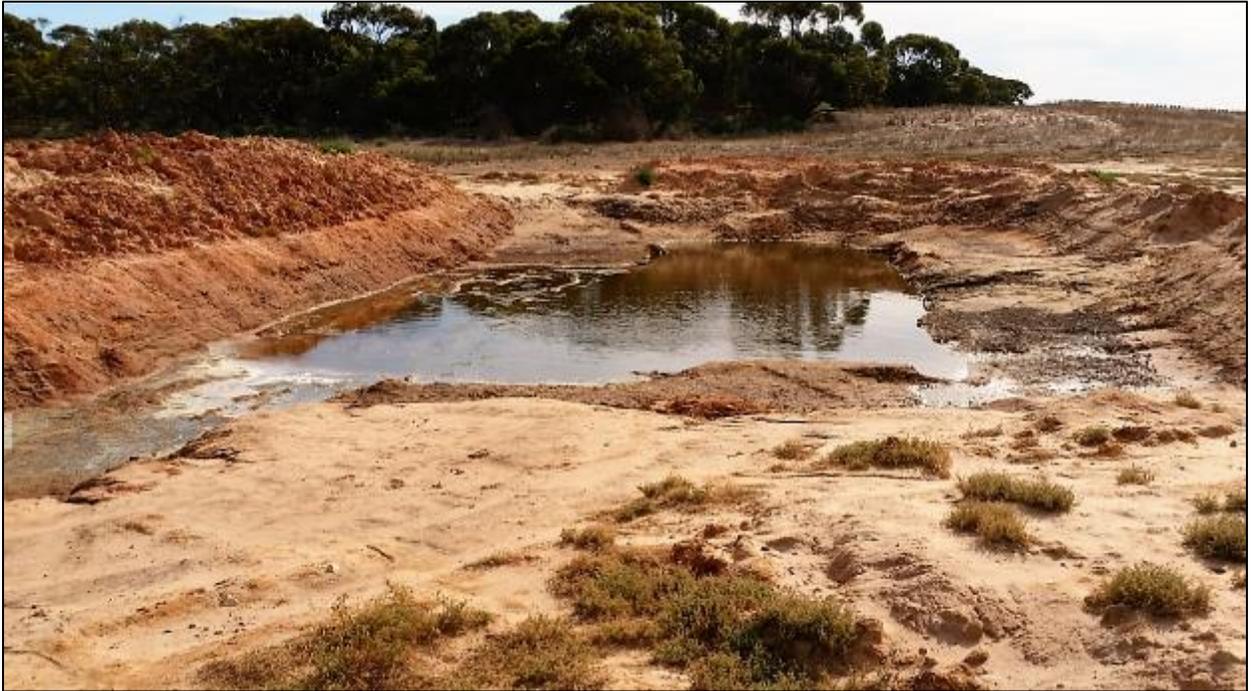
Fig 67. Large pit at seep area nearly empty in Feb 2016

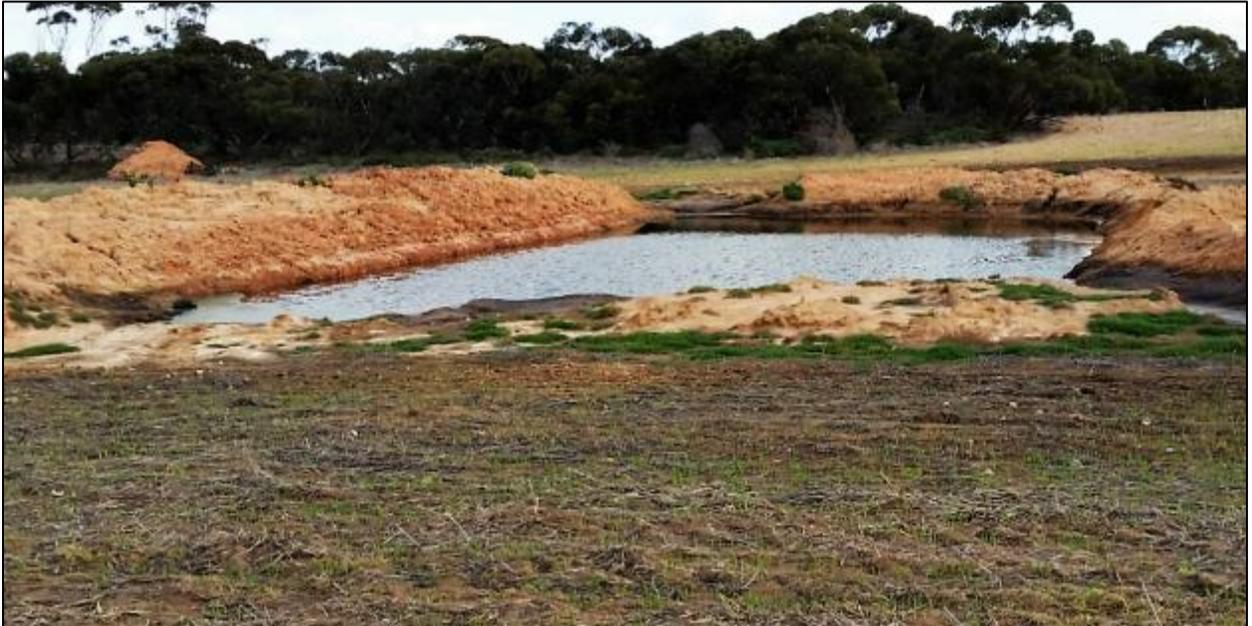
Fig 68. Large pit at seep area full at May 2016 after March rain

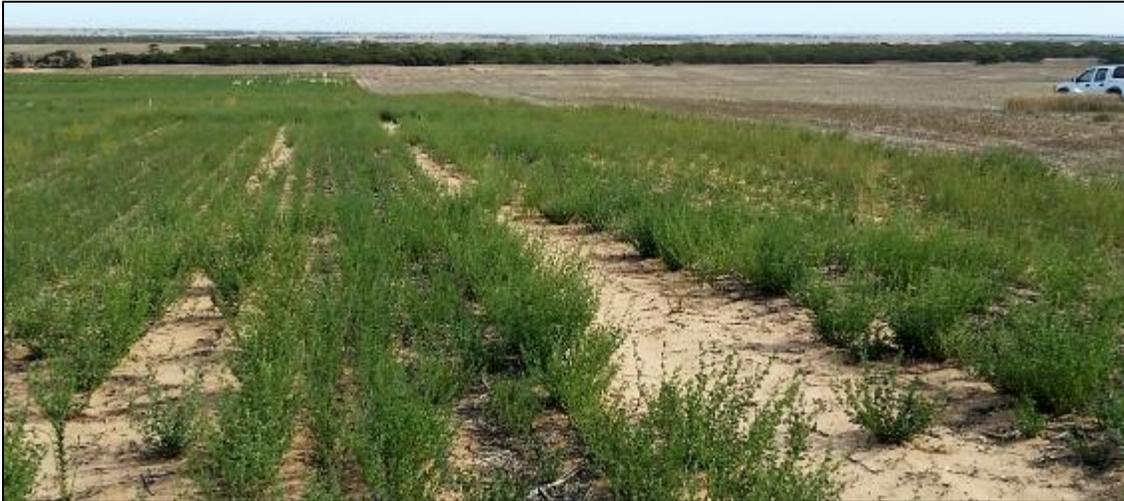
The variable sand around the soil moisture probe area experienced a 46% reduction in plant density, maintaining an average 13.3 pl/m². While this is quite lower than the previous areas, the plants are quite larger where densities are lower. This is shown in Figs 75 and 81.

Fig 75. Lucerne above moisture probes, variable sand area, Feb 2016
