PORT ADELAIDE STATE HERITAGE AREA

EXISTING CONDITION ASSESSMENT AND RECOMMENDATIONS

FEBRUARY 1992

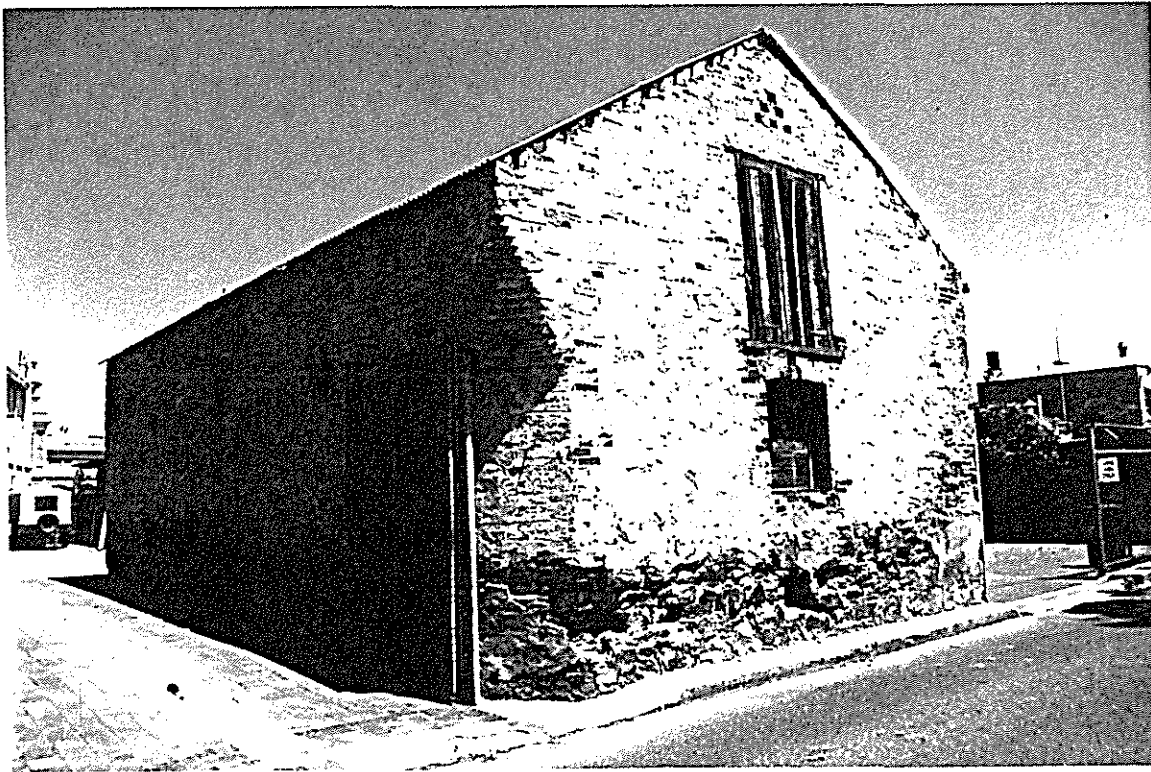
ADDRESS: Calton Street

BUILDING HISTORY AND ANALYSIS: This building was the stables of the Port Admiral Hotel and is simply constructed in random stone, rubble and brick. It is currently in poor condition having been rendered on the side wall (presumably to address the damp problem). It is currently at risk, with gutters deteriorated and down pipes non functional. There is extreme deterioration of stone work and brick work, all joinery is badly dilapidated and roofing is inadequate with absence of fascias and barge cappings.

BUILDING IMPROVEMENT RECOMMENDATIONS: Stabilisation of this building is recommended to prevent further deterioration. Full restoration of this simple structure would be an expensive exercise and economically could be hard to justify. However, such simple structures are part of the Port's character and retention and restoration, stabilisation and recycling is to be strongly encouraged.

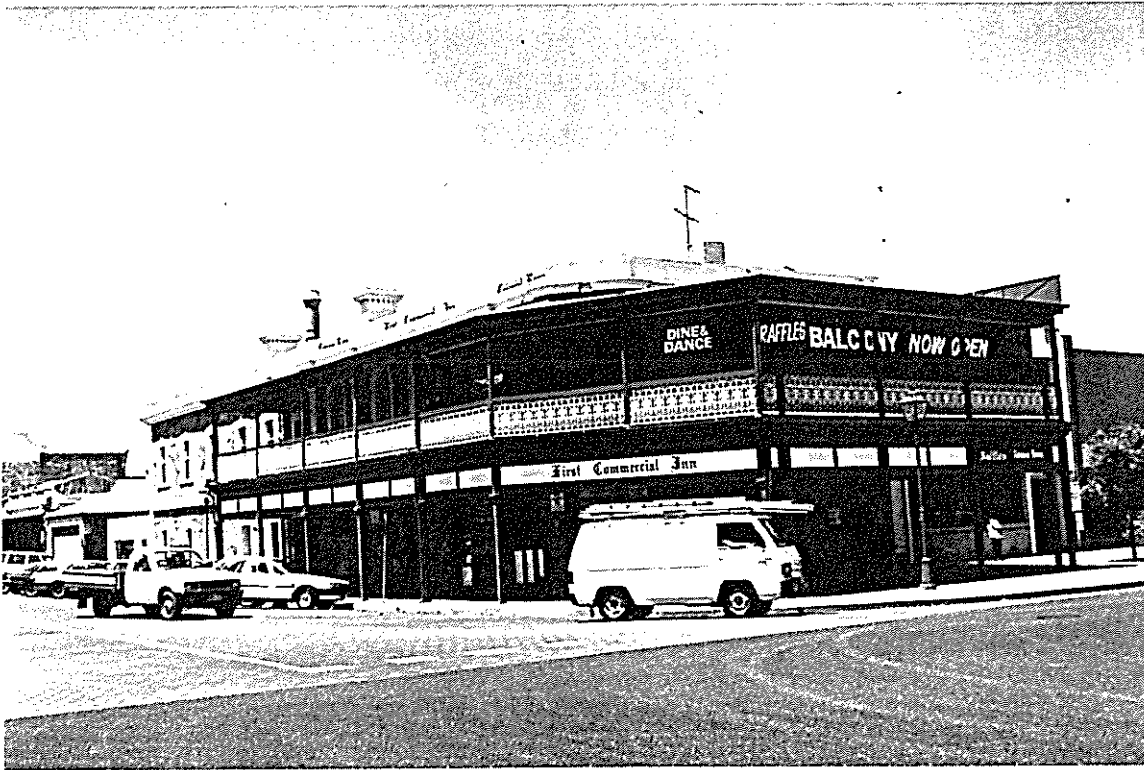
ADDRESS: 29-31 Commercial Road

BUILDING HISTORY AND ANALYSIS: The Commercial Hotel obtained its first license in 1840 but the original hotel was destroyed in a fire in 1857 which burnt out most of the block to the Port Admiral Hotel. It appears that the present hotel was built in the late 1880s and subsequent to that date the exterior has been altered. Originally the two storey verandah contained paired columns and a stripped roof as viewed in early photographs. Early sign writing hoarding is visible on the lower verandah level. The verandah was subsequently extended to footpath line at both levels to achieve its present configuration. This building has been upgraded and restored although the recent glazed infilling of the verandah at the upper level is inappropriate.

BUILDING IMPROVEMENT RECOMMENDATIONS: Continued careful maintenance of this building and removal of verandah infilling is recommended.

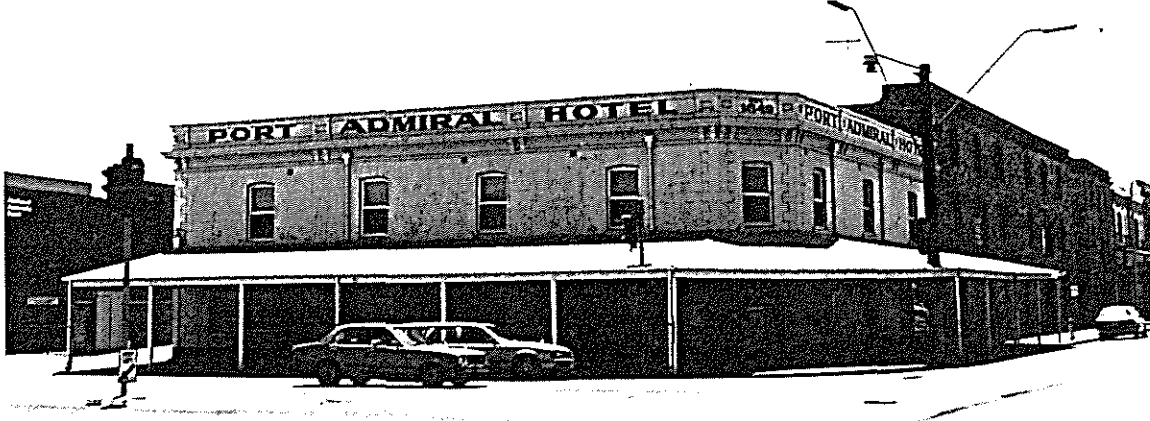
ADDRESS: 55 Commercial Road (cnr St Vincent Street)

BUILDING HISTORY AND ANALYSIS: This Hotel was first licensed as the "Railway Hotel" because one early scheme had routed the railway down the Port Road. An early engraving (1849-51) of this hotel survives at a time when there was not parapet or verandah constructed to the building. The verandah was added later than 1886. Original early rainheads installed at the time of parapet construction survive. The verandah is simple in detailing and appears to be a structural replacement of an earlier verandah (as there is no chamfering or any detailing to posts). The ground level to this building has steadily built up over time.

BUILDING IMPROVEMENT RECOMMENDATIONS: This building would benefit from reinstatement of original detailing which has been lost over time, including:

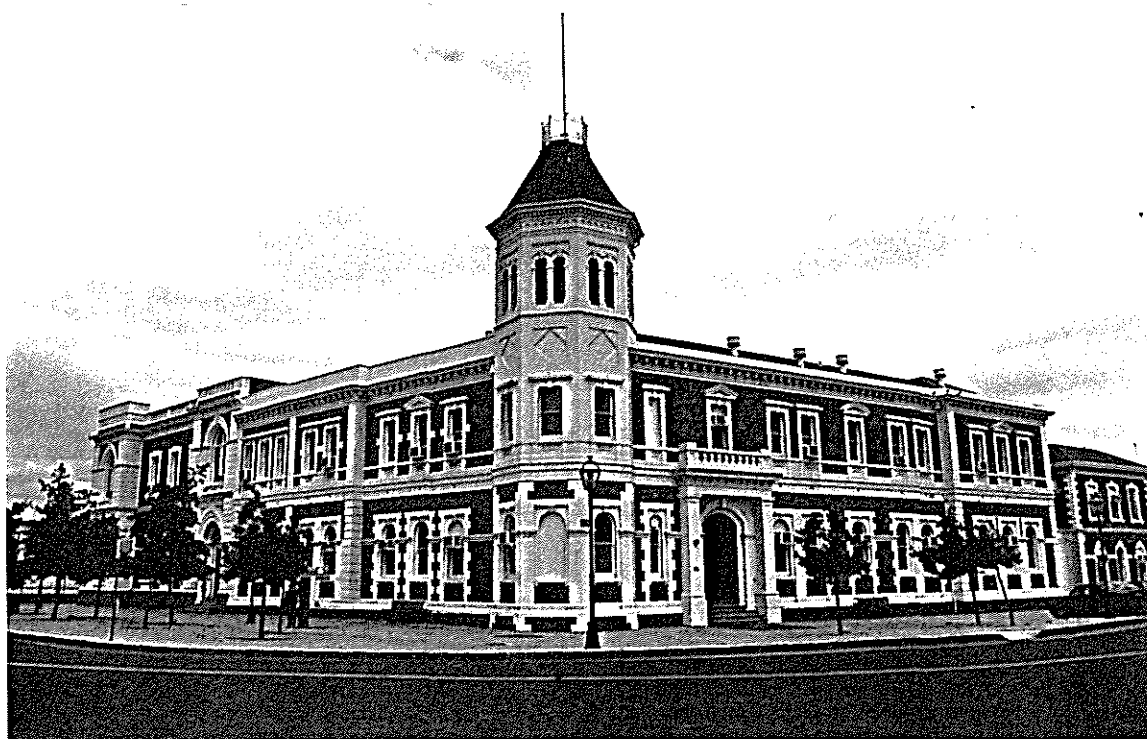
ADDRESS: 56 Commercial Road (North Parade & Nile Street)

This building has recently been the subject of a Conservation Plan which has been prepared by Peter Donovan & Associates and reference should be made to this study for a detailed physical and historical analysis.

The whole complex of buildings is currently vacant.

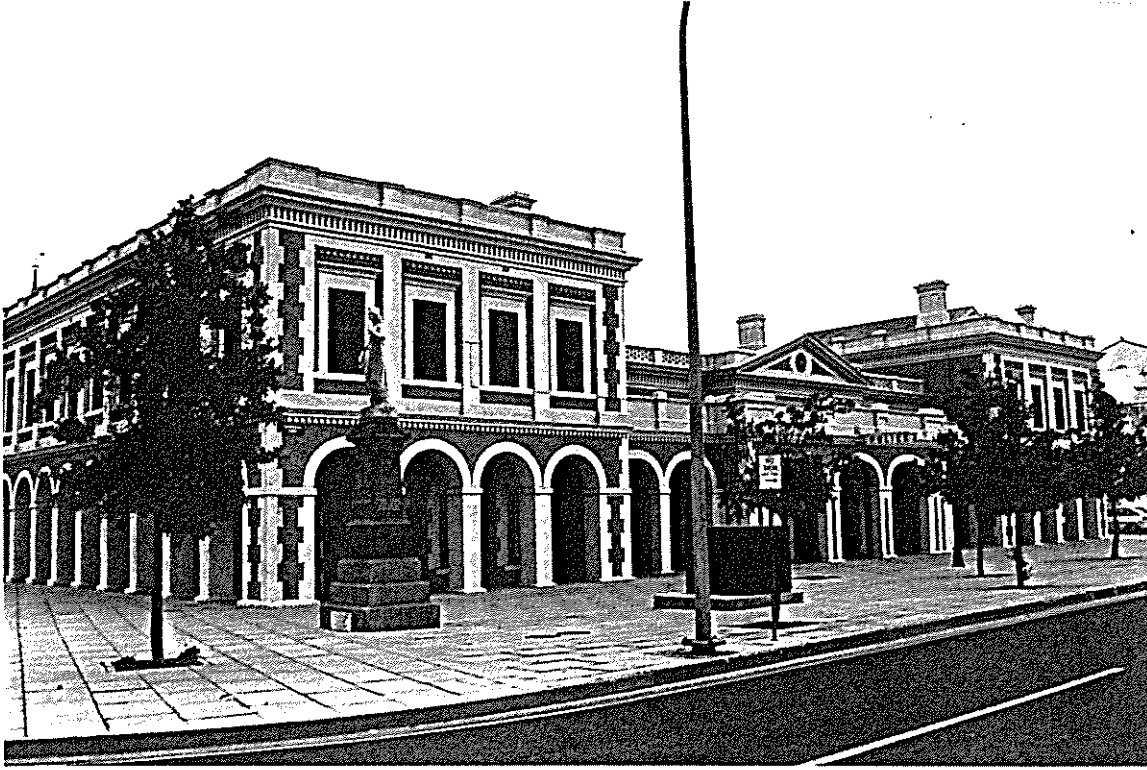
ADDRESS: 66 Commercial Road (cnr St Vincent Street)

The original building was of face blue stone, and it is evident by referring to early photographs that the ground level has been built up substantially concealing the base plinths of the substantial posts. The brick pillars have been repaired over time and rendered over and all brick dressings are now painted. There is evidence of serious problems of rising damp associated with this building and this is evident also on the front pillars.

BUILDING IMPROVEMENT RECOMMENDATIONS: An urgent assessment of the condition and proposed usage of this building must be undertaken immediately. It is a prominent government owned building which is located at a major intersection and is rapidly deteriorating. The building is at great risk.

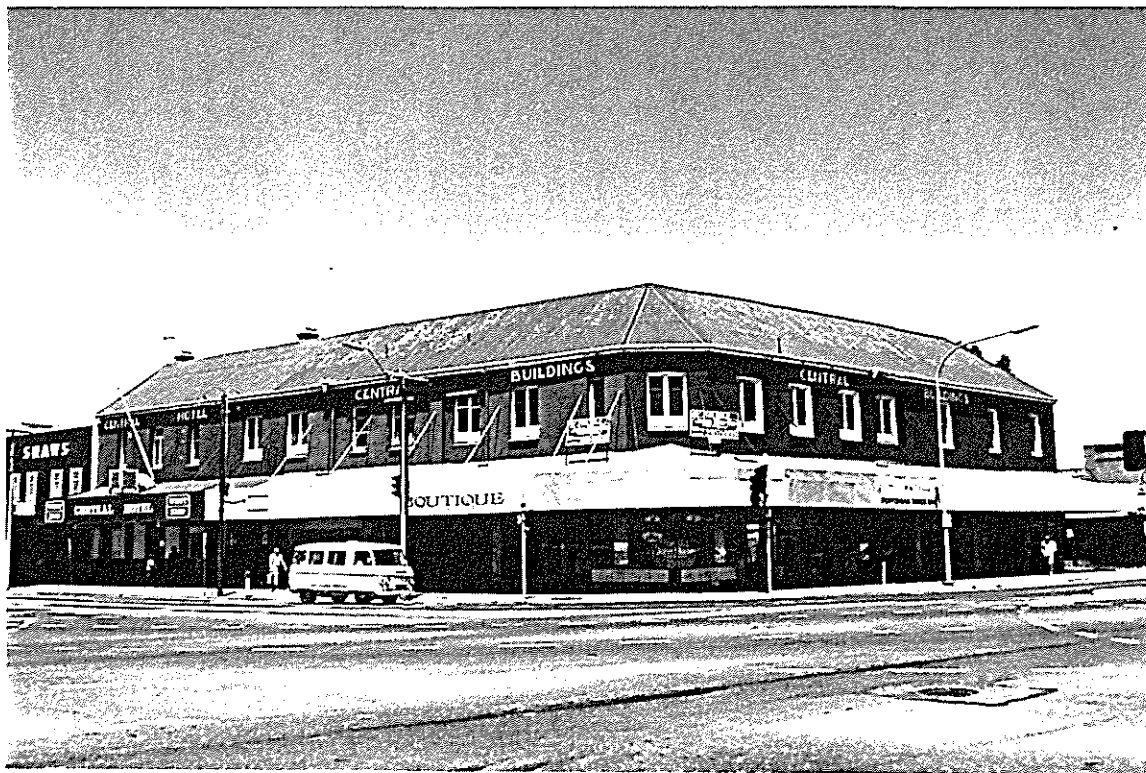
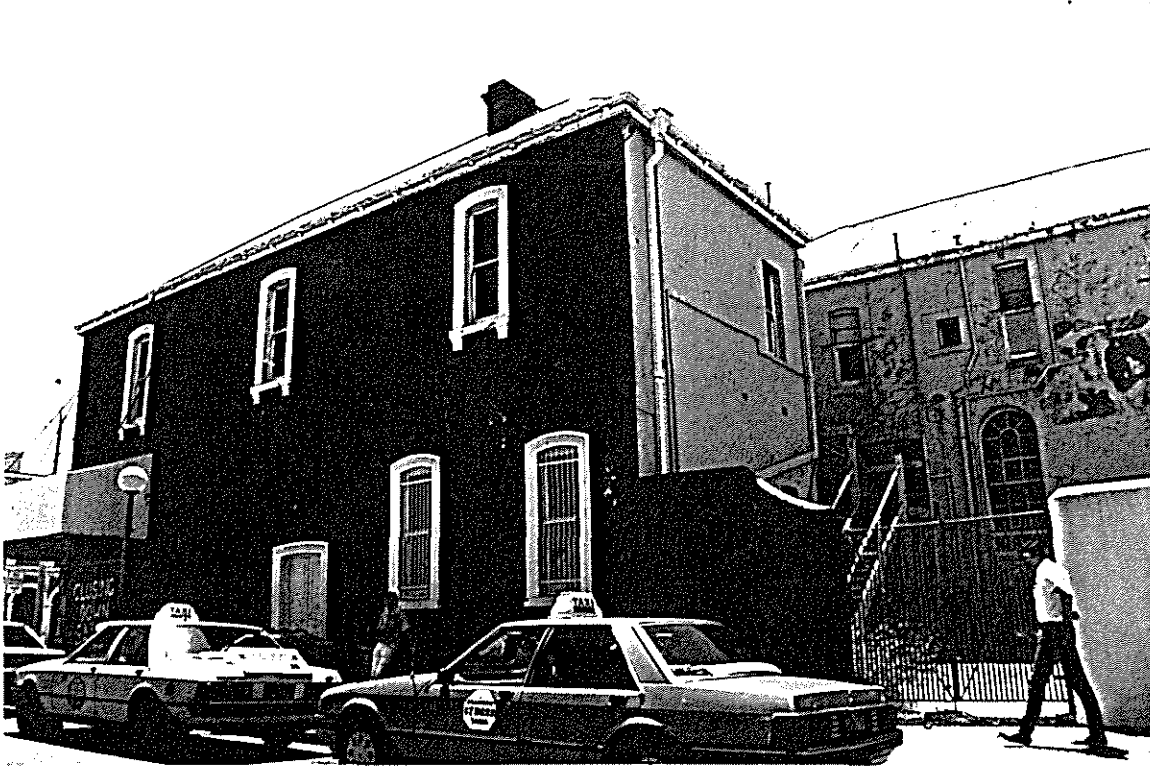
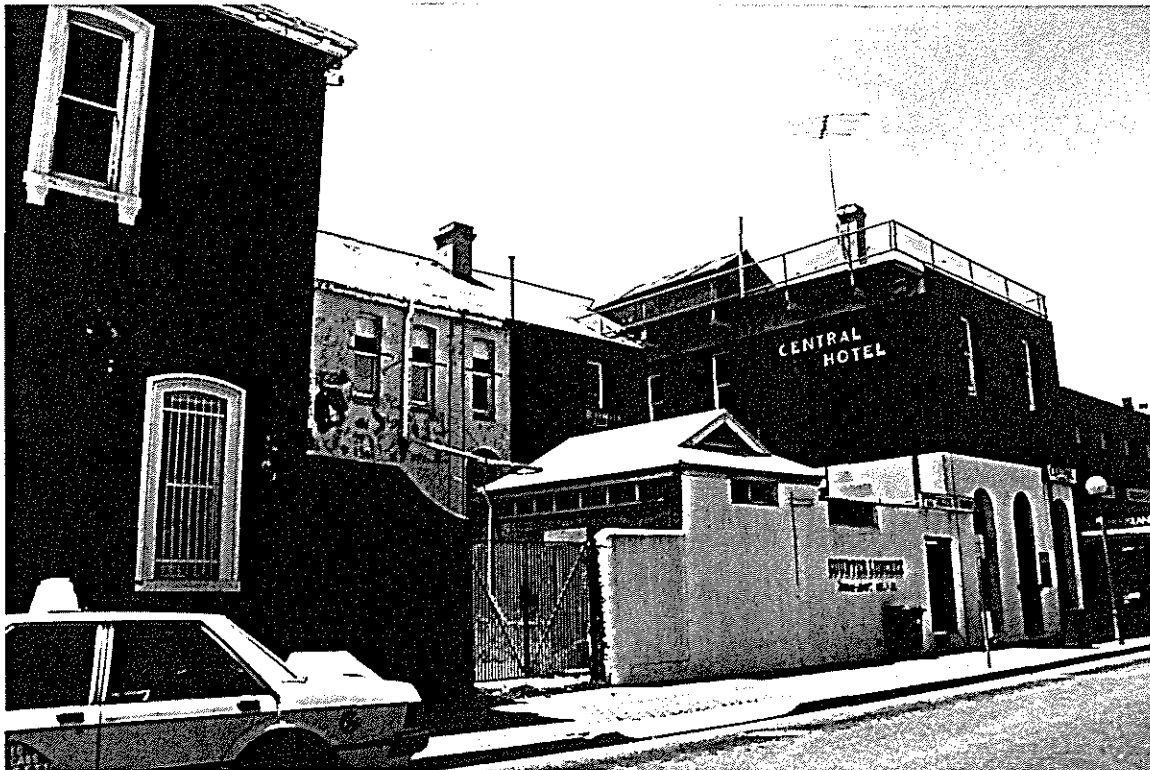
ADDRESS: 74 Commercial Road (cnr St Vincent Street)

All the shop fronts were upgraded in the 1920s incorporating typical detailing from this building, including, tiling, nickel plated shopfittings, vitrolite panelling, cantilevered awning and pressed metal soffit lining, panelled paired entry doors, slate thresholds and tessellated tiling, much of this survives in good condition from this period. Four shopfronts along the St Vincent Street frontage have been altered. Rear detailing survives intact from the 1850s including two fine arch headed multipaned double hung windows. The elevation to Marryatt Street retains original detailing with rendering around simple double hung windows.

Rear views of Central Buildings from Maryatt Street

BUILDING IMPROVEMENT RECOMMENDATIONS: This building is currently under threat as it has been for sale for almost a year. It is empty apart from the hotel and is deteriorating rapidly. Major refurbishment and restoration of this building is problematic given the noisy corner location and the loss of integrity of the building. Its significance as one of the earliest and largest buildings in the Port justifies the retention

and reuse of this building, despite its current deteriorated physical condition. Any threat of demolition should be promptly accounted by an internal assessment of this building and analysis. Simple maintenance and improvement works need to be undertaken to make this building usable in the short term.

This building is currently unprotected as it does not fall within the Port Adelaide State Heritage Area. Its historical significance and retention of early architectural elements justifies additional assessment and possible addition to the State Heritage Register for this building.

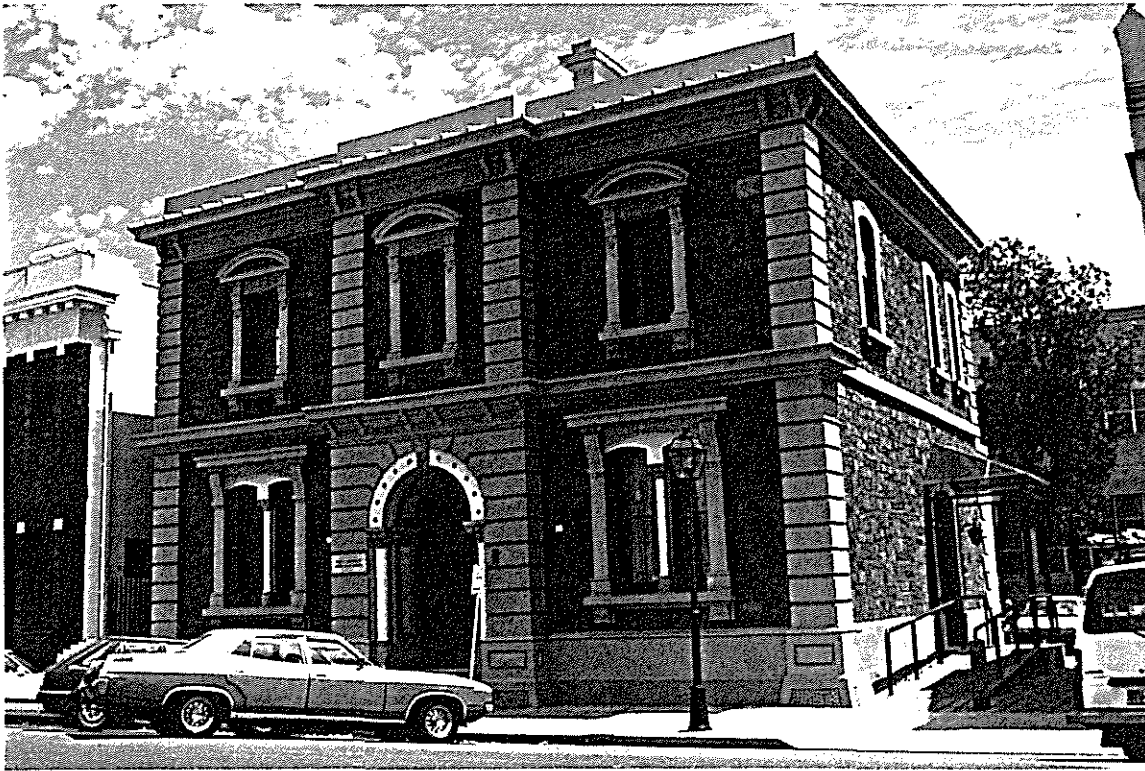
ADDRESS: 9 Divett Street

BUILDING HISTORY AND ANALYSIS: This building was constructed in 1863 possibly to the design of Edmund Wright or E J Woods Architect, both of whom designed other National Banks in Adelaide. The building has been recently well restored and is now occupied by offices. Externally the building is in good repair, and internally original features such as cornices, the staircase and all joinery survive intact and in good condition. All original bank fittings have been removed.

BUILDING IMPROVEMENT RECOMMENDATIONS: This building should continue to be carefully maintained to ensure it remains in good condition.

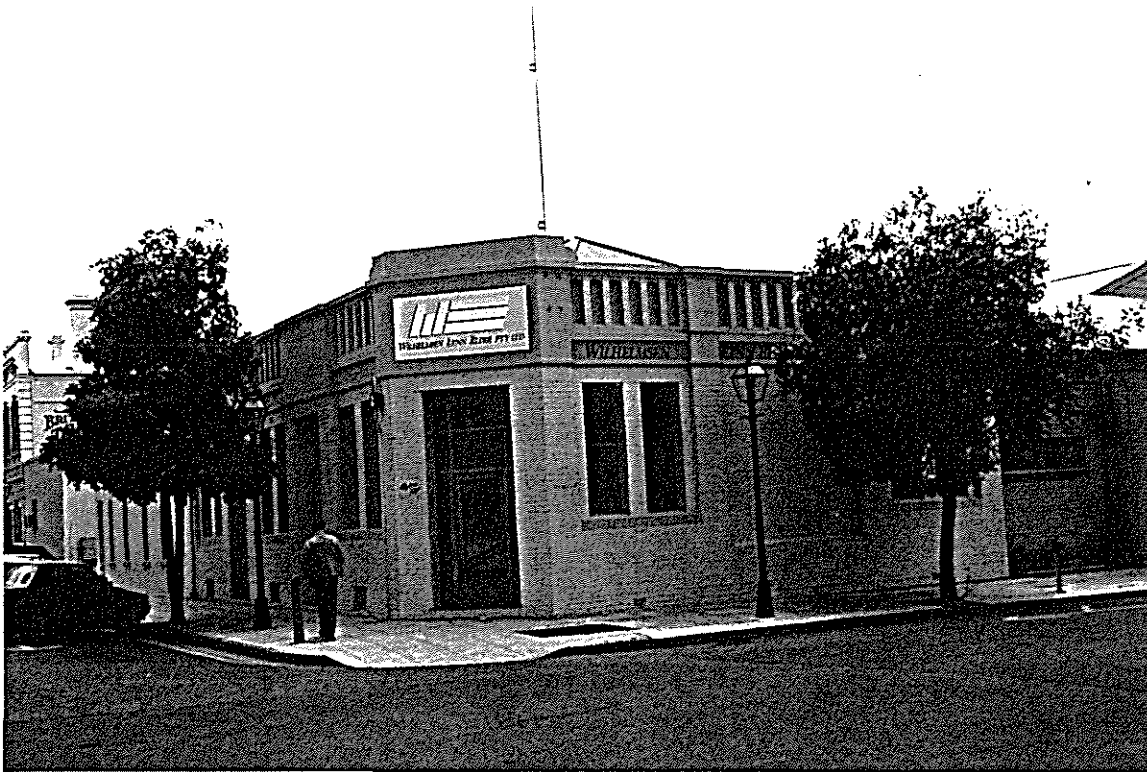
ADDRESS: 17 Divett Street

BUILDING HISTORY AND ANALYSIS: This corner building replaced an early two storey building used by Gambling and McDonald, carriers, which is visible on the 1886 map. The present building is a simple brick single storey warehouse/office with interesting and well considered parapet detailing. The existing sign on the splayed corner is unfortunate.

BUILDING IMPROVEMENT RECOMMENDATIONS: Reassessment of the corner sign is suggested. The building should continue to be well maintained. Long term consideration could be given to careful removal of paint from brick work which would highlight the original render contrast against face brickwork. This is currently obscured by the paint finish.

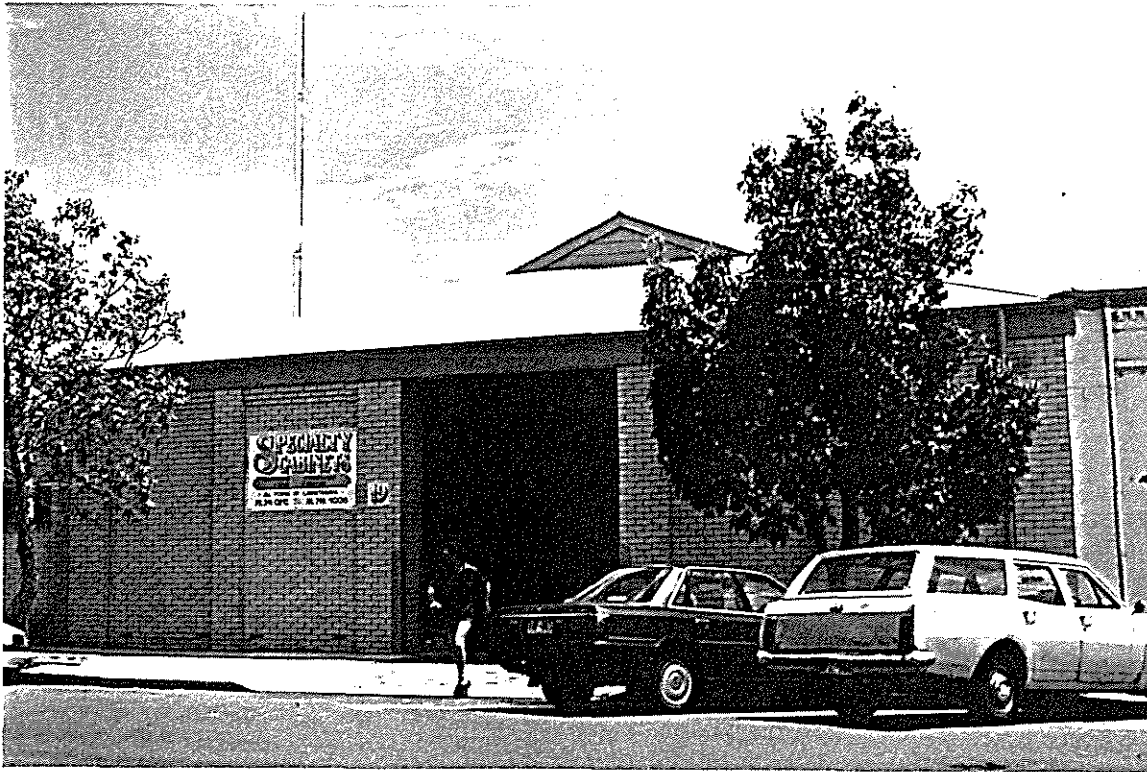
ADDRESS: 19 Divett Street

BUILDING HISTORY AND ANALYSIS: This shed with brick frontage is a recent replacement of an earlier building. The current detailing with expressed pilasters makes some effort to present an appropriate facade.

BUILDING IMPROVEMENT RECOMMENDATIONS: This facade would be improved by the rendering of the existing yellow bricks which are inappropriate for a heritage area. Otherwise, the simple detailing of this facade and the roof form is appropriate and well considered.

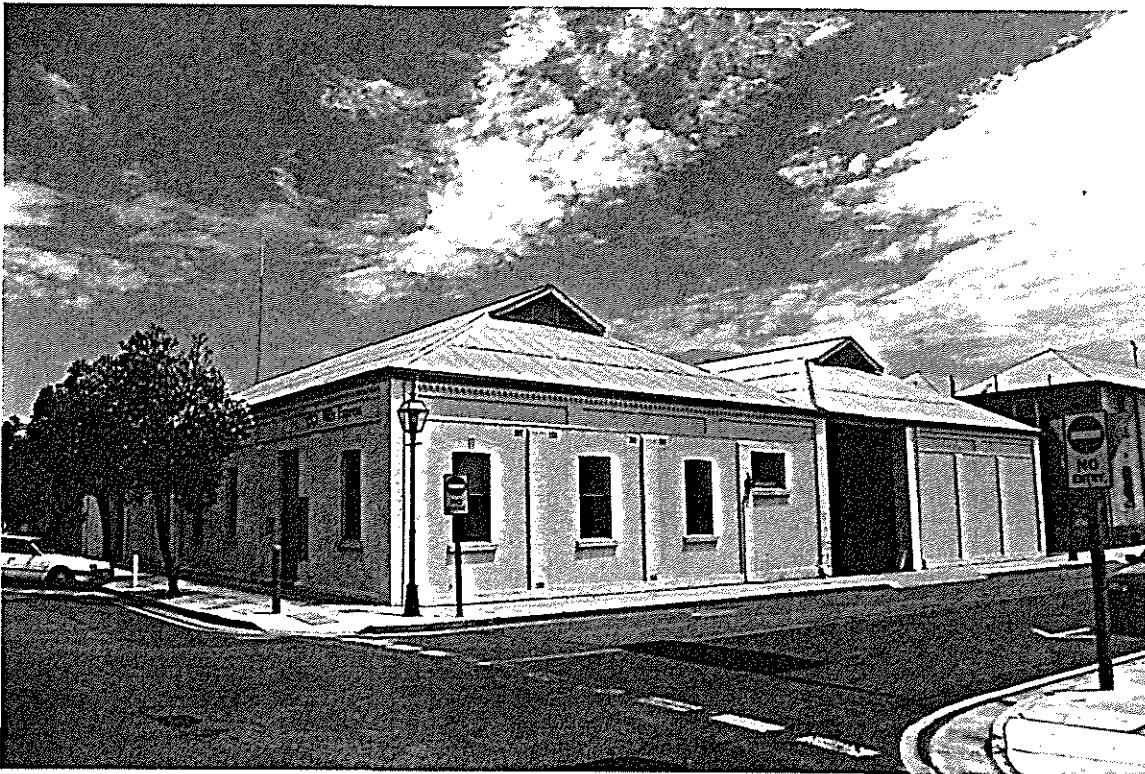
ADDRESS: 21 Divett Street cnr Timpson Street (former George Wills & Co Ltd)

BUILDING HISTORY AND ANALYSIS: This large warehouse comprises two sections and is visible in a early photograph dated 1924. In this photograph the original stone facade material is visible and this remained in good condition although painted along the Divett Street frontage. It is unfortunate that to the Timpson Street frontage a skim render has been applied over the stone work.

The buildings are currently empty and in neglected condition with a broken window to the Divett Street frontage. There is evidence of drainage neglect with downpipes discharging into blocked storm water pipes. A brick pillar to the Timpson Street frontage shows considerable distress with evidence of acute rising damp problems. A rear downpipe discharges directly onto the wall and the rear open drain along the internal drainway is full of rubbish and generally dirty.

BUILDING IMPROVEMENT RECOMMENDATIONS: It is critical that this building be occupied and used as there are many items of simple maintenance work that need to be undertaken. The downpipes should be directly connected to stormwater drains which need to be cleared. The rear drainage system need to be reassessed. The source of damp to the brick pillar needs to be immediately ascertained and rectified. It appears that a downpipe overflows at this point, with water from the bottom gutter discharging over the top of the wall. A rain head in this location is urgently required before further deterioration to the building occurs.

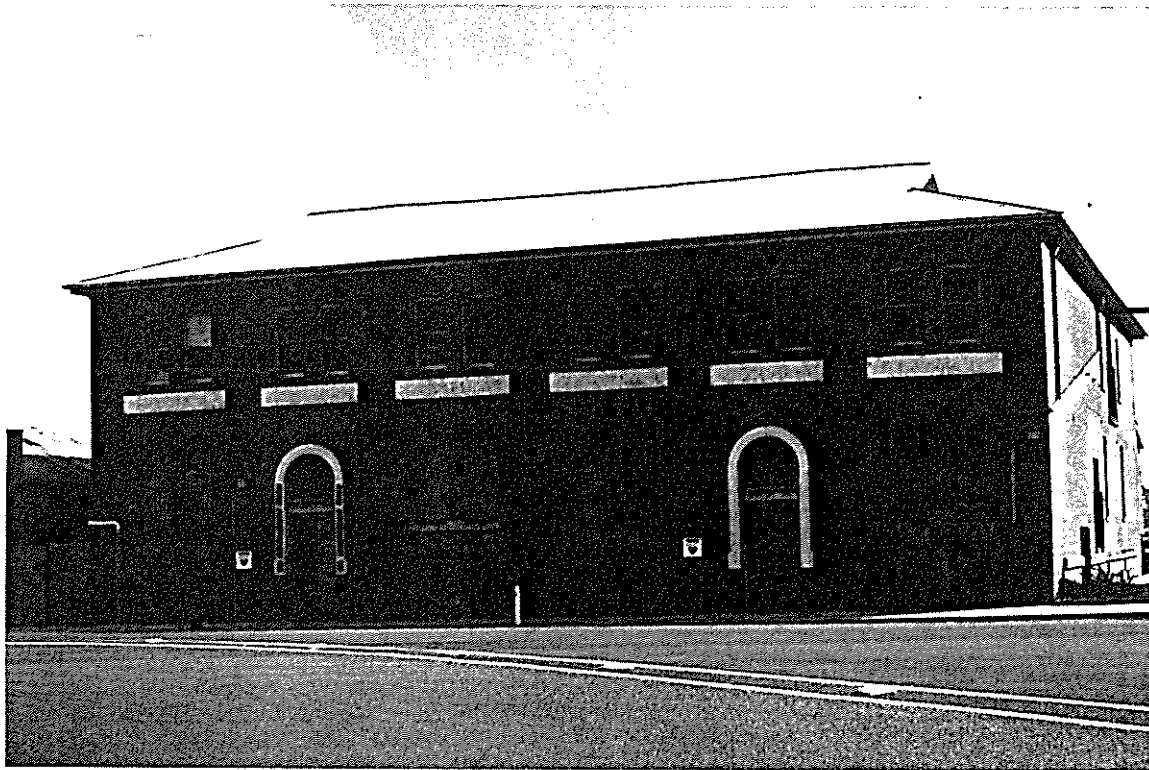
ADDRESS: 27-29 Divett Street

EXISTING CONDITION AND ANALYSIS: Internally this building is of great significance as it retains the original cast iron column and steel beam construction system and large exposed first floor hardwood joists. Two fine identical timber staircases survive, constructed of oregon. The building is divided into two sections and each comprises a basement level, ground floor level (with trap doors leading to basement) and first floor level. The first floor level retains original open timber truss sections with an unlined galvanised iron roof. All timber flooring throughout appears in good condition apart from a section in the first floor where a cement screed covers the flooring. Part of the interior is currently filled with Maritime Museum items.

The internal surface of the walls is showing signs of mortar disintegration, particularly on the west wall where mortar is extremely soft. There is damage associated with roof leaking elsewhere or internal walls.

Externally the building is in a neglected condition requiring repainting of joinery and removal of sign panels below the first floor windows. Glass replacement is also required to broken windows. The roof is in poor condition with gutter severely rusted out. The treatment of stormwater with P.V.C. discharge pipes on the front elevation is entirely unsatisfactory for a building of this significance and should be readdressed.

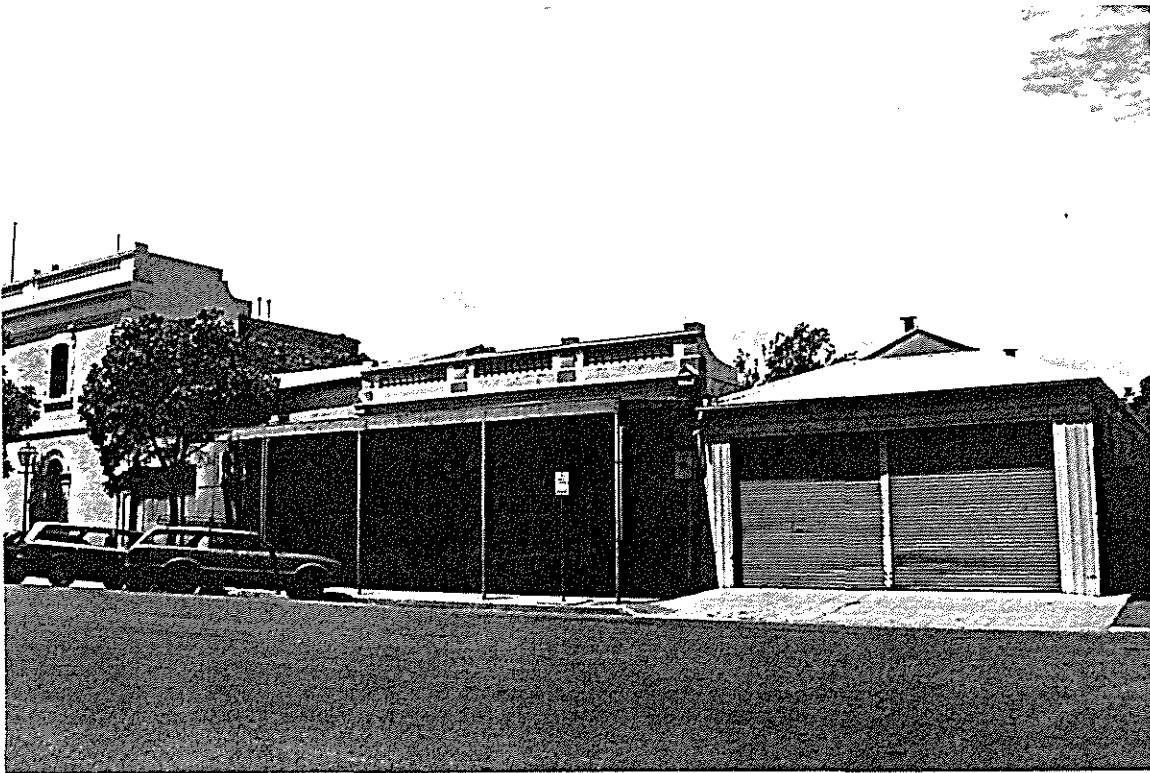
ADDRESS: 8, 10, 12 Divett Street

BUILDING HISTORY AND ANALYSIS: The simple single story scale of this frontage. The condition of these buildings is not good and the frontage of the central balustraded section has been inappropriately rendered. The minimal joinery detailing survives.

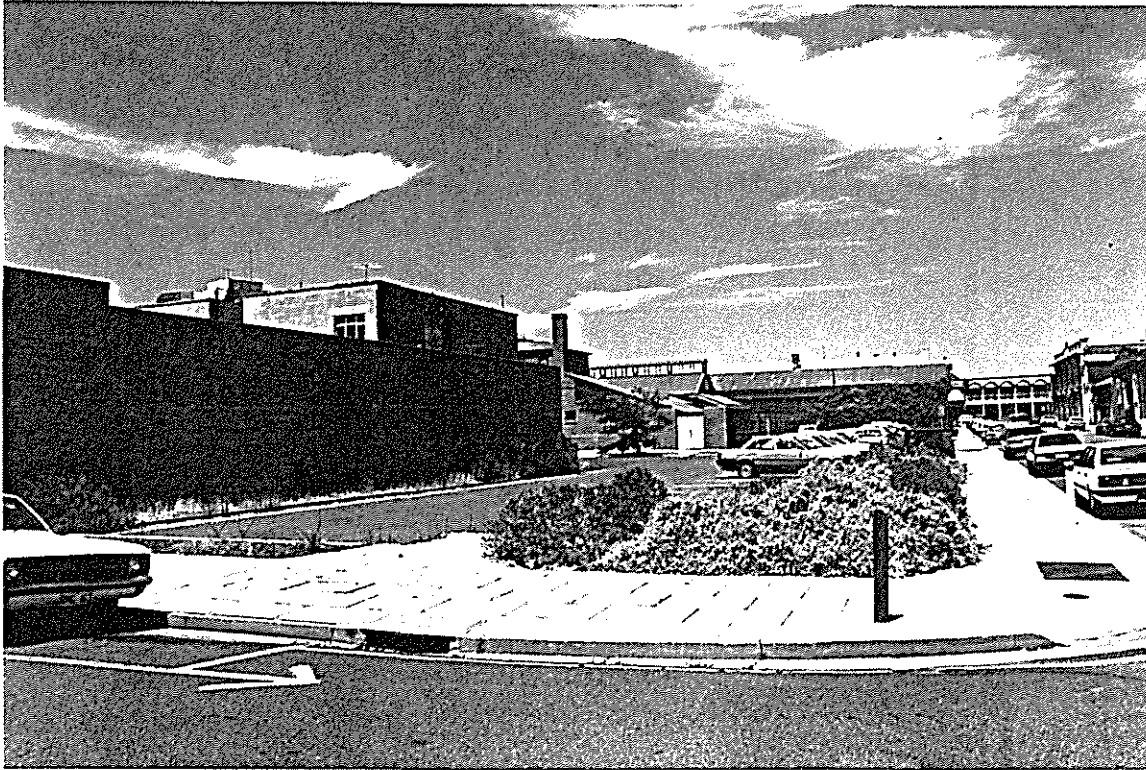
NAME: Divett/Timpson Street Carpark - vacant land

ANALYSIS & RECOMMENDATIONS: This site is currently used as a carpark. The landscaping around the periphery is in most cases dead, covered with weeds and is generally very unattractive. If this site is to remain as a carpark, the current owner should be requested to upgrade the landscaping and to plant suitable trees together with the installation of a watering system.

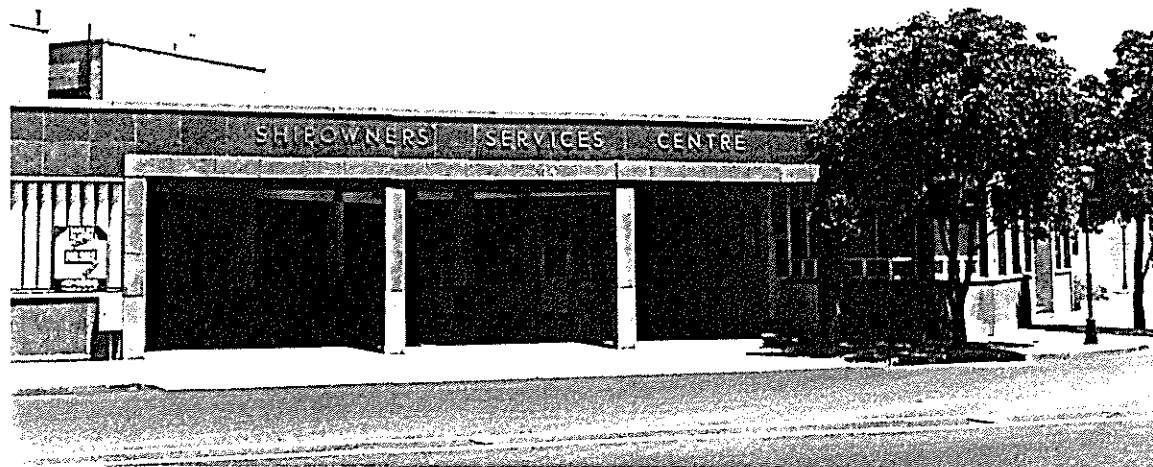
BUILDING HISTORY AND ANALYSIS: A large corner site which fronts to both Divett & Todd Street. The Todd Street section is two storey and typical of the 1940s. A single storey (with a covered vehicle bay at the corner) utilizes terrazzo panels. This building has recently been sold and it is unknown what the plans for the site are. No buildings on the site reflect the detailing and character of early port structures although the scale and massing of the two storey section is appropriate. Any development proposals for this site should be carefully considered in relation to the adjacent Port Dock Hotel and the brick warehouse opposite this in Divett Street.

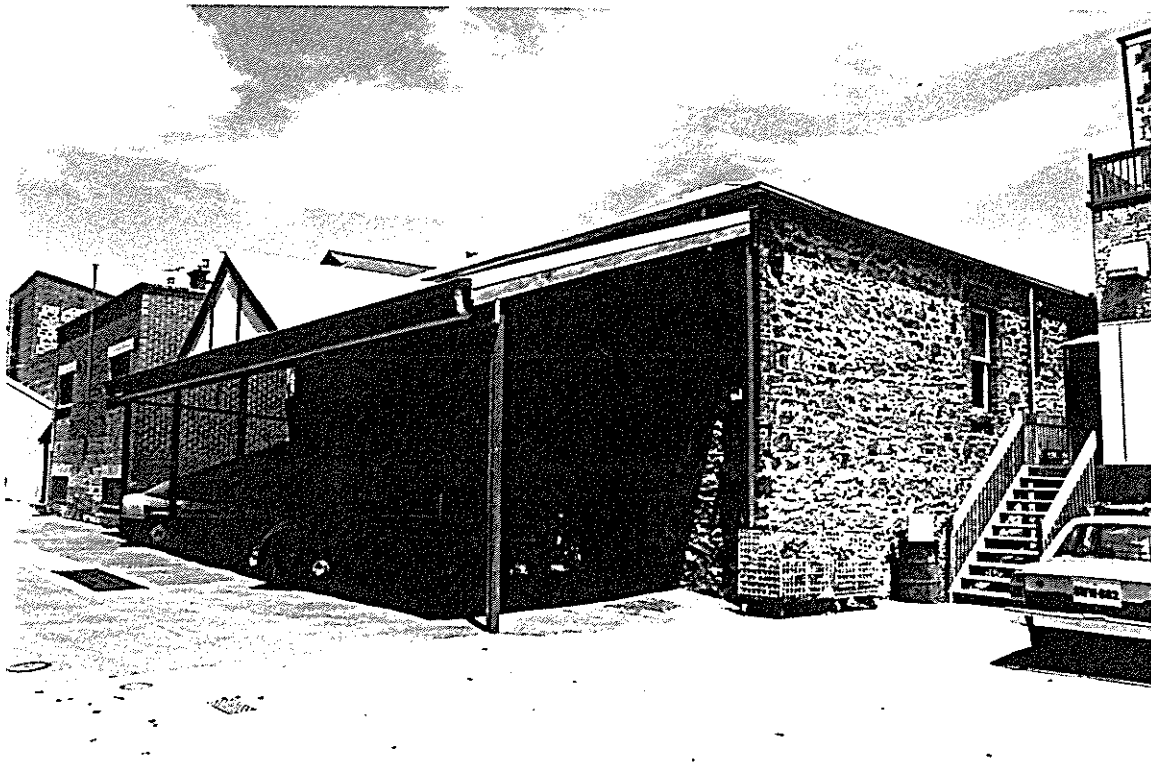
Rear of 124 Lipson Street indicating bluestone structure and semi excavated basement

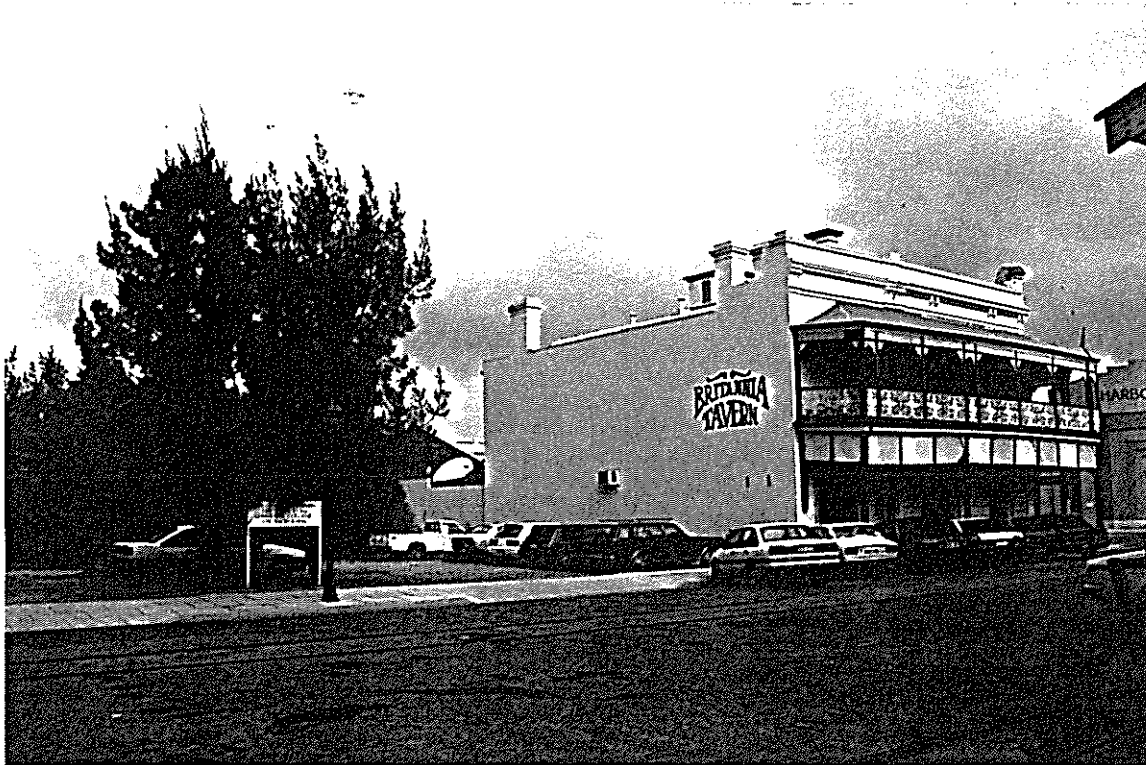
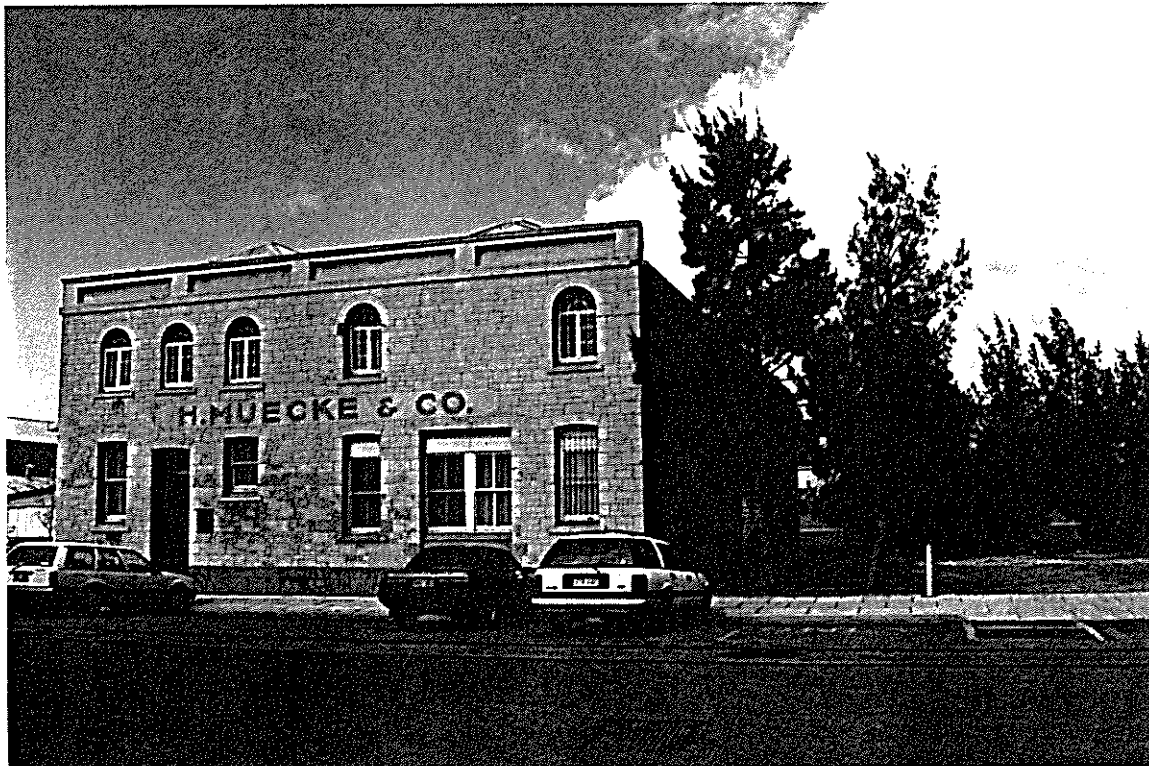
Buildings adjacent to vacant block, North Terrace

- If new development is to be **separated from adjacent buildings**, separation is preferable along the Britannia Tavern side, allowing continued views of the side elevation of this building. The new H Muecke & Co. building has an unfinished appearance to its side elevation which would be better obscured.

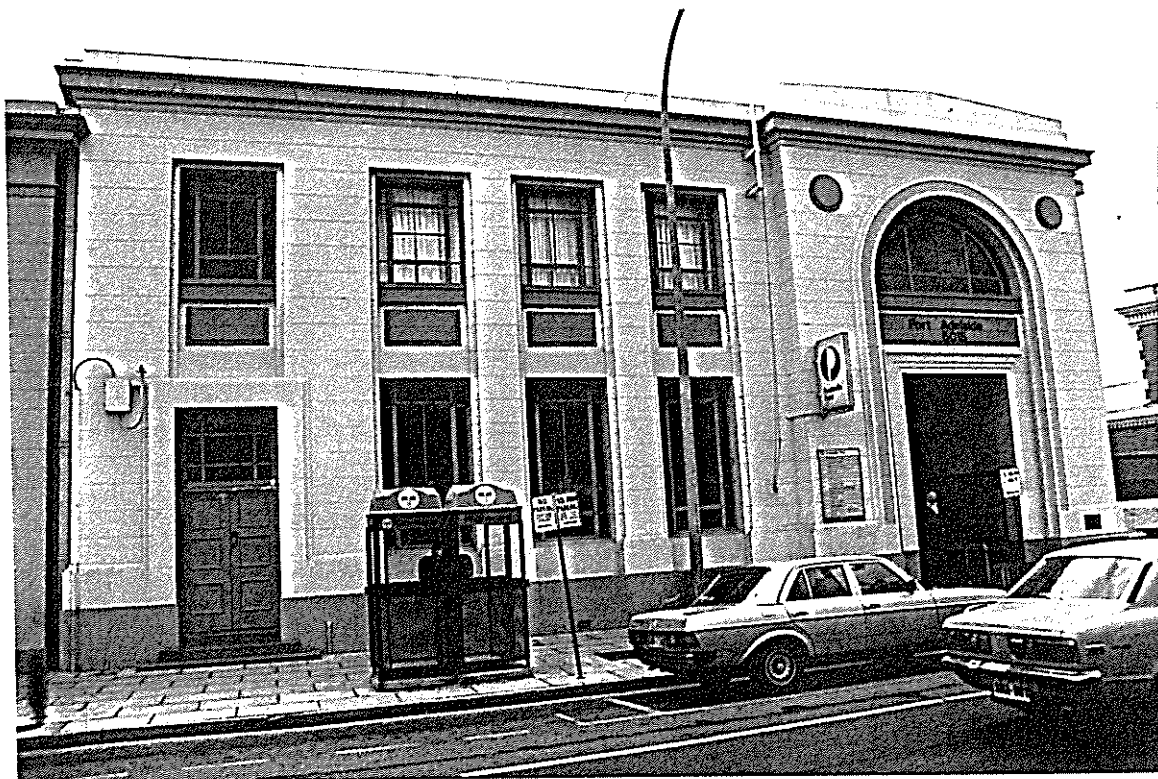
NAME: Post Office (~~former Commonwealth Savings Bank~~)

Post Office
BUILDING HISTORY AND ANALYSIS: This building was originally constructed in 1928 as the ~~Commonwealth Savings Bank of Australia~~. It is a well detailed building which has been successfully adapted to its use as a ~~Post Office~~. ^{which} It retains original metal frame windows and appears in good condition and is well looked after.

BUILDING IMPROVEMENT RECOMMENDATIONS: This building should continue to be maintained in good condition.

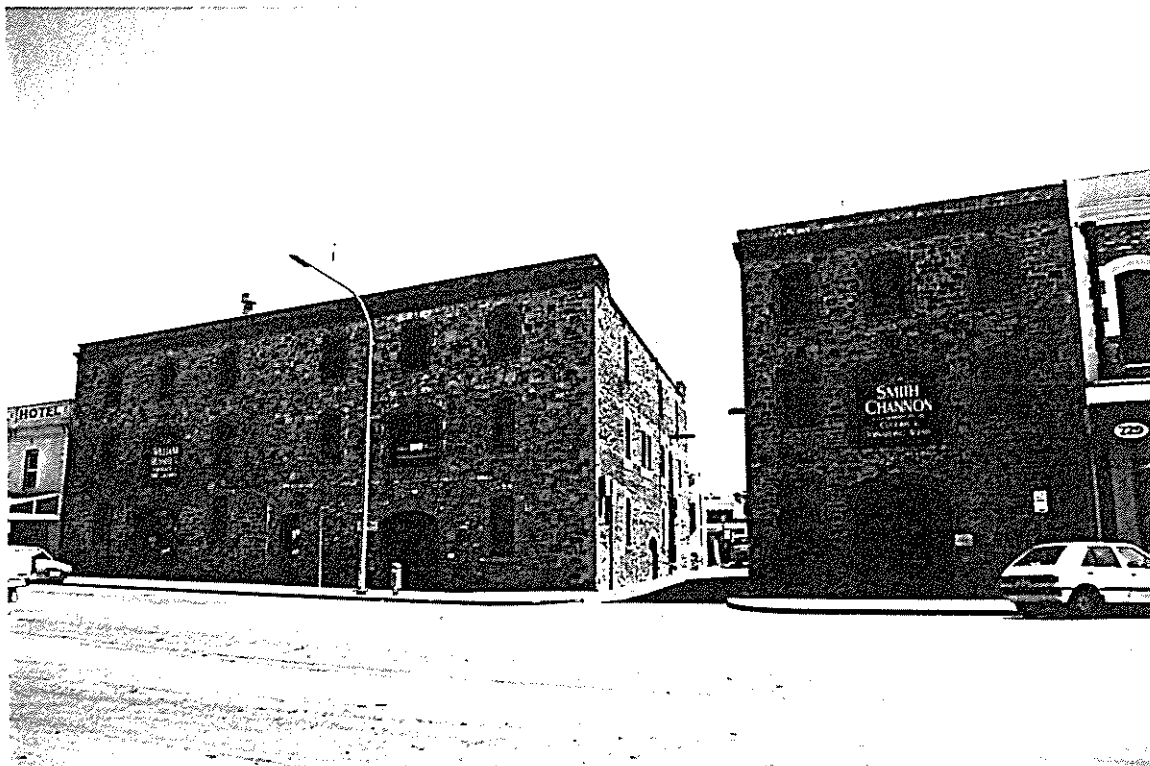
NAME: Stone Warehouses

An early photograph survives of these three warehouses and this photograph has been used in the careful restoration of the frontages. After 1977 these buildings all had their stone facades carefully stripped of paint work and original opening configurations reinstated. The buildings are currently carefully maintained and in good condition.

BUILDING IMPROVEMENT RECOMMENDATIONS: Ongoing careful maintenance of these buildings is recommended.

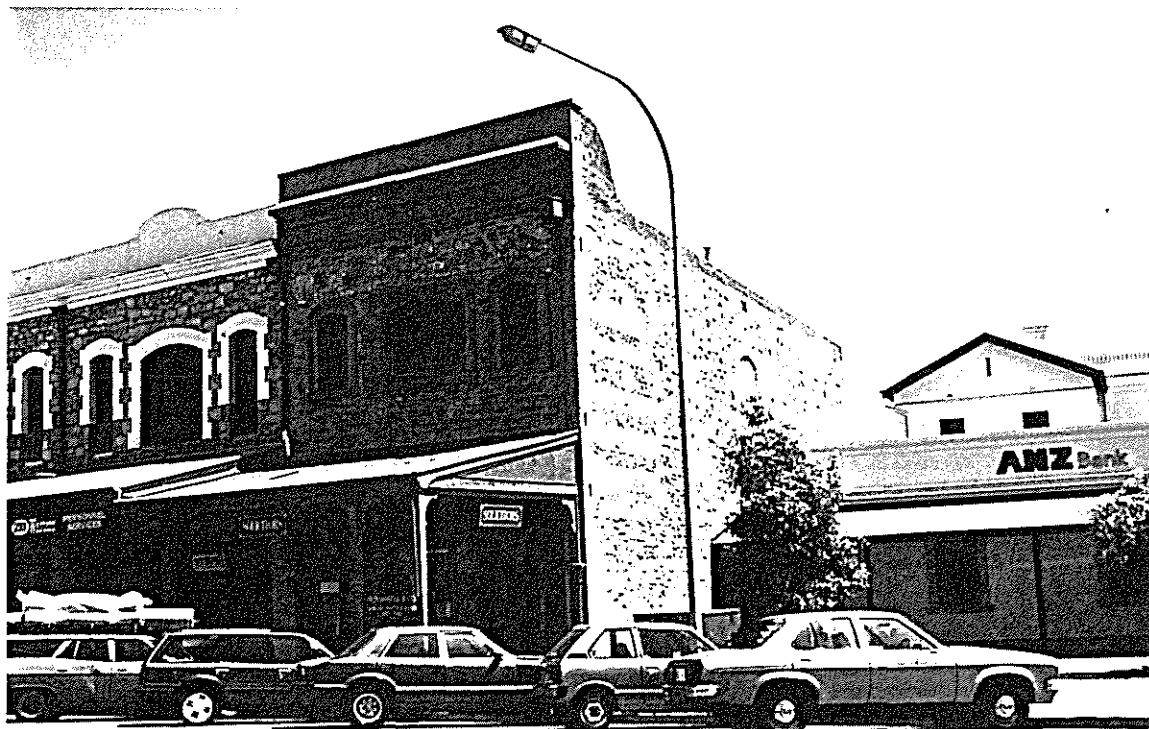
NAME: Scammell & Co. Barristers and Solicitors

Urgent attention is required for downpipes at both ends which currently discharge against posts causing drastic timber deterioration. Verandah fascia detailing is also coming away and generally the verandah requires repairs.

BUILDING IMPROVEMENT RECOMMENDATIONS: Reassessment of the existing straight fronted shopfront configuration should be undertaken. The original framing members survive and the reinstatement of a carefully detailed recessed entry shopfront
