PORT ADELAIDE STATE HERITAGE AREA

EXISTING CONDITION ASSESSMENT AND RECOMMENDATIONS

FEBRUARY 1992

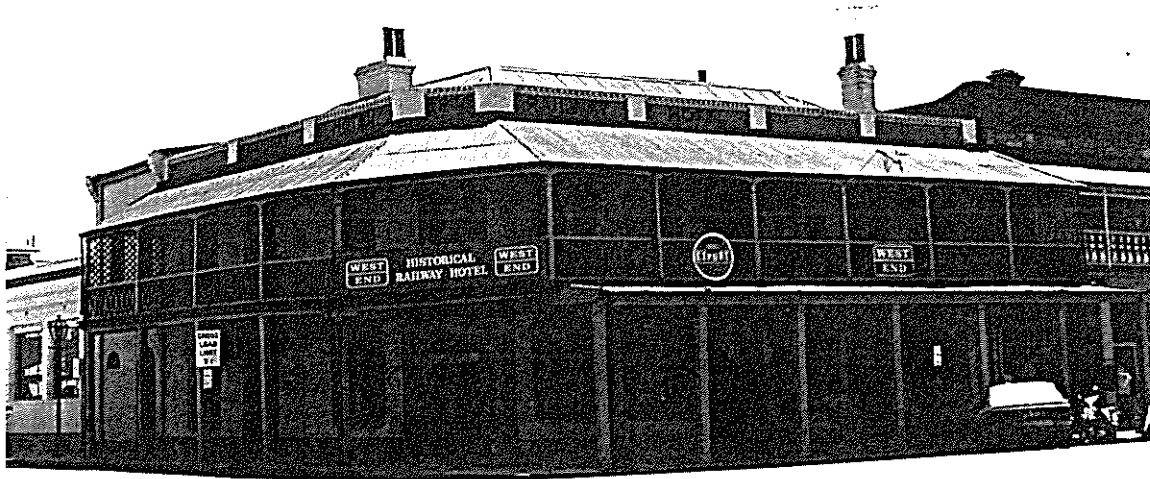
NAME: Railway Hotel

BUILDING HISTORY AND ANALYSIS: This stone and brick corner hotel was constructed in 1856. The building is constructed of random stone work to the ground floor with brick construction above indicating possibly two stages of construction. The two storey verandah appears to be early, incorporating simple cast iron work and plain detailing including scalloped fascia boards to the first floor. The building is generally in fair condition although there is evidence of deterioration to verandah posts and detailing to both levels. The verandah frontage to Lipson Street shows marked sign of deterioration with jacking up of the verandah floor with packing pieces at the top of verandah posts. The rear service yard is enclosed by a simple brick two storey section to the Lipson Street frontage. This gives access to toilets and the cellar. The rear wall is stone to the first floor level and brick above and both surfaces are painted. Cement rendering to the base of the wall indicates presence of damp to the building. The second storey balcony is clad in ripple iron balustrading with simple timber hand rails. The entry door off Lipson Street is particularly noteworthy with crude timber framing together with panelling of ripple iron. This is currently in poor condition and the original security bar survives at the rear of this door.

BUILDING IMPROVEMENT RECOMMENDATIONS: In the long term careful restoration of the verandah is required. There are defective elements including rotten verandah post bases and shortened columns where splicing-in work or replacement is required. Reinstatement of simple bead moulding to top of posts needs to be undertaken to the Lipson Street frontage where these are currently all missing. All

Long term careful removal of paint to stone and brick work could be considered to re-expose original finishes. This should be carefully done to avoid any damage to face stone and brick. Any gutter replacements should be undertaken in ogee profile guttering. Rationalisation of the large corner beam to the verandah balcony floor should be considered in any verandah improvement works.

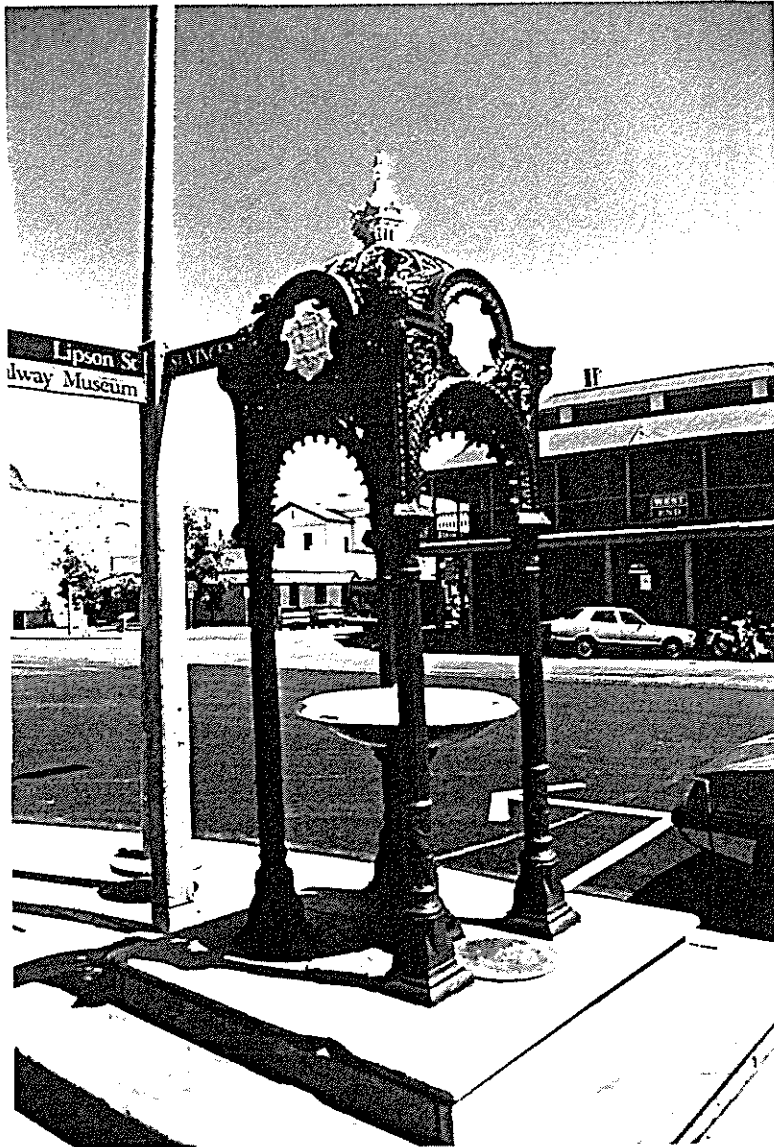
NAME: Drinking Fountain

BUILDING HISTORY AND ANALYSIS: A drinking fountain "erected by public subscription to John Formby Esq Mayor, 1870-3" A simple cast iron structure which has recently been repainted by Council. It sits on Mintaro slate base and Macclesfield marble. It is in good condition apart from some damage to the top lantern which has some missing iron elements at the top. The recent repainting has been done with minimal preparation and is viewed as a temporary presentation measure only.

Any new painting should incorporate the use of carefully selected heritage colours and an investigation of original colours through paint scraping analysis. The drinking fountain mechanism should be repaired and made operational if possible.

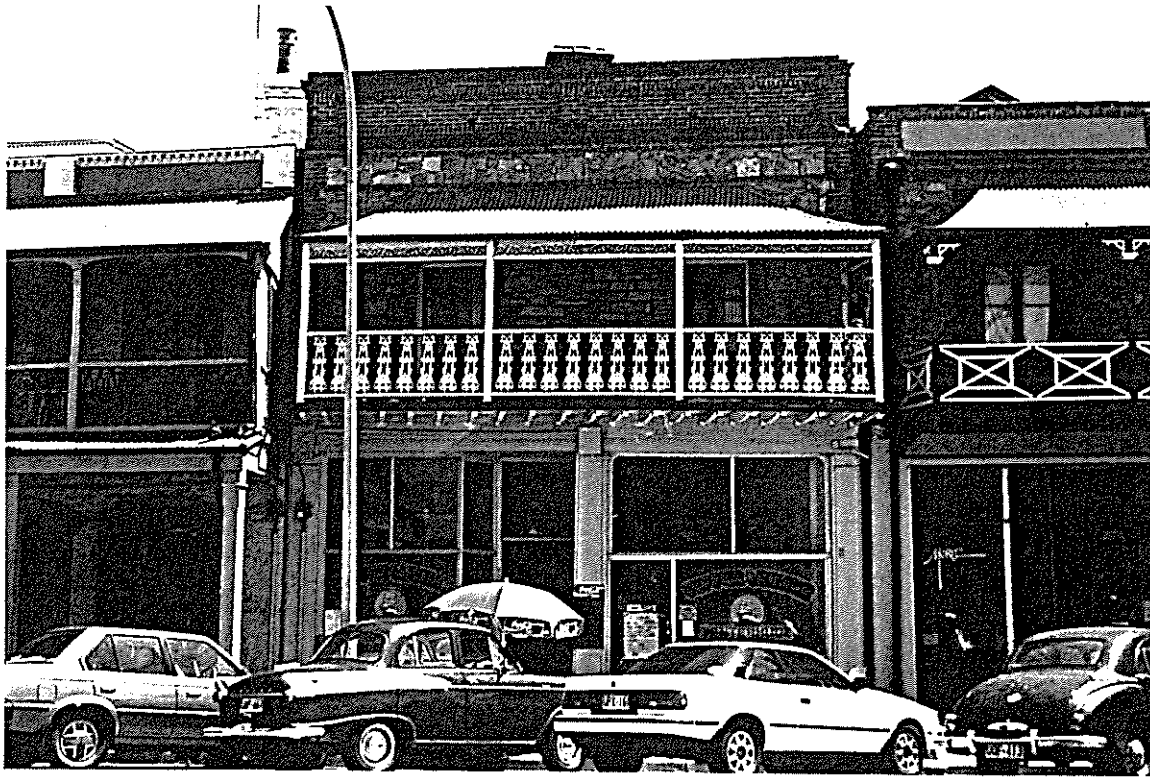
NAME: Winterhude Garden Coffee Lounge

BUILDING IMPROVEMENT RECOMMENDATIONS: This building is currently well presented and should be carefully maintained. There is evidence of mortar deterioration to the finely detailed brick parapet and ongoing careful maintenance of mortar work should be undertaken to prevent deterioration of the fabric.

The ground floor frontage to no. 251 is not original and reinstatement of a recessed entry shopfront is recommended. This could be modelled on the configuration of the adjacent shopfront at 249.

The stallboard detailing to no. 249 with vertical v-jointed boarding is not original and reinstatement of original panelling to this section of the shopfront would be an improvement together with rounding off of the window sill above. An example of appropriate stallboard panelling can be found at no. 253 which could be used as a model for this shopfront.

Any replacement of guttering to balconies should be undertaken in ogee profile guttering.

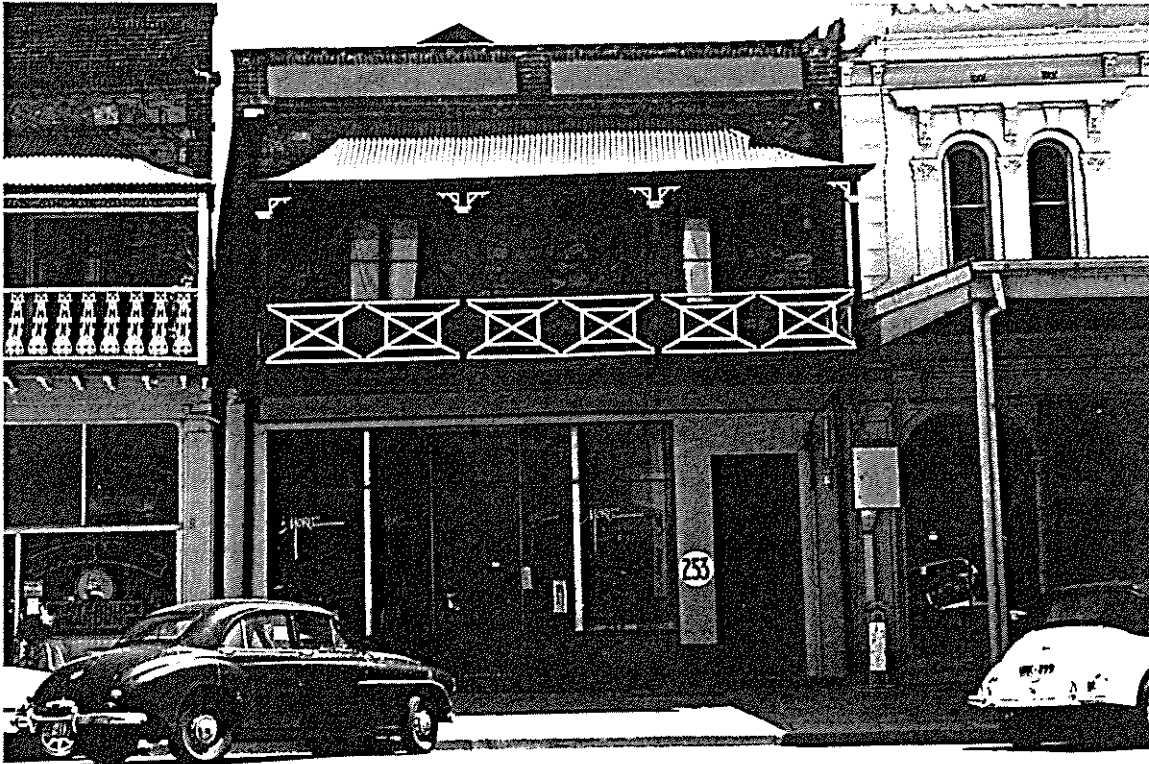
NAME: Moritz Fine Furniture

BUILDING HISTORY AND ANALYSIS: This shop has recently been carefully restored by the current owner, incorporating removal of paint to first floor, reinstatement of french doors to balcony and reconstruction of the balcony. In addition, repairs and restoration of the shopfront has also been undertaken. All works have been done in accordance with the early 1886 sketch with the exception of the current balustrading detailing, which is nevertheless appropriate.

BUILDING IMPROVEMENT RECOMMENDATIONS: This building is currently very well presented and continued careful maintenance is recommended.

Any replacement of guttering to balconies should be undertaken in ogee profile guttering.

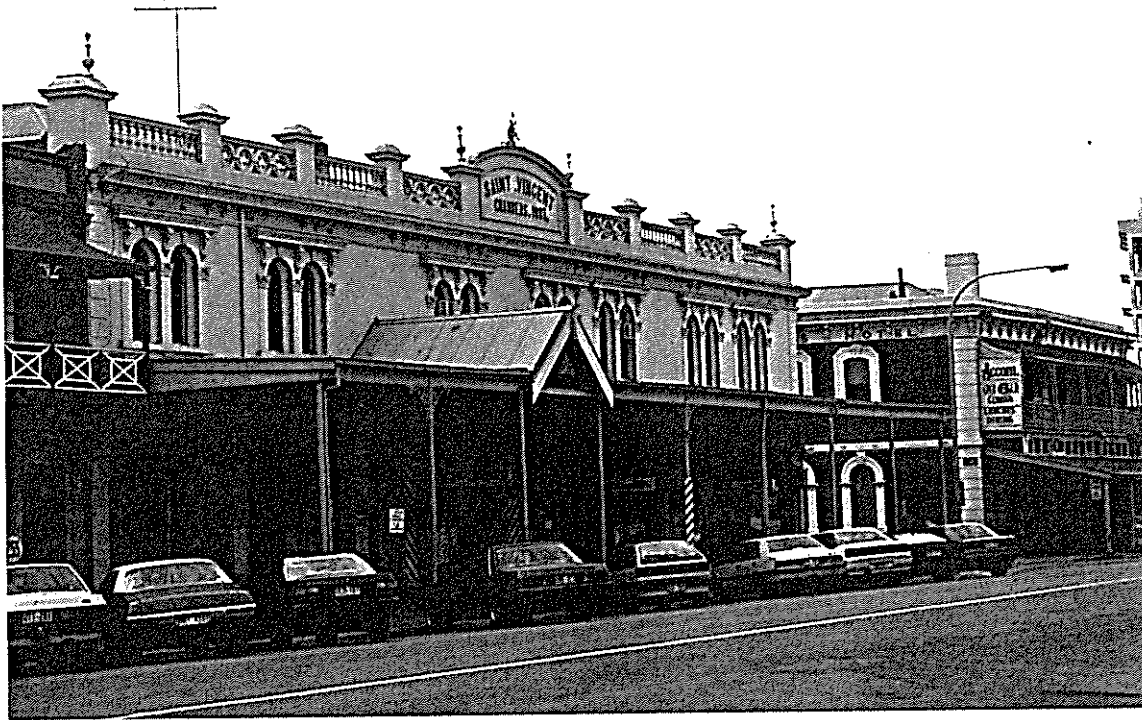
NAME: St Vincent Chambers

This building survives substantially intact retaining very fine original shop fronts. Two sets of entry doors have been replaced with modern doors but the original entry doors reputedly survive at the rear of the building. The verandah appears to have been rebuilt at an unknown date to its current configuration incorporating a rather clumsy pediment detail to mark the entrance to "St Vincent Chambers" access steps behind. The original edge beam and three original cast iron columns with capitals survive. The rear verandah, structure survives although this has been enclosed with later corrugated iron and sheeting. This verandah originally incorporated cast iron balustrading with frieze work at the first floor level.

Original entry doors are missing to 257, 259, 263, 265. Original entry doors survive to 255. Doors to 263, 265 have reputedly been retained in storage. Three airconditioning units have been installed at the upper level windows.

The gable to the verandah should also be rebuilt to more appropriate detailing.
