Mallee Dune Seepage near Karoonda

Report to SAMDB NRM Board
Chris Henschke and Rebecca Tonkin
Rural Solutions SA
October 2011

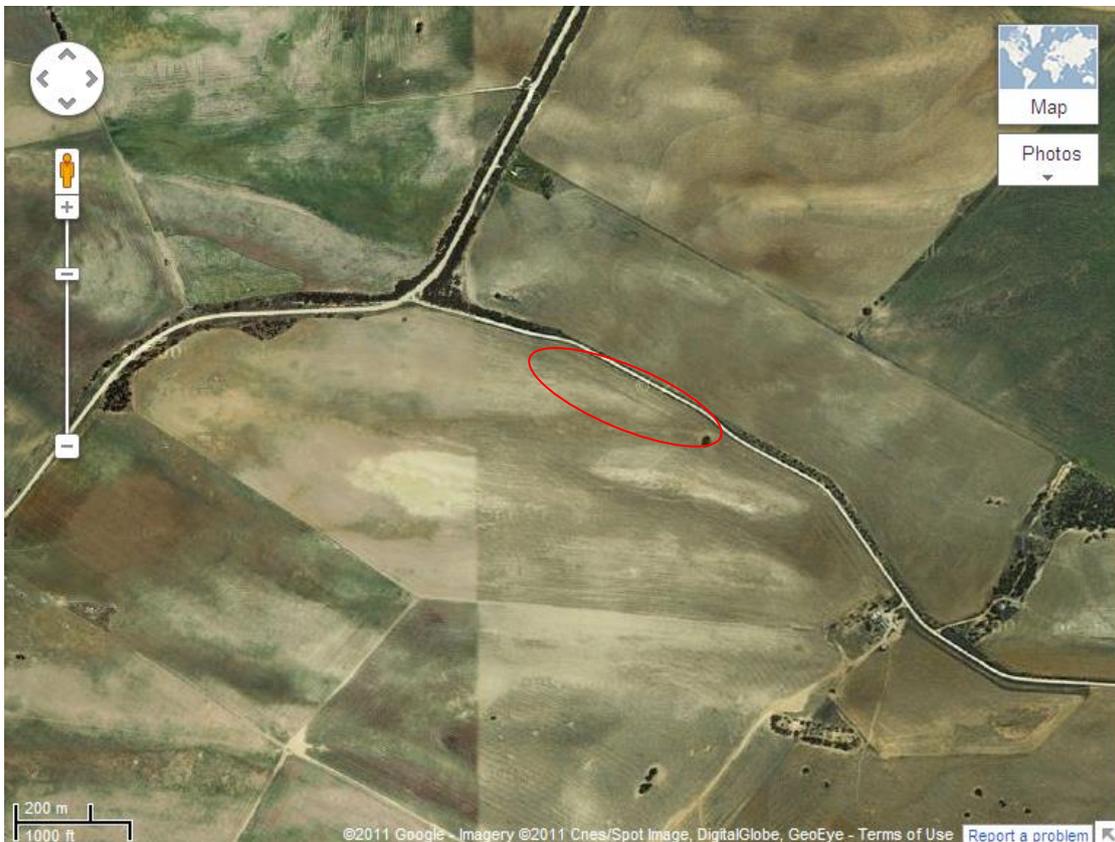
Figure 1: Satellite image of the area affected on Stuart Pope's property (circled), -35.130193,139.830422 (decimal latitude and longitude, image from Google Maps, accessed 21/11/11).

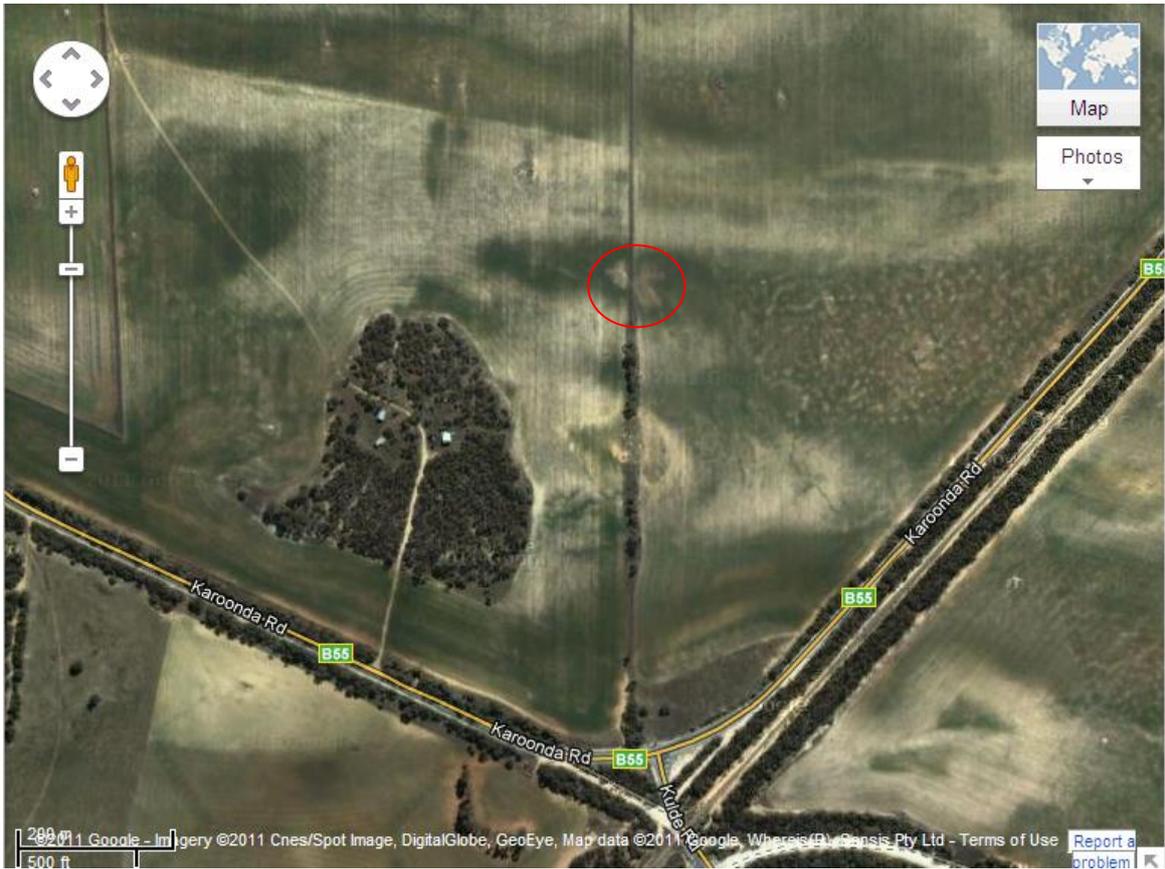
Figure 2: Satellite image of the area affected (circled) near Wynarka, - 35.152302, 139.663632 (decimal latitude and longitude, image from Google Maps, accessed 21/11/11).

The situation is different on the land located near Wynarka, currently being leased by Peter Rose. Here salinity is evident as the ground is bare and scalded (Figure 6), with salt crystals visible on the surface (Figure 7). The area is too soft for machinery to be driven over for most of the year, and so cannot be sown to crops or pasture. No plants are growing on the most severely affected parts, and around it are mostly growing rye-grass, brome, and thistles.

Until a few years ago this area was apparently not saline although tending to be boggy, and grew good crops, but it has gradually turned saline, and the area has become larger. There is concern that it may continue to expand.

Revegetating the site with salt-tolerant species is likely to be successful as long as plants are placed in soil which is not too saline. This may require a gradual approach, planting at the edges of the saline waterlogged area and moving in as the area becomes drier and less salty. Once plants have established and roots have accessed the deeper moisture, they should do well. Salt on the surface should leach away over time with normal rainfall.

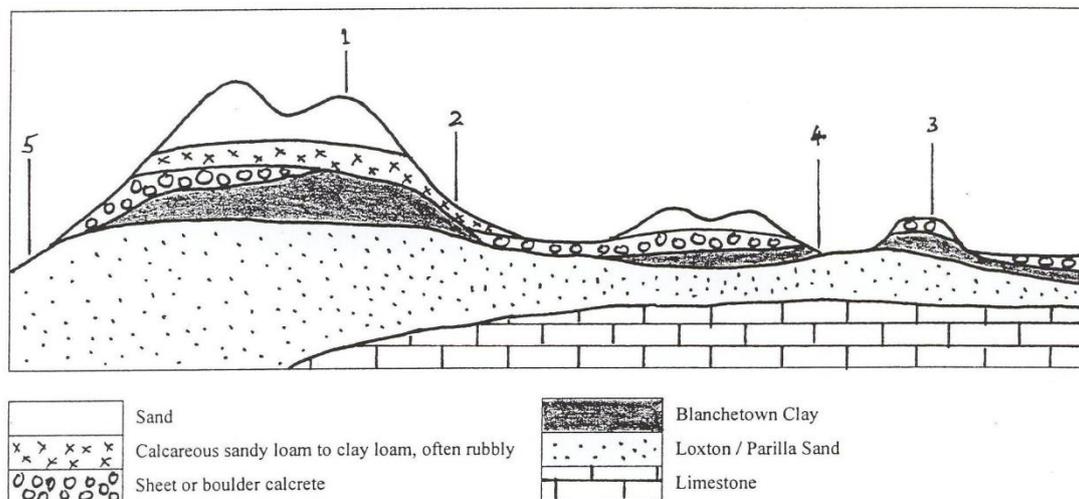
Sand dunes (code 1 in Fig. 10) characteristically contain non-wetting sands and this promotes surface runoff which funnels down and concentrates into hollows and depressions at the foot of the dune (code 4 in Fig. 10). Rainfall may also infiltrate the dune in places and seep along the clay interface, eventually discharging into land-locked depressions ('pans') at the base of the dune.

Figure 10: Generic cross-section showing typical sequence of soils and geology in the mallee, where 1 = deep sand on sandhill, 2 = calcareous sandy loam at break of slope and 4 = loam over clay on a flat or swale/depression (after Maschmedt, 199?)

In these seepage areas the crop suffers from 'wet feet' and the 'pans' become bare due to lack of cover. The landholders also mentioned that summer weeds used to inhabit these areas and so would help to dry them out. This is no longer the case with more effective chemical weed control and hence these areas tend to remain bare as the excess water is no longer being used up in the 'pans'.
