## EARLY BRICKS AND BRICKWORK IN SOUTH AUSTRALIA

DENR

DEPARTMENT OF ENVIRONMENT AND NATURAL RESOURCES

Prepared by State Heritage Branch

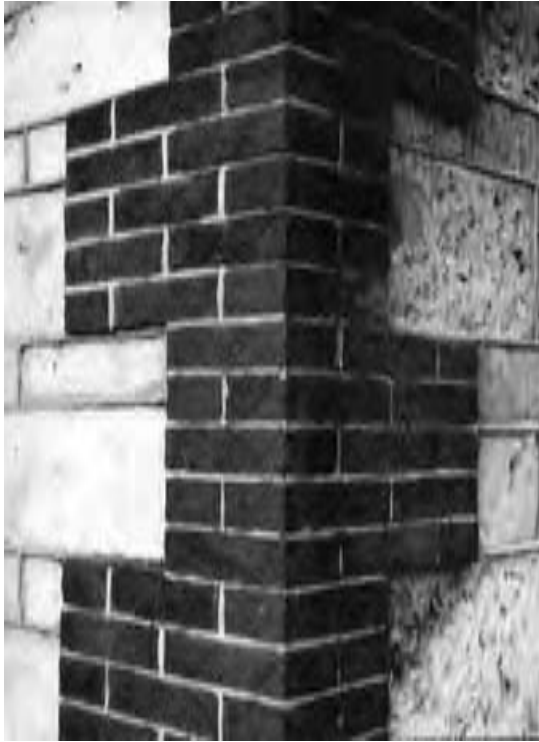
*Brick quoins on a limestone building: Old Parliament House, North Terrace*

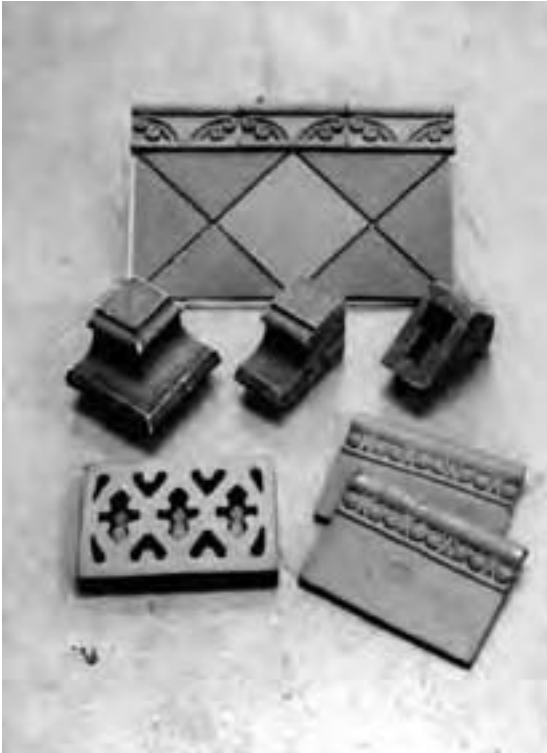
*Architectural ceramic ware by John Clift Pottery, Adelaide: tiles, special bricks, ventilator, garden edging*

South Australia until Wunderlich established a plant at Edwardstown in the early 1920s. Stoneware tiles were in use as damp-proof courses in masonry buildings, and brickworks supplied ceramic ventilators to allow air flow through brick walls. Walls were finished with glazed ceramic tiles in a rich variety of colours. Terracotta (the Italian words literally mean cooked earth) was sometimes used for ornamental wall panels, usually in conjunction with decorative brickwork. Terracotta mouldings were available for every detail of a house from edging lawns and paving garden pathways to roof cresting and chimney pots.

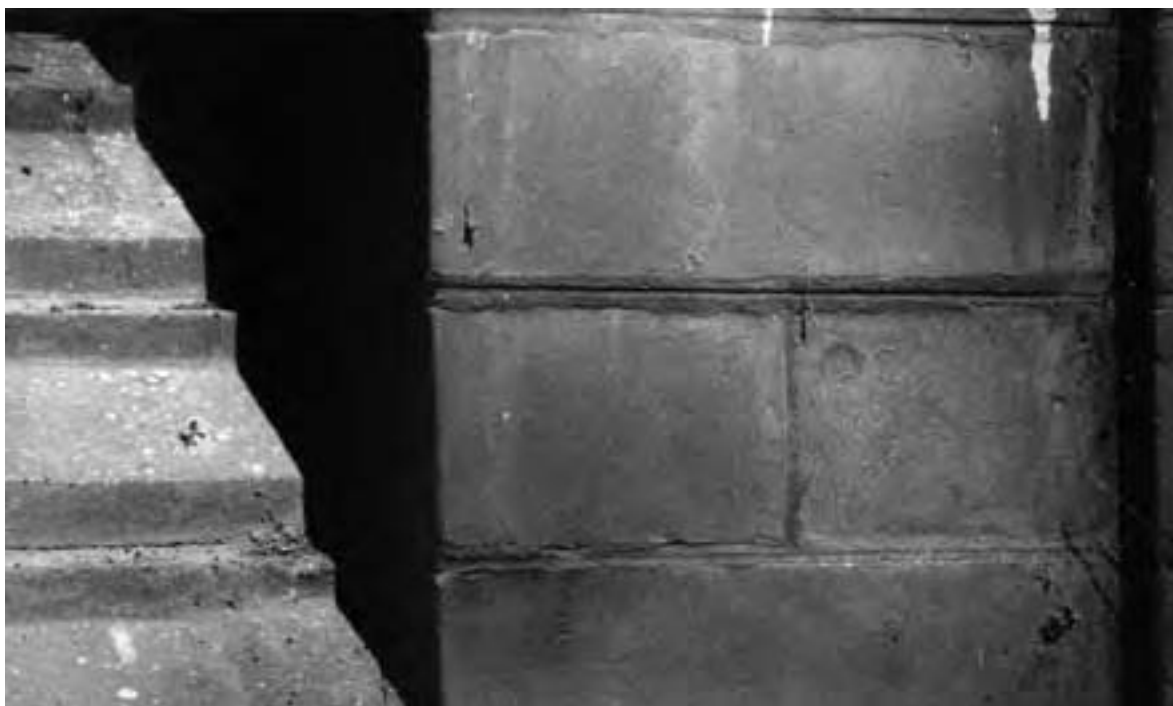
*Ruled joints*

straightedge along the centre of every joint line, and painted white, creating the illusion that the wall had been laid with microscopically fine mortar joints. In a variation of this technique, the white pointing was sometimes painted only along the horizontal joints, and the vertical joints were left brick-red, making the brickwork appear to be composed of continuous long slabs of brick.

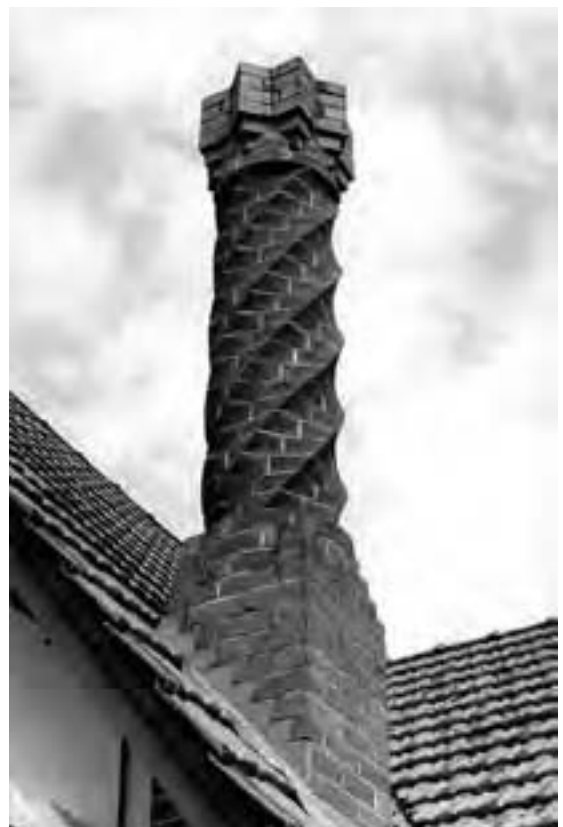
*Helical Tudor revival chimney on a house at Glen Osmond*

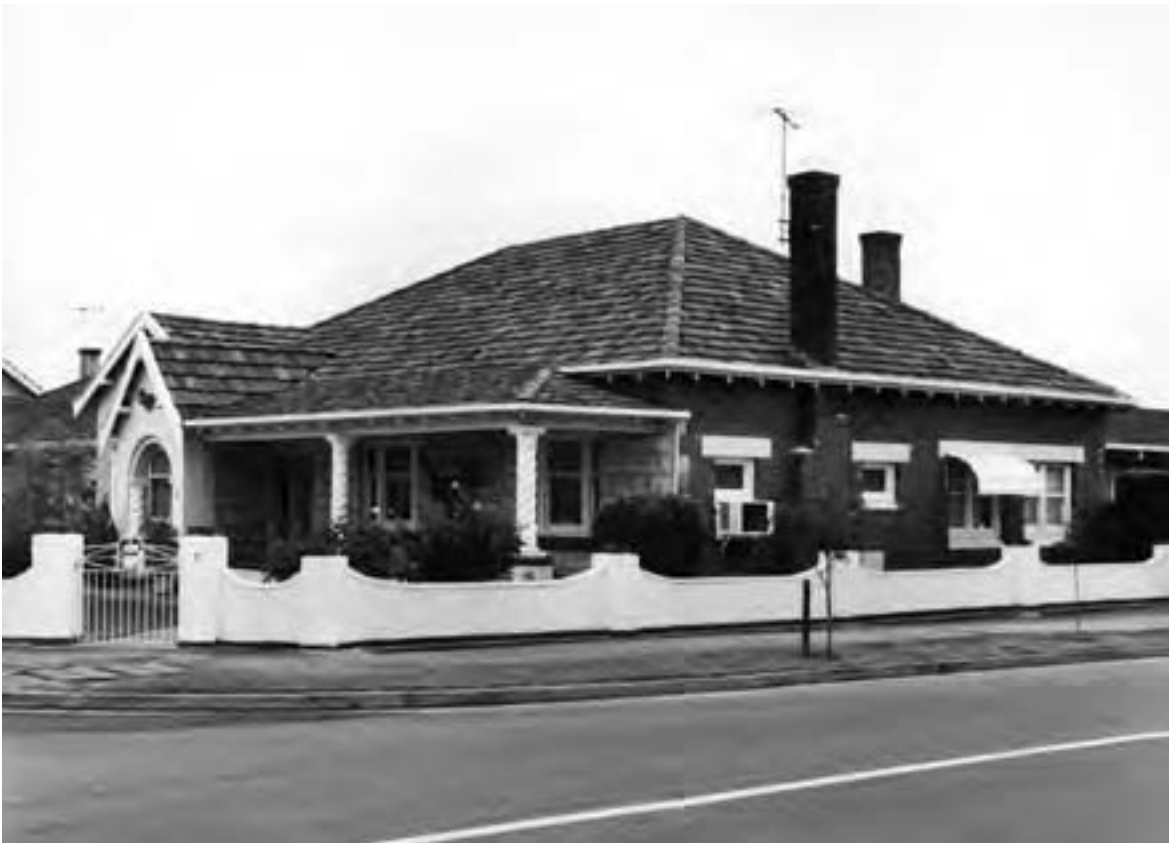
*Red brick bungalow with sandstone veneer front wall*

In the 1950s, cream brick was taken up enthusiastically by the mass market to become the staple exterior finish of the post-war decades. It was supplemented by the development of brick veneer construction, in which a light timber frame is lined with plasterboard and faced with a single skin of bricks. What appears to be a brick house can be built at little more than half the price of cavity brick, on lighter foundations, with no visible interior cracking. But there is a hidden price to pay in the longer term, because a brick veneer wall

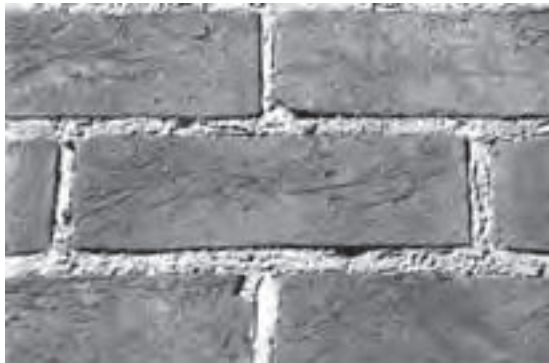
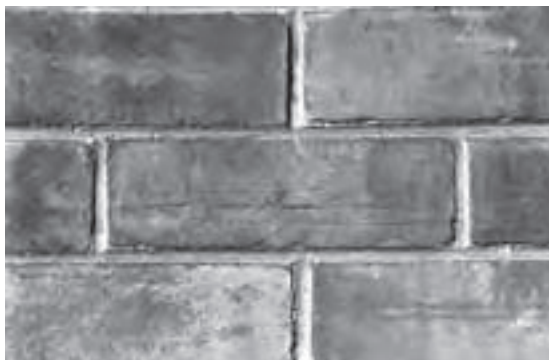
*Top: Characteristic fold marks on a hand-made brick  
Above: Hack marks on a hand-made brick*

bricks were fairly rough, and show mould marks, air bubbles and poor arrises from the moulding process. There is often a characteristic pattern of creases and folds (not cracks) in the sides of a handmade brick, formed as the clay dragged down the side of the mould. As they were very soft, they often also have hand prints, hack marks and damage from being dropped and handled before drying. Their surfaces may also show the texture of the sand used in the mould. However, carefully made and selected face bricks may not be easily recognised as handmade, for they can be virtually indistinguishable from machine-made bricks.

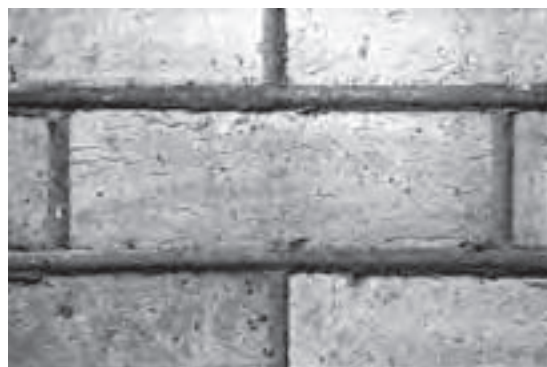
*Cracking pattern on a wire-cut extruded brick*

A more common method of brick manufacture was by wirecutting, a technique invented in Britain in 1836. Wet plastic clay was extruded from the pugging machine through an aperture which produced a continuous rectangular stream of clay the dimensions of the flat side of a brick. This was cut into bricks at regular intervals by a number of wires either stretched across a frame, or forming the spokes of a rotating wheel. A single machine could produce 12,000 to 18,000 bricks in a day.

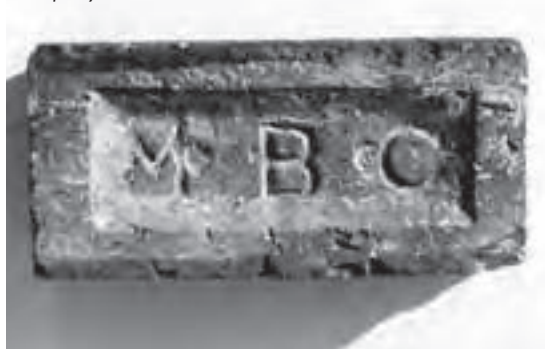
*Re-pressed brick from the Metropolitan Brick Company c1903*

To remedy some of these deficiencies, wet plastic bricks were sometimes placed in an iron mould when partially dried, and subjected to very great pressure. This disguised their wire marks, gave them a highly finished appearance with sharp arrises, and could also be used to add a frog and a manufacturer's brand. At

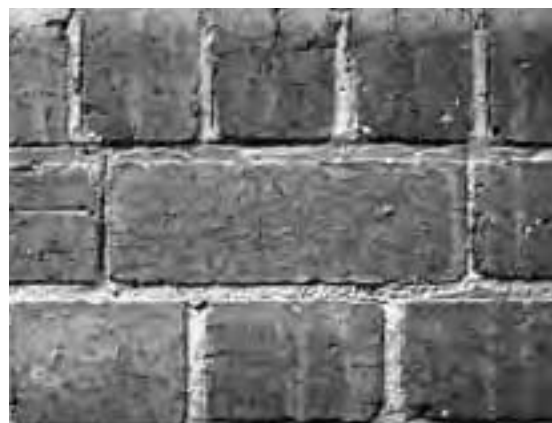
*Star cracking on a stiff plastic brick*

all the bricks from one mould are normally completely uniform; many of the bricks in a wall will be exactly the same size. The surface usually has a hard glossy appearance, and is often marked by fine cracks. There may be star patterns of cracks where the clay has shrunk around stones in firing. Being hard, they will not usually show hack marks or handling damage.

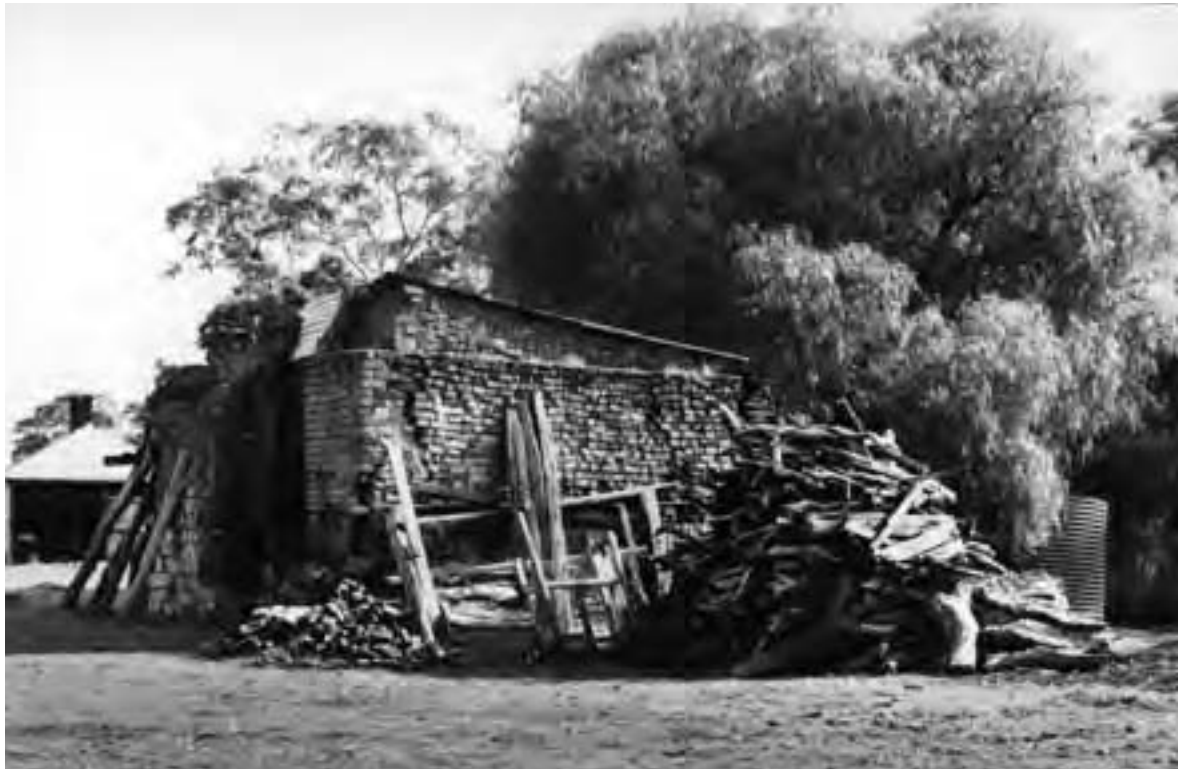
*Scotch kiln at Bowyer brickworks*

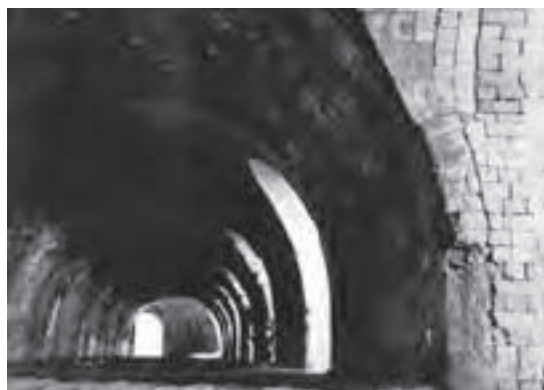
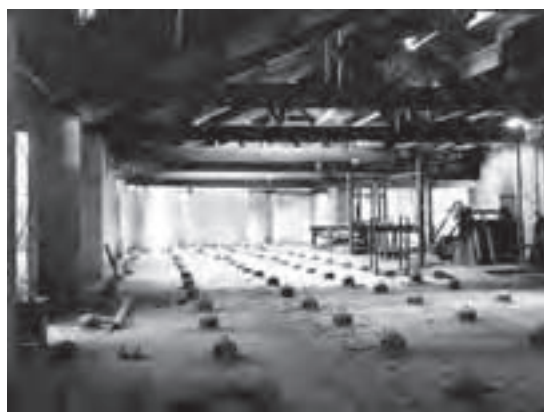
*Fire ports of a Hoffman kiln at Allenby Gardens  
(demolished 1990)  
Interior of a Hoffman kiln at Torrensville (Heritage SA files)*

A Hoffman kiln had one long vaulted chamber which could be divided into smaller compartments by temporary stoppings. Above the firing chamber was a gallery with rows of firing ports in the floor, which were fuelled by sweating stokers hauling barrows of coal. Underground flues connected all parts of the firing chamber to a central chimney stack. The bricks were fired in a continuous cycle whereby at any moment, part of the kiln was being

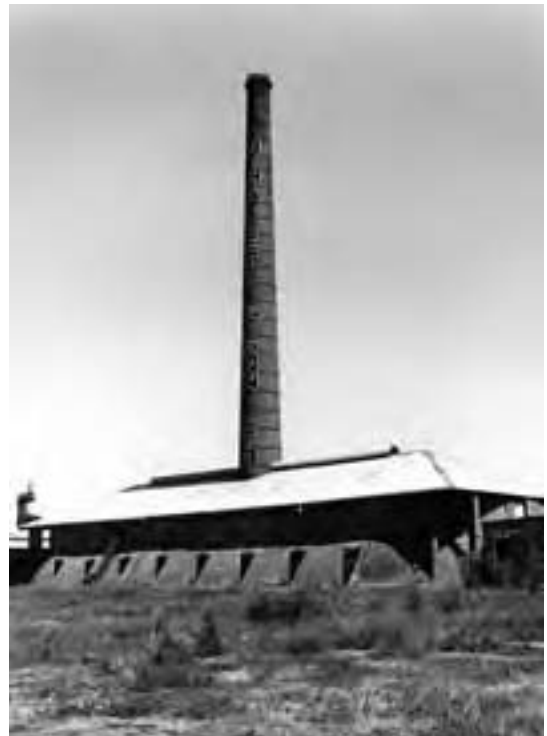
*Hoffman Kiln at Torrensville, now the Brickworks Market (Heritage SA files)*

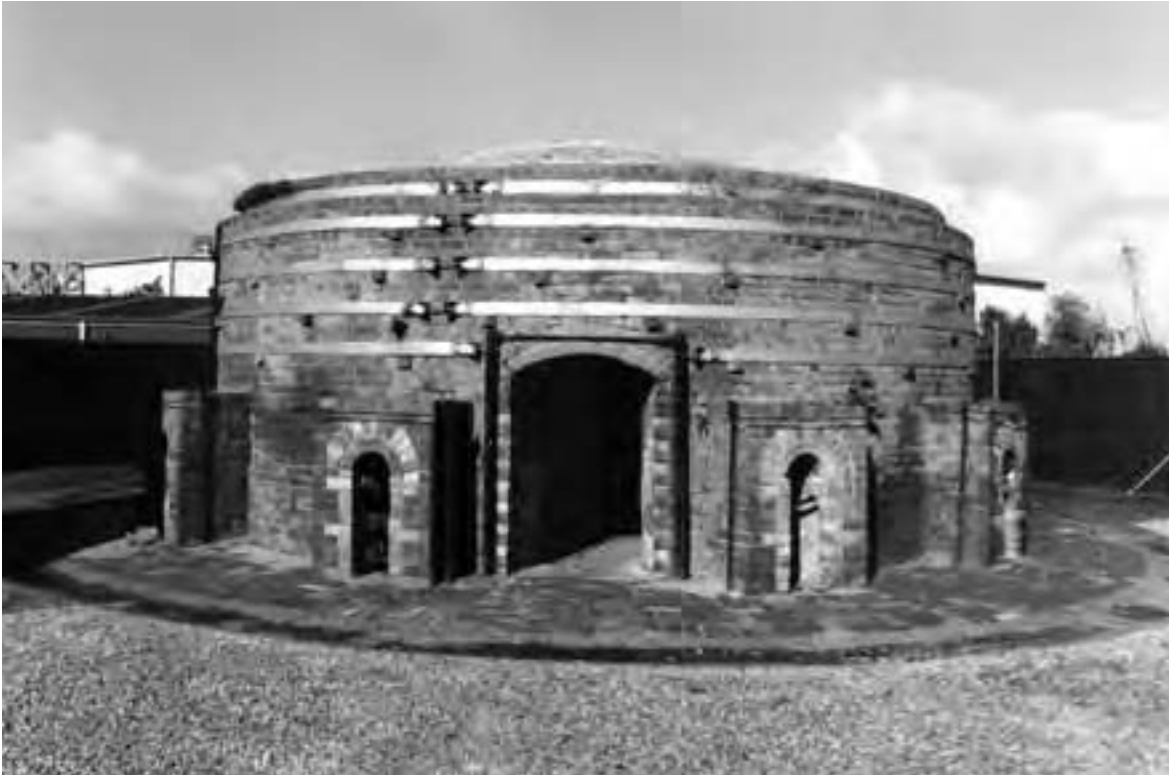
*Circular downdraught kiln at Beverley*

The kiln designs that eventually became most popular in South Australia were the downdraught types, sometimes circular, but more often rectangular in plan with a vaulted roof. Furnaces at the sides sent the hot gases up the walls, but they then had to flow downward between the bricks to exit via flues in the kiln floor which led underground to a chimney stack nearby. This design was more efficient because the flame spent more time in contact with the bricks. The downdraught kilns were reliable and long lasting, and produced attractive and well-fired bricks. There are a number of downdraught kilns still standing; some which were constructed in the early twentieth century are still in use in the ceramic industry.

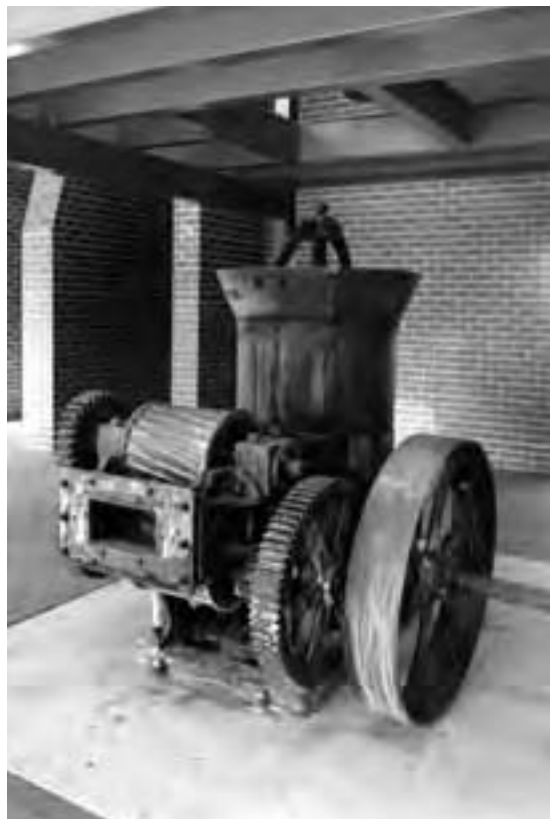
*Brick making machine from Halletts Welland plant (1913) now at Beverley Museum*

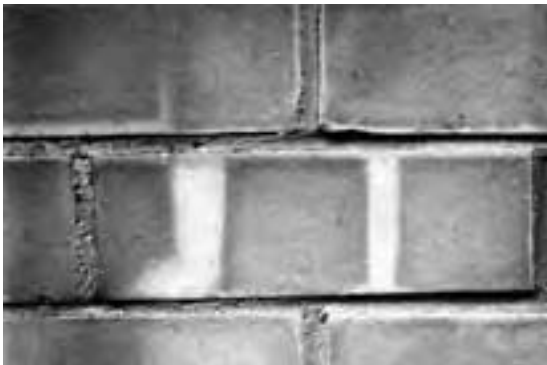
*Kiss marks on a modern brick*

In addition, the same clay fired at different temperatures may produce quite differently coloured bricks. The amount of oxygen and other gases present in the kiln will further determine whether the bricks are oxidised or reduced, and this will affect their colour: rich orange or red bricks are always oxidised, but the same bricks fired in a reducing atmosphere (one that removes oxygen) may be a dark grey or brown. Wood-fired bricks are normally brighter in colour than those fired with coal. As conditions will vary from place to place within the kiln in one firing, depending on how the bricks are stacked, and how the kiln gases flow around them, there may be considerable colour variation even in a batch of bricks made from the same clay and fired in the same kiln on the same day. Even a single brick may show colour variations caused by other bricks touching it or being very close to it in the kiln and so affecting the gas flow over its surface. These are called kiss marks.

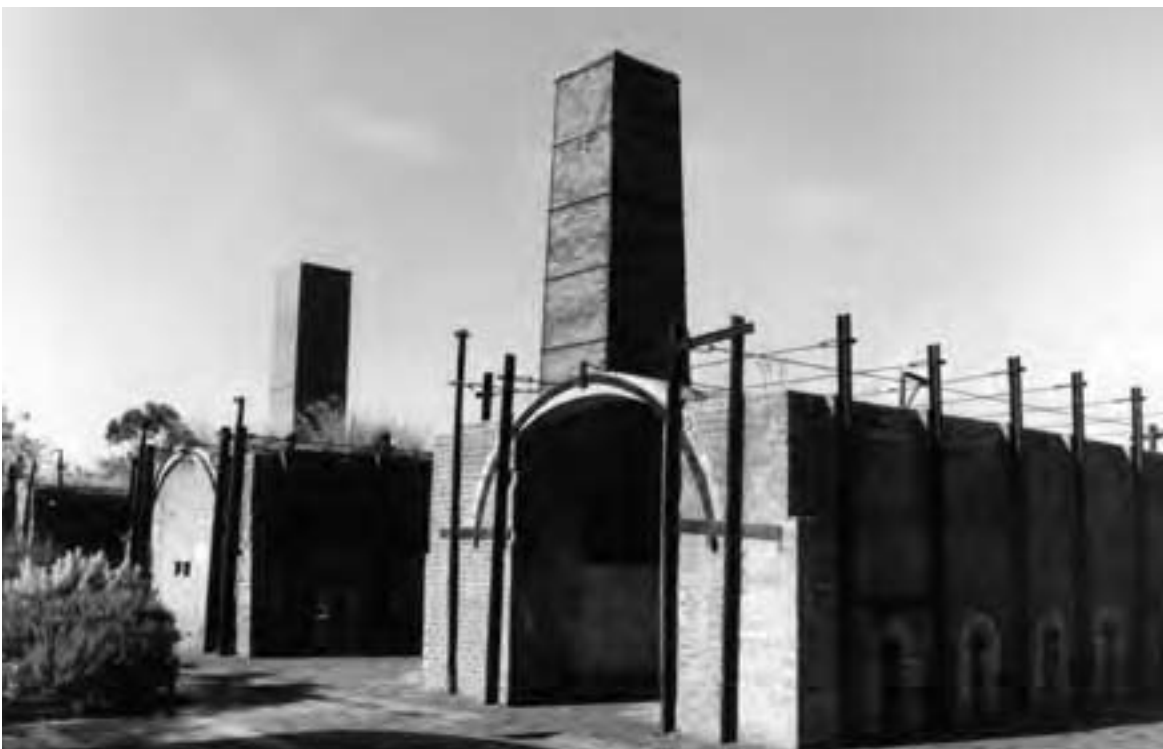
*Vaulted downdraught kiln at Beverley*

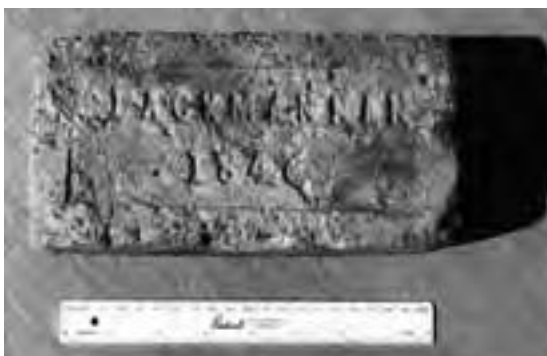
*Occasionally a brick is stamped with a date like this firebrick which has the stamp 'LACKMANNAN 1846'.*

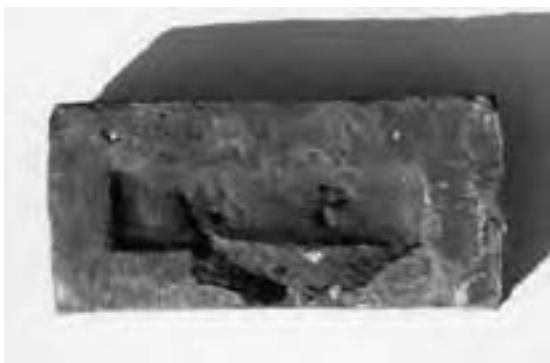
*Hand-made brick for William Peacock's tannery (1840)*

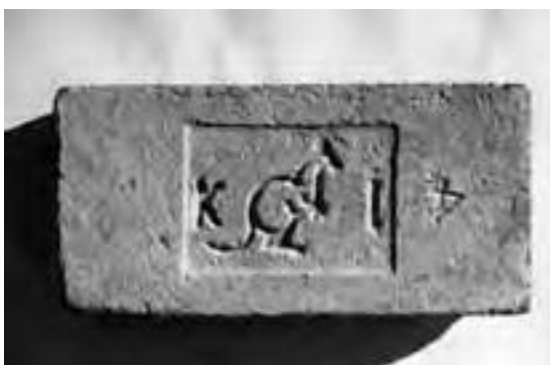
*The Kangaroo Island China Stone and Clay Company made high quality bricks at Penneshaw from 1907-1910*

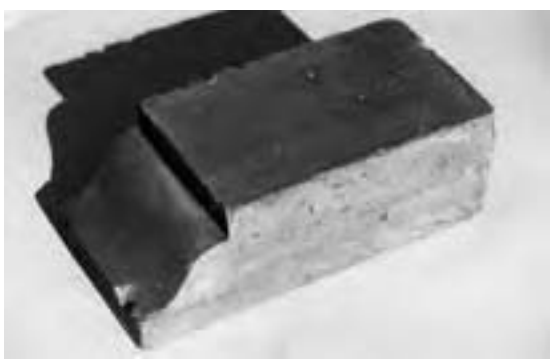
*Special brick used for cornices or other decorative details*

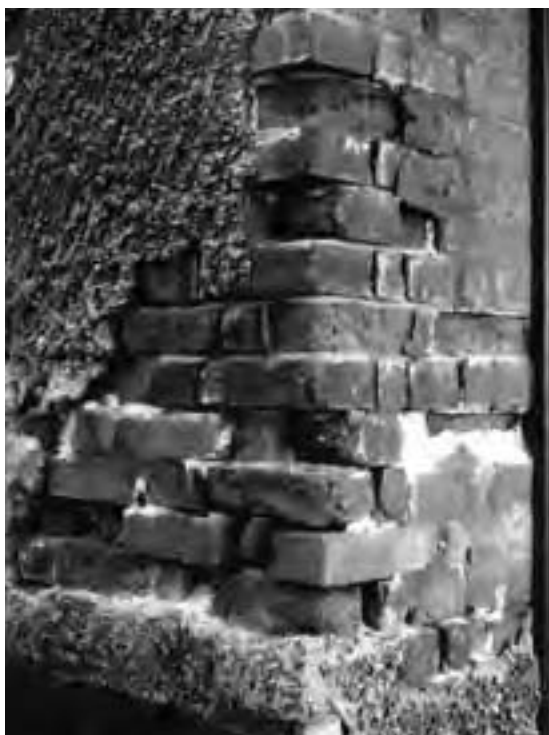
*Characteristic effect of salt attack on brickwork*

Rising damp or ground damp, or what many South Australians know as 'salt damp', gives rise to common conservation problems in all forms of masonry, brick as well as stone. Most bricks are porous; they allow water to soak into them and to evaporate from them. When brickwork is in contact with the ground, they soak up some of the water that is in the soil. Some of that water then evaporates from brick surfaces that are in contact with the air. A hydrological flow is set up, with water continuously moving upward from the ground through tiny spaces in the bricks by capillary action, and evaporating from the surface of the wall. Problems arise because the water contains salts in solution, and they cannot evaporate with the water. They remain behind, forming crystals on the brick surface, and in a layer just under the surface. The growth of these crystals can exercise powerful forces, which cause mechanical damage to the bricks by levering small particles off the surface. The result is a zone or line of damage, usually roughly horizontal, where the brick surface is loose and crumbly, and particles can be seen falling off onto the ground. (Refer to Technical Note 3.8 Rising Damp and Salt Attack.)

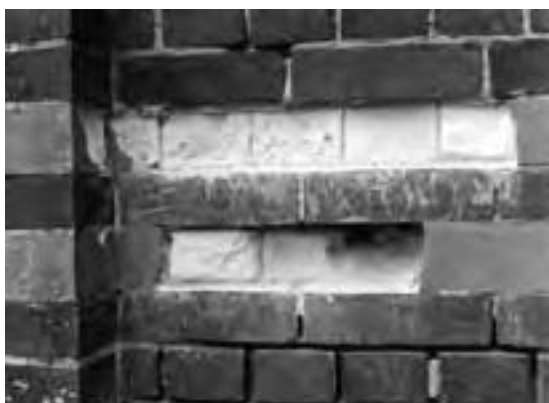
*Salt attack has been worsened by the use of hard render in an attempt to seal in damp*

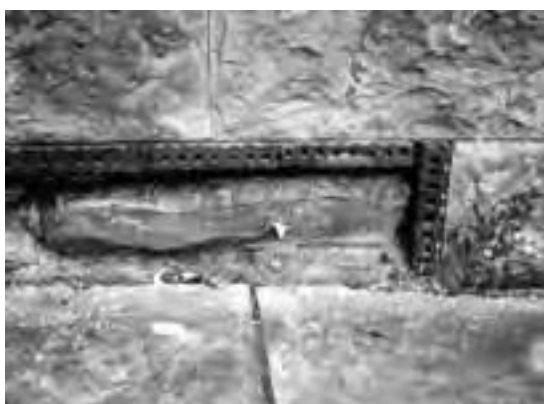
*Ceramic dampcourse in a stone wall. Note the decayed stone under the dampcourse. The concrete path has covered the damp course at right, and is allowing water to enter the wall*

have them, apparently because the early builders misunderstood the implications of the dry climate; or the building may have a damp course which has deteriorated, or been damaged. The ground level may have been raised, allowing water to enter the wall above the damp course. Laying concrete paths or aprons around a building increases the water flow in the walls. Blocking the ventilators in brickwork may have caused moisture to build up in wall cavities and underfloor spaces, increasing the load on the walls, or there may be water entering the wall from a controllable cause such as a lawn sprinkler, or a leaking pipe.

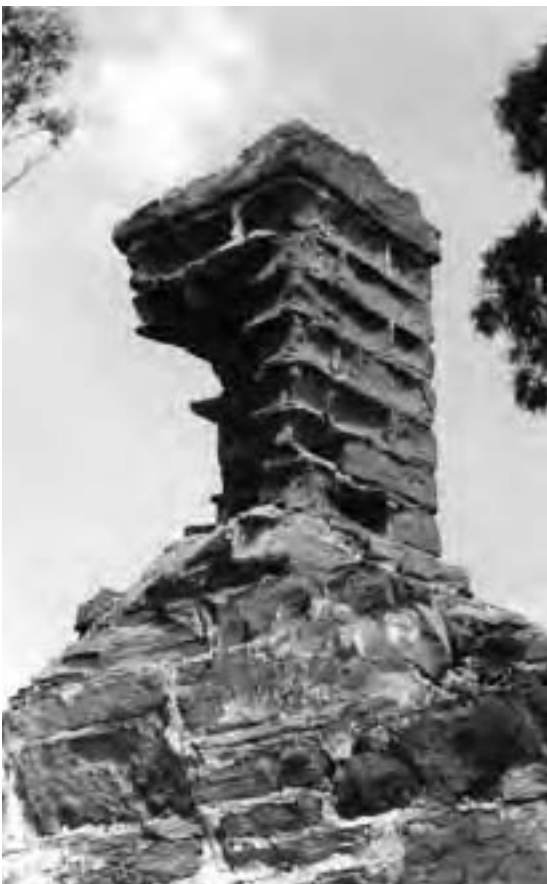
*The result of using soft bricks with hard mortar*

In more recent decades there have been misguided attempts to cure rising damp by re-pointing the walls with harder mortar. The results are invariably disastrous; the impervious mortar forces the wall's entire evaporation load onto the adjacent bricks, accelerating their deterioration. Generally speaking, the softer the mortar, the longer the bricks will survive.

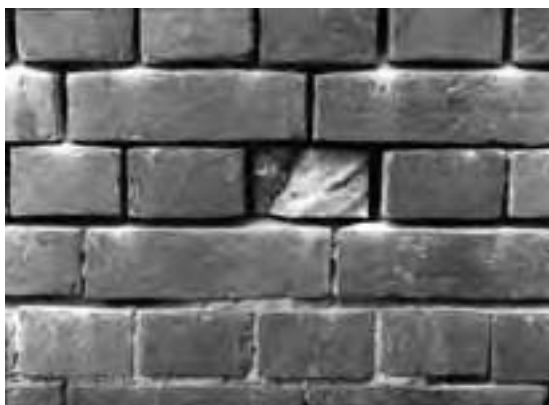
*Rising damp will sometimes attack bricks unevenly. Note the deterioration of mortar*
