# Salt attack and rising damp

## A guide to salt damp in historic and older buildings

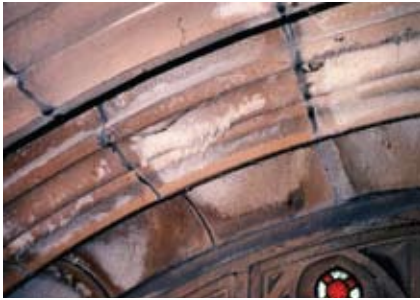
**Figure 4** Thin needles of salt extruding from the top of a window arch. A slipped roofing slate punctured the copper roof gutter, allowing rainwater to wash salts into the stonework.

When the rate of evaporation from the wall surface is low (such as in humid climates, or in cellars and basements with little air movement) the evaporative front may be at or very near the surface, in which case salt crystals will grow as long thin needles, extruding from the wall face (Figure 4). This is known as efflorescence and is commonly seen as a relatively harmless white powder on the surface of new brickwork.

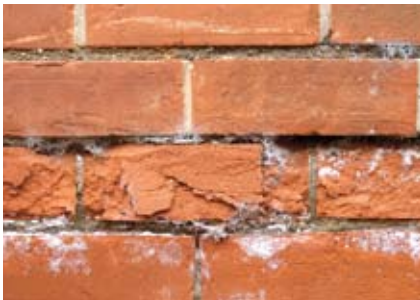
**Figure 5** Salt attack in bricks causing disruption and loss of the fireskin, the harder outer surface that develops during firing in the brick kiln.

However, when the rate of evaporation is much greater, the evaporative front will be inside the wall and salts will crystallise within the pores of the masonry (subflorescence). The force exerted by rapidly crystallising salts is very high and sufficient to disrupt even the strongest masonry material. Crystal growth leads to either grain-by-grain loosening, which produces fretting and crumbling of the surface (particularly to soft mortars) or to delamination of a complete skin, such as the case hardening found on many sandstones (Figure 3) or the fireskin on bricks (Figure 5).

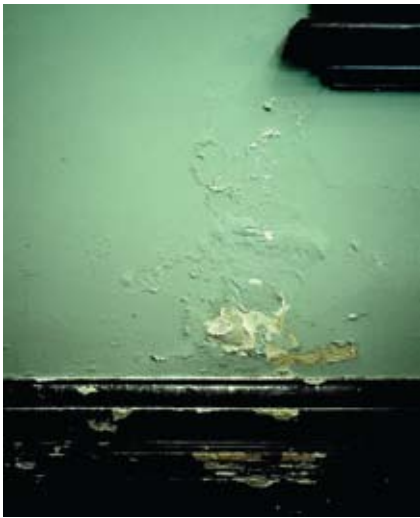
**Figure 7** Typical blistering of paintwork and damage to internal plaster due to the combined effects of rising damp and salt attack. The skirting is a cement moulding and also shows salt damage.

Rising damp may show as a high-tide like stain on wallpaper and other interior finishes, and when more severe, as blistering of paint and loss of plaster (Figure 7, and also Figure 15). Musty smells are common in poorly ventilated rooms and particularly in cellars and basements (see Box 1: *Damp rooms may be unhealthy*). Externally, a damp zone may be evident at the base of walls with associated fretting and crumbling of the masonry (Front cover & Figure 2).

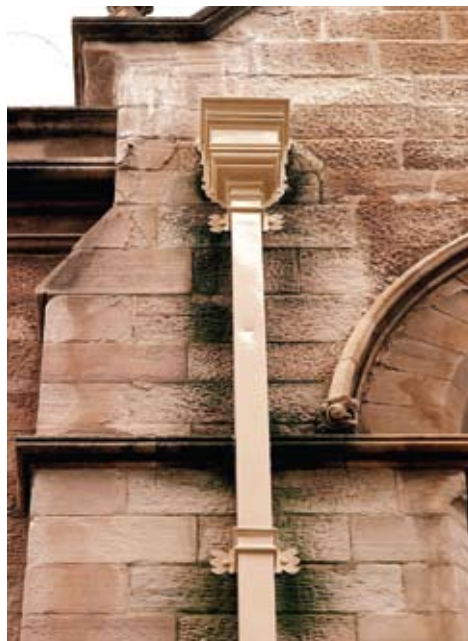
**Figure 14** (right) Two examples of falling damp. Overflow from the blocked rainwater head is made apparent by dark green algae. The coping above the rainwater head is allowing water through to the stones below. Salt attack is causing these stones, above and to the left of the rainwater head, to decay.

The typical debris that builds up in roof gutters and on parapets (such as fallen leaves, bird manure, mosses and dirt) contains weak acids which will contribute to masonry decay by slowly dissolving weaker components leading to progressively more porous and permeable materials. Salts also accumulate on the tops of buildings, not only near the coast, where sea spray is a major factor, but even in central Australia, where wind storms whip up salts from the dry salt lakes and where tiny particles of salt rain from the sky. Though the rates of accumulation of air-borne salt are relatively low, with time a building can absorb sufficient salt to cause damage, particularly when it is all concentrated at one point, such as the top of a blocked downpipe or rainwater head. The importance of regular maintenance of gutters and downpipes cannot be over-emphasised (Figure 14).

evaporates from the wall surface and leaves the salts behind (Figures 4 & 14). Tracing damp back to the point of entry can be difficult, particularly when the masonry is rendered and/or painted and the moisture is trapped behind the render or paint coating.

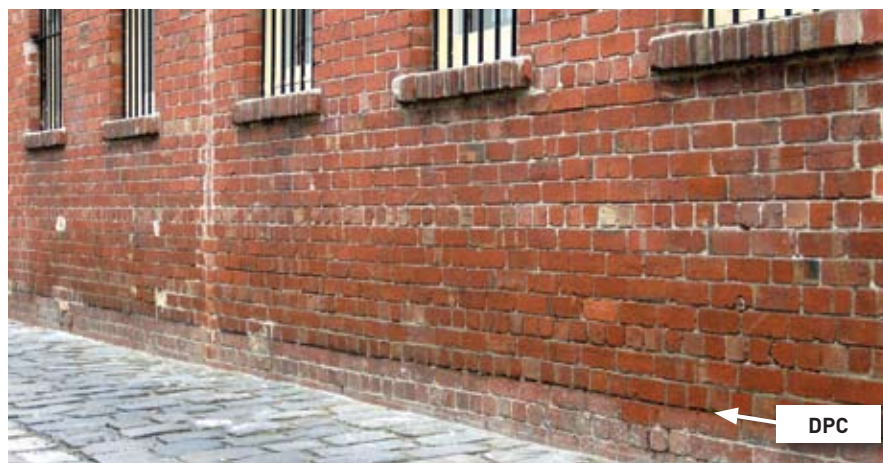
**Figures 15 and 16** In both these examples of penetrating damp the walls are wetter above the DPC than below. At right moisture is penetrating horizontally from a concrete floor, while on the left (in a basement) moisture is coming through the wall from the ground outside. Had the left hand example been an external surface, the paint would have prevented rain from flushing salts out of the wall.

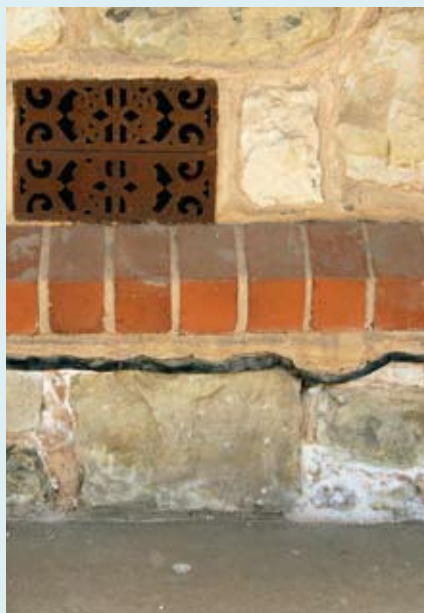
Beware of contaminated materials such as sands and other aggregates. Chemical analysis of the strong efflorescence in the photograph shows it to be predominantly magnesium sulphate (epsomite), a very soluble salt. Its origin is almost certainly from contaminated dolomite quarry sand used as a bed for the concrete paving in the foreground. A former quarry produced a dolomite aggregate for concrete and roadmaking and the crusher fines (quarry sand) were widely used as a bed for paving bricks and concrete. Some parts of the quarry contained pyrite (iron sulphide) which, on exposure to the atmosphere after crushing, oxidised to liberate sulphuric acid.

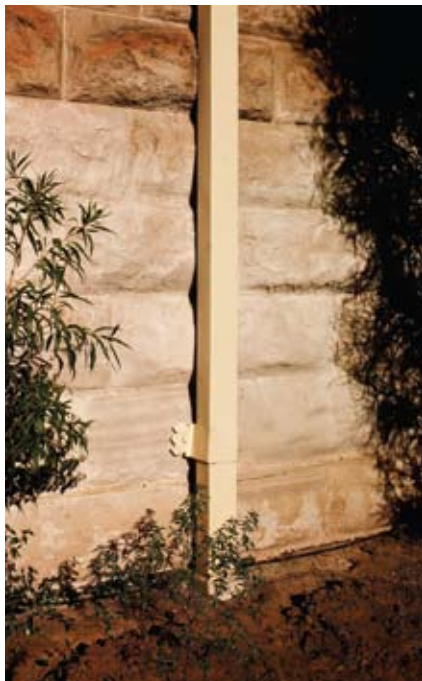
**Figure 24** Garden beds against walls almost guarantee salt damp problems. Here the DPC was buried by 300 mm of soil — five courses of sandstone have been severely damaged.

**Figure 25** Sterile zone between wall and garden — paved with coarse gravel to allow rainfall in and evaporation out. Drainage is provided by an agricultural drain wrapped in geofabric. Garden sprinklers are replaced with drippers and are kept at least 500 mm away from walls.

Gardens against walls are particularly bad — soil levels build up as mulches are added, fertilisers contribute soluble salts and watering by enthusiastic gardeners washes it all into the walls (Figure 24). Garden beds should be pulled back and a sterile zone at least 300 mm wide left against the walls. Sprinkler systems should be replaced with drippers and kept well away from walls (Figure 25).

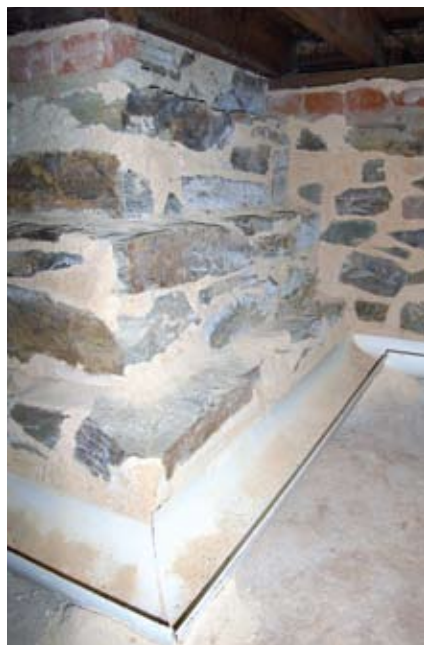
**Figure 27** Semi-circular sections of PVC piping catch salt and other debris from sacrificial plasters and mortars on the walls beneath the floor of a church. Bedded on the same sacrificial mortar mix as that used for the walls, the pipes prevent the recirculation of the salts through the soils below and are cleaned out annually. White salts are visible on the stones in the centre of the photograph.

Controlling evaporation of moisture from sub-floor walls or from adjacent soils is one of the fundamentals of successfully managing rising damp. The emphasis is on control because there can be too much of a good thing. Too much underfloor ventilation may lead to salt attack on the inside faces of walls and on dwarf walls supporting floors. This could lead to unseen damage and could become dangerous. Regular inspection of underfloor spaces is therefore important. Where higher rates of ventilation are needed to manage dampness it may be necessary to apply sacrificial plasters to vulnerable walls (Section 13) and to catch debris from them so that salts are not recirculated (Figure 27).

As they crumble, sacrificial mortars and plasters will produce a dust of sand, lime and salt which should be collected and periodically removed, rather than allowing the salt to re-enter the soil and so be recycled up the wall. When protected from rain strike (internally, in a cellar, or on a veranda) a drop-sheet of strong plastic sheeting can be useful (Figure 31). An alternative treatment, using half round PVC piping beneath a timber floor is shown in Figure 27.

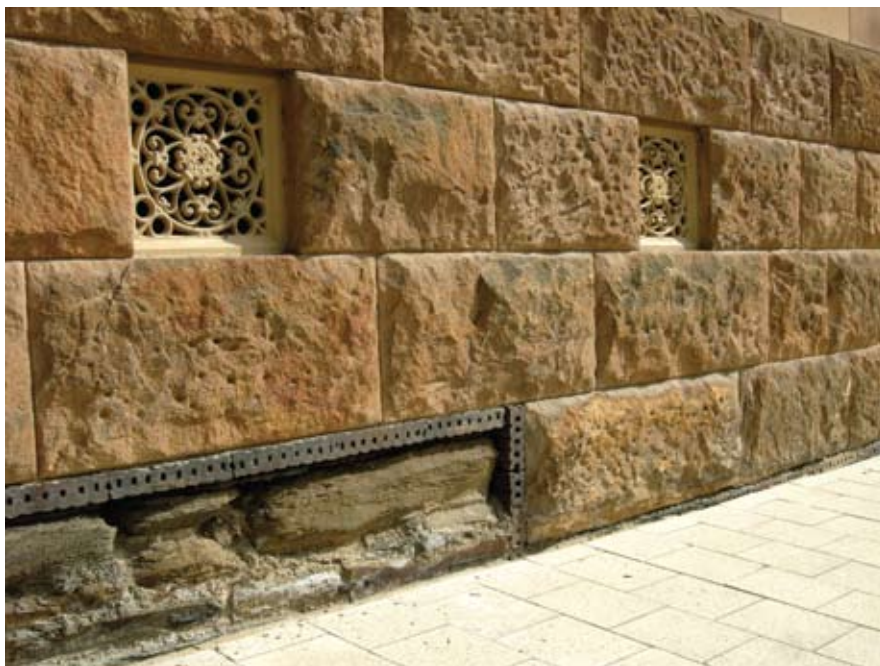
**Figure 34** Stonework below the DPC needs attention as salts accumulate and the mortar and bluestone erode. In the first instance sacrificial treatments should be used to manage the problem. The 1879 ceramic DPC is doing an excellent job of protecting the sandstone above it, although where it steps down the slope it is compromised by hard paving that is laid too high, allowing splash onto the stone (see Box 2: *Location of DPCs*).

Responding to increasing salinity problems, some local councils are requiring higher standards of construction of modern buildings, particularly in regard to concrete slabs and footings for housing. This guide is about existing buildings and is focused on those that have deficient, absent or bridged damp-proof courses. Even buildings with good damp-proofing are not immune to salt damage and many will require ongoing maintenance to control the problem (Figure 34).

The point of these recommendations is to keep the size of the potential evaporative zone below a DPC to a minimum in order to limit decay due to salt attack (Figures 10 & 34). Decay below a DPC will require ongoing maintenance. See Box 7: *Potential negative impacts of DPC installation* for an additional perspective.

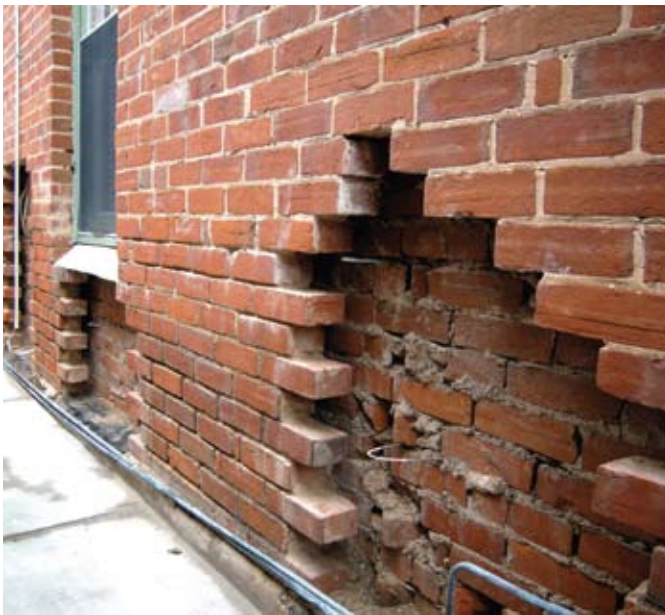
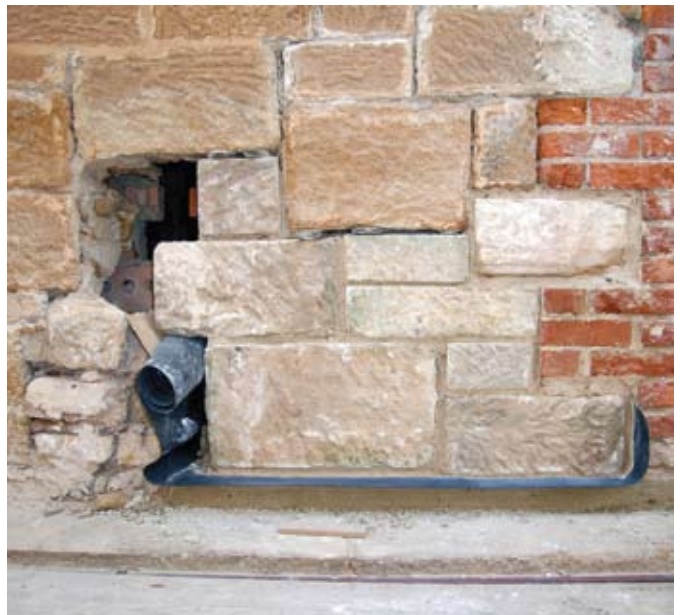
**Figures 35 and 36** Undersetting to install new damp-proof courses. At left sections, known as pins, are removed from a cavity wall, while at right a pin has been rebuilt on a plastic DPC, the end of which is rolled up ready for use in the next section. In the case of cavity walls, such as at left, the inner leaf also needs to be treated, using one of the methods described in this guide. Where solid walls are being underset, such as on the right, the entire thickness of the wall must be removed and rebuilt to allow a DPC to be installed across the full width of the wall. Partial undersetting of a solid wall is bad practice as the damp will continue to rise through the remaining portion.

The traditional physical means of introducing a new DPC is the technique known as undersetting, or masonry replacement. Undersetting should not be confused with underpinning, which is a treatment for structural cracking due to settlement or footing failure. In undersetting, sections of the base of the wall are removed down to the footing and progressively replaced with new materials and a DPC. Small sections (or pins) of brick or stonework are removed (including all decayed material), leaving pillars to support the wall structure (Figure 35). A DPC is incorporated as each pin is rebuilt; after the new mortar cures the top joint is packed tightly to take up the load of the wall (Figure 36). Adjacent sections are then removed and rebuilt until the whole wall has a new base incorporating a continuous DPC. Figure 37 is an example of undersetting carried out in the 1930s.

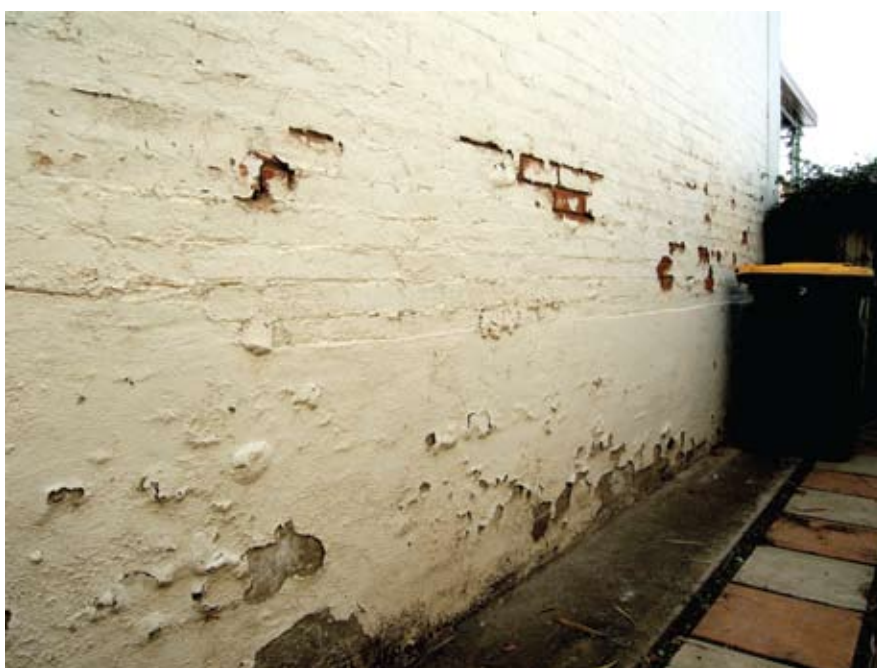
**Figure 54** Failure of an acrylic paint coating due to salt damp. The bottom part of the wall is rendered in cement, which has contributed to the damp rising further due to its relative (but not total) impermeability. Decay of the brickwork is focussed where the paint film fails because that's where salt crystallises as moisture evaporates. The paint and the render should be removed and replaced with a more vapour-permeable coating such as limewash.

The same principle can be applied to plasters or renders. By using weak plasters the evaporative front (and hence decay) is moved from the original masonry out into the new plaster. Provided there is sufficient evaporation from the sacrificial plaster, decay can be limited to the lower parts of a wall. These treatments are the opposite of the incorrect practice of rendering the base of affected walls with dense, relatively impermeable cement renders. This simply prevents the evaporation of moisture, which continues rising up the wall until it can evaporate above the render, starting the problem all over again (Front cover & Figure 54).

Acrylic (water-based) paints are more vapour-permeable than alkyd (oil-based) paints; the latter should not be used where walls remain damp or are still drying out after DPC insertion. Even the acrylics can be too impermeable for old walls (Figure 54). In these circumstances alternative coatings such as cement-based paints and traditional limewashes should be considered. Limewashes are more vapour-permeable than cement-based paints.

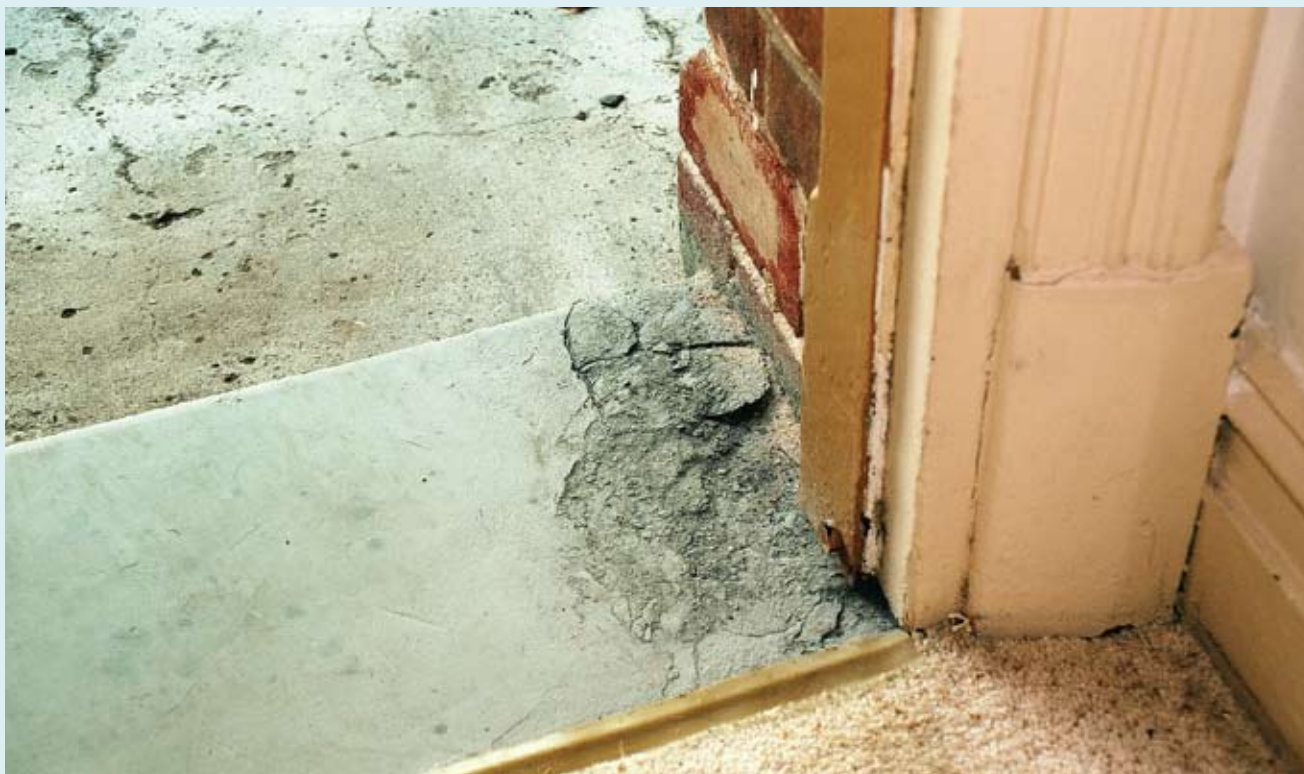
Box 9, Figure 55

A brick house built in about 1900 had a slate front doorstep. Mild damp affects parts of the house particularly near the front door, causing the doorstep to delaminate and become powdery on the surface due to salt attack. The badly worn step was replaced in the mid-1980s with a new piece of slate from the same quarry. Within five years the new step began to decay in the same manner (Figure 55, below). What happened? Why did the first step last eighty-odd years and yet the second need replacing after ten? Perhaps the slate is not what it used to be?

The explanation is that it took eighty years for rising damp to draw salts from the soils up into the walls to a concentration sufficient for it to cause decay in the first step (see Figure 17 in Section 9.4). The second step was built into this already salt-laden environment and so it began to decay shortly afterwards.

The dense layered nature of slate contributes to its demise — its very fine pore structure has a high suction along the layers, while being relatively impermeable across the layers. Thus the slate will draw any available moisture in from its edges — edges which are butted against salty brickwork.

The third step, which is now doing fine after ten years, had its edges sealed with slate sealer prior to installation (several coats of siloxane dampcourse fluid would be an alternative). The new step is bedded on a plastic DPC and on weak mortar that will decay sacrificially in preference to the adjacent brickwork.
