Lakeshore erosion monitoring data analysis

Sarah Yu Department of Environment, Water and Natural Resources

May, 2014

DEWNR Technical Note 2014/03

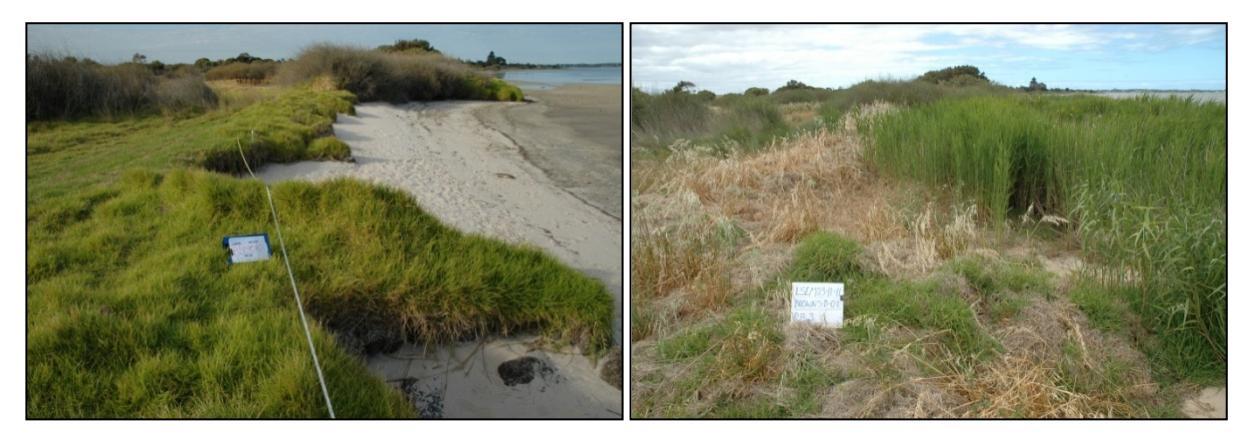
Figure 5-1. Browns Beach right photo point in April 2007 (I) and November 2011 (r)

This site experienced minor erosion during the monitoring period, with net erosion at the left (L), centre (C) and right (R) monitoring points found to be 0.25 m, 0 m, and 0.3 m, respectively (average of 0.183 m across the three points). Erosion of 0.4 m and 0.6 m was measured following the April – October 2007 period at L and R, respectively, when the average lake level was 0.209 m AHD, and prevailing winds were from the NNE, WNW, W and S.

However, accretion was also apparent at some other monitoring visits; possible reasons for this include measurement inaccuracy as a result of kikuyu spreading along the bank, sand deposition (0.3 m accretion was observed at R during the April 2008 monitoring visit) and later establishment of the nearshore reed bed. No erosion was observed in April 2011 after lake water levels had returned to normal; in fact, a small amount of accretion was noted, possibly as a result of the phragmites reed bed establishment (Figure 5-1).

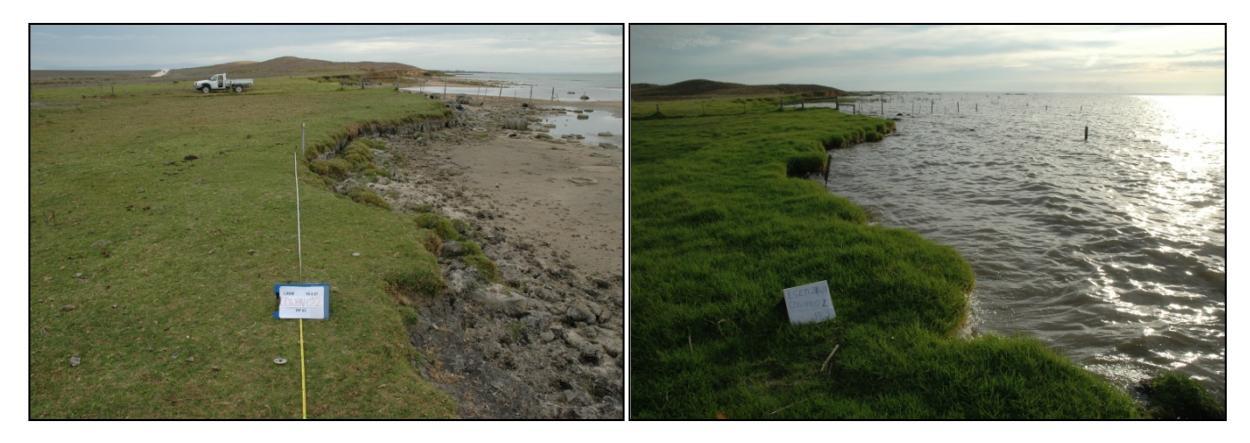
Figure 5-2. Cowan02 right photo point in April 2007 (I) and April 2011 (r)

No erosion measurements were made at this site after November 2010. Moderate total shoreline erosion losses of 0.7, 0.2 and 0.8 m were measured at L, C and R, respectively. Minimal erosion was recorded between 2007 and 2009 – most of the shoreline loss was recorded in the November 2010 monitoring visit, immediately after lake levels had returned to normal operating levels after the drought.

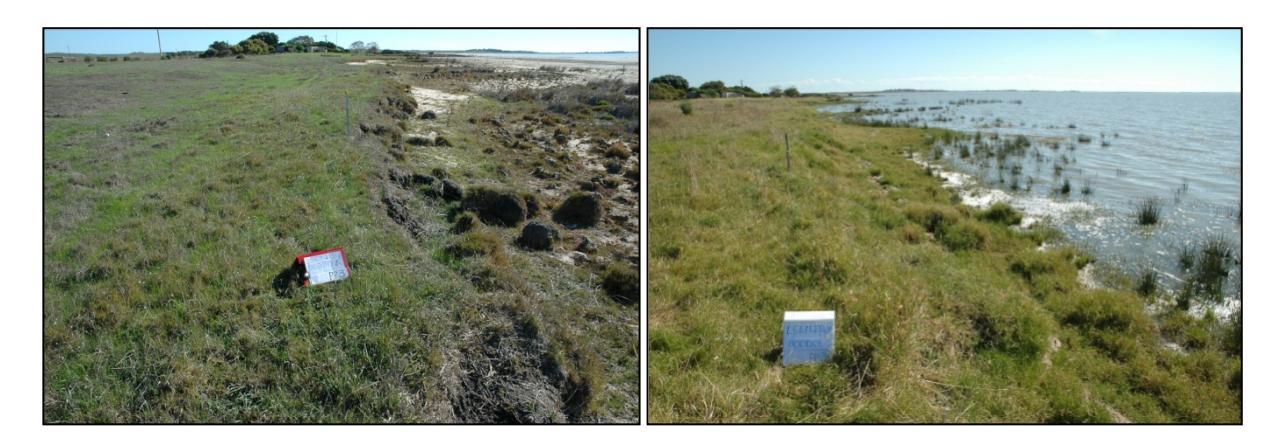
Figure 5-3. Dodd01 right photo point in April 2008 (I) and April 2011 (r)

The monitoring site was established in April 2008. Erosion at this site was very minor over the monitoring period, with shoreline losses ranging between 0.1 and 0.2 m across the three measured points (L, C & R). When lake operating levels had returned to normal, bank erosion was only recorded at L and C, whereas the erosion at R occurred when the waterline was well offshore due to the drought and was due to the crumbling of dry bank soil.

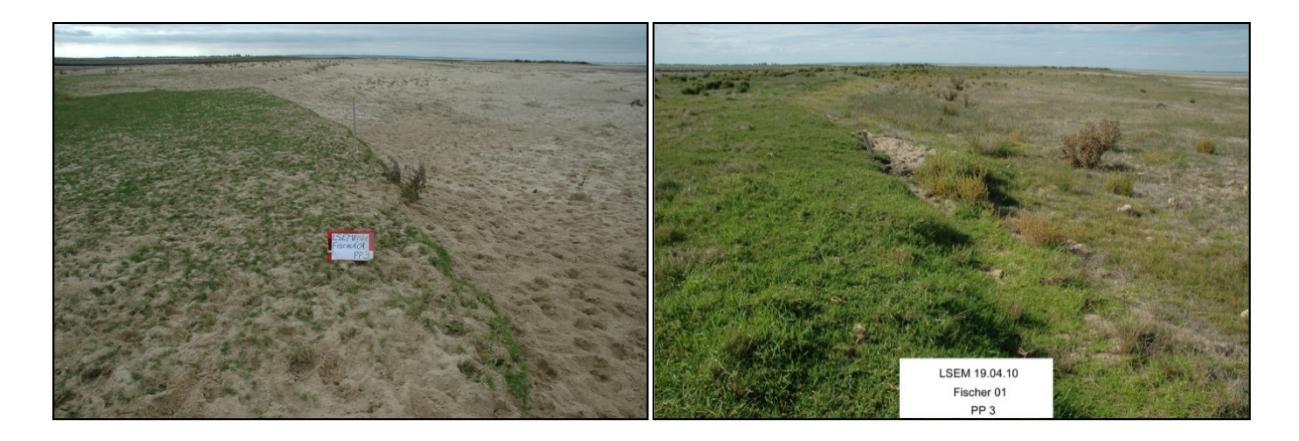
Figure 5-4. Fischer01 right photo point in May 2008 (I) and April 2010 (r)

The monitoring site was established in April 2008 with erosion monitoring ceased in 2010 when the monitoring point markers were destroyed by cultivation for cropping. Erosion measurements were undertaken only in November 2008 and April 2009. During this time, lake levels were very low due to the drought and no net erosion occurred. However, some accretion was recorded due to the windblown lakebed sand that was deposited onto the shore. The deposition of aeolian sand from the dry lakebed during 2008 and 2009 is unsurprising since the shoreline directly faces the prevailing wind of the drier summer months (November to March).

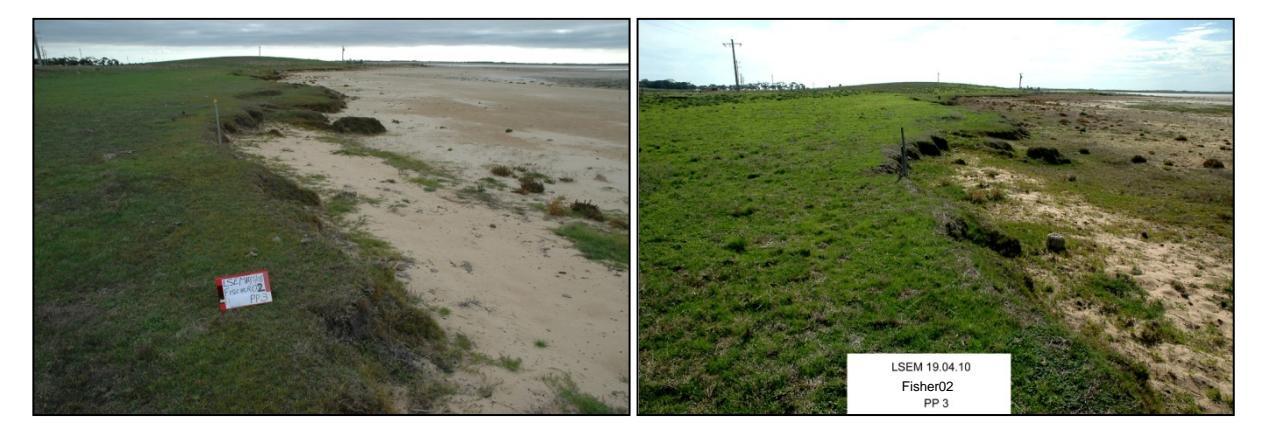
Figure 5-5. Fischer02 right photo point in May 2008 (I) and April 2010 (r)

The monitoring site was established in April 2008 with erosion monitoring ceased in 2010 when the monitoring point markers were destroyed by cultivation for cropping. Erosion measurements were undertaken only in November 2008 and April 2009. During this time, lake levels were very low due to the drought and no net erosion occurred.

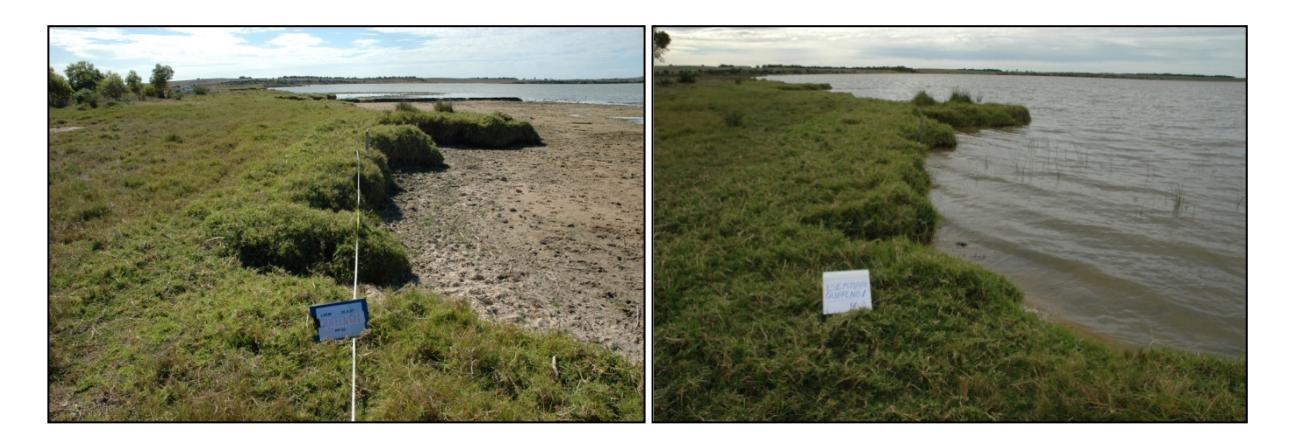
Figure 5-6. Griffen01 right photo point in April 2007 (I) and May 2011 (r)

Erosion at this site was moderate. At the April 2007 monitoring visit, 0.5 m of bank loss was observed at the left (L) transect. At the April 2011 monitoring visit, following the return of normal lake levels, further erosion of 0.3, 0.8 and 0.9 m was measured at L, C and R, respectively. The average shoreline loss measured at this site was 0.9 m, with almost all of the erosion occurring during the period when lake levels were at or near normal operating levels. Given the site's south-easterly aspect, it is likely that the prevailing summer-period winds (typically ranging SSW to SSE) were a contributing factor to wave erosion of the shoreline.

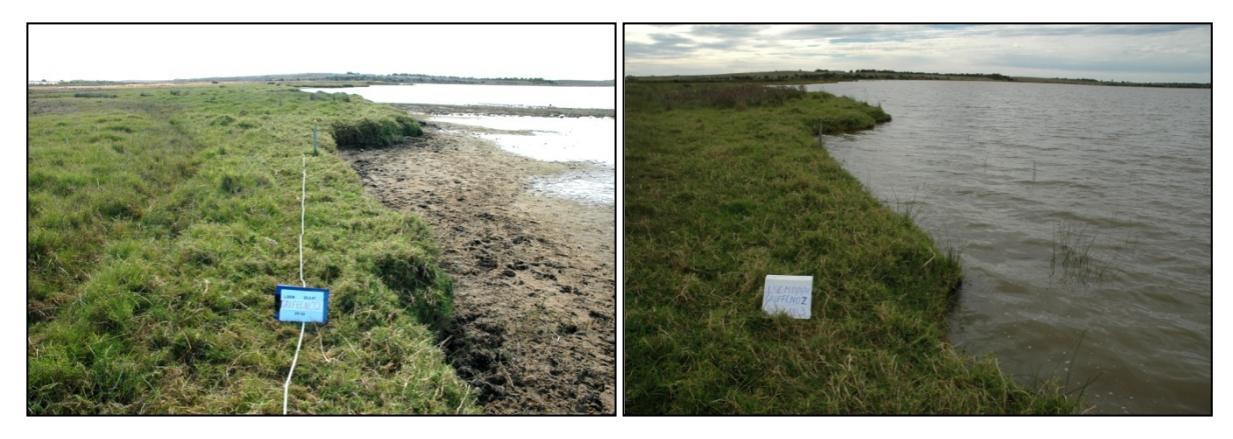
Figure 5-7. Griffen02 right photo point in April 2007 (I) and May 2011 (r)

The characteristics of Griffen02 are almost identical to those of Griffen01 (Figure 5-7). Griffen02 is located approximately 80 m NNW of Griffen01, on the northern side of the groyne. Erosion at this site was minor. No erosion was observed at L or C during the monitoring period, however 0.4 m of net shoreline loss was measured at R following the restoration of normal operating lake levels after the drought.

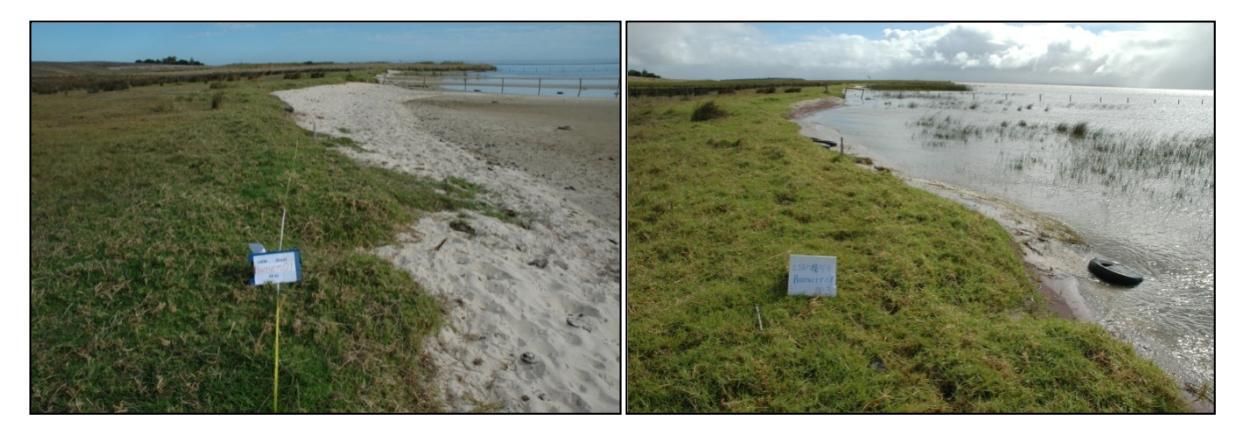
Figure 5-8. Hartnett right photo point in April 2007 (I) and May 2011 (r)

No erosion was recorded at this site; in fact net shoreline accretion was observed at all three transects (L, C and R), varying between 0.03 and 0.85 m. The shoreline growth at this site is attributable to the spreading of the kikuyu cover across the sandy beach. Furthermore, the shoreline does not face a commonly-prevailing wind direction (although northerly winds are frequent during some winter (April – October) periods).

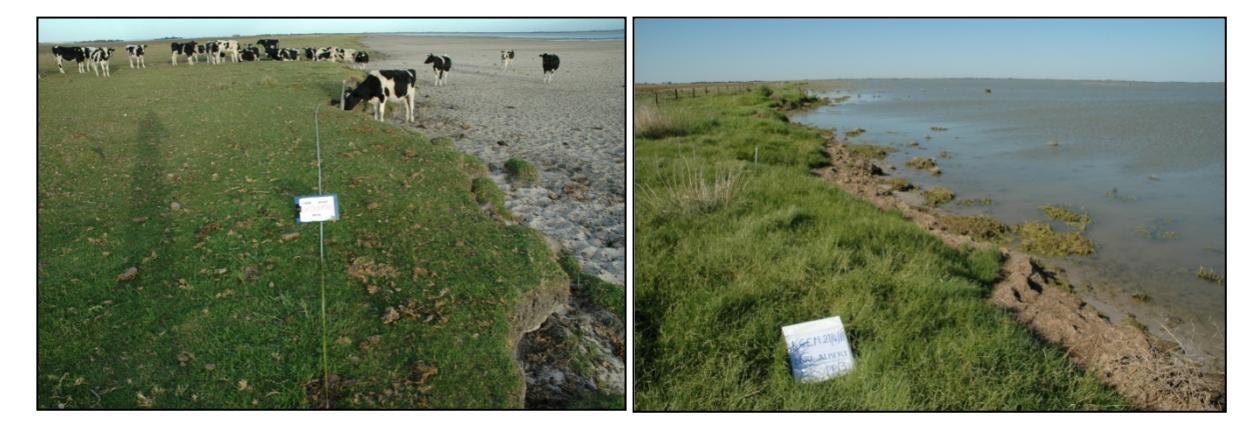
Figure 5-9. Lake Albert Station right photo point in April 2007 (I) and May 2011 (r)

No erosion measurements were taken at this site after November 2010 due to the base marker having been broken off and monitoring pegs having been buried in sand. No erosion was observed following the restoration of normal lake levels after the

drought, presumably due in part to the thick blanket (up to 20 cm deep) of dried algae that was deposited along the shoreline, protecting the bank from physical erosion by water waves. Between setup in November 2006 and April 2009, the net erosion observed was estimated to be 0.7 and 0.5 m at the L and C transects, respectively, whereas net accretion of approximately one m was observed at the R transect.

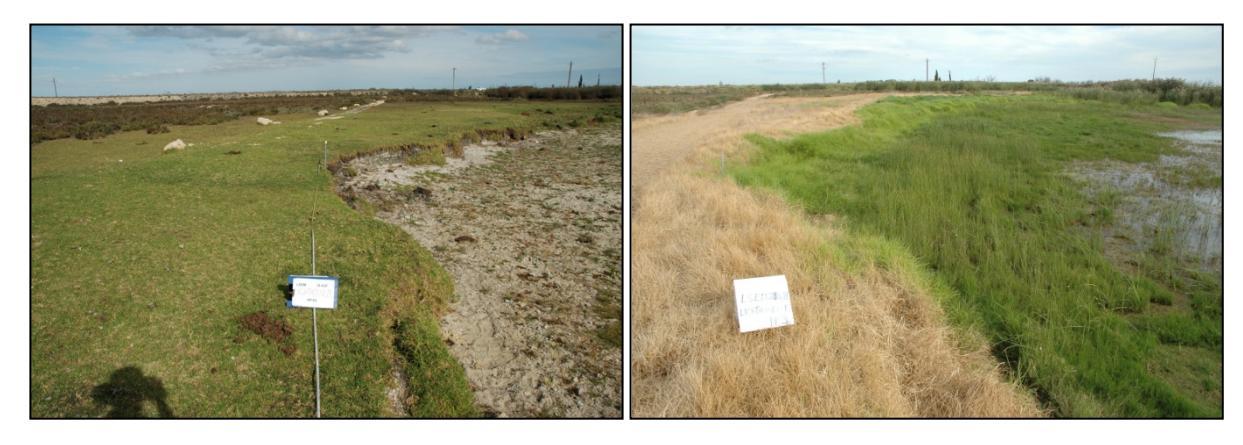
Figure 5-10. Lighthouse right photo point in April 2007 (I) and April 2011 (r)

The 0.6 m high Poltalloch soil lake shoreline is vegetated with kikuyu and paspalum and was regularly grazed by cattle until 2010 when exclusion fencing was constructed. When the lake levels were restored to normal levels in late 2010 after the drought, the lake edge was noted to be covered with kikuyu, algae and other plants. The kikuyu was sprayed for weed control in April 2011, as can be seen from Figure 5-10.

Erosion at this site was moderate. However, all erosion during the monitoring period was observed to be a result of crumbling of the dry bank and trampling by cattle. At the time of the site setup, the water level was already too low to produce any water erosion and no erosion was observed after normal lake operating water levels were restored in late 2010. Shoreline loss at this site was 0.95, 0.4 and 0.05 m, measured at L, C and R, respectively.

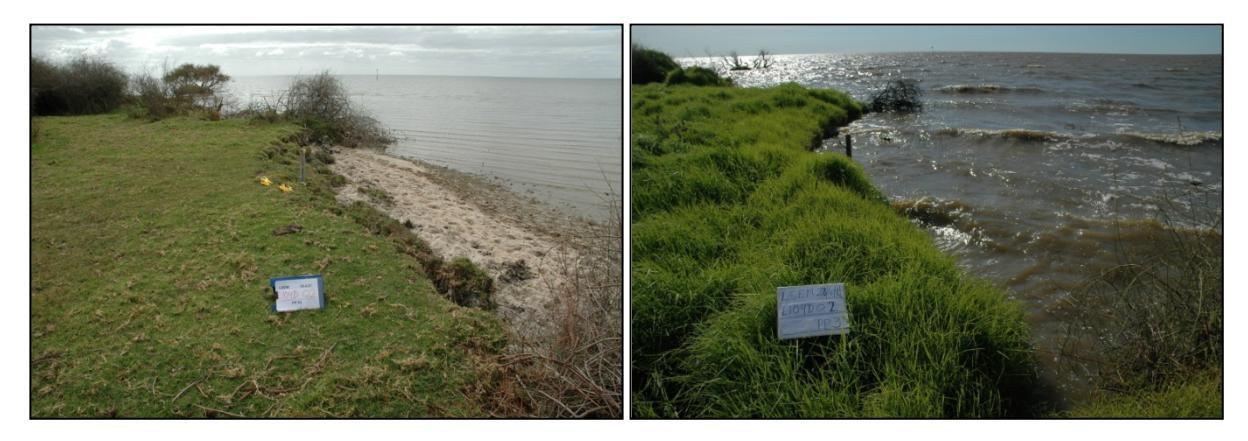
Figure 5-11. Lloyd02 right photo point in April 2007 (I) and April 2011 (r)

Some of the erosion at this site is attributable to cattle trampling of the dried and cracked bank during the drought period. Overall erosion at this monitoring site was moderate, with shoreline losses of 0.6, 0.9 and 0.35 m respectively, measured at L, C and R. All the erosion at C occurred following the restoration of normal lake operating levels. The site does not directly face a prevailing wind direction. However, due to its location at the entrance of the Narrung Passage, the shoreline is nevertheless likely to be affected by wave and current action due to wind-driven flow between the lakes.

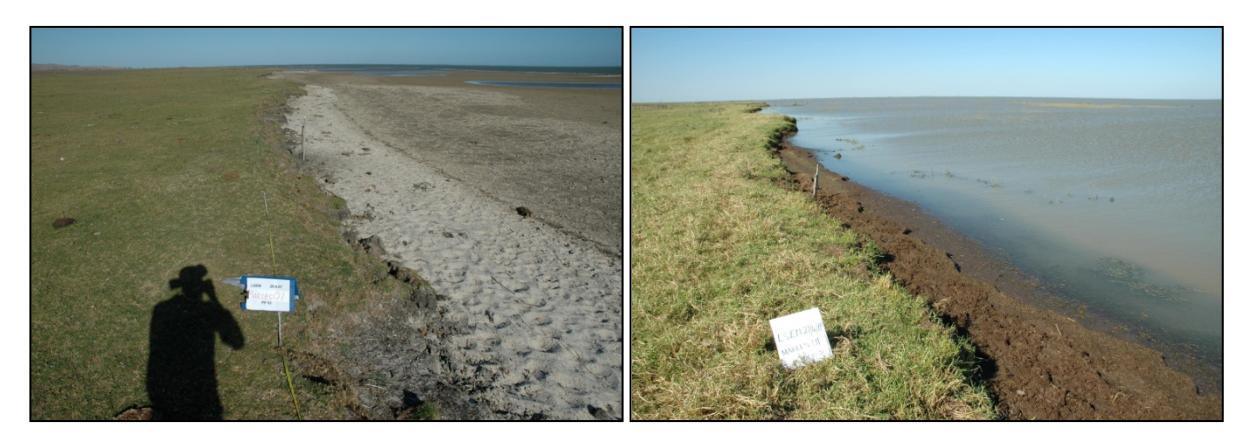
Figure 5-12. Marles right photo point in April 2007 (I) and April 2011 (r)

This site directly faces the prevailing wind for the warm months of the year, with a wave fetch up to 17 km. As a result, shoreline losses averaging one m were measured across all transects (L, C and R) within the first few months following setup in November 2006. During 2008, when the dry lakebed was exposed, significant onshore sand drift occurred, with sand being deposited up to 55 m inland of the shoreline. Stock trampling of the dry cracked shoreline contributed to some erosion during the drought. Following the return of normal operating lake levels, a large amount of algae and mulch material was washed onshore (visible in the second photograph in Figure 5-12), protecting the shoreline from significant erosion for at least the first few months.

Erosion at this site was significant, with total shoreline losses of 1.02, 0.97 and 1.12 m measured across L, C and R, respectively, almost all of which occurred during the first few months of monitoring before the waterline had receded well south of the shoreline.

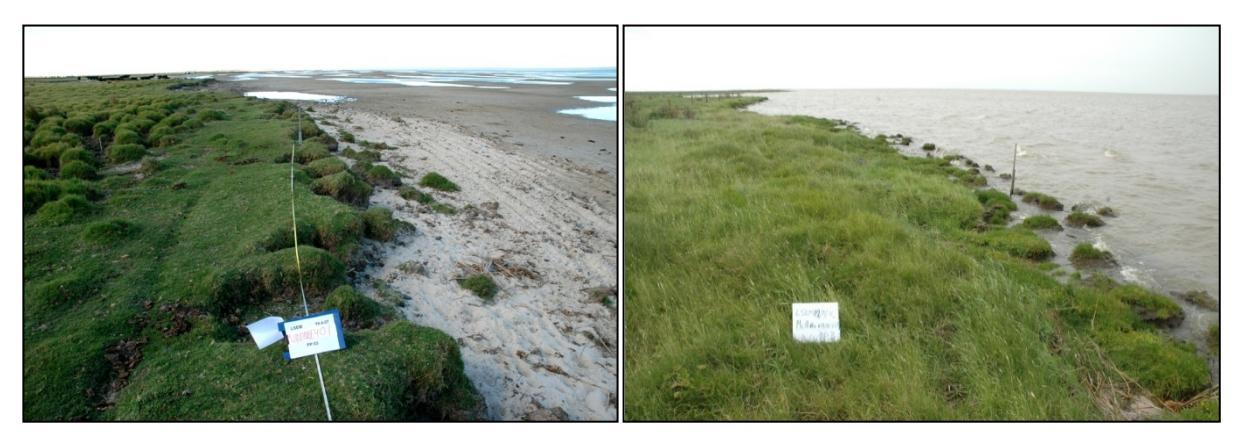
Erosion at this site was significant. Shoreline losses of 2.3, 1.1 and 1.35 m respectively were measured at the L, C and R transects, with practically all of the erosion occurring during the final months of the monitoring period, after normal lake levels were restored.

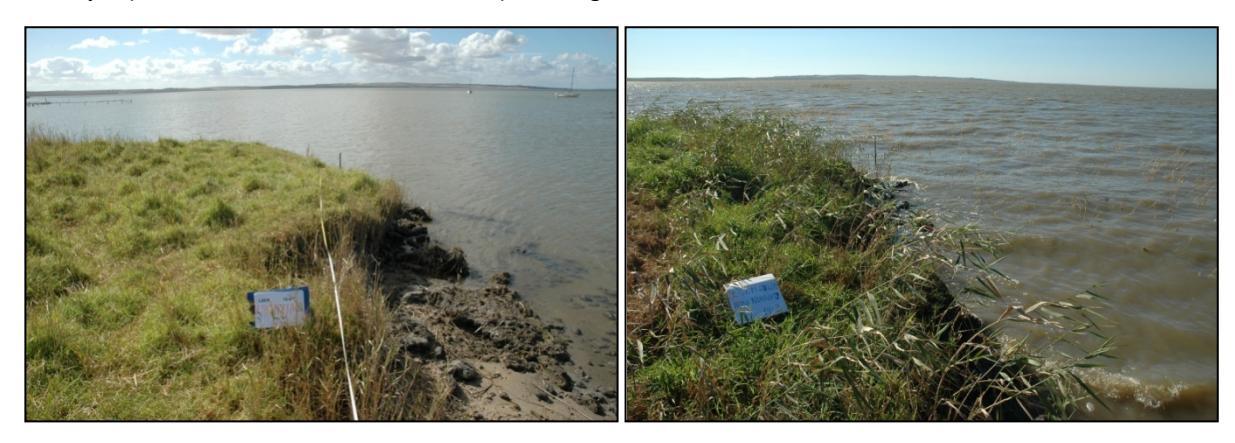
Figure 5-14. Nurra Nurra02 right photo point in April 2007 (I) and April 2011 (r)

Erosion at this site was severe. Although negligible erosion occurred during the initial drought period, significant shoreline losses were observed at the November 2010 and April 2011 monitoring visits, following the restoration of normal lake operating levels. Total erosion losses of 2.1, 2.0 and 1.2 m were measured at the L, C and R transects, respectively. Having a south-easterly aspect, the shoreline does not face a prevailing wind direction.

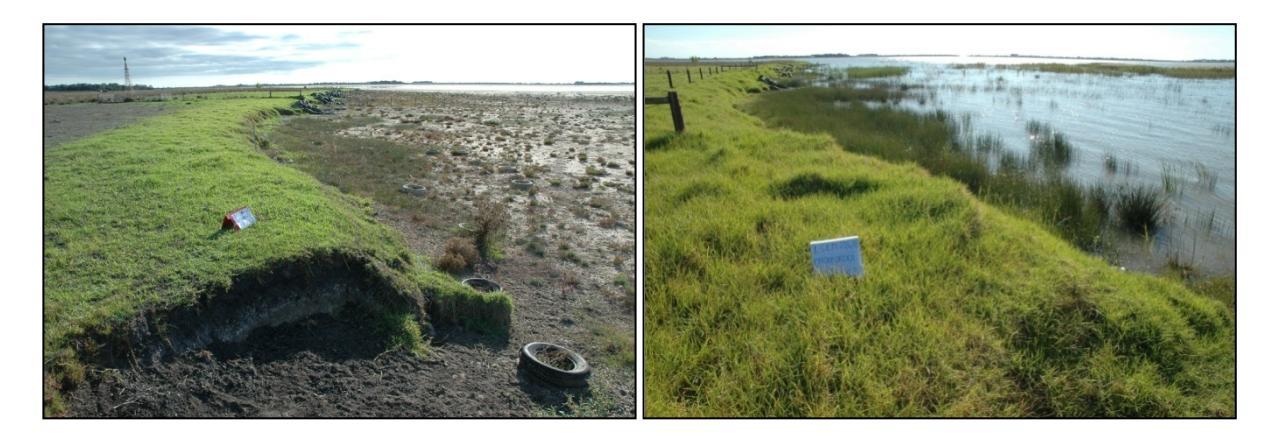
Figure 5-15. Pitchford01 right photo point in May 2008 (I) and April 2011 (r)

The Pitchford01 monitoring site was established in April 2008 when the waterline was already well offshore due to the drought conditions. No shoreline measurements were taken after November 2010 as the base marker had been removed. The site is located on an eroded western shore of Lake Albert, on the northern side of Rumpley Point. The shoreline has a northerly aspect and a medium erosion risk rating. The shoreline consists of a 0.7 m high Poltalloch soil bank, vegetated with kikuyu and was grazed by cattle until an exclusion fence was constructed in 2010 (Figure 5-15). Following the restoration of normal lake levels, phragmites and rushes rapidly became established up to 80 m offshore.

No erosion was observed at this site.

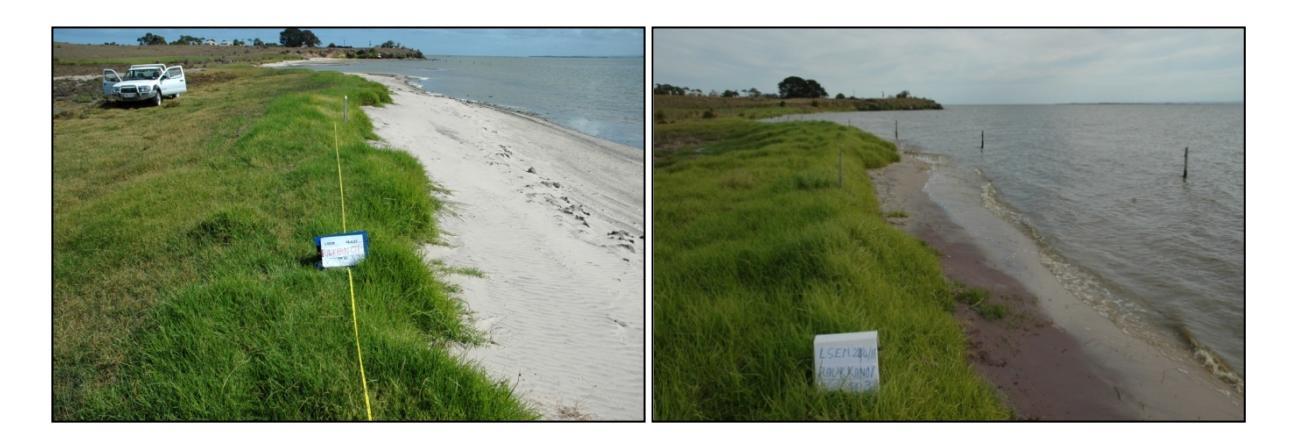
Figure 5-16. Raukkan01 right photo point in April 2007 (I) and April 2011 (r)

Stock trampling of the foreshore dune caused some erosion during the drought period, but within a few months of the return of normal lake levels, the shoreline had been restored, such that net accretion averaging 0.35 m from the original baseline measurements was observed across all three transects. The shoreline does not face a prevailing wind direction.

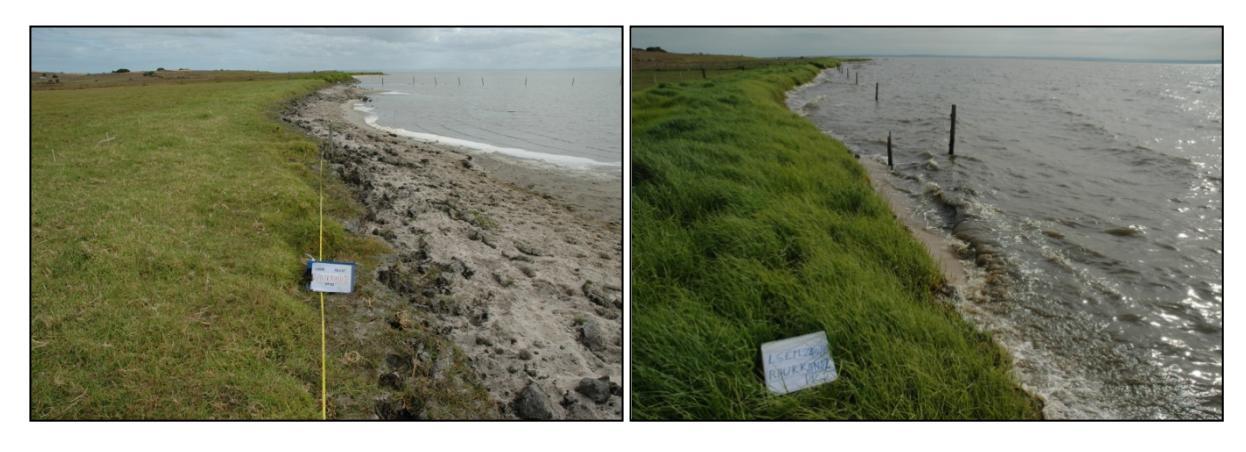
Figure 5-17. Raukkan02 right photo point in April 2007 (I) and April 2011 (r)

Raukkan02 is located approximately 1.8 km WNW of Raukkan01 and has a northerly aspect. This site lacks the foreshore dune present at Raukkan01, with the result that the lake edge was subject to damage and erosion from a combination of sand drift and stock trampling of the dry and crumbling 0.4 m high Poltalloch soil bank during the drought period (Figure 5-17). With the restoration of normal lake levels, significant erosion occurred across all transects – 1.0, 1.5 and 1.2 m respectively at L, C and R. The shoreline at this monitoring site does not face a prevailing wind.

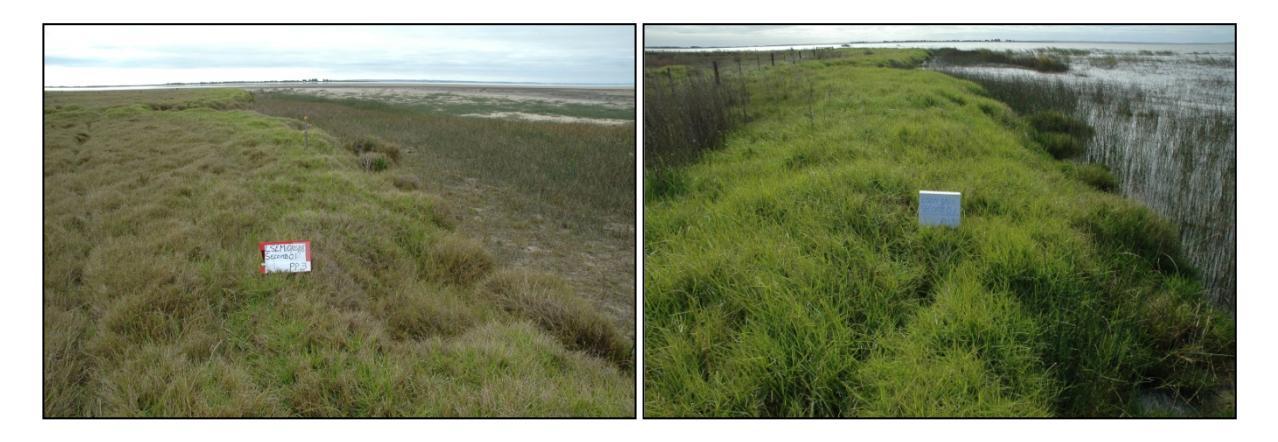
Figure 5-18. Secomb01 right photo point in May 2008 (I) and May 2011 (r)

No erosion occurred at this site. Some minor variations in shoreline measurements were noted during 2008 and 2009, but were attributable to changes in the dense kikuyu matting on the lake edge. No erosion occurred following the restoration of normal lake levels. The shoreline does not face a prevailing wind direction.

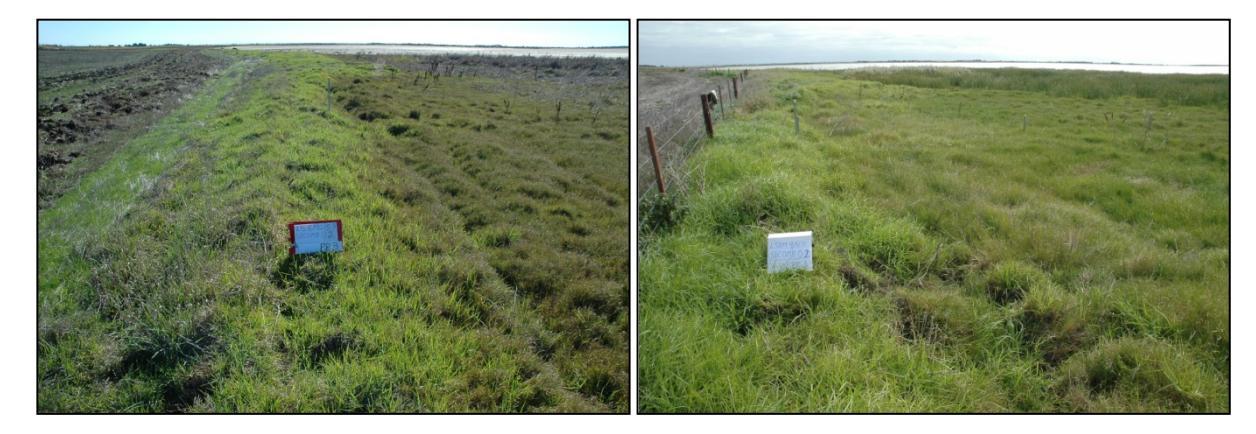
The Secomb02 monitoring site was established in April 2008, approximately 50 m inshore of the bank, which has a selfestablished reed bed (Figure 5-19). The site is located approximately 360 m north-west of Secomb01 along the south-western shore of Lake Albert. This monitoring site has a north-easterly aspect and is located on a shoreline with a medium erosion risk rating. The shoreline is vegetated with kikuyu, paspalum, typha and phragmites and grazing is excluded.

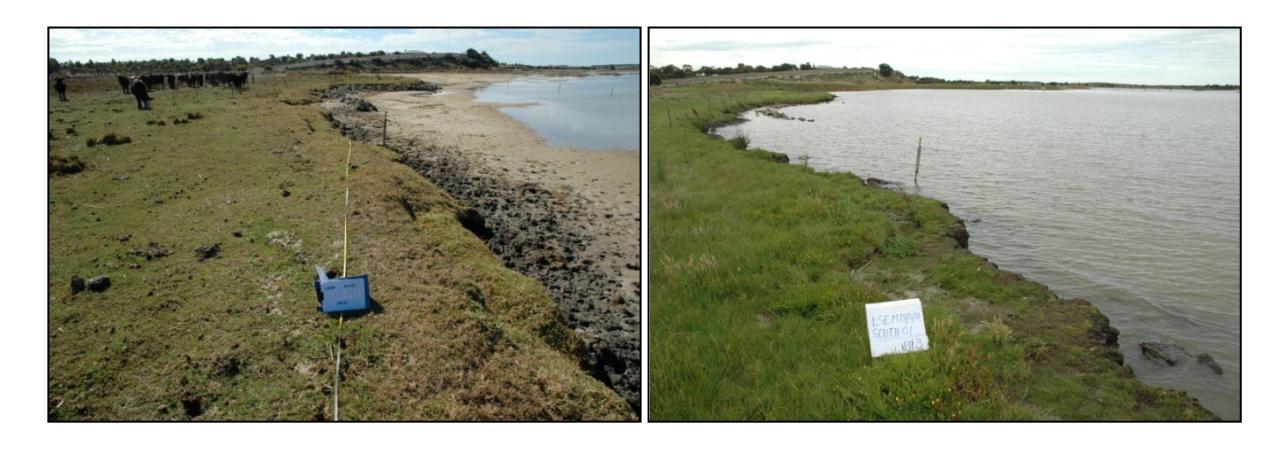
The South monitoring site is located on the eroded south-western shoreline of Point Sturt in Lake Alexandrina and has a southwesterly aspect and a high erosion risk rating. The 0.4 m Poltalloch soil bank is vegetated with paspalum and subject to controlled cattle grazing (Figure 5-20).

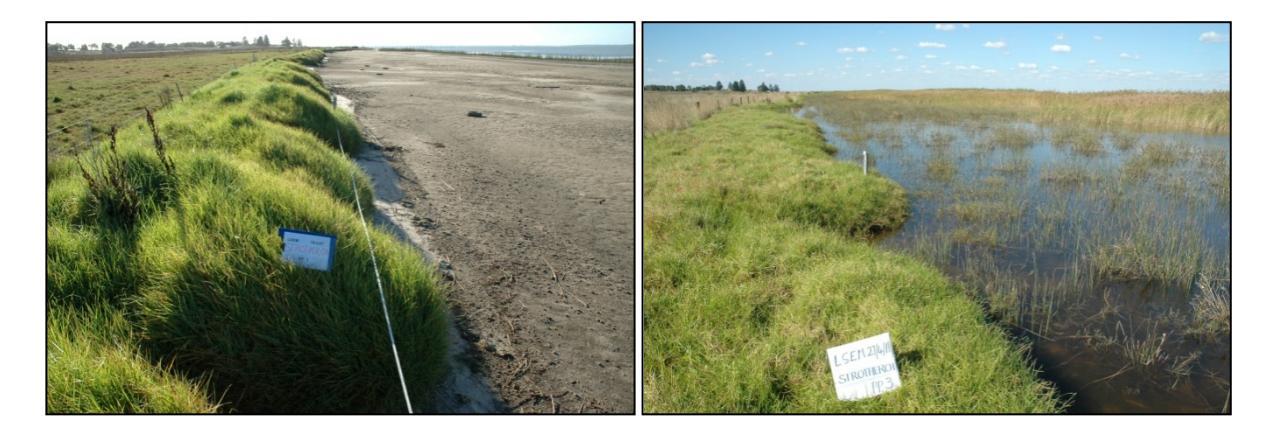
Figure 5-21. Strother01 right photo point in April 2007 (I) and April 2011 (r)

Although this shoreline faces a prevailing wind, erosion at this site was negligible as a result of the established reed bed. Very minor erosion (0.1–0.2 m) occurred at the L and R transects shortly after the monitoring site was set up in November 2006, but no erosion occurred subsequently, even with the return of normal operating lake levels.

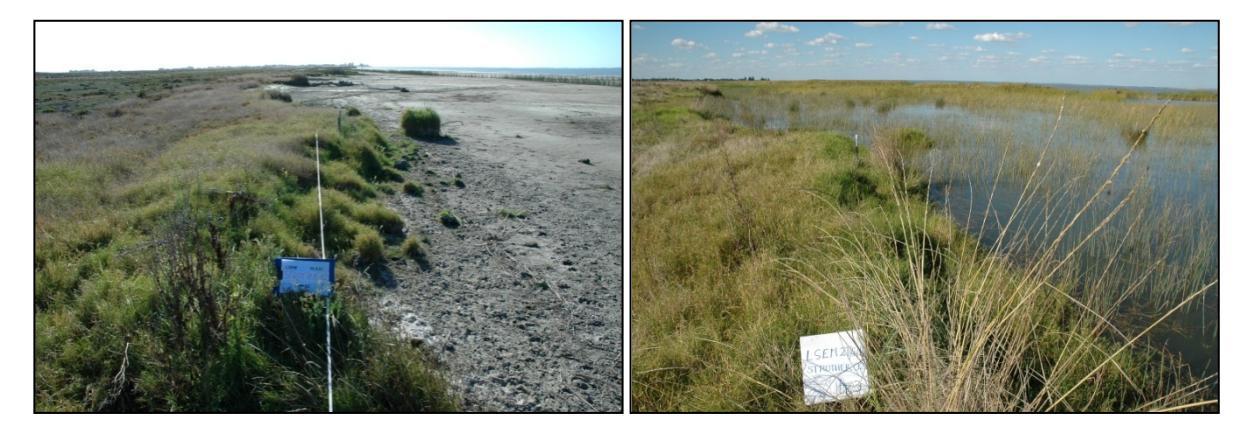
Figure 5-22. Strother02 right photo point in April 2007 (I) and April 2011 (r)

Although this shoreline has exposure to a prevailing wind, erosion at this site was negligible as a result of the established reed bed. Minor erosion (0.15–0.3 m) occurred at the L and R transects shortly after the monitoring site was set up, but no erosion occurred subsequently, even with the return of normal operating lake levels.

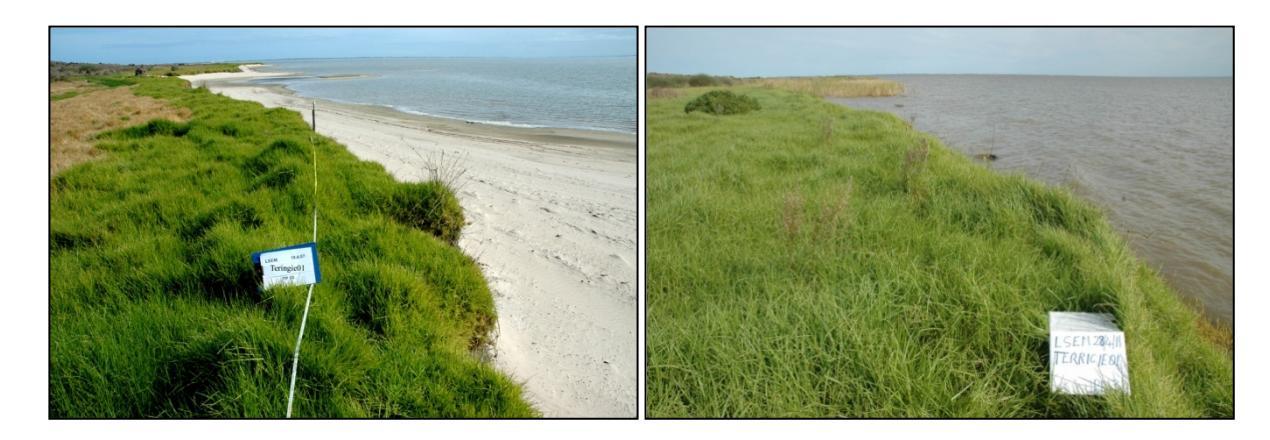
Figure 5-23. Teringie right photo point in April 2007 (I) and April 2011 (r)

No net erosion occurred at this site. Net shoreline growth of 0.25 and 0.4 m, at the L and R monitoring points respectively, was measured at the April 2011 monitoring visit, with almost all of this occurring after the return of normal lake operating levels.

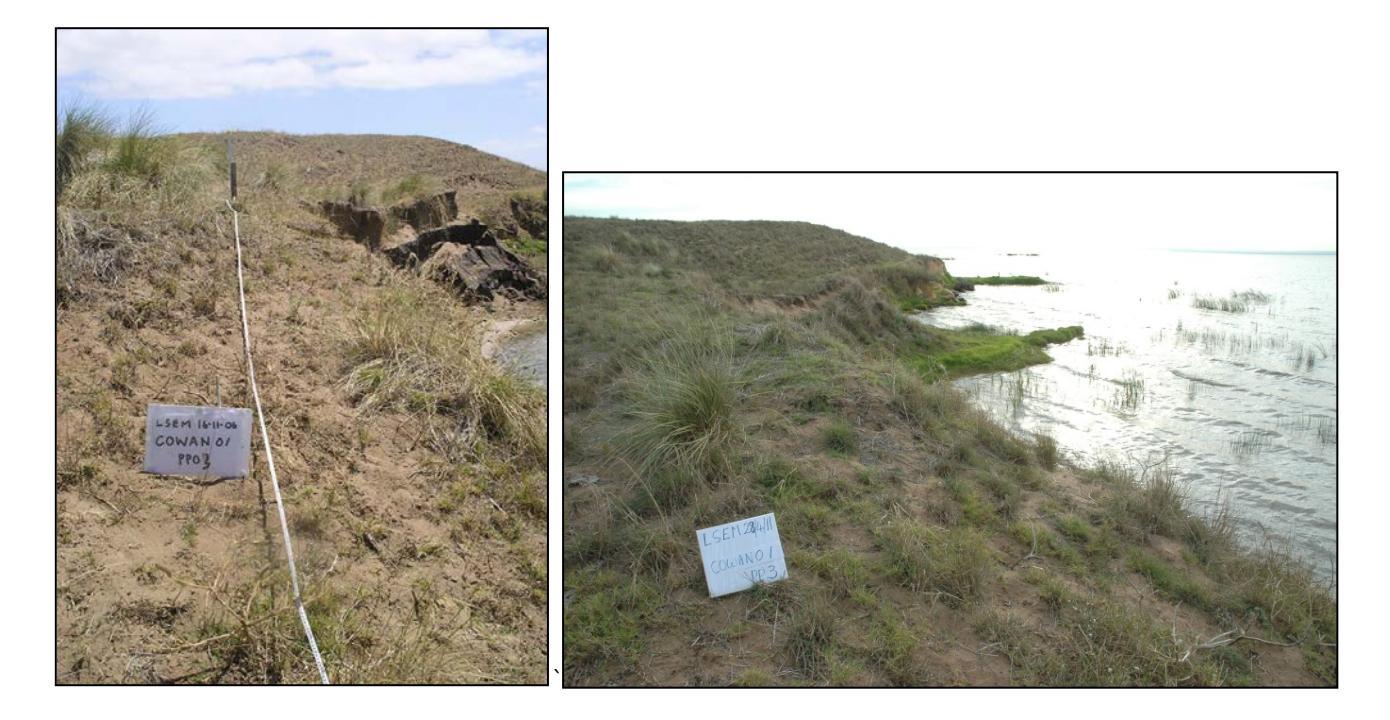
Figure 5-24. Cowan01 right photo point in November 2006 (I) and April 2011 (r)

Cowan01 is characterised by a 3 m high sandy cliff face (Figure 5-24). It is located north-east of Pt McLeay in Lake Alexandrina, in a shoreline section with a NNW aspect and high erosion risk rating. Erosion typically occurs at this site as a result of slumping of 0.5–1 m wide sections, due to direct erosion and undercutting of the sand at beach level. As the site is regularly grazed by cattle, the erosion can be exacerbated by stock trampling and breaking of the dune edge. Bundled tyres have been packed against the base of the cliff to the east of the site to try to control the shoreline erosion. The site is vegetated with marram and other grasses and during the drought blue lupins were observed growing on the exposed lake bed.

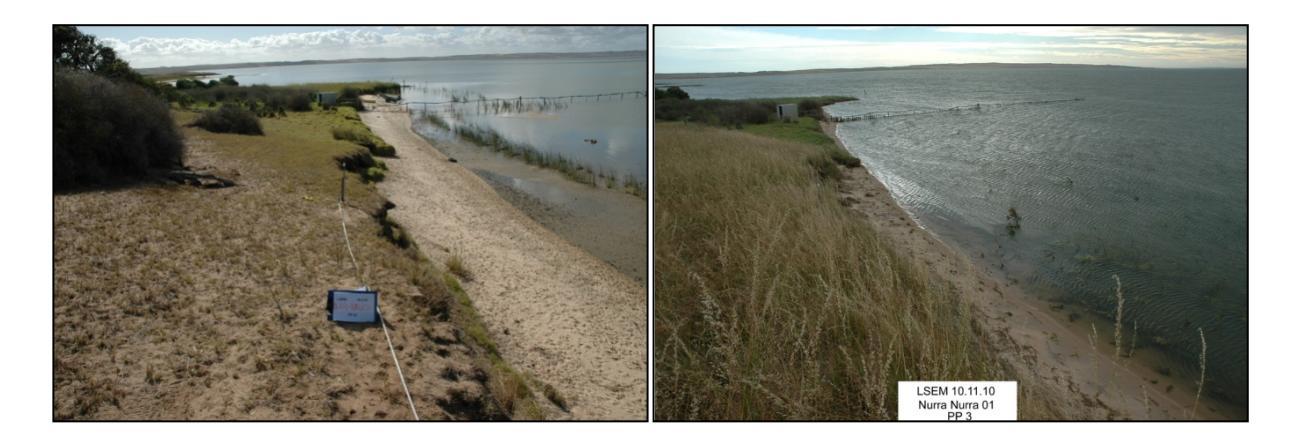
Figure 5-25. Nurra Nurra01 right photo point in April 2007 (I) and November 2010 (r)

Erosion at this site was relatively minor, with total shoreline losses of 0.35, 0.3 and 0.74 m measured at the L, C and R transects, respectively. Given that cliff slumping occurred even when the water was hundreds of m from the shoreline during the drought, there is little evidence from the limited available data to indicate a direct link between water level and shoreline erosion at this site. No erosion was observed at the April 2011 monitoring visit, when lake levels were at their highest for the monitoring period.

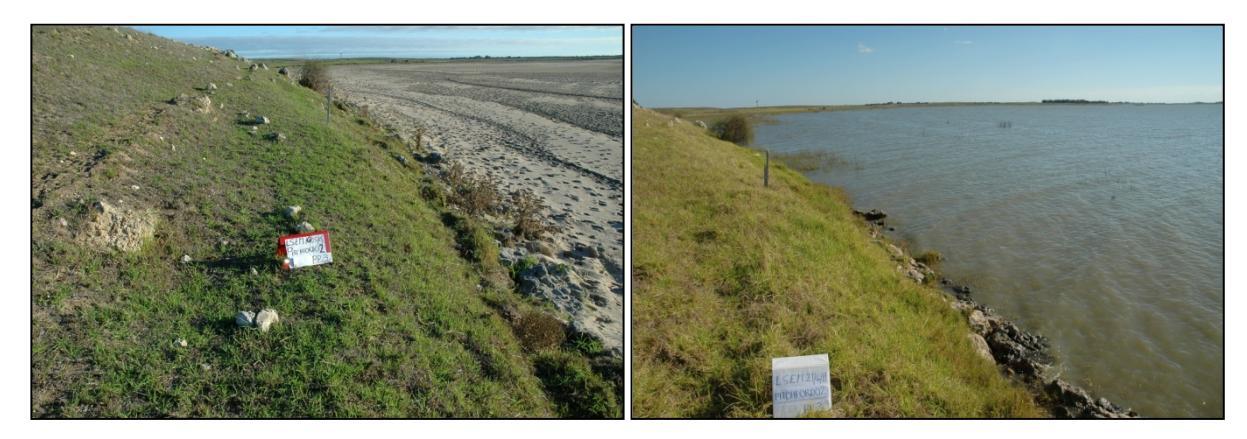
Figure 5-26. Pitchford02 right photo point in May 2008 (I) and April 2011 (r)

No erosion was observed at this site.

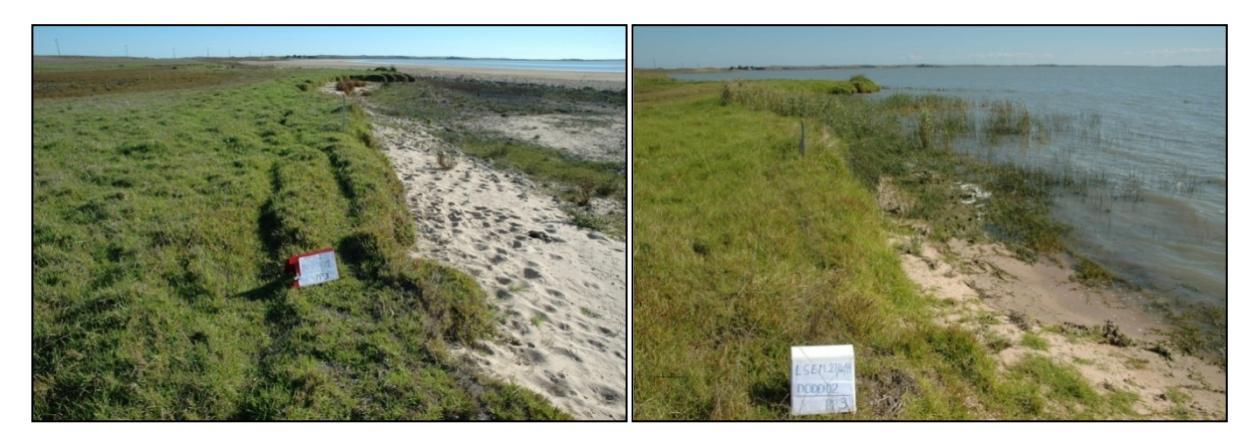
Figure 5-27. Dodd02 right photo point in May 2008 (I) and April 2011 (r)

The monitoring site was established in April 2008. No erosion was measured at this site during the monitoring period; in fact slight accretion (0.1 m) was measured at R during the April 2011 monitoring visit.

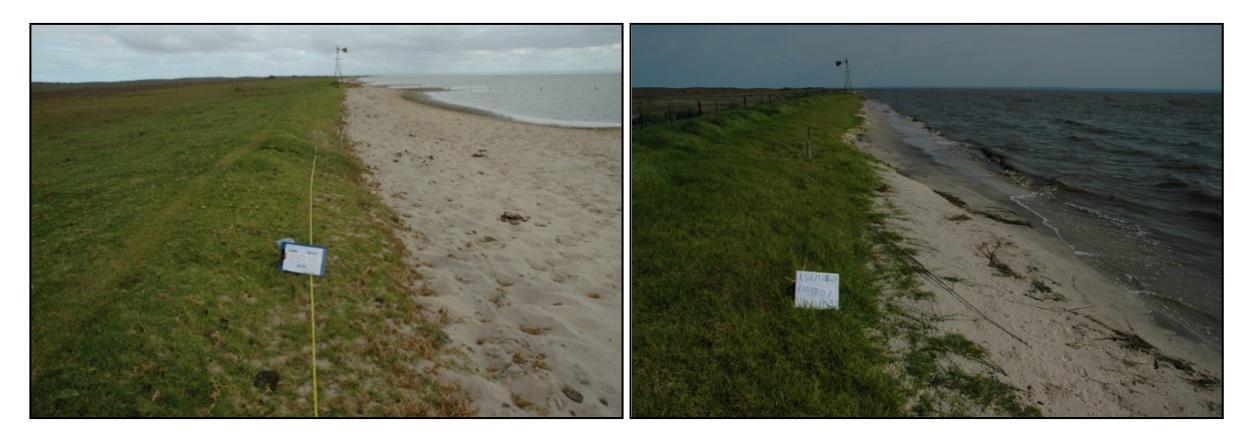
Figure 5-28. Lloyd01 right photo point in April 2007 (I) and April 2011 (r)

Sand deposition on the shoreline from the exposed lakebed was observed during 2008 and 2009. Shoreline measurements were taken to the edge of the kikuyu cover. The kikuyu retreated during the period when the lake levels were very low, but

returned with the restoration of normal lake levels in 2010. No erosion was observed following the restoration of lake levels. No net erosion occurred at this monitoring site, with shoreline growths of 0.55, 1.1 and 0.65 m recorded at L, C and R, respectively.

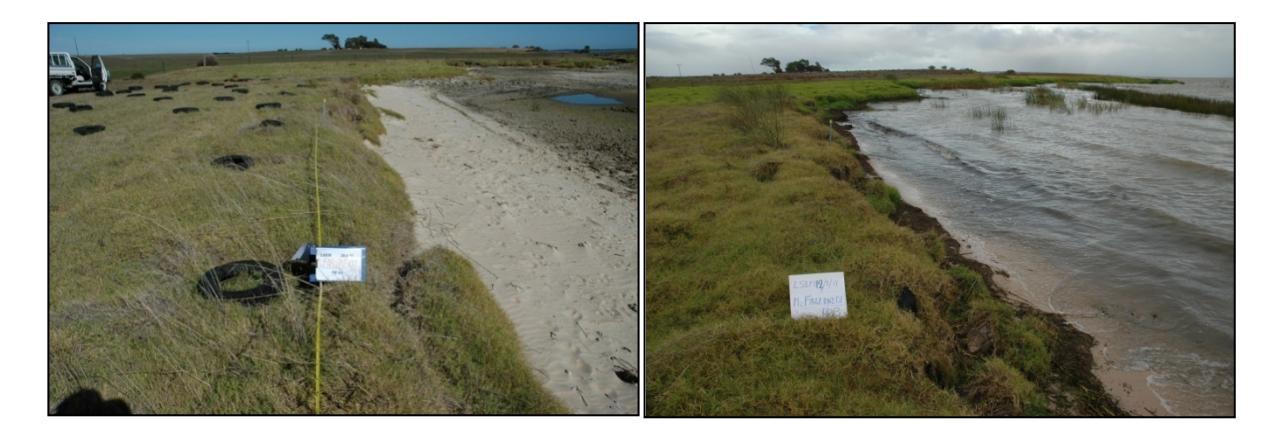
Figure 5-29. McFarlane right photo point in April 2007 (I) and May 2011 (r)

The McFarlane monitoring site is located on the eroded north-eastern shore of Lake Alexandrina opposite Pomanda Point, on a section of shoreline with a westerly aspect and low erosion risk rating. The shoreline consists of a calcareous sand bank, 0.8 m high, overlying a clay soil (Figure 5-29). The shoreline is vegetated with couch grass and protected from grazing by an exclusion fence constructed 20 m from the shoreline. Offshore reed beds were established in early 2007 and regenerated following the return of normal lake levels after the drought.

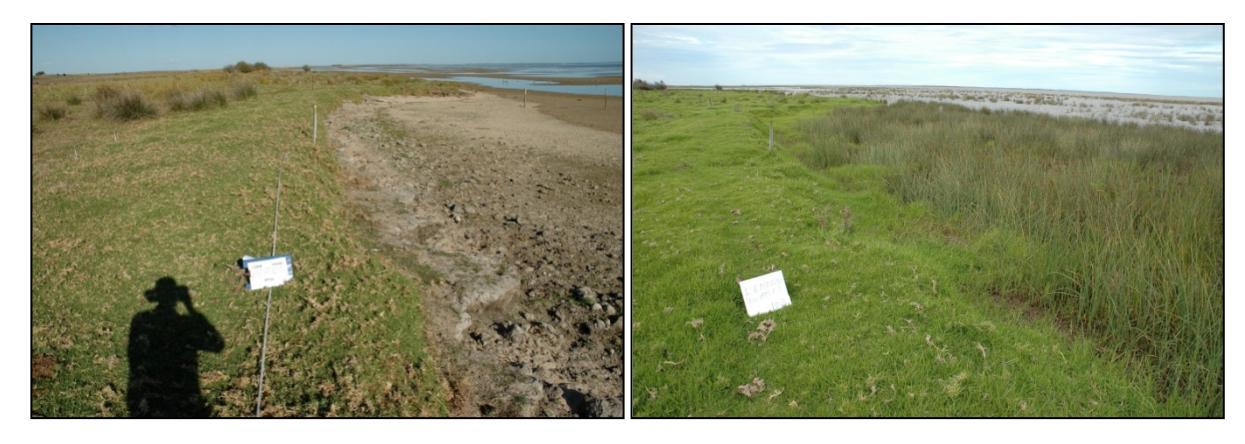
Figure 5-30. Withers right photo point in April 2007 (I) and May 2011 (r)

Although this site is exposed to a prevailing wind, no erosion was observed. However some minor erosion of the bank was observed along the L transect during the period that the lakebed was dry, with the waterline located 350 m offshore, due to the trampling of cattle grazing the lakebed. Shoreline growths of 0.6 and 0.2 m, respectively, were measured at the C and R transects.
