South Australian Heritage Act 1978-82	Register of State Heritage Items ITEM EVALUATION SHEET Buildings and Structures	Ref. No. 6630-10435
	Item STONE WALL COMMERCIAL STREET (EAST SIDE) BURRA	Status None
Age 1850's	Subject -	Style Vernacular

South Australian Heritage Act 1978-82	Register of State Heritage Items ITEM EVALUATION SHEET Buildings and Structures Item: STONE WALL COMMERCIAL STREET (EAST SIDE) BURRA	Ref. No. 6630-10435 Prepared By: Ivar Nelsen Iris Iwanicki
---	--	--

**Stone Wall located on the east side of Commercial Street and Ware Street
cnr Commercial & Ware Streets, Burra**

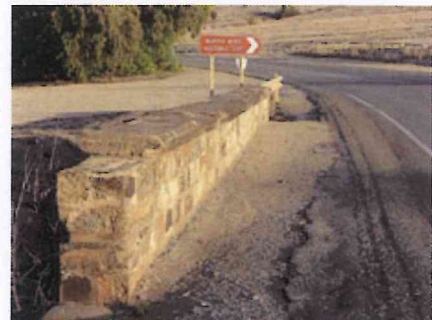
Eastern parapet, Market Street, 2005

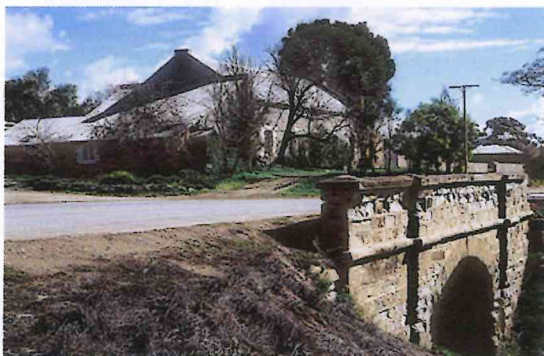
With the widening of the main road, sections of Mine Bridge have been removed at various times and the creek bed has been backfilled on the western side. Only the eastern parapet and arch detailing now survive, with a concrete pipe channelling water from the mine site to the west.

Eastern arch and parapet, 1994

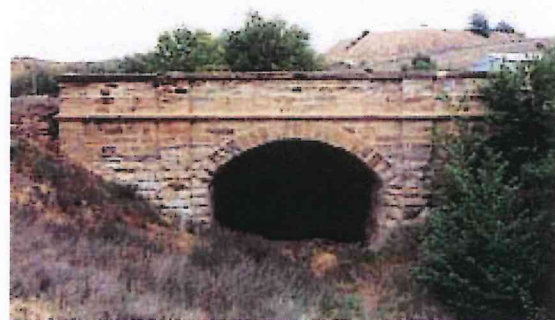
Creekbed and surviving stone arch, 2005

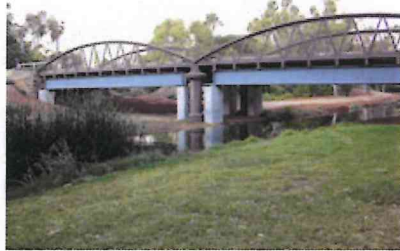
The bridge consists of two 18-metre arched spans, on two metal pillars sunk into the creek bed. It was originally finished with jarrah planking, but the Highways Department replaced this with concrete in the 1930s.

Kooringa Bridge, 2005

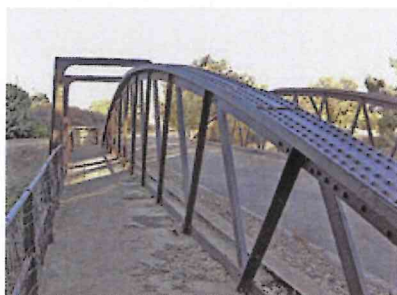
Footpath, Redruth Bridge, 2005

The Redruth Bridge cost £1,400 to build, and replaced an earlier timber laminated arch bridge that had become quite rotten and unsafe. The bridge was designed as an iron bow-string truss with shaped stone abutments, and provided separate vehicular and pedestrian access. Like the bridge at Kooringa, the Redruth Bridge was originally finished with jarrah planking, which was replaced with reinforced concrete in the 1930s.

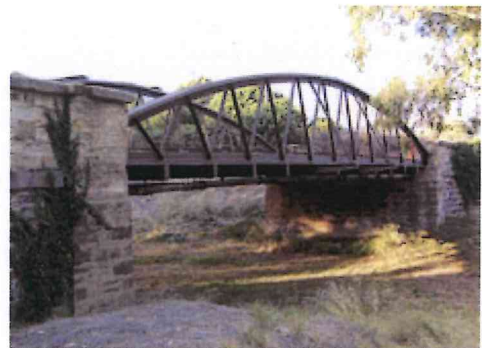
Redruth Bridge, 2005

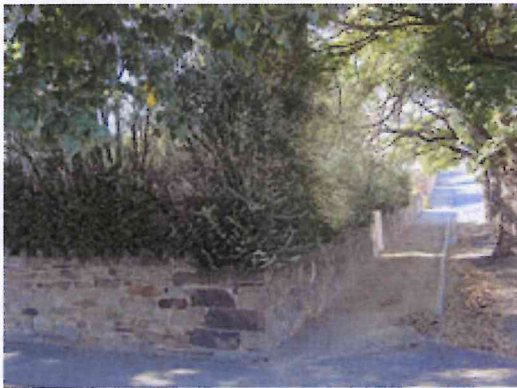
Corner Commercial (east) and Ware Streets, 2005

The wall on Commercial Street's east side is an L-shaped one, on the corner of Ware Street. It stands near the remains of Burra's first Roman Catholic chapel and school (late 1840s).

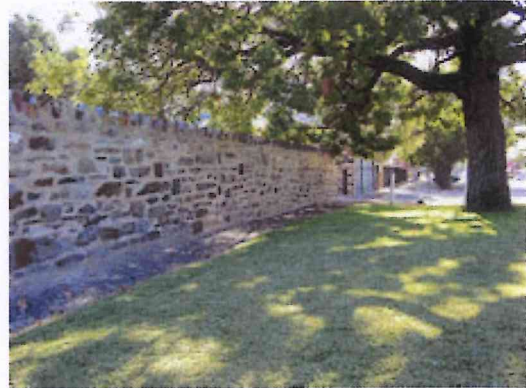
Wall on Commercial Street (west), 2005

The wall on the west side of Commercial Street stands near 'The Paddock', where the bullock teams were pastured, opposite the original Burra Hotel and by the main southern entrance to the town.

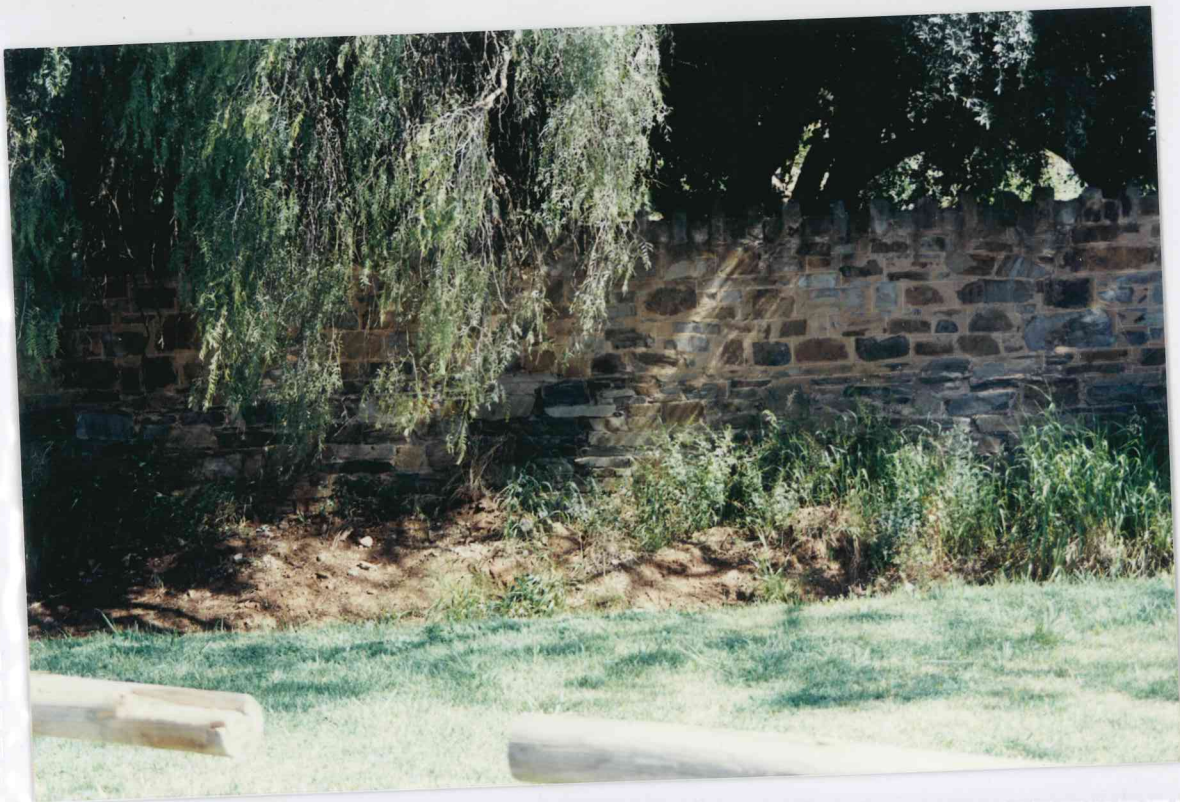
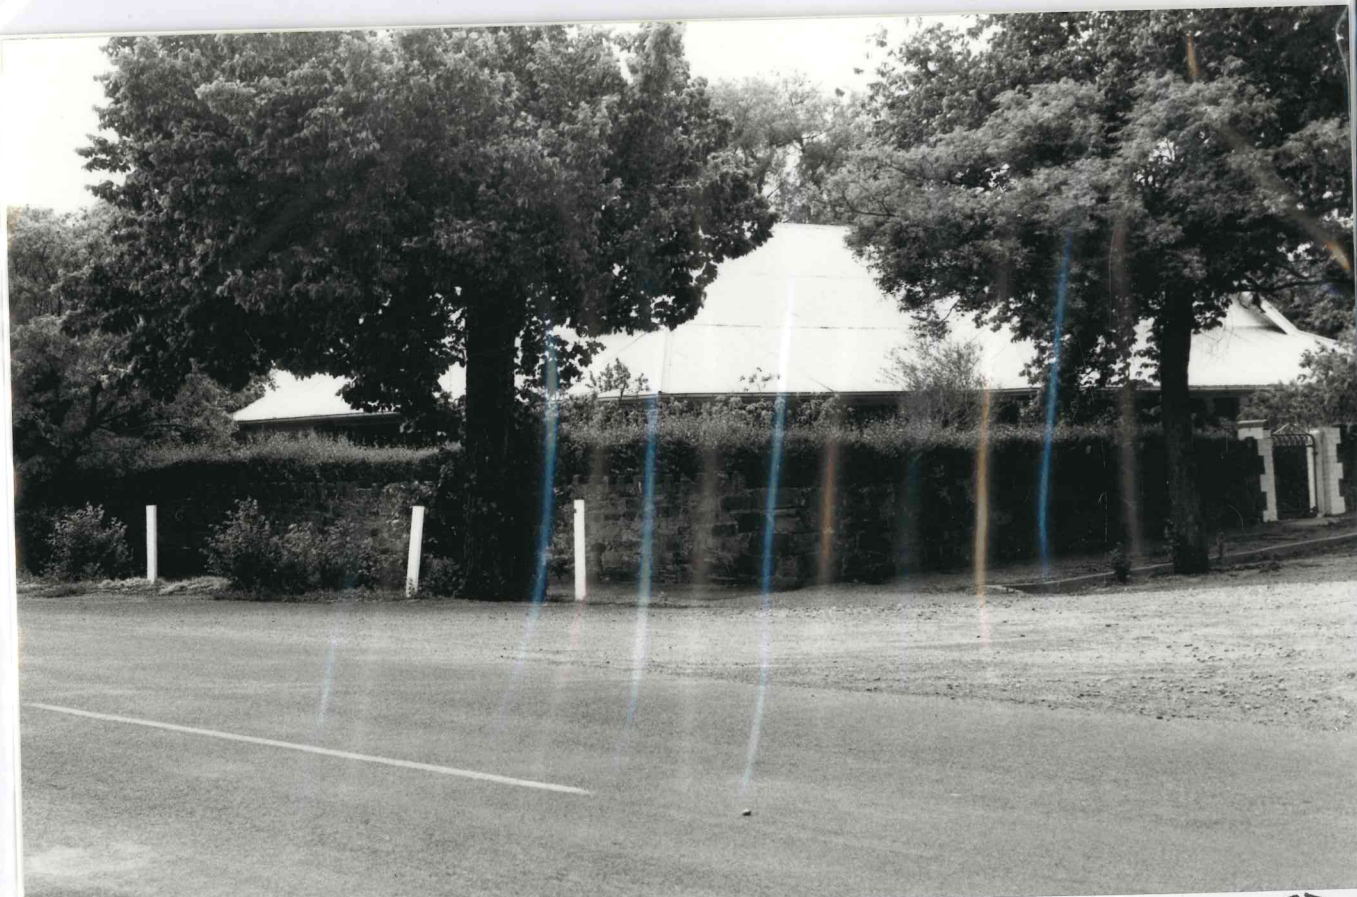
6630-10435
STONE WALL

Context	Illustrates the workmanship of Burra's stone masons, many of whom were of Cornish origin.	E	VG X	AG	FP	NA
Person/Group	Not readily available, possibly Cornish masons.			X		
Event	No known event					X
Architect/Builder	Not readily available.					X
Design	'L' shaped plan, stone wall with castellated stone capping, this capping is relatively unique to Burra but not rare.			X		
Construction	Coursed rubble stone, castellated to course.			X		
Interior	Not applicable.					X
Representation	Similar to many other stone walls in Burra, several of this type have been included with recent approved nominations.			X		
Continuity	Attached to the ruins of the original Catholic Chapel, part of a residential property now (1920's) reflected in the wall across the road.			X		
Local Character	A contributing element in the character of Burra, obscured by trees and vegetation behind it, located on main entry road.			X

Landmark	Not a striking visual element, its contribution is more subtle, somewhat overshadowed by vegetation behind it.				X	
Alterations	None obvious, no indications of being part of a larger walled area.	X				
Condition	No obvious faults.			X		
Compatibility	Still used as a perimeter wall.	X
