HERITAGE SURVEY
ITEM IDENTIFICATION SHEET

Item No. : NAR:007
ITEM NAME: National Bank
Former or other names:

LOCATION:
Address: 81-83 Smith Street,
Naracoorte
Allotment: 11
Section : c
Hundred : Naracoorte
County : Robe
L.G.A. : Naracoorte
S.H.P. Region: 6
A.M.G., Ref. Z: 54 N: 5909800
E: 476950

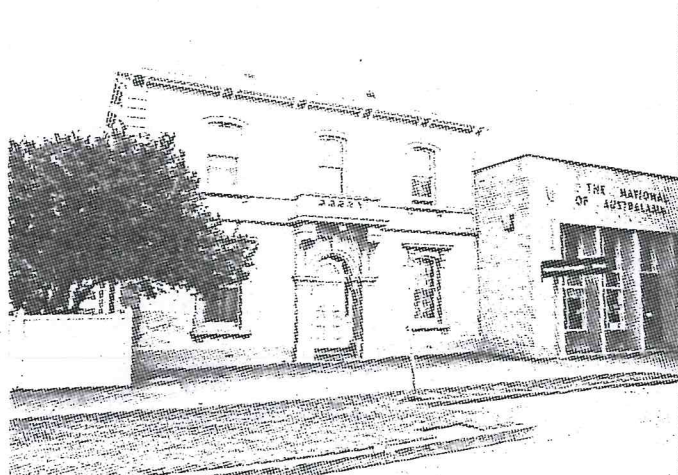
PHOTOGRAPHS:
Slide No : 3/35
Film No : 4
Negative No: 8

Random coursed limestone with green painted quoins, surrounds and string course. Corrugated galvanized iron hipped roof. Elaborate dressed stone detailing around Smith Street entrance with small overhanging parapet above door. Door has semicircular fanlight and sidelights. Two storey building with Georgian proportions and Classical detailing.

The National Bank established a branch in Naracoorte in 1867 and the present building was erected in 1873. This building was remodelled in about 1956, when the present single storey banking chamber was added to the southern side.
