# Case study: Re-use of irrigation drainage water

**Location:** Riverland

**Project:** Investigation of the potential commercial viability of using saline irrigation drainage water to grow fruiting date palms.

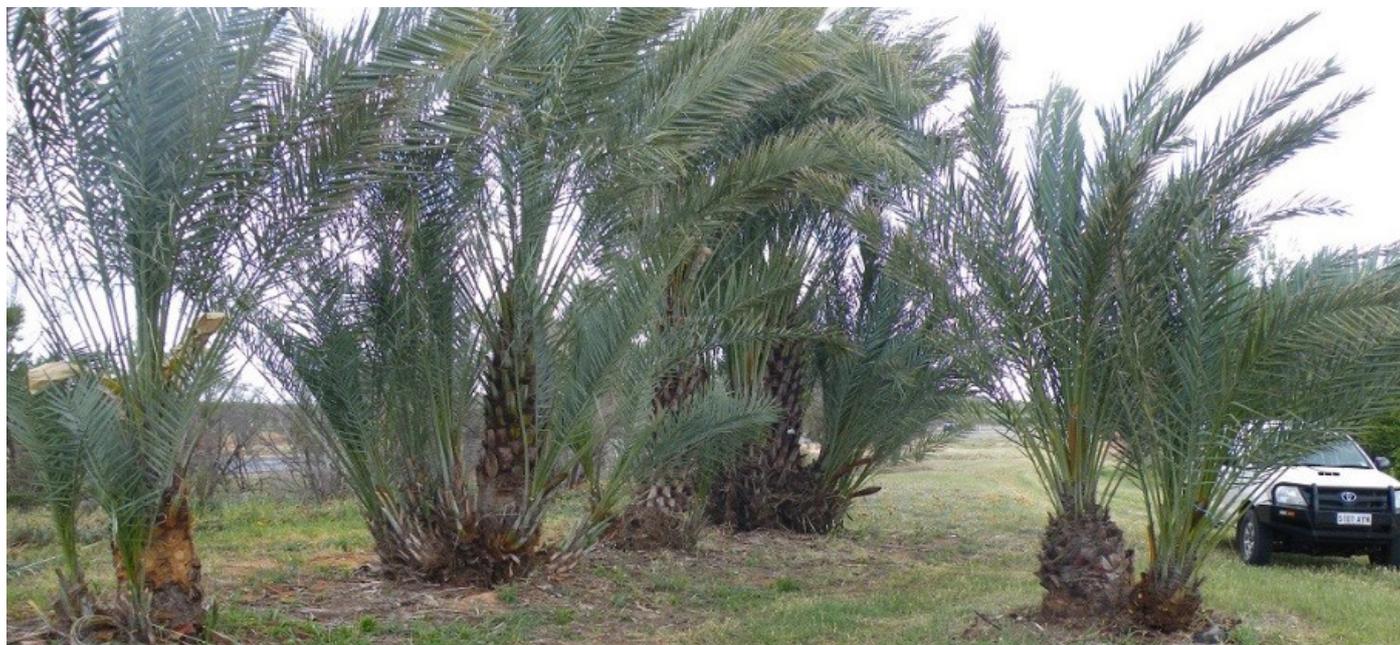
Above – the date palms after pruning ready for irrigation. Image: D Reilly

A small existing planting of five date palms was pruned back in 2013 in preparation for commercial production. In October 2014, a water meter and sprinklers were installed to measure and deliver the re-used water on the date palms.

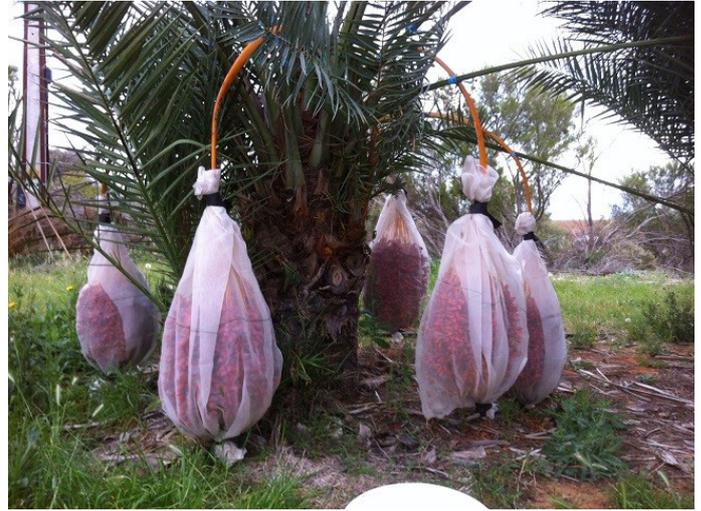
Above – One of the female palms in fruit. The fruit are covered in protective bags to prevent bird and insect damage.  
Image: D Reilly

The two female palms produced five fruit bunches yielding 58.5 and 44kg. In comparison, commercial date growers would aim for around 90kg per palm from 10-12 fruit bunches. The female palms in this study originated from seed whereas selected elite cultivars are used to establish commercial plantings. With time and management it is expected production would increase.
