# FRANKLIN HARBOUR

HERITAGE SURVEY OF THE EYRE PENINSULA AND WEST COAST

(REGION 12 - SOUTH AUSTRALIA)

ITEM IDENTIFICATION SHEET

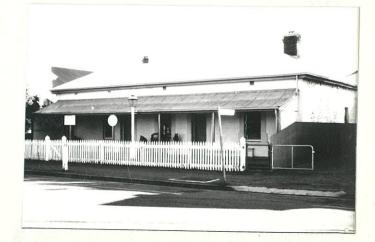
B & W No .: 1/21

Rendered limestone walls and quoins with hipped corrugated galvanised iron roof and brick chimneys. Raked verandah with simple timber posts. Multi-paned double hung sash windows and fanlight. White picket fence along front boundary.

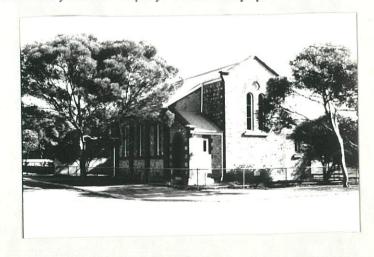
1/36

Foundation stone laid October, 1908, by James Cleave. Opened April, 1910, by Archdeacon Samwell. When the Archdeacon had been to Lincoln, England, previous to lauing of foundation stone he had been presented with a carved capitol, of pillar from St. Hugh's Cathederal which dates back to A.D. 1210 and was being restored at the time of his visit. The pillar was placed in the sanctuary of St. Hugh's, Cowell and served as a Creedence table.
