HERITAGE SURVEY OF THE EYRE PENINSULA AND WEST COAST

5. D.C. OF LE HUNTE

ITEM IDENTIFICATION SHEET

Prepared for the State Heritage Branch of the Department of Environment and Planning by Danvers Architects, Adelaide 1987.

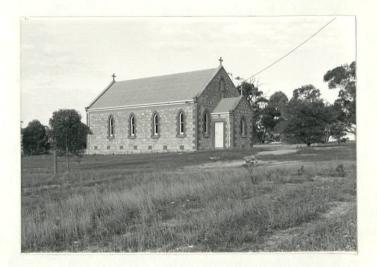
ITEM NO .: LEH:001

Good

Random rubble stonework church with brick quoins. Gable ended corrugated galvanised iron roof with crosses at all apexes. Ecclesiastical windows. Random rubble stonework porch.

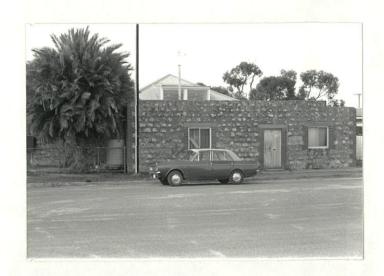
ITEM NO .: LEH:002

Fair

Random rubble stone building with brick quoins and hipped corrugated galvanised iron roof. Modern windows. Addition of random rubble stone.

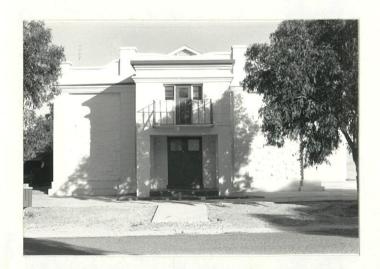
ITEM NO .: LEH:003

Good

Rusticated stonework building with rendered quoins. Hipped corrugated galvanised iron roof with gablet. Porch and parapet wall on front elevation.

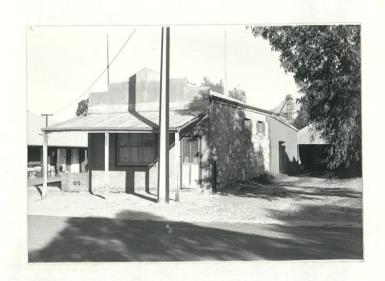
ITEM NO .: LEH:004

Fair

Rubble walls with rendered facade and brick quoins. Gable ended corrugated galvanised iron roof with metal. parapet wall. Raked verandah with simple timber posts. Plate glass windows. Corrugated galvanised iron lean-to.

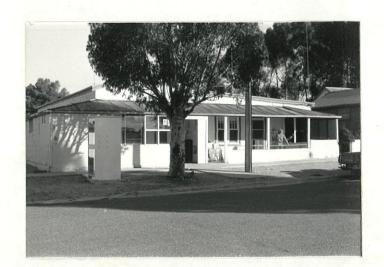
ITEM NO .: LEH:005

Fair

Rubble building with gable ended roof clad with corrugated galvanised iron. Raked return verandah, partly built in. Lean-to at side.

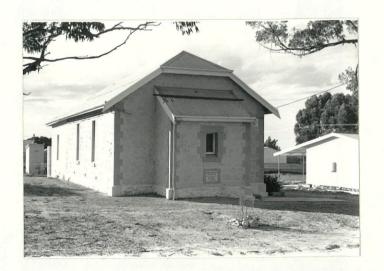
ITEM NO .: LEH:006

Good

Painted random rubble stonework church with brick quoins. Half hipped roof clad with corrugated galvanised iron. Double hung sash windows. Painted random rubble stone addition and porch.

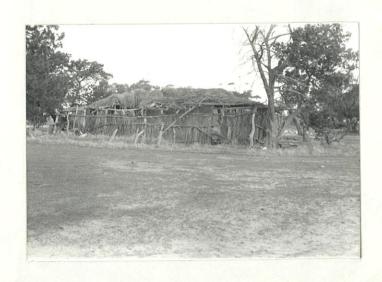
ITEM NO .: LEH:008

Dilapidated

Walls of thatch with native pine uprights. Thatch roof.

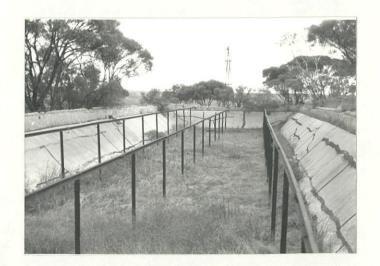
ITEM NO .: LEH:010

Fair

Random rubble stone tank with rendered internal walls. Mostly underground.

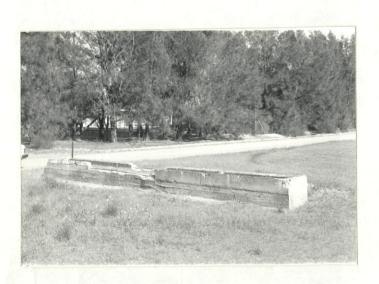
ITEM NO - LEH:011

Concrete trough, 8 metres long.

It was used by both horses and camels.

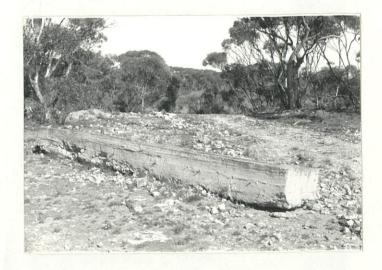
ITEM NO .: LEH:012

Fair

Concrete trough, 8 metres long.

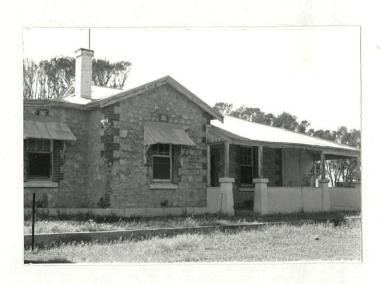
ITEM NO.: LEH:014

Dilapidated

Random rubble stonework house with brick quoins. Hipped and gable ended roof clad with corrugated galvanised iron. Gablet and brick chimneys. Partly built in, raked return verandah is extension of roof with masonry balustrade. Multi-paned double hung sash windows and window hood.

Built as a Manager's residence for the Research Station for the Department of Agriculture.
